*Board of Supervisors
City and County of San Francisco*

Government Audit and Oversight Committee

Supplemental Report for Foundation Settlement Investigation

**SUPPLEMENTAL REPORT
FOUNDATION SETTLEMENT INVESTIGATION
301 MISSION STREET
SAN FRANCISCO, CALIFORNIA**

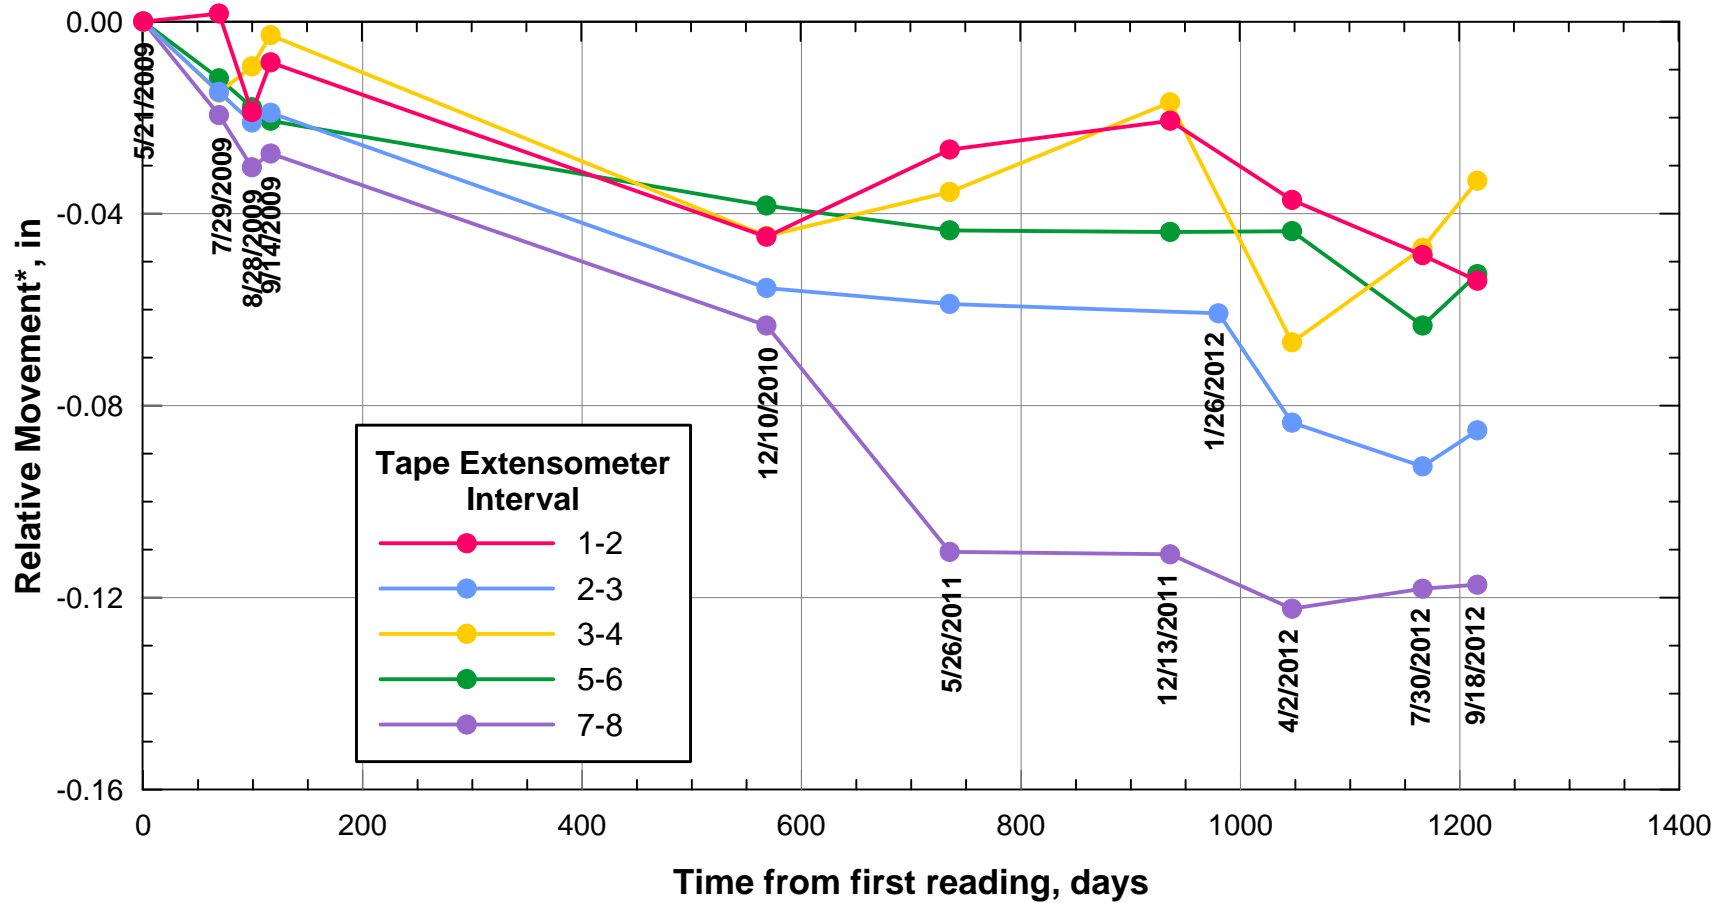
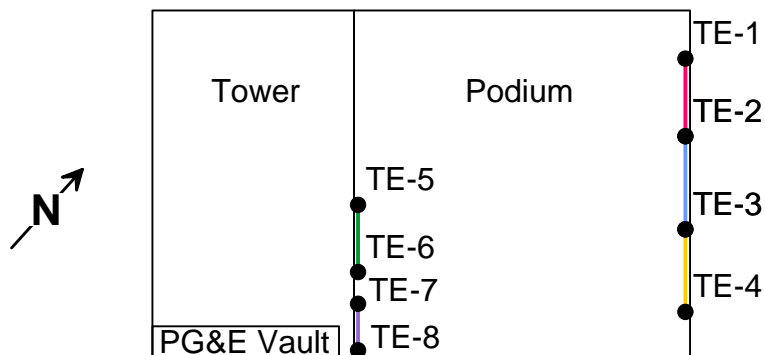
RELATIVE MOVEMENT OF TAPE EXTENSOMETER INTERVALS

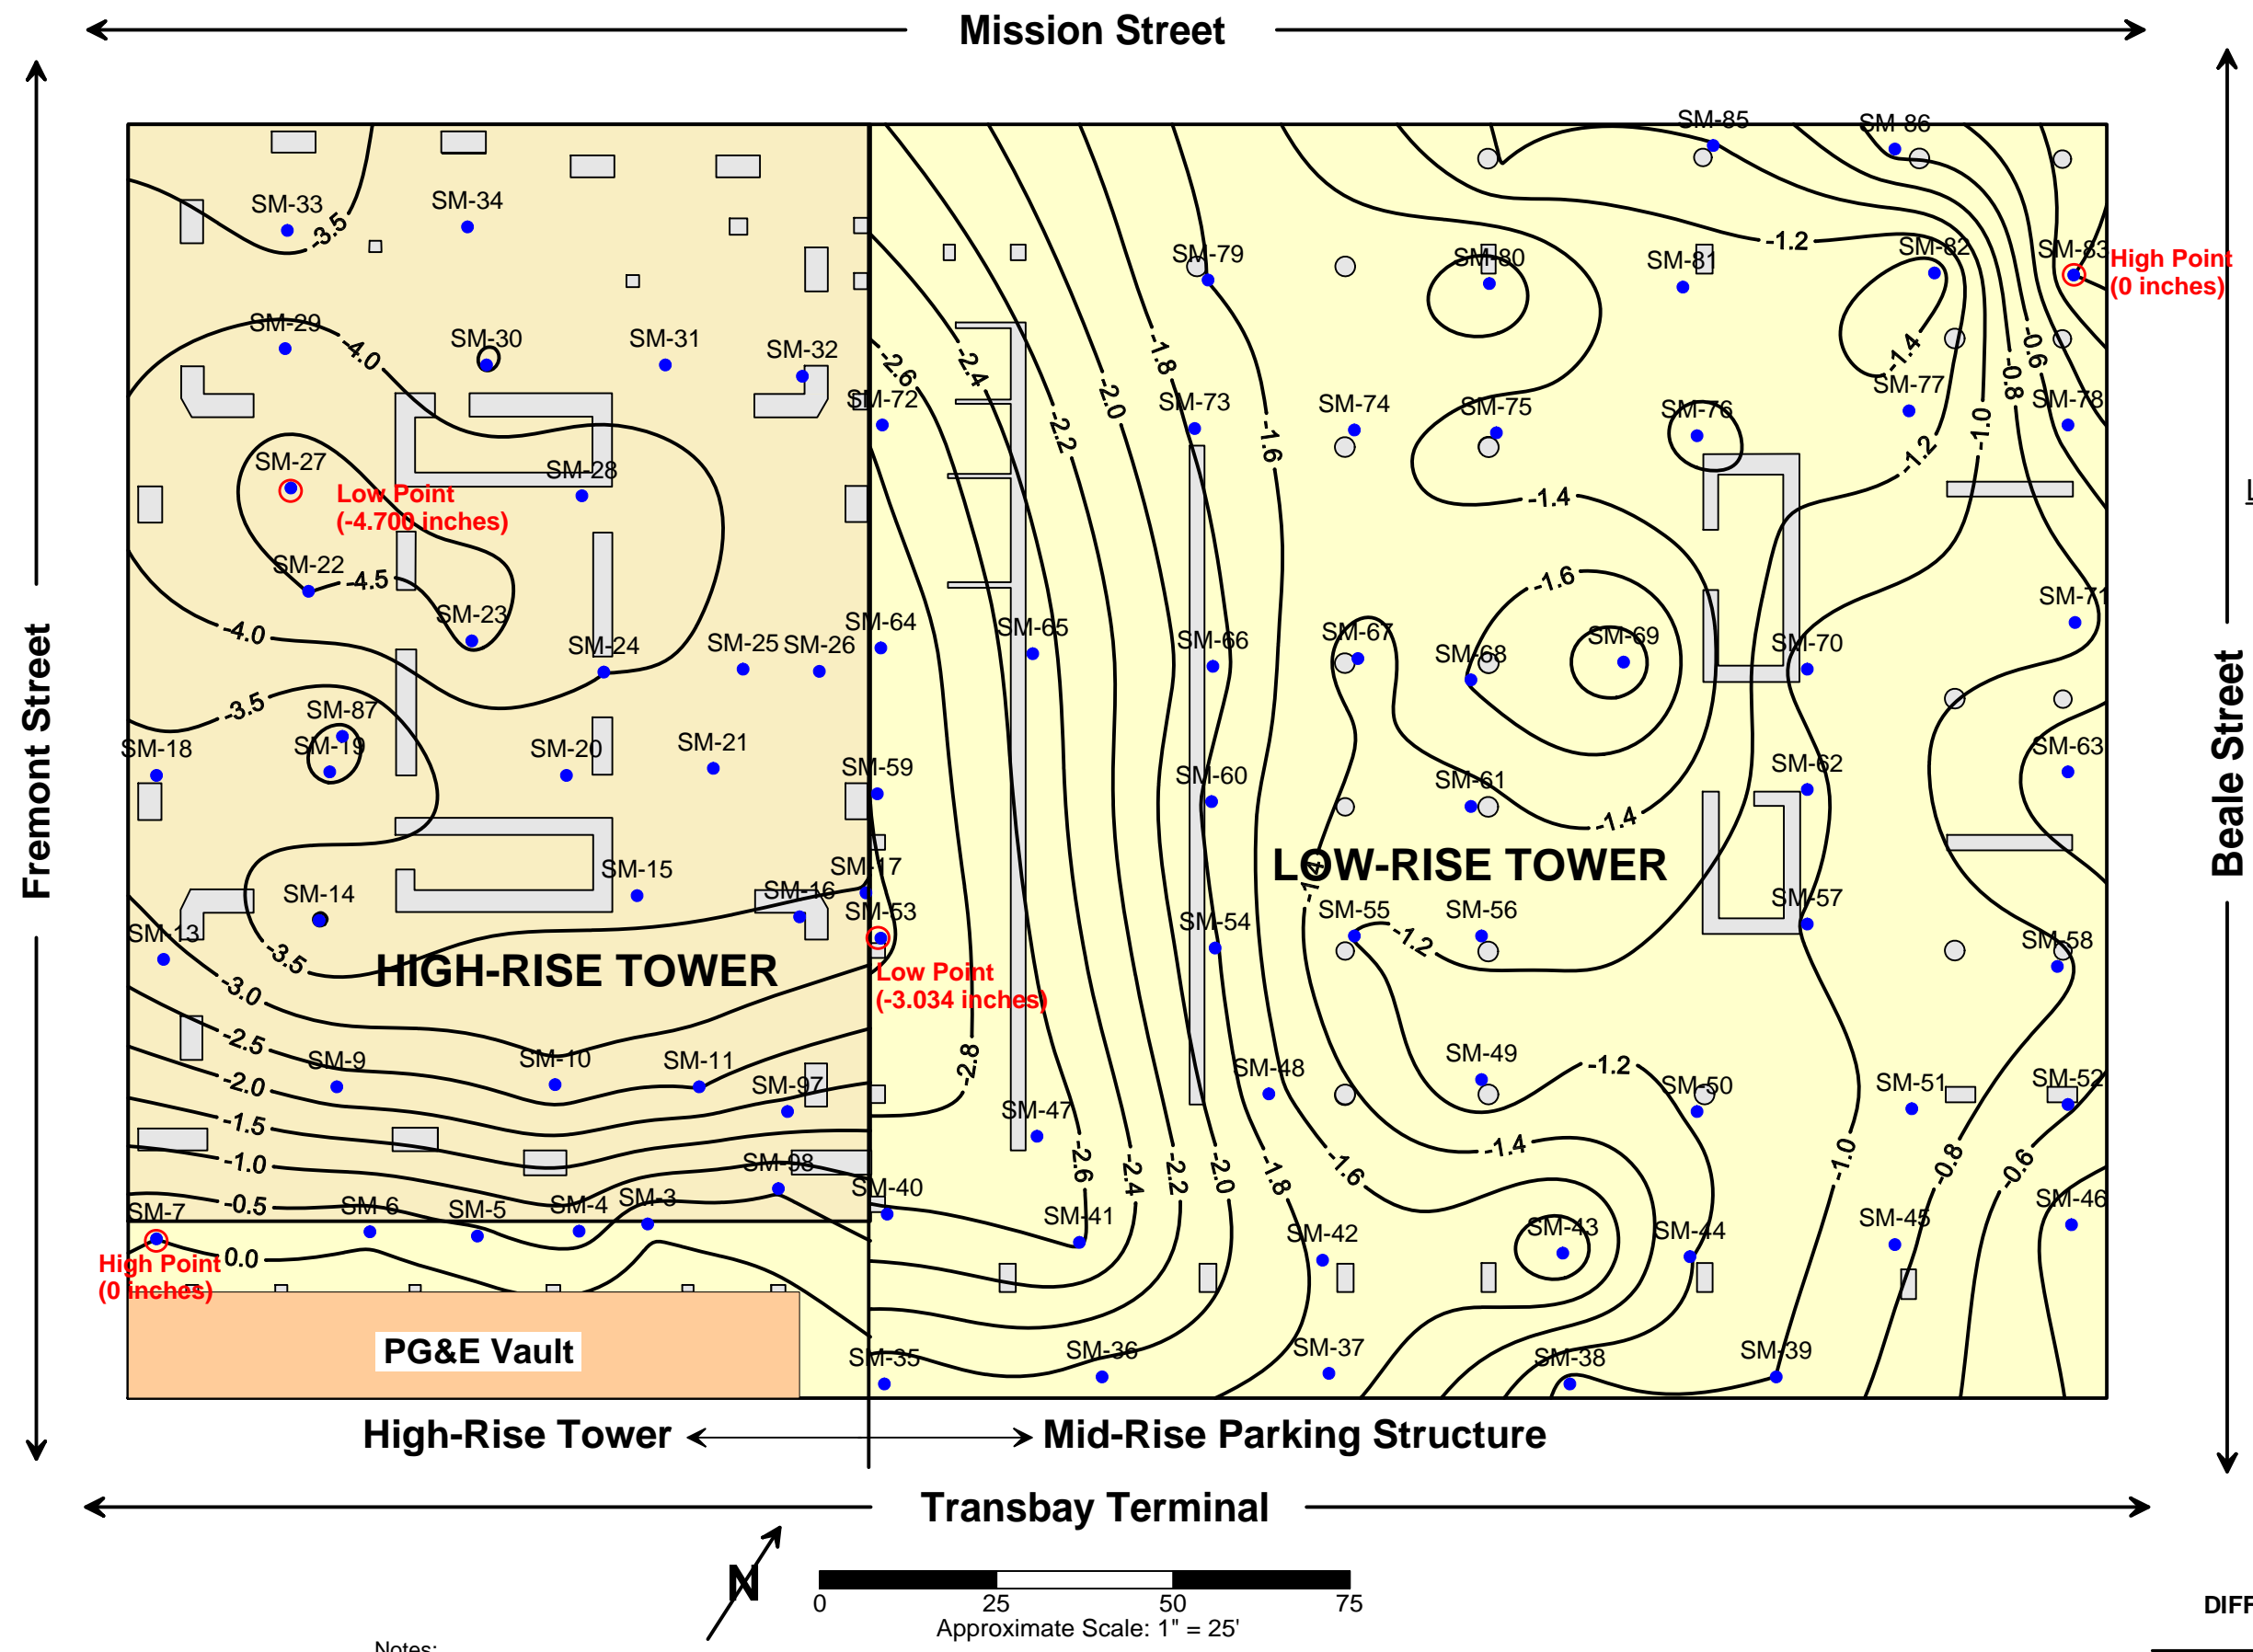
DIFFERENTIAL FLOOR ELEVATIONS (INCHES)
DECEMBER 26, 2012 SURVEY
Transbay Transit Center
301 Mission Monitoring
Transbay Joint Powers Authority
San Francisco, California
January 2013

Notes:
Contours represent differential elevation, in inches, between the highest point and all other points taken on December 26, 2012.
Level B-1 at Mid-Rise Parking portion of survey site is approximately 4 inches higher than Level B-1 at High-Rise Tower portion.
The PG&E vault is inaccessible for monitoring.
Contour intervals are different between the High-Rise Tower and the Low-Rise Tower.

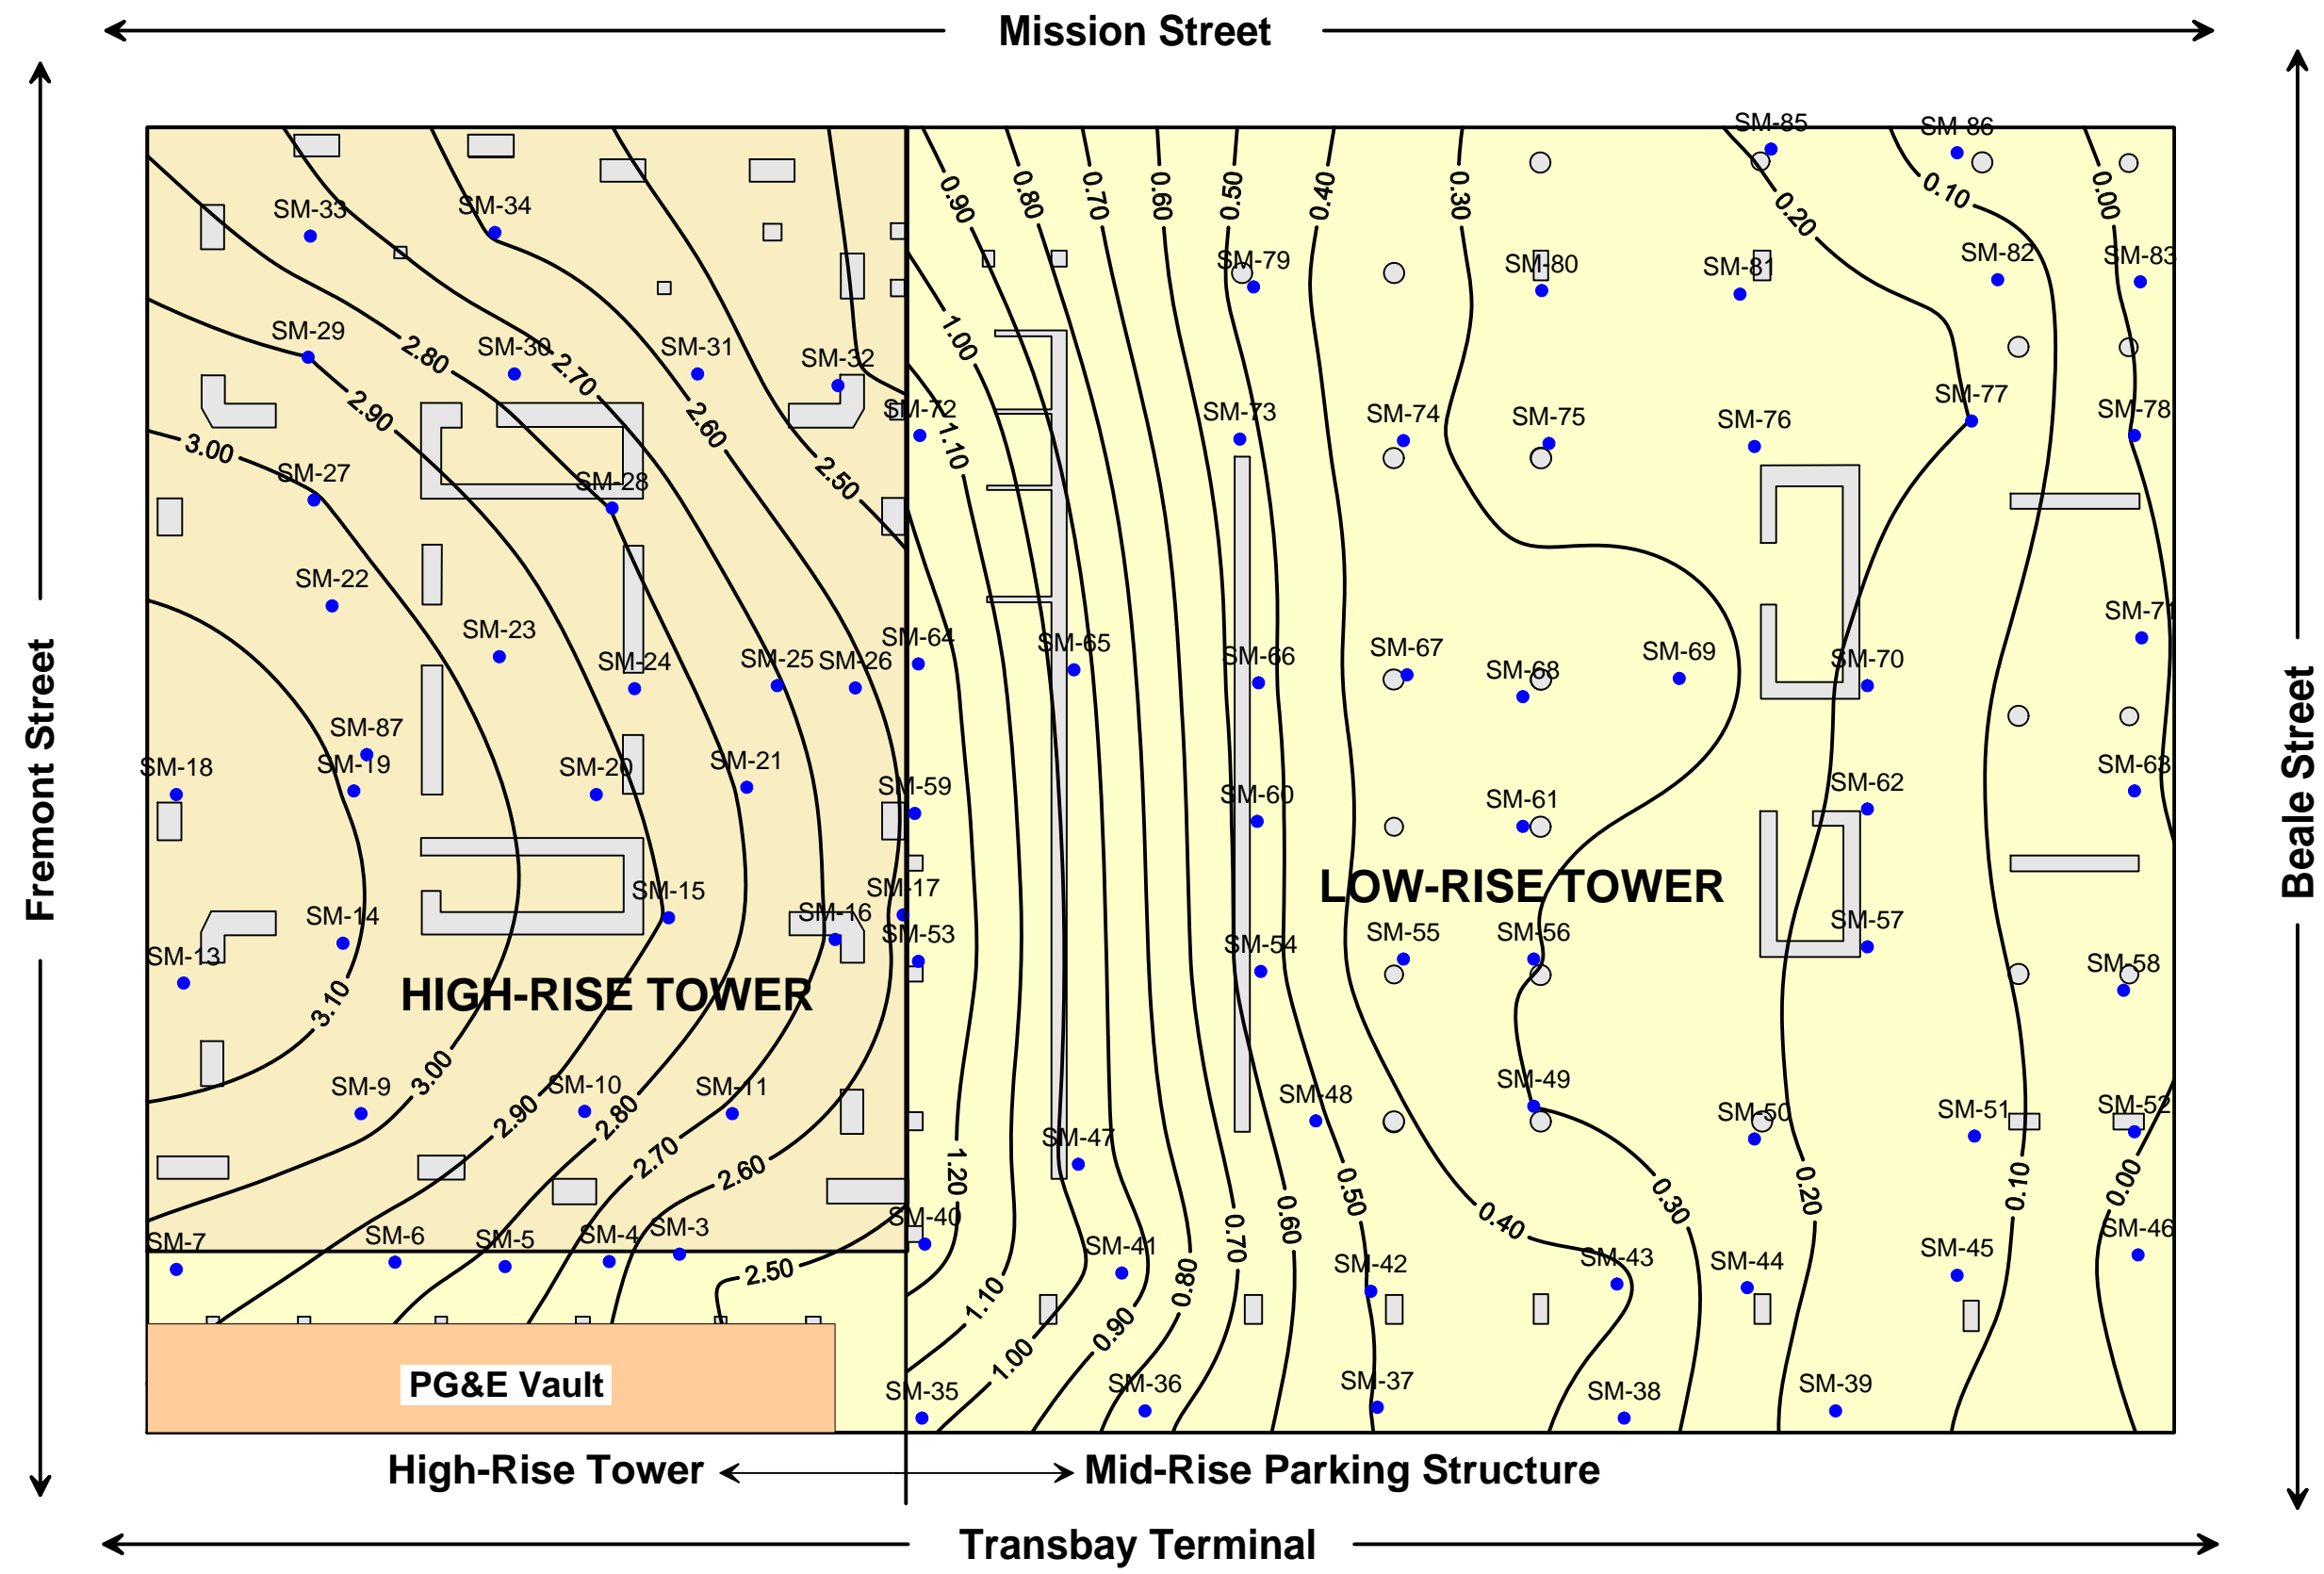
**CONTOURS OF SETTLEMENTS MEASURED AT THE
FIRST LEVEL BASEMENT OF THE 301 MISSION STREET
STRUCTURE BETWEEN APRIL 30, 2009 AND DEC**
Transbay Transit Center
301 Mission Monitoring
Transbay Joint Powers Authority
San Francisco, California
January 2013

Notes:
Contours represent elevation change, in inches, between Baseline survey (April 30, 2009) and readings taken on December 26, 2012.
Level B-1 at Mid-Rise Parking portion of survey site is approximately 4 inches higher than Level B-1 at High-Rise Tower portion.
The PG&E vault is inaccessible for monitoring.
Negative values of settlement (within Low-rise Tower) indicate uplift.

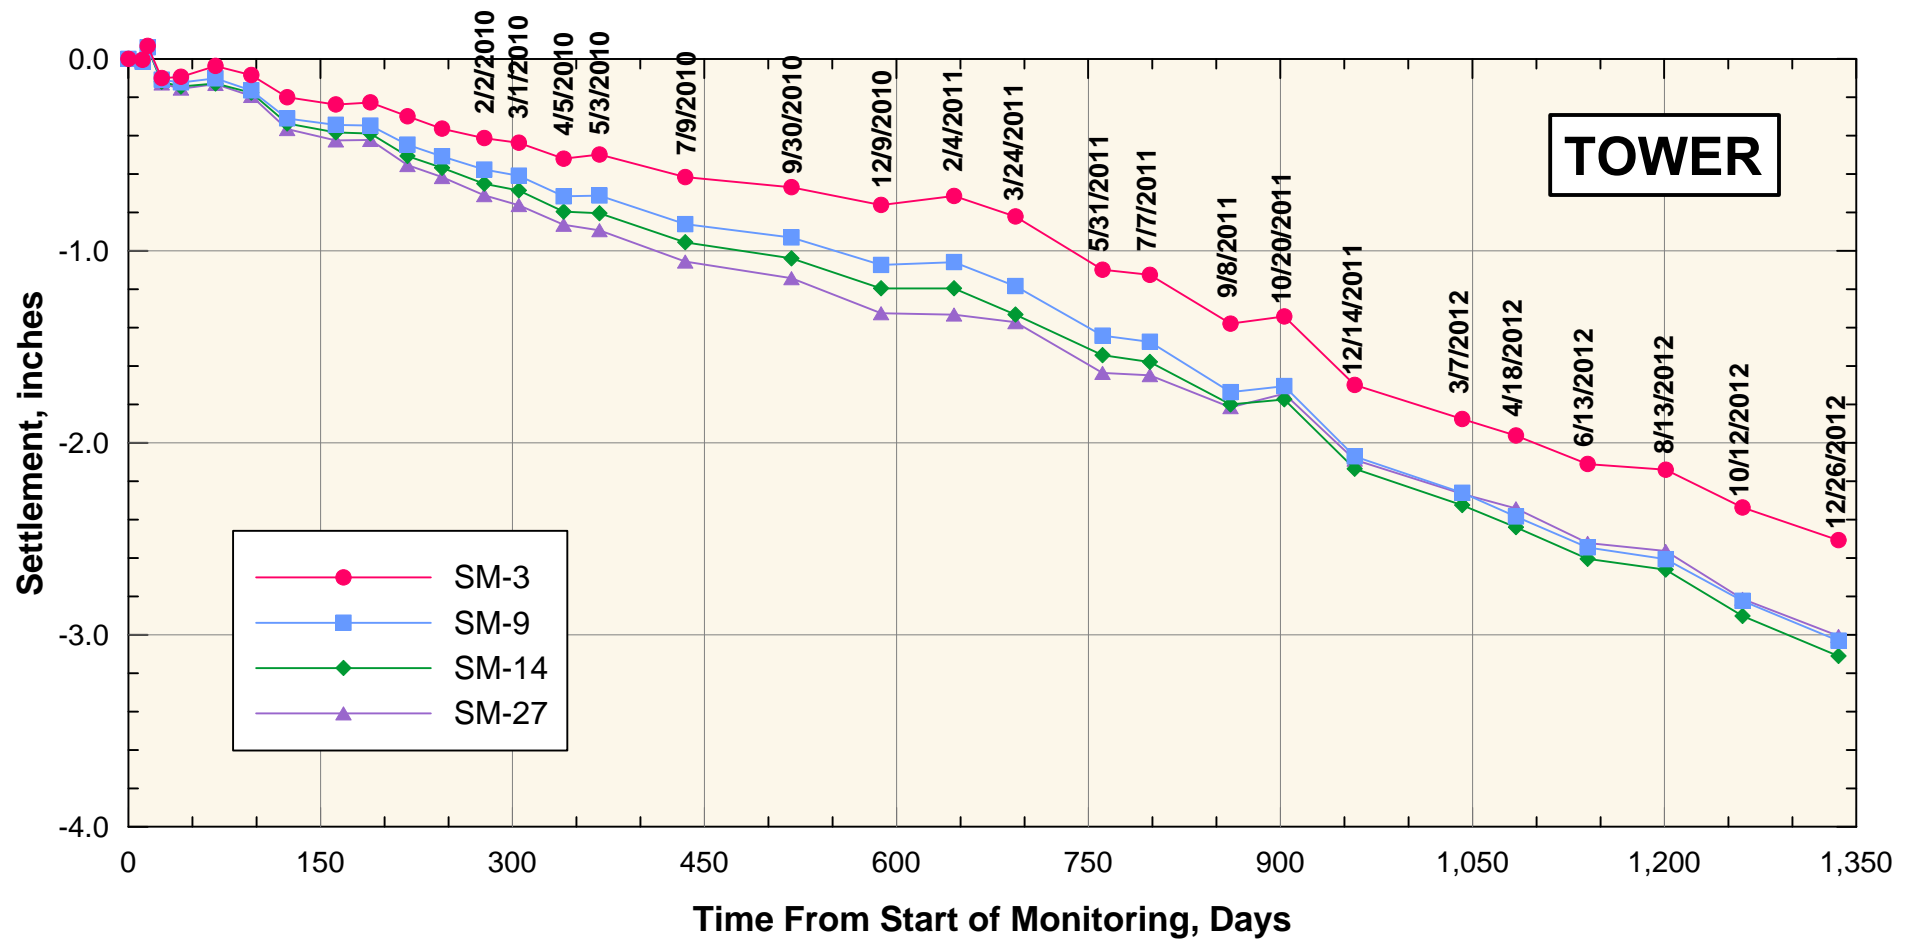
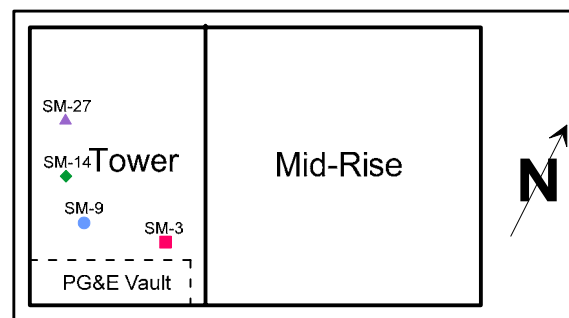
**SETTLEMENT OVER TIME
FLOOR ELEVATIONS AT LEVEL B-1
OF 301 MISSION PROPERTY- TOWER:
APRIL 30, 2009 THROUGH DECEMBER 26, 2012**

Note:
Initial (Baseline) reading
taken on 04/30/09

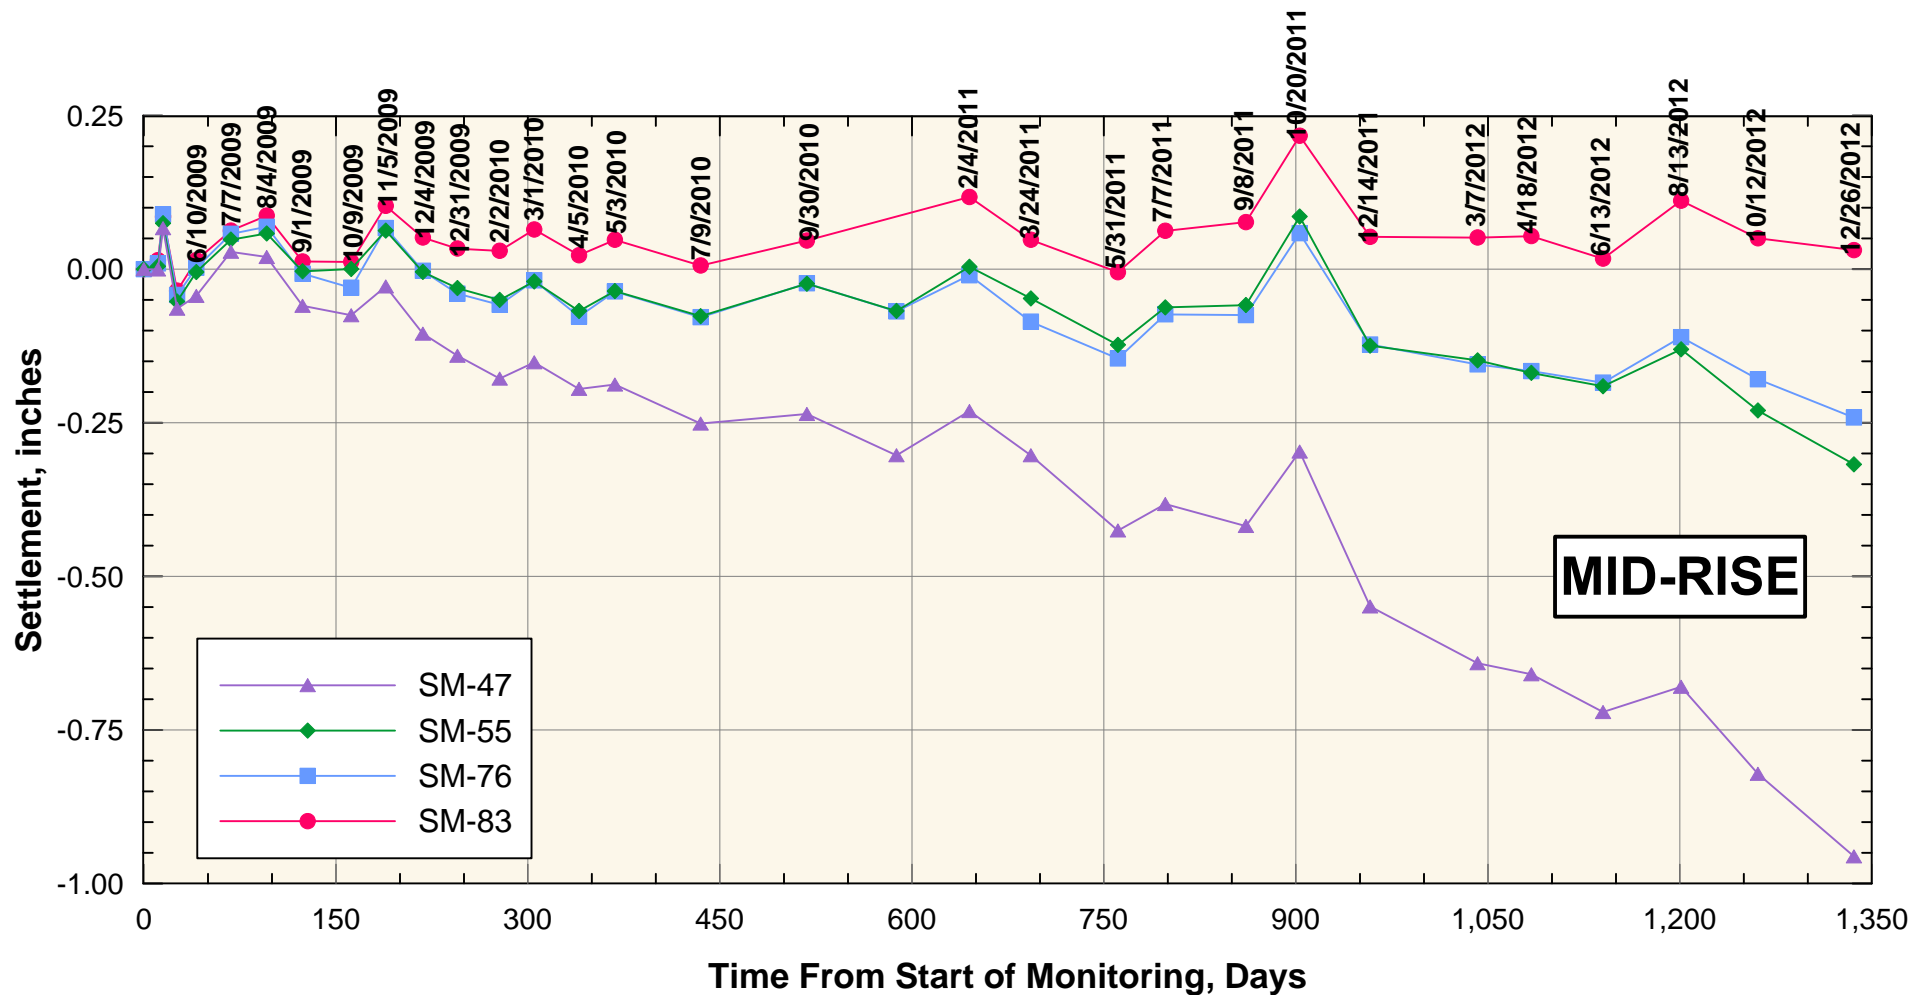
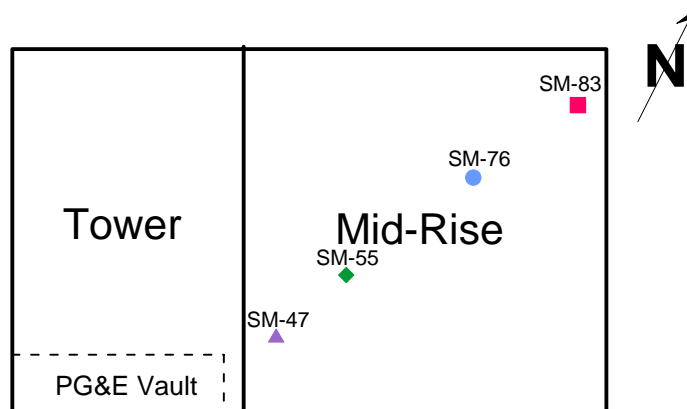
**SETTLEMENT OVER TIME
FLOOR ELEVATIONS AT LEVEL B-1
OF 301 MISSION PROPERTY- MID-RISE:
APRIL 30, 2009 THROUGH DECEMBER 26, 2012**

Note:
Initial (Baseline) reading
taken on 04/30/09

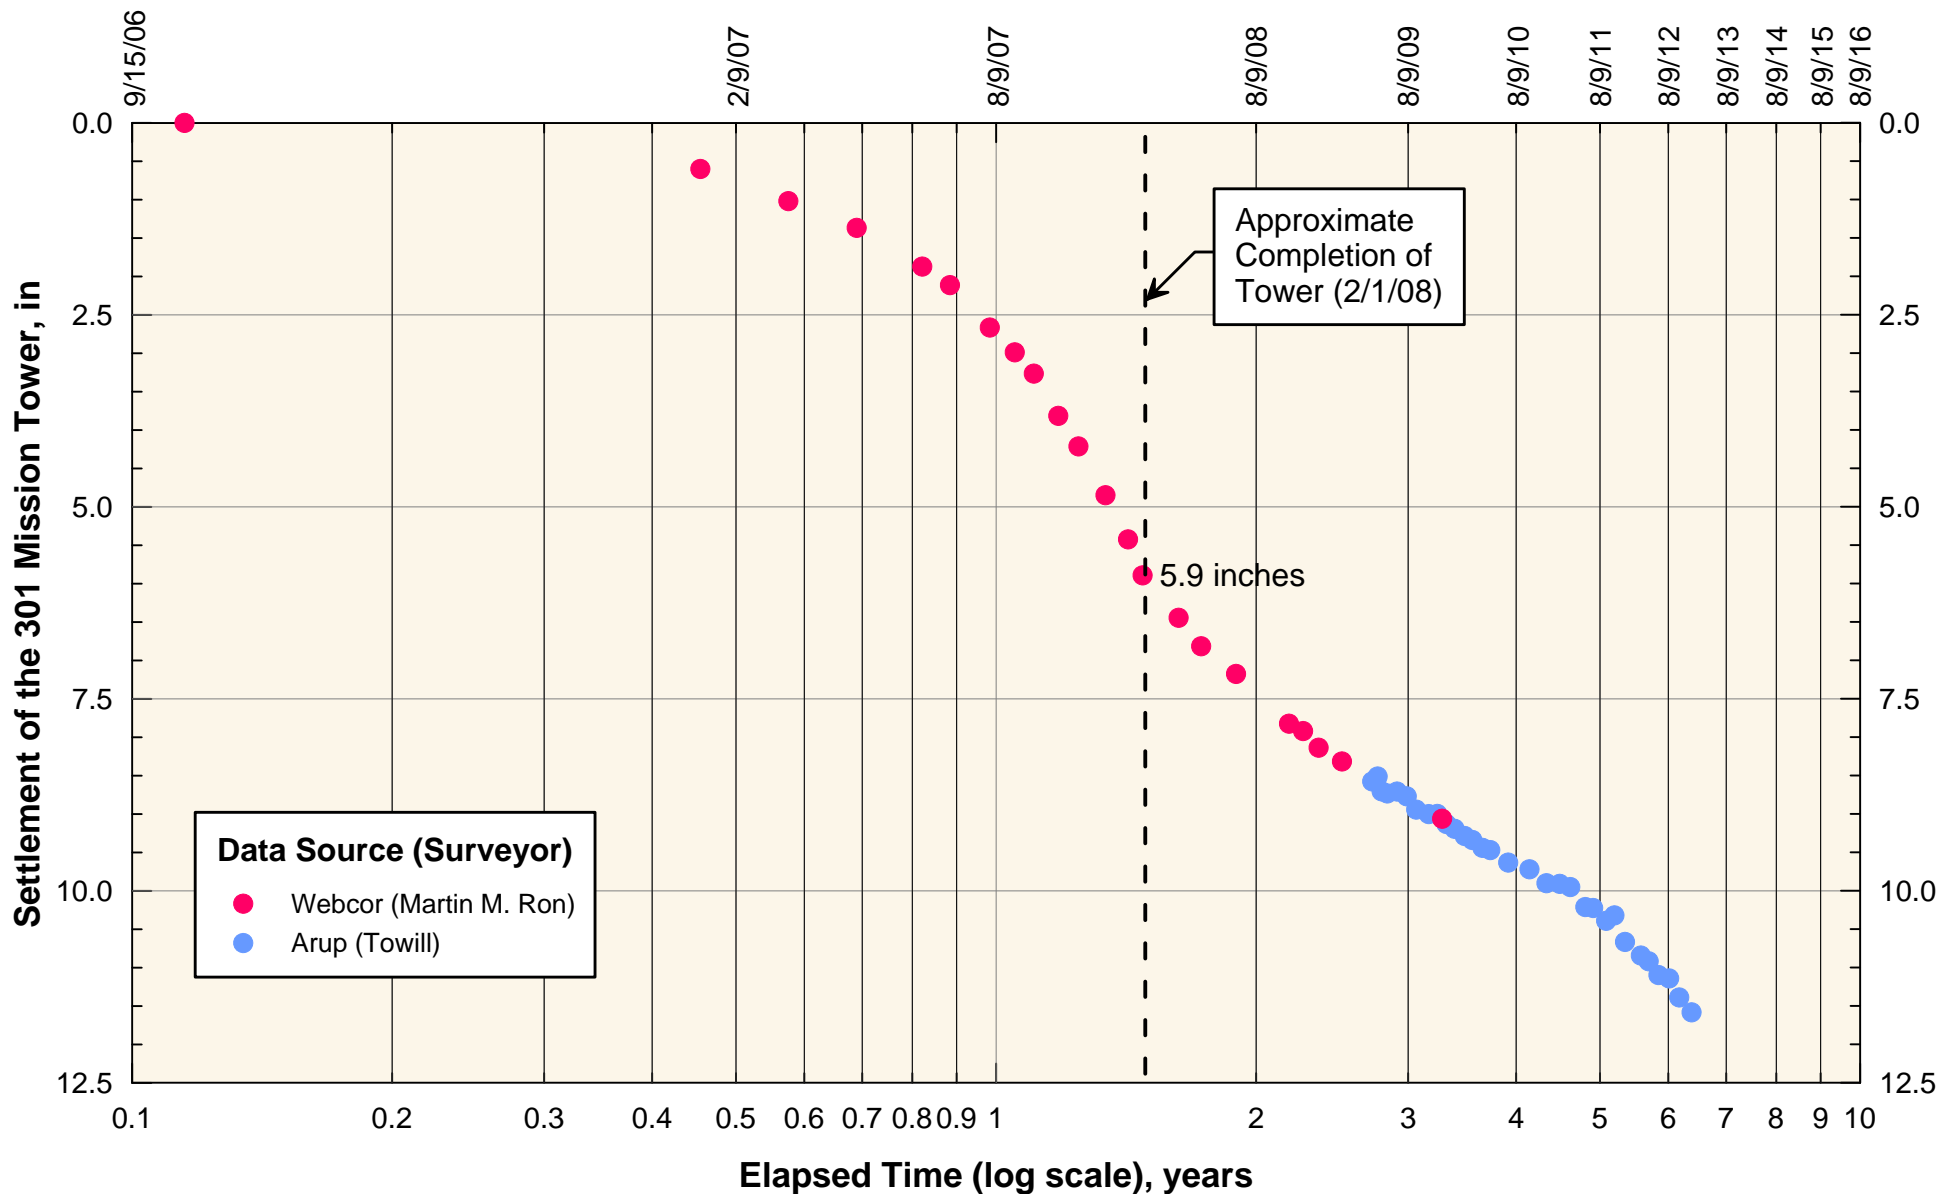
**SETTLEMENTS OF THE 301 MISSION TOWER
 INCLUDING MONITORING DURING CONSTRUCTION**

Beginning of Tower Construction: 8/9/06
 End of Tower Construction: 2/1/08
 Construction Duration: 542 days (1.5 years)

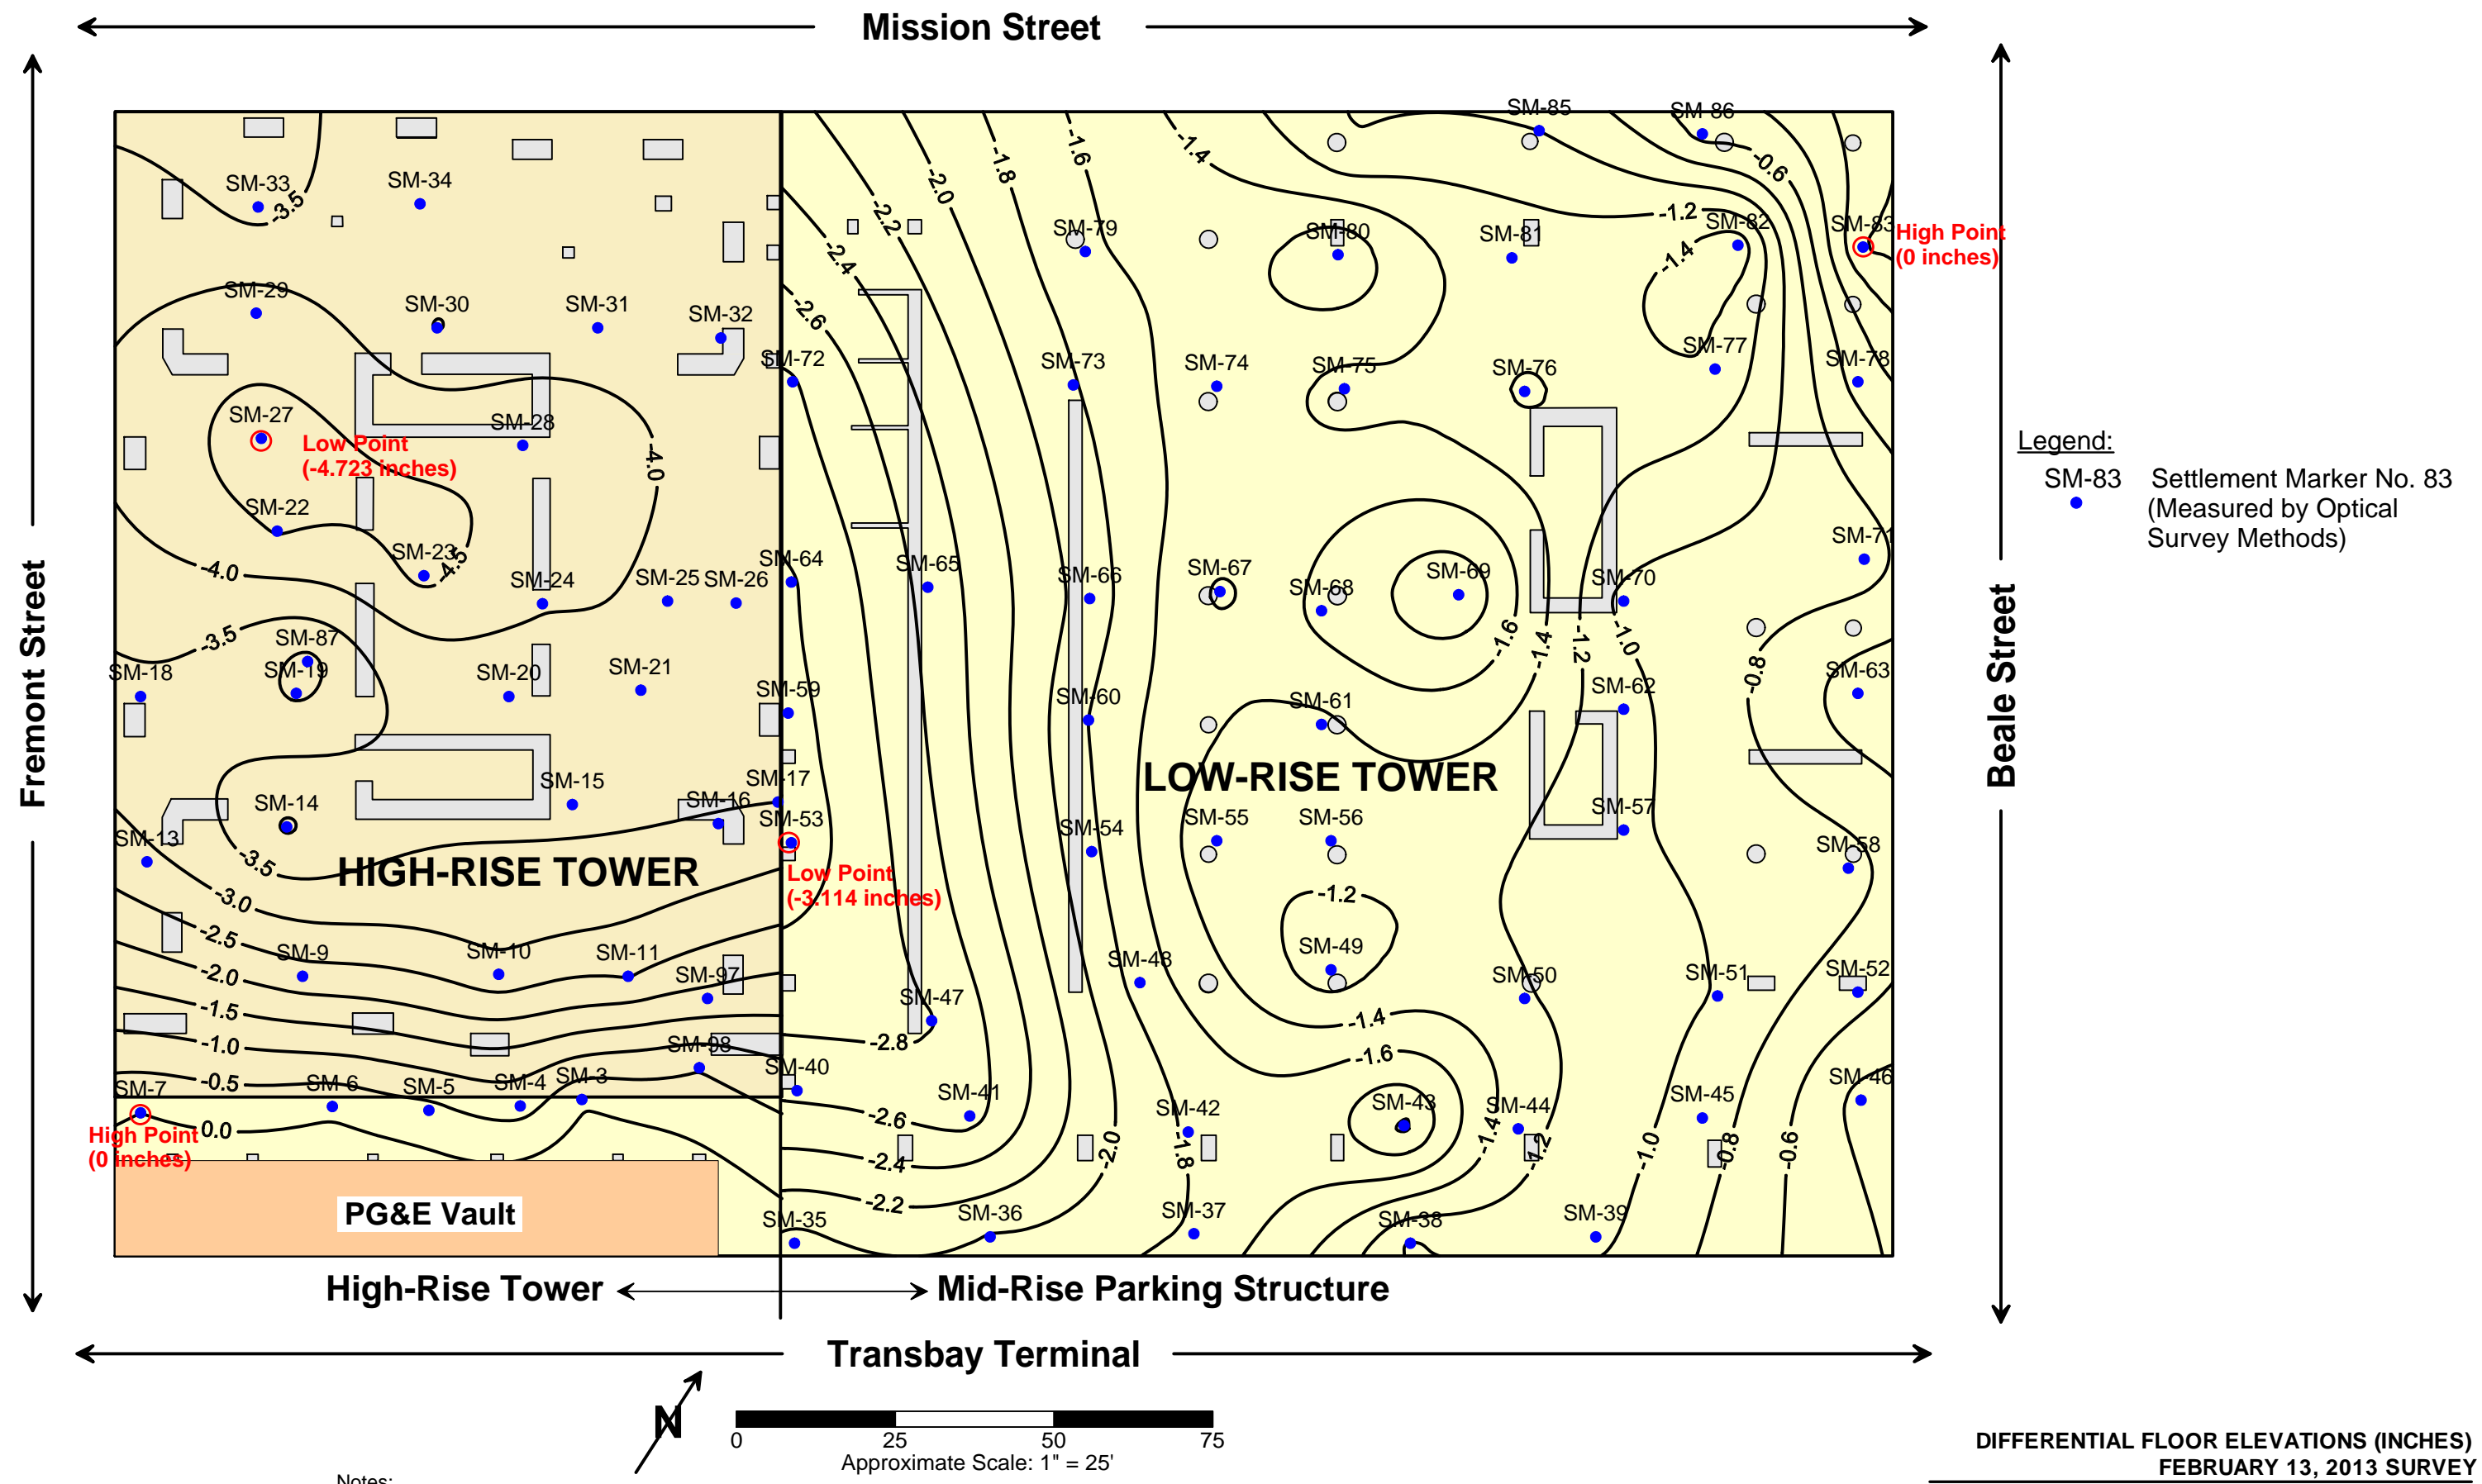
Contours represent differential elevation, in inches, between the highest point and all other points taken on February 13, 2013.

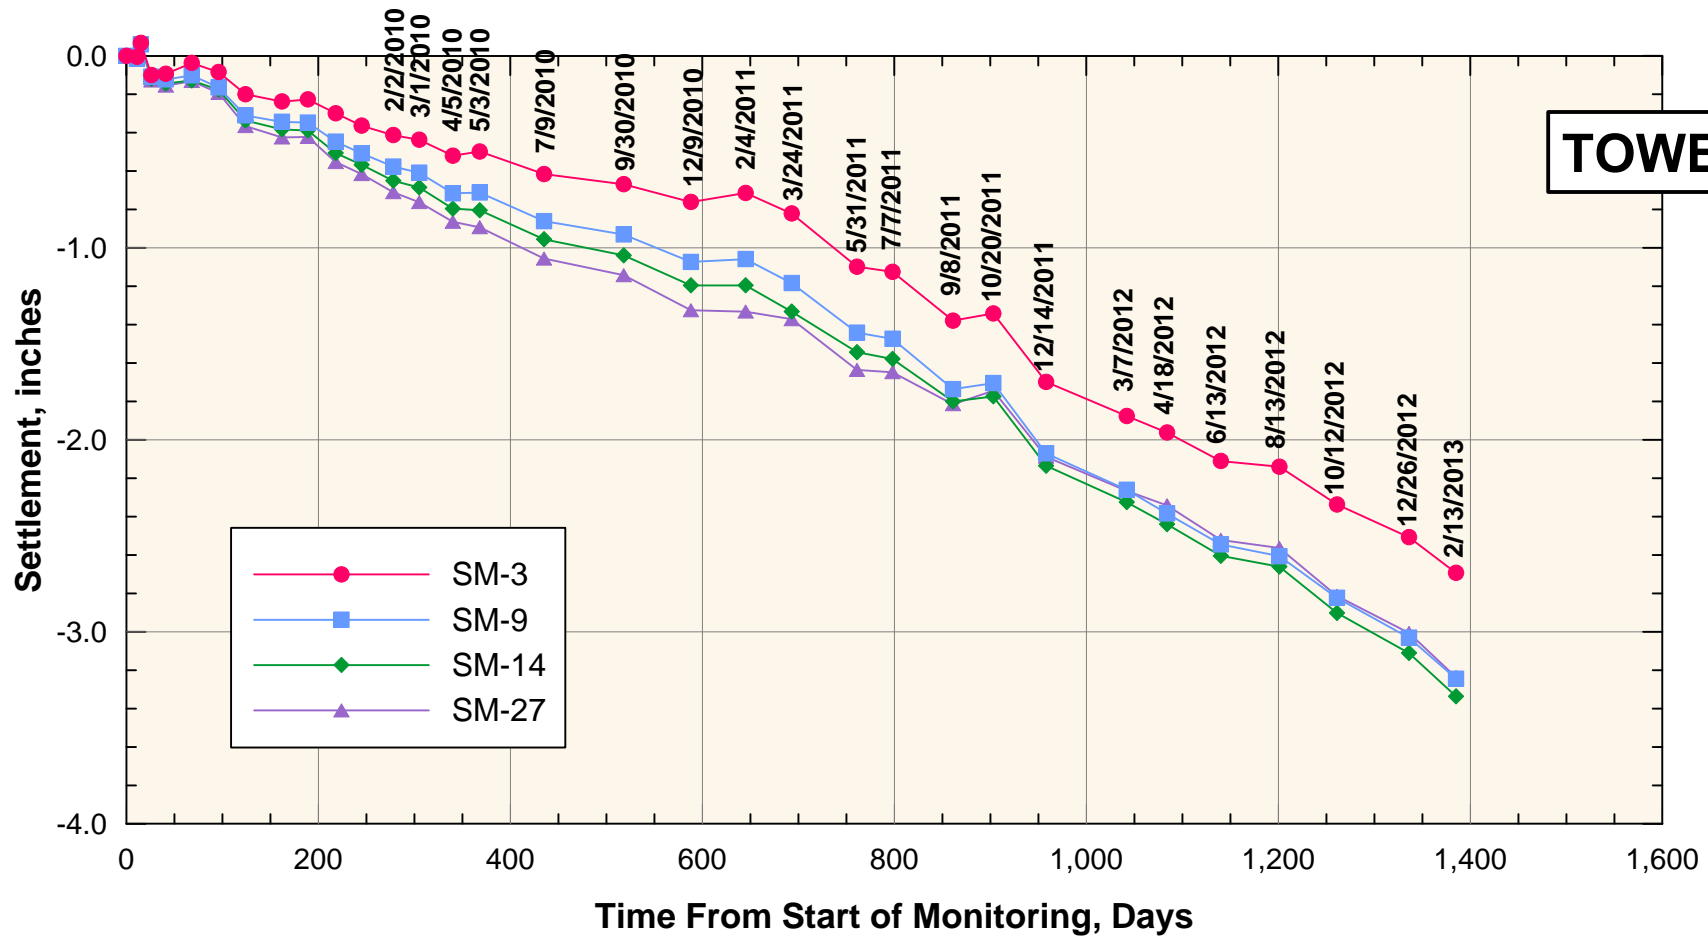
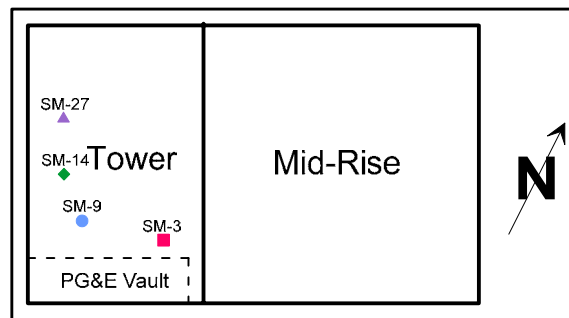
**SETTLEMENT OVER TIME
FLOOR ELEVATIONS AT LEVEL B-1
OF 301 MISSION PROPERTY- TOWER:
APRIL 30, 2009 THROUGH FEBRUARY 13, 2013**

Note:
Initial (Baseline) reading
taken on 04/30/09
