*Board of Supervisors
City and County of San Francisco*

Government Audit and Oversight Committee

Supplemental Report for Foundation Settlement Investigation

**SUPPLEMENTAL REPORT
FOUNDATION SETTLEMENT INVESTIGATION
301 MISSION STREET
SAN FRANCISCO, CALIFORNIA**

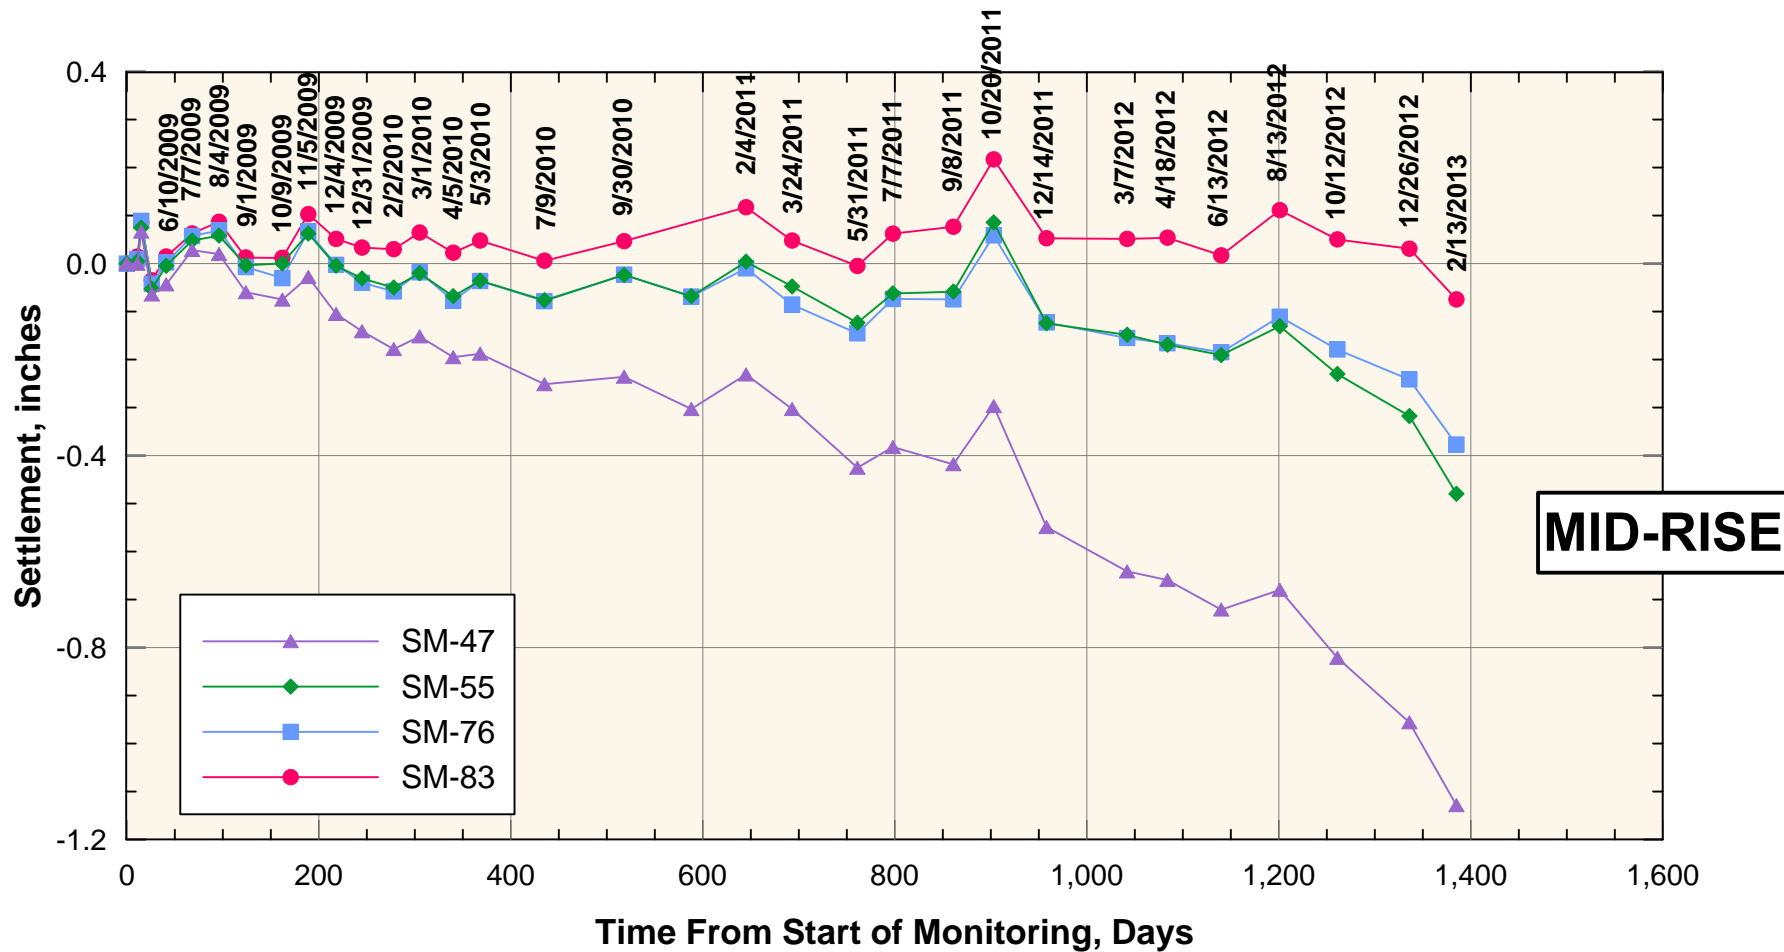
**SETTLEMENT OVER TIME
FLOOR ELEVATIONS AT LEVEL B-1
OF 301 MISSION PROPERTY- MID-RISE:
APRIL 30, 2009 THROUGH FEBRUARY 13, 2013**

Note:
Initial (Baseline) reading
taken on 04/30/09

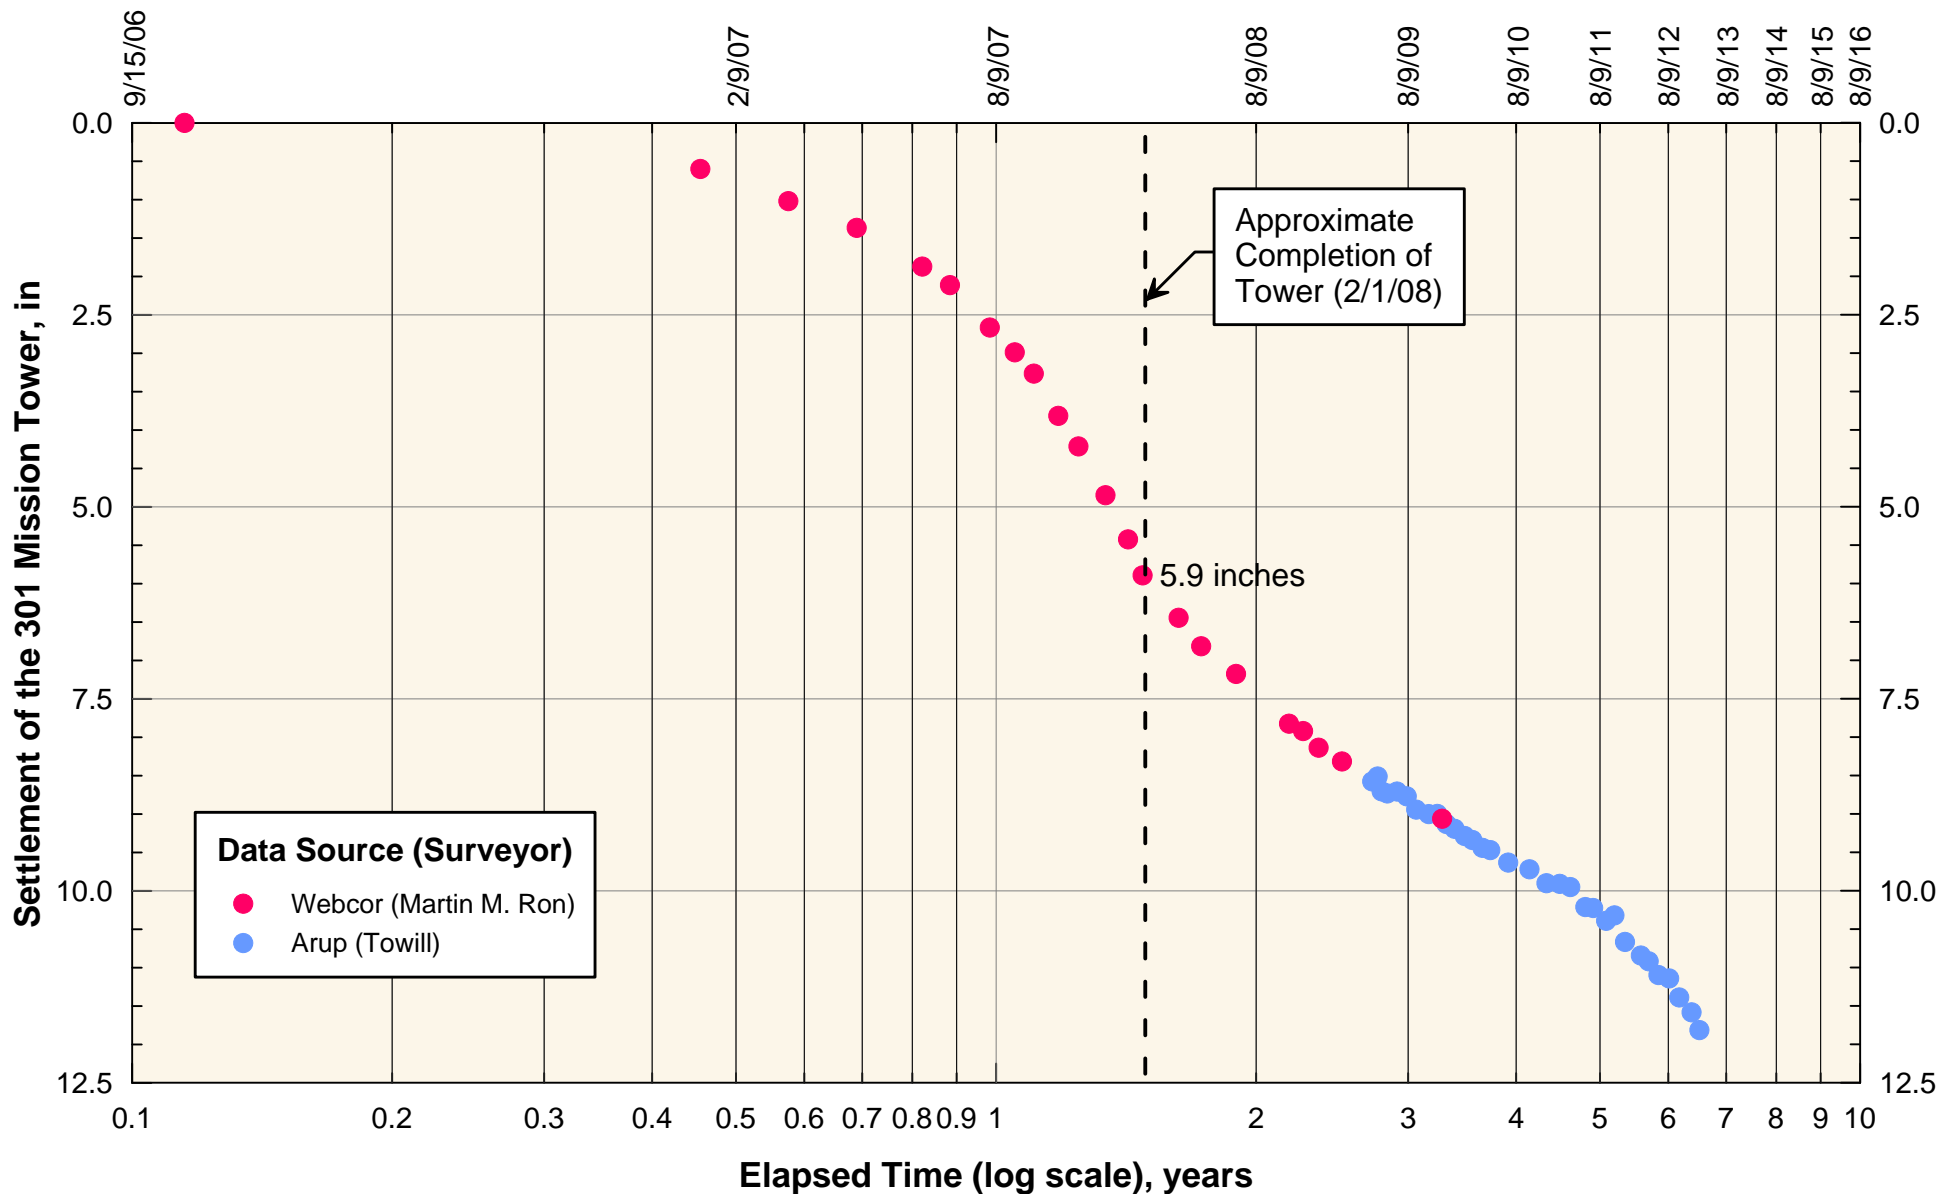
**SETTLEMENTS OF THE 301 MISSION TOWER
 INCLUDING MONITORING DURING CONSTRUCTION**

Beginning of Tower Construction: 8/9/06
 End of Tower Construction: 2/1/08
 Construction Duration: 542 days (1.5 years)

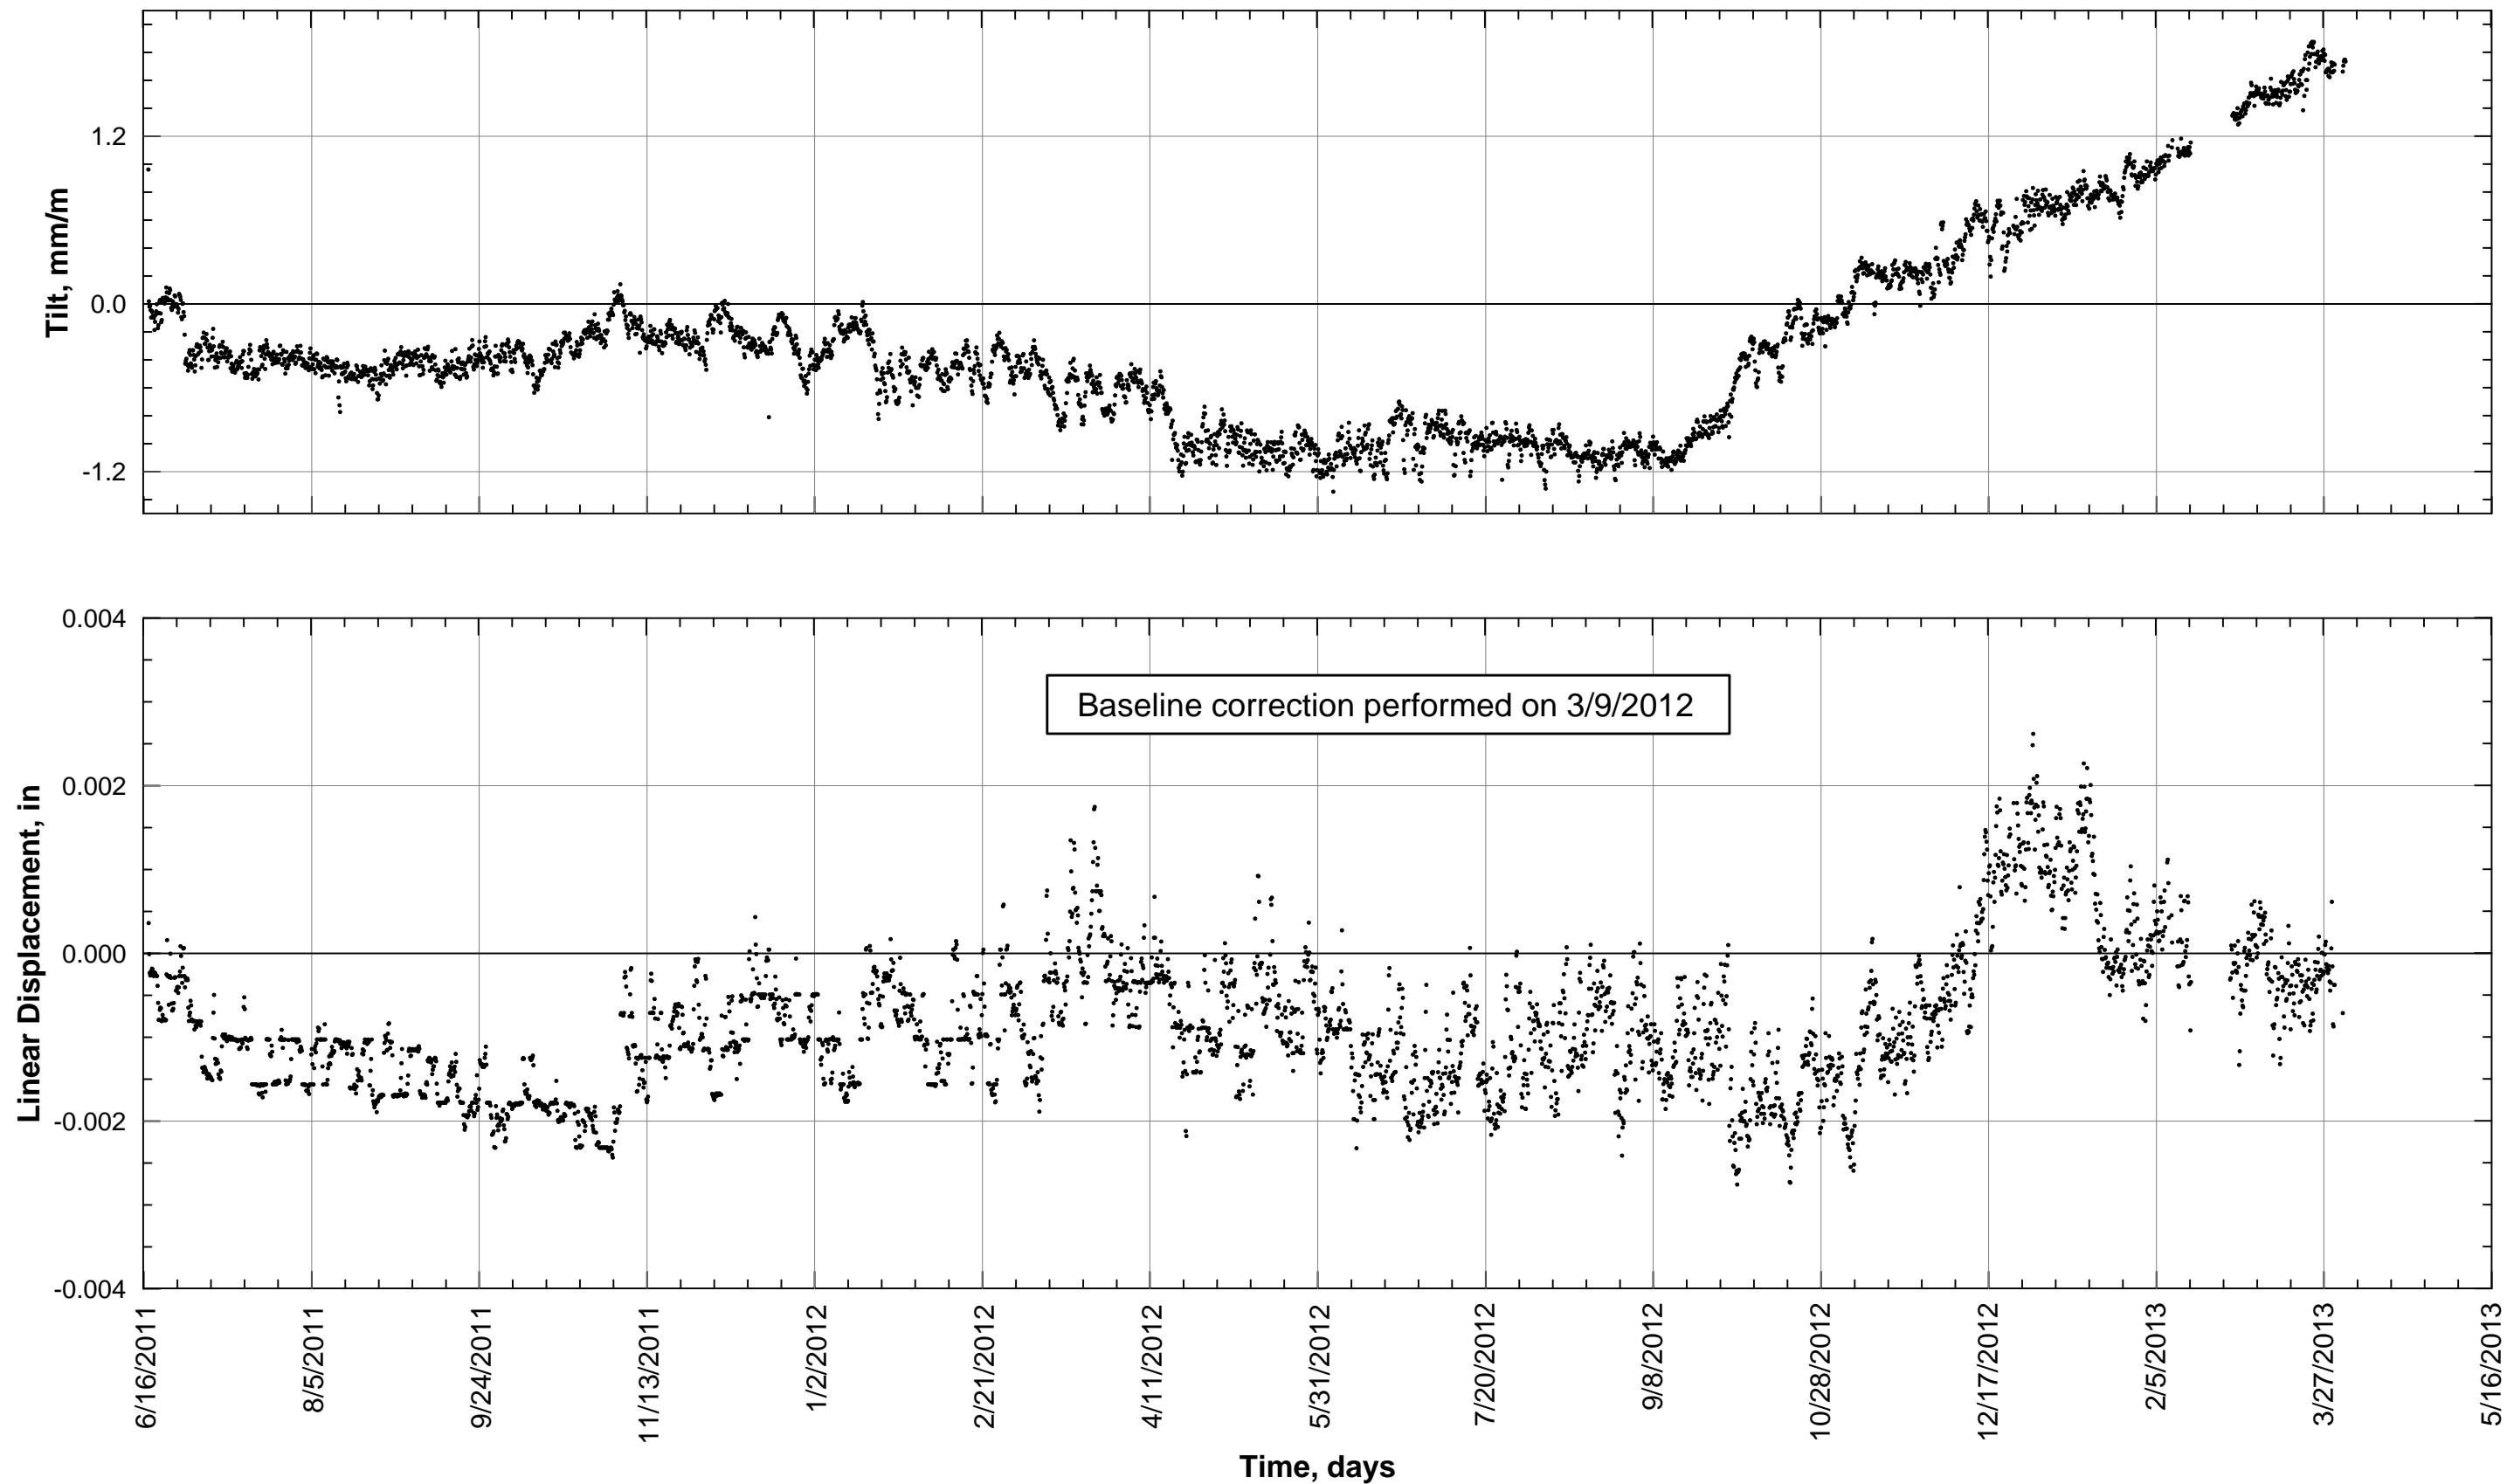
UTILITY CROSSING MONITORING DATA: UC-01

original baseline. An example of the baseline correction for UC-01 is presented on Plate 13 which displays the raw and corrected data as well as the magnitude of the jump. The jump on UC-01 and UC-03 occurred on the same day and was likely caused by the same event given their proximity. The jump on UC-07 occurred during the manual gauge length measurements on 3/19/2013 and was likely inadvertently bumped while the measurement was taken.

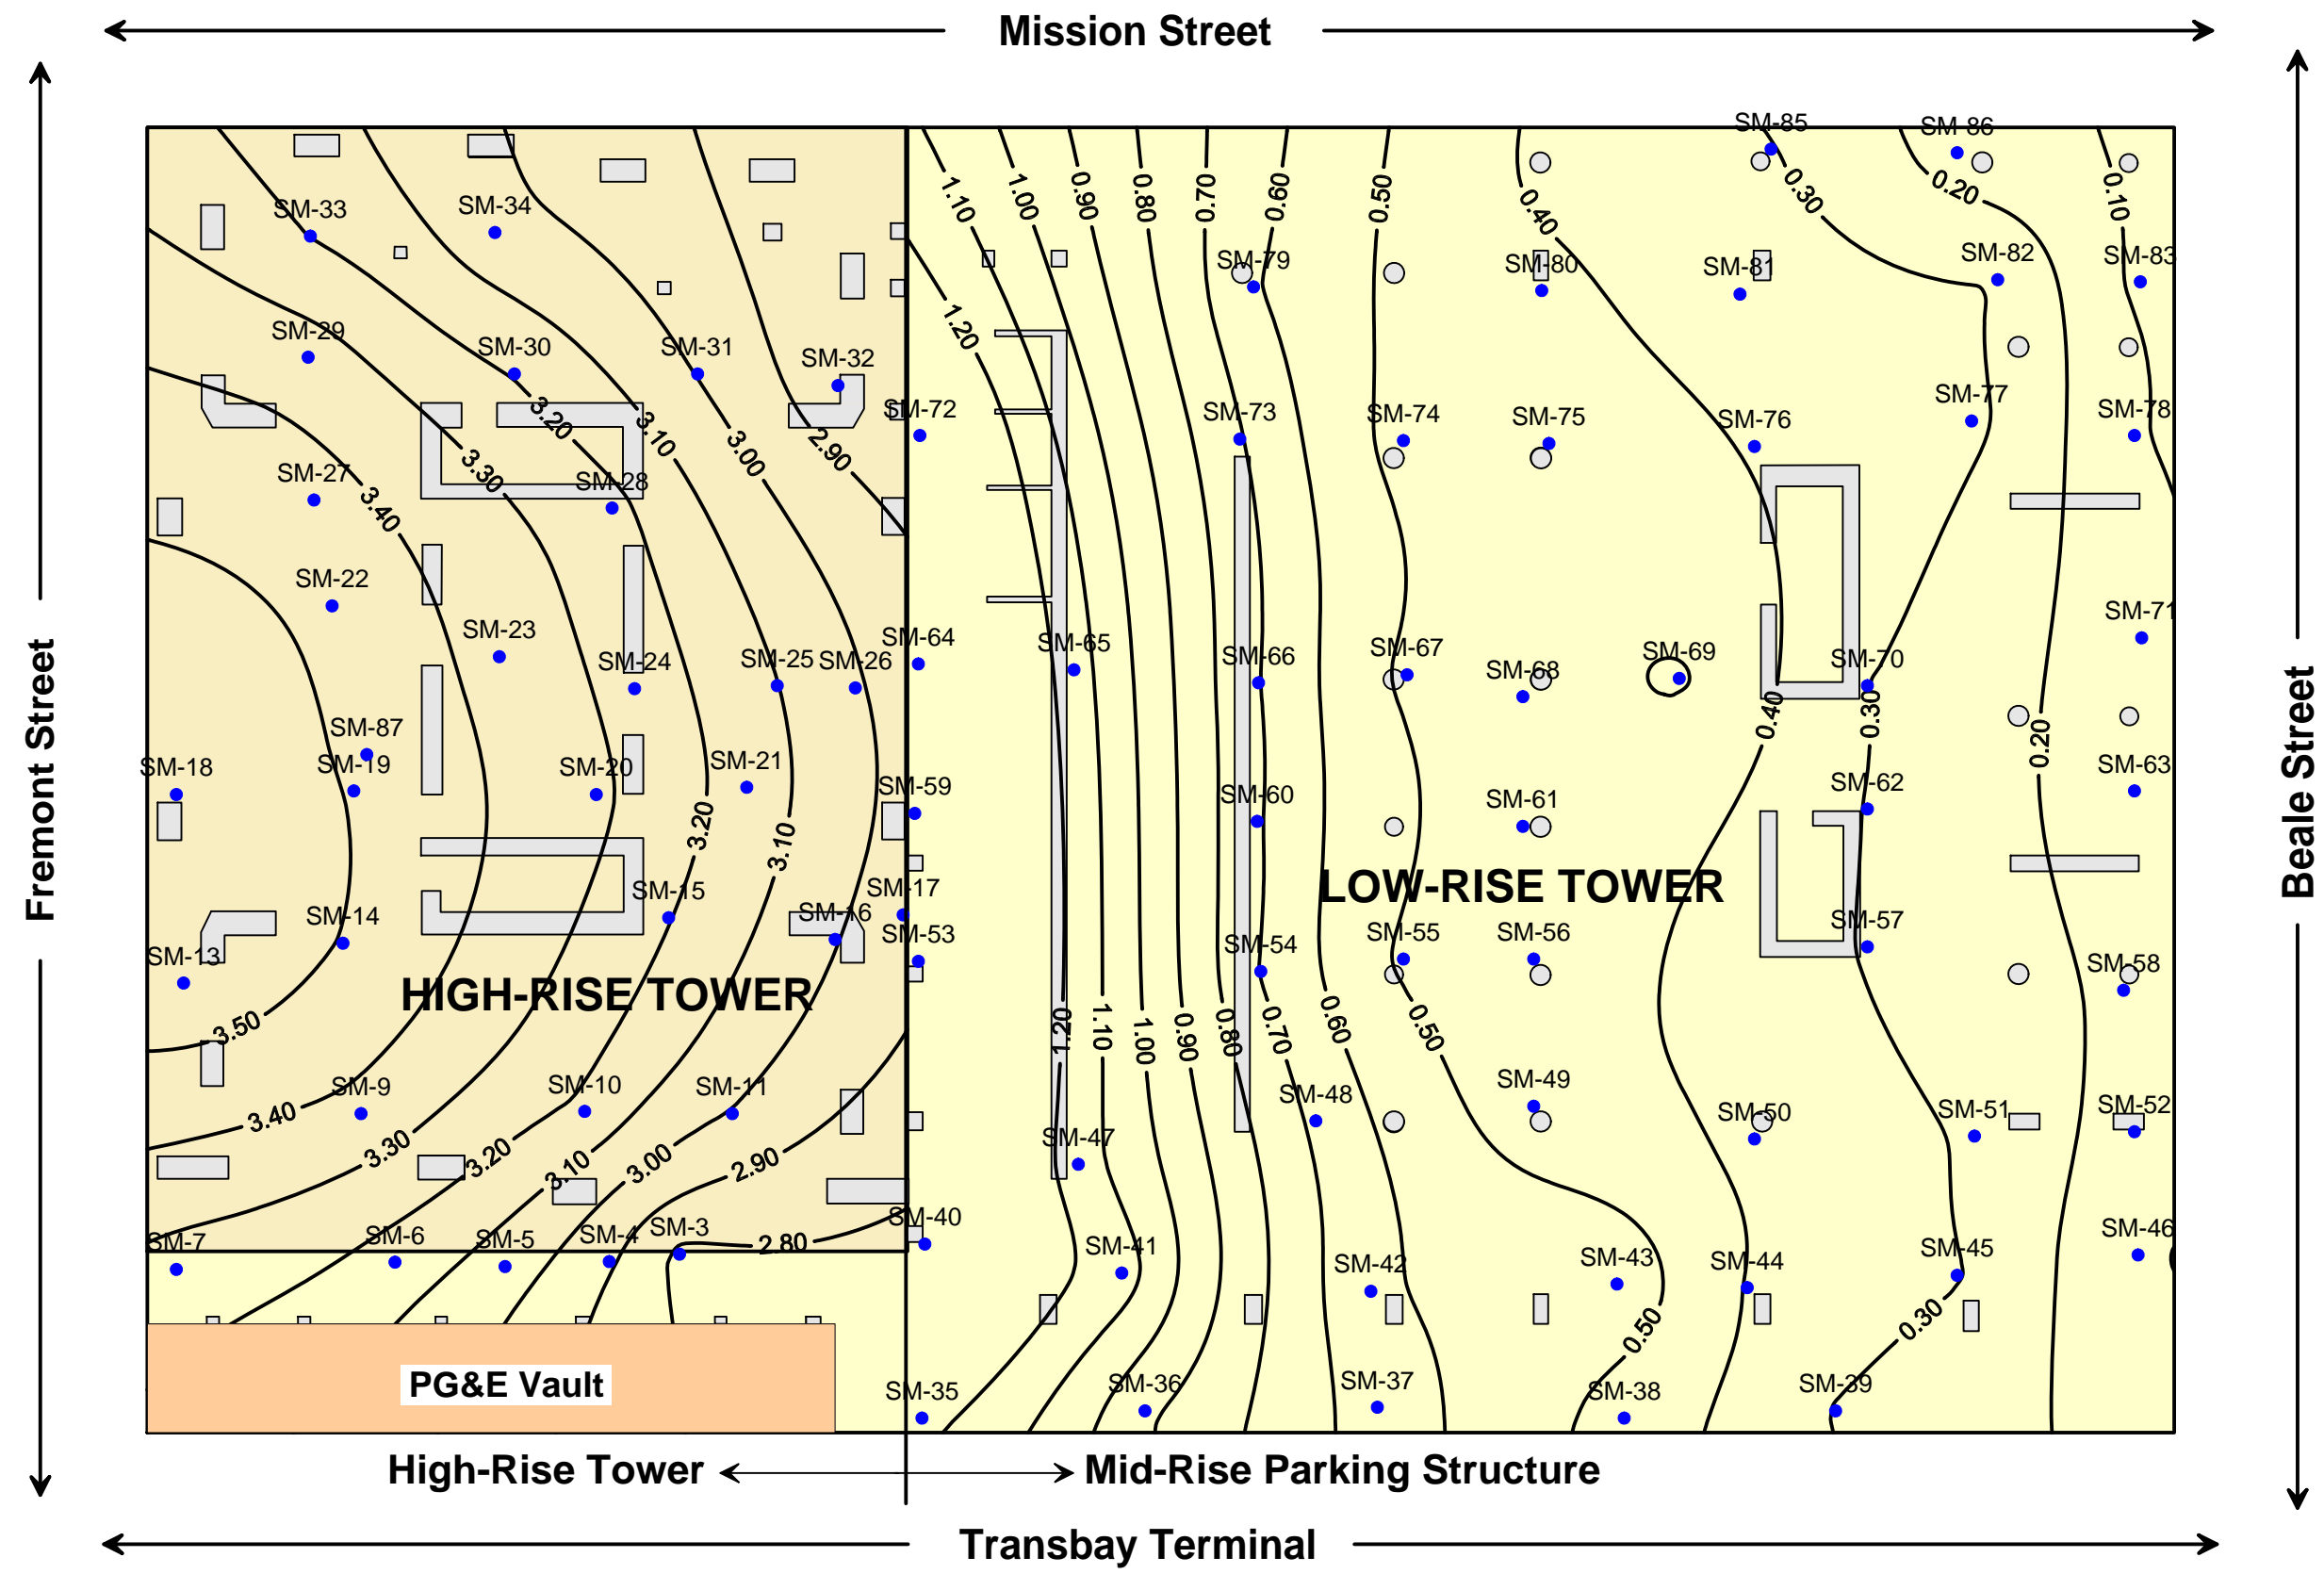
Notes:
 Contours represent elevation change, in inches, between Baseline survey (April 30, 2009) and readings taken on April 19, 2013.
 Level B-1 at Mid-Rise Parking portion of survey site is approximately 4 inches higher than Level B-1 at High-Rise Tower portion.
 The PG&E vault is inaccessible for monitoring.
 Negative values of settlement (within Low-rise Tower) indicate uplift.

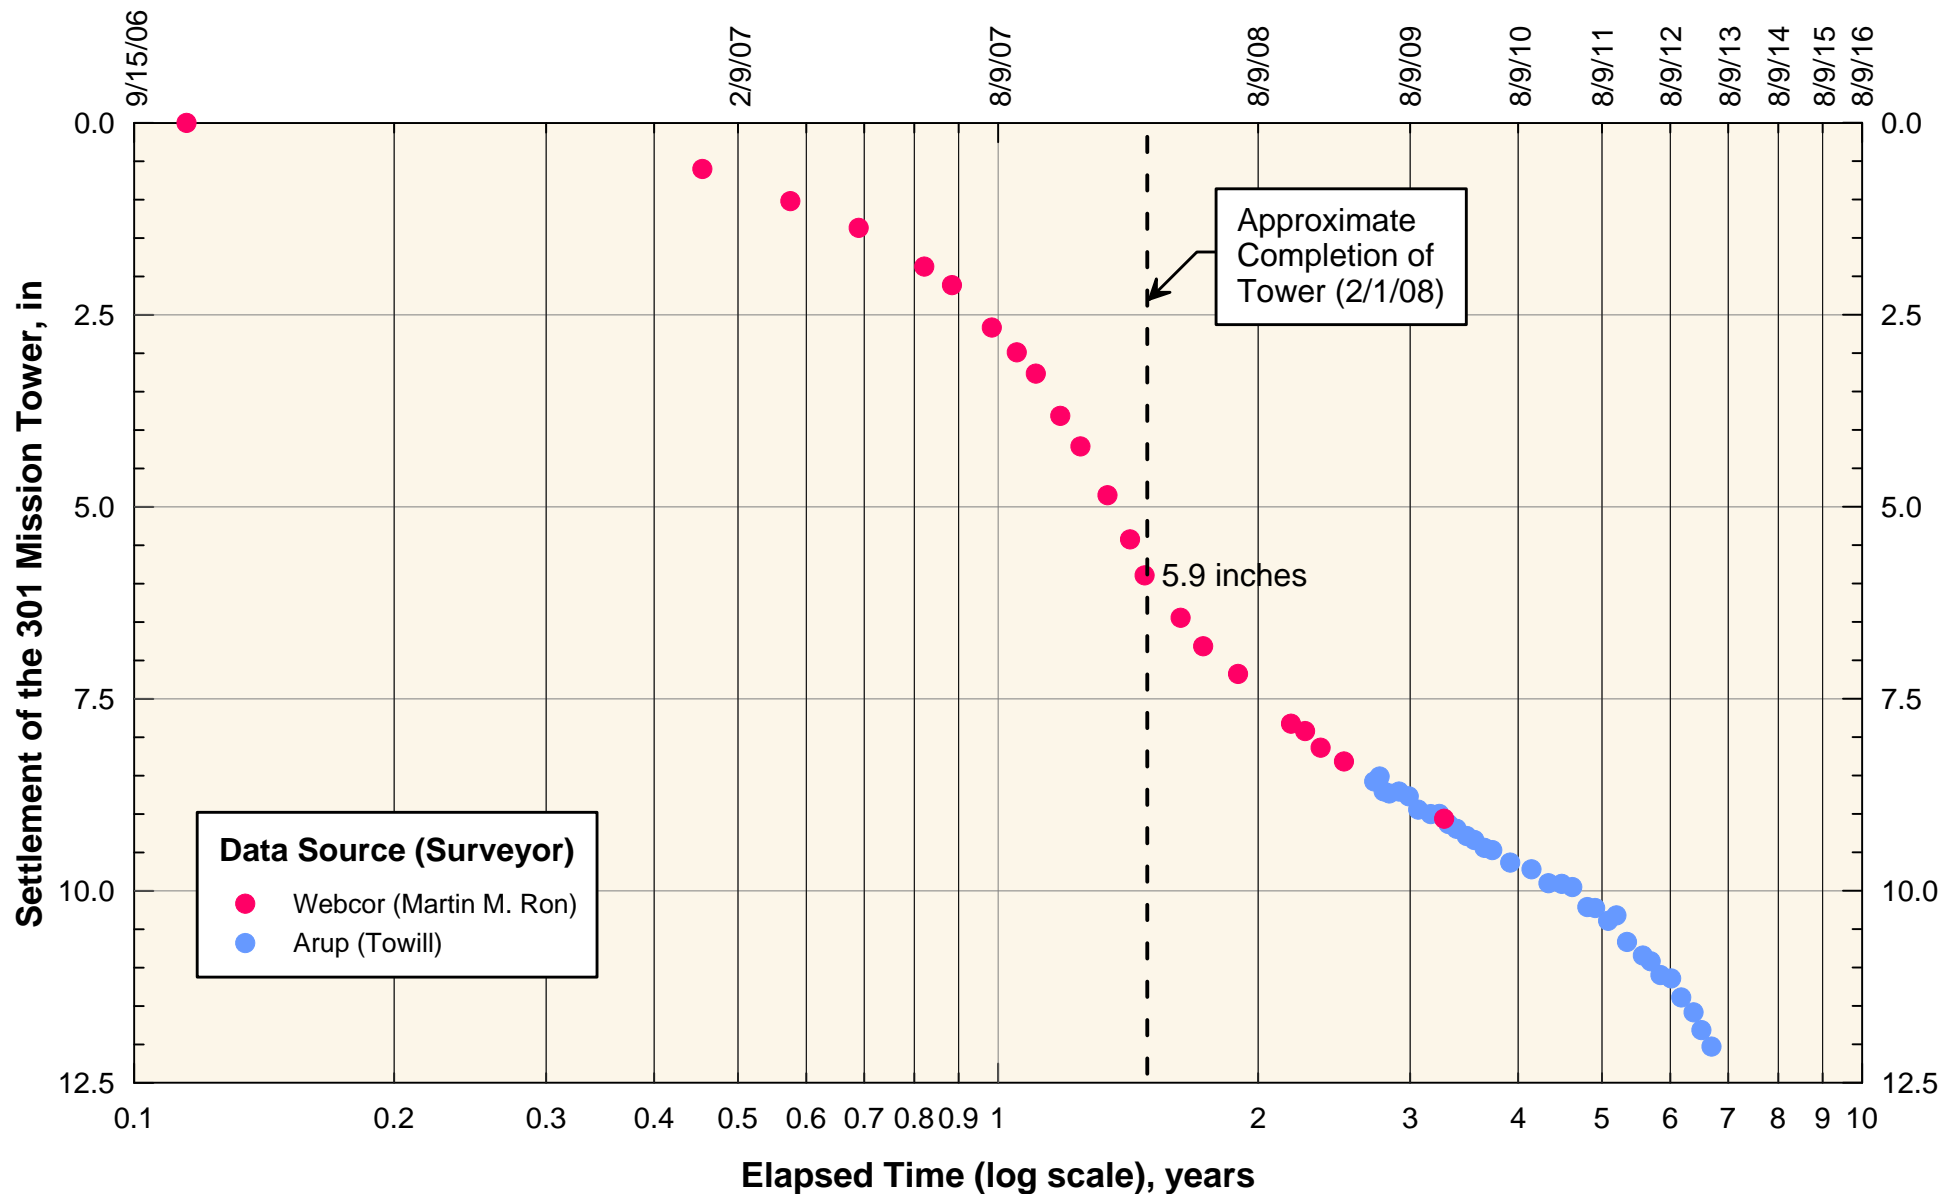
**SETTLEMENTS OF THE 301 MISSION TOWER
 INCLUDING MONITORING DURING CONSTRUCTION**

Beginning of Tower Construction: 8/9/06
 End of Tower Construction: 2/1/08
 Construction Duration: 542 days (1.5 years)

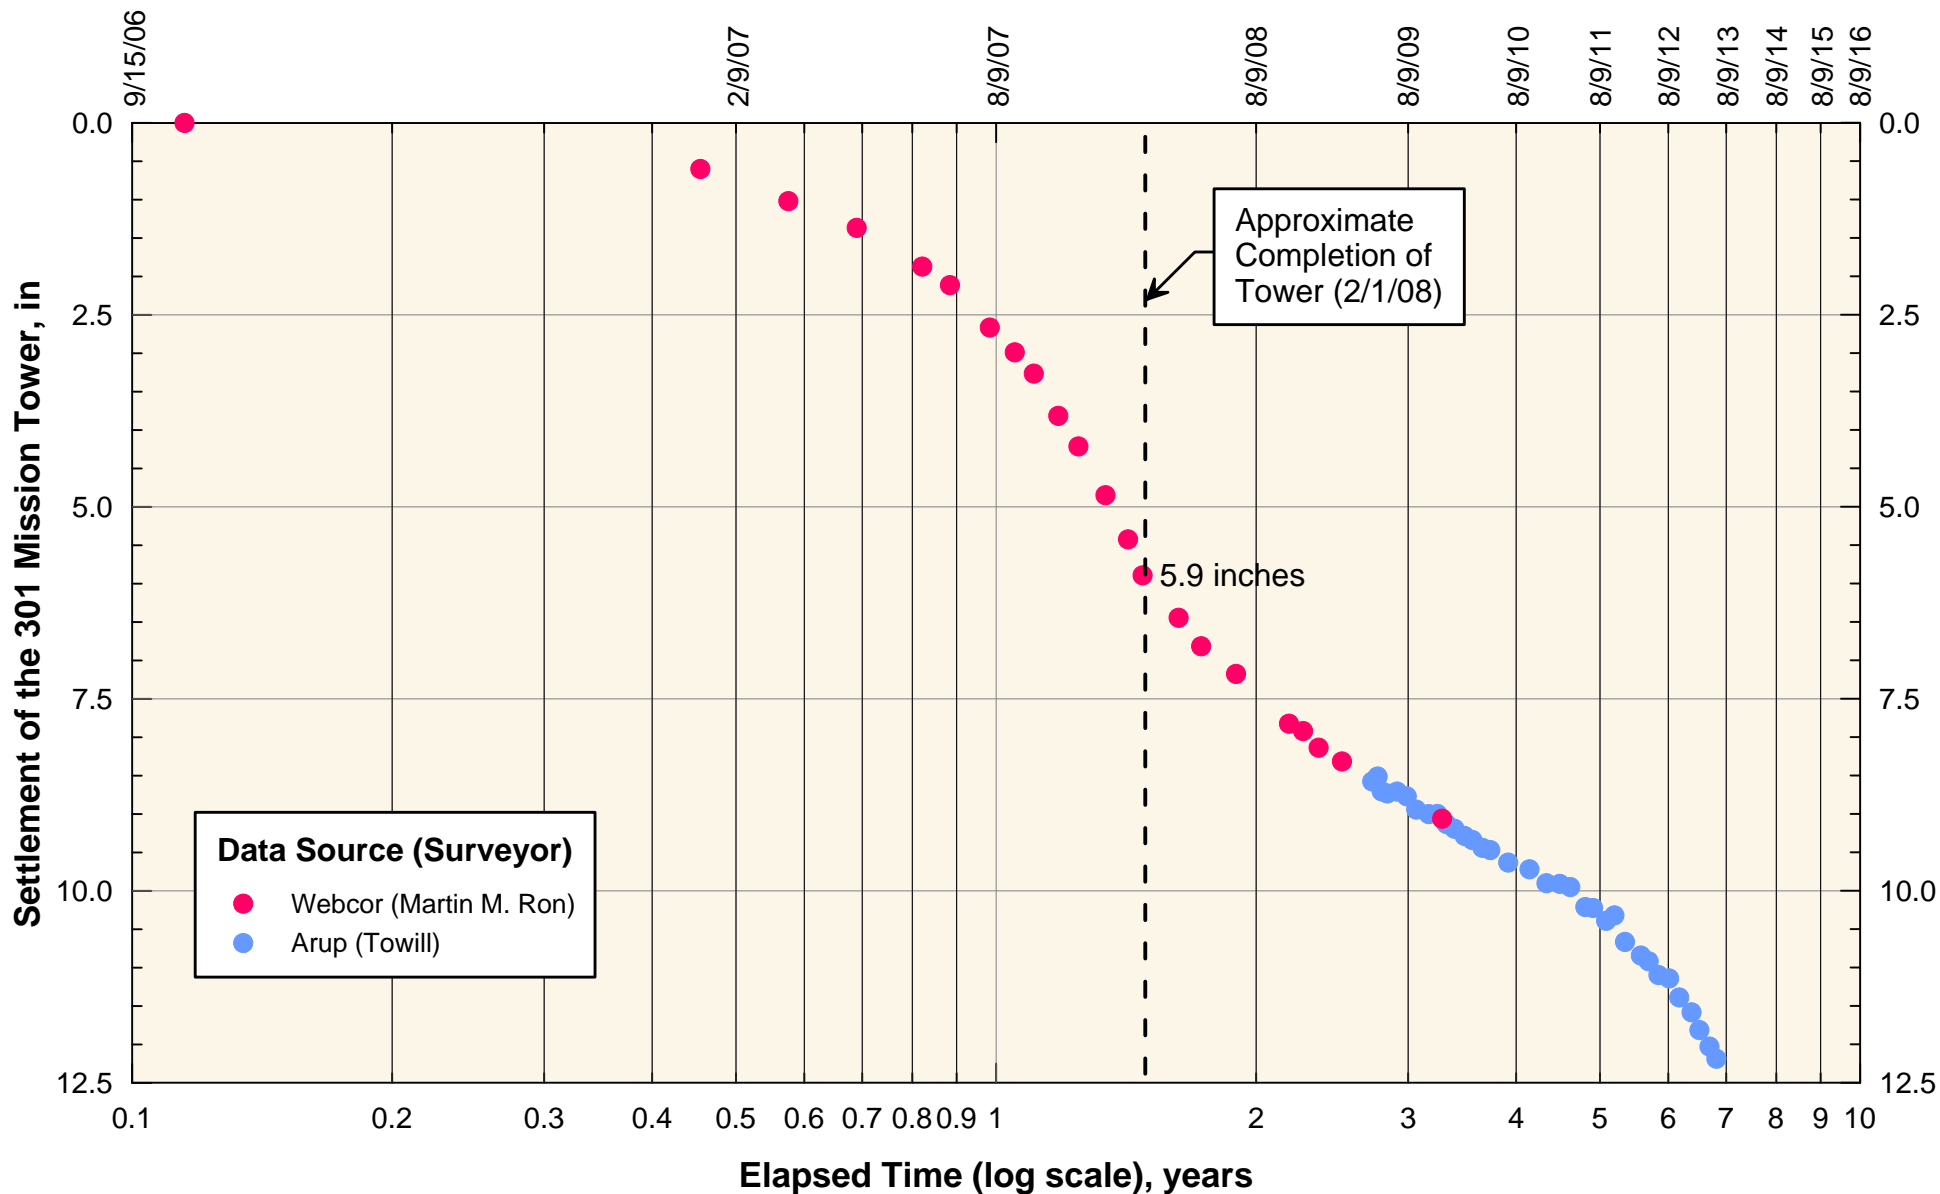
Beginning of Tower Construction: 8/9/06
 End of Tower Construction: 2/1/08
 Construction Duration: 542 days (1.5 years)

**SETTLEMENTS OF THE 301 MISSION TOWER
 INCLUDING MONITORING DURING CONSTRUCTION**

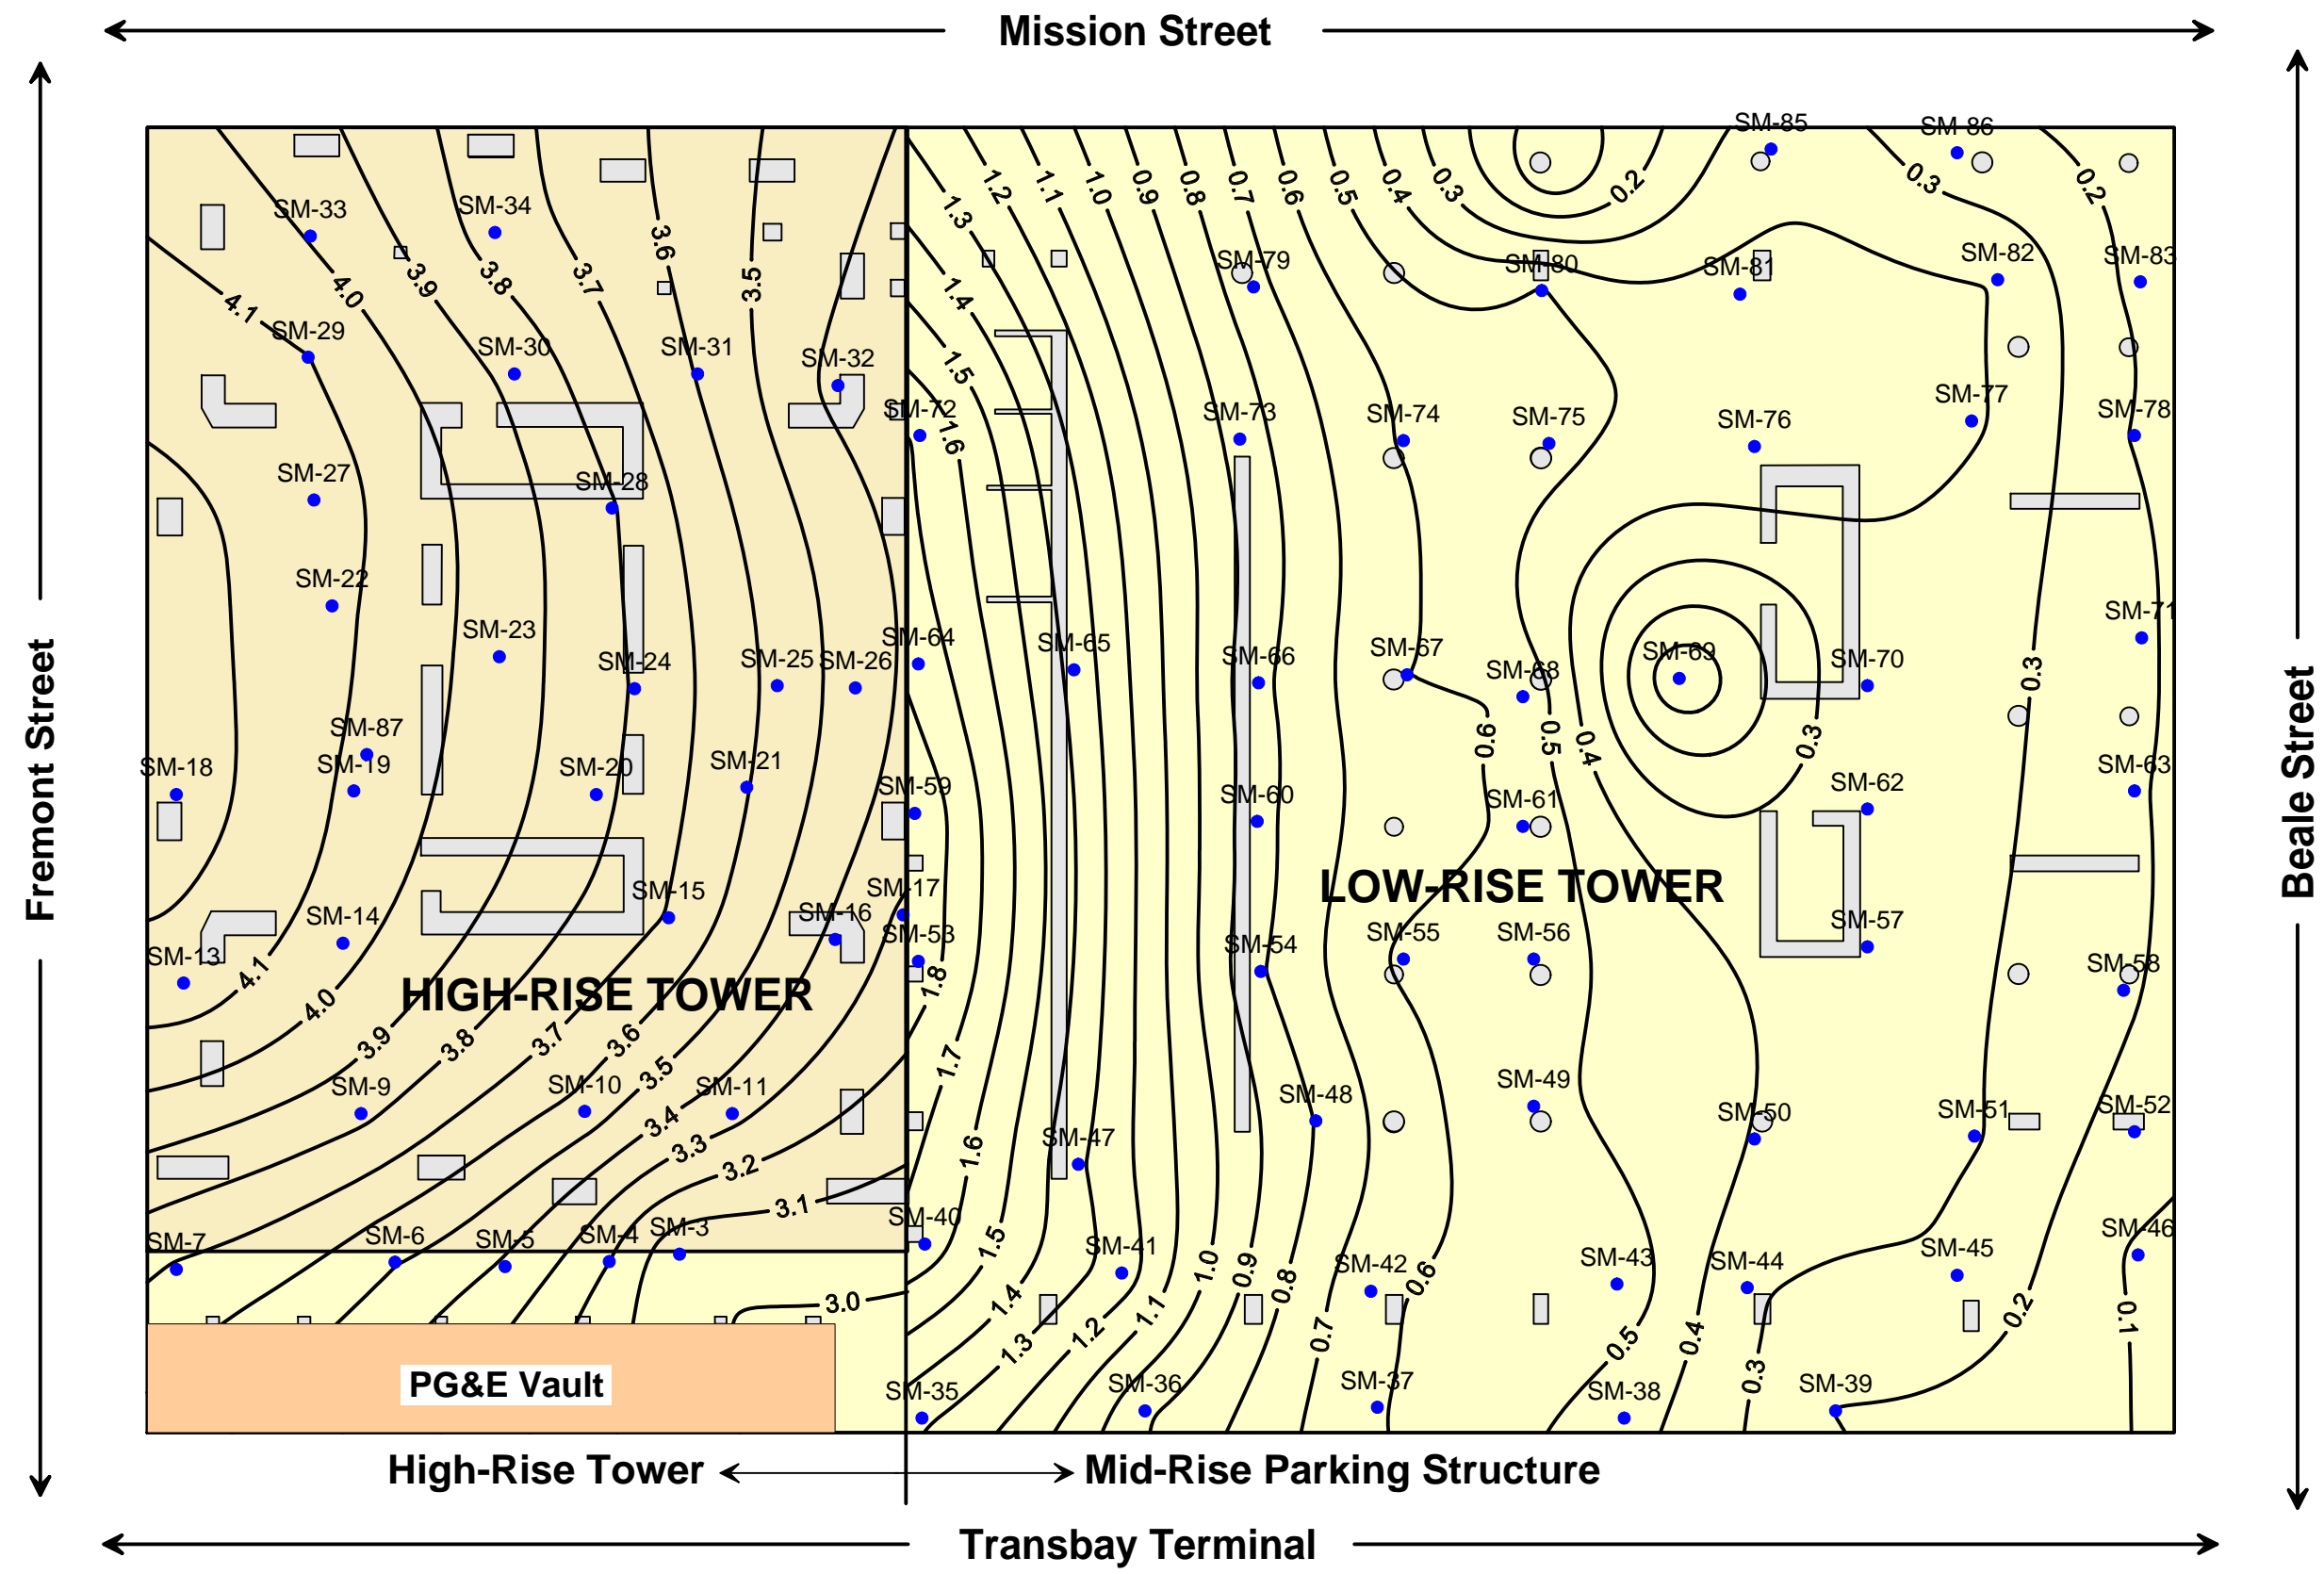
Notes:
 Contours represent elevation change, in inches, between Baseline survey (April 30, 2009) and readings taken on October 9, 2013.
 Level B-1 at Mid-Rise Parking portion of survey site is approximately 4 inches higher than Level B-1 at High-Rise Tower portion.
 The PG&E vault is inaccessible for monitoring.
 Negative values of settlement (within Low-rise Tower) indicate uplift.

CONTOURS OF SETTLEMENTS MEASURED AT THE 1ST LEVEL BASEMENT OF THE 301 MISSION ST STRUCTURE BETWEEN 04/30/2009 & 10/09/2013
 Transbay Transit Center
 301 Mission Monitoring
 Transbay Joint Powers Authority
 San Francisco, California
 November 2013

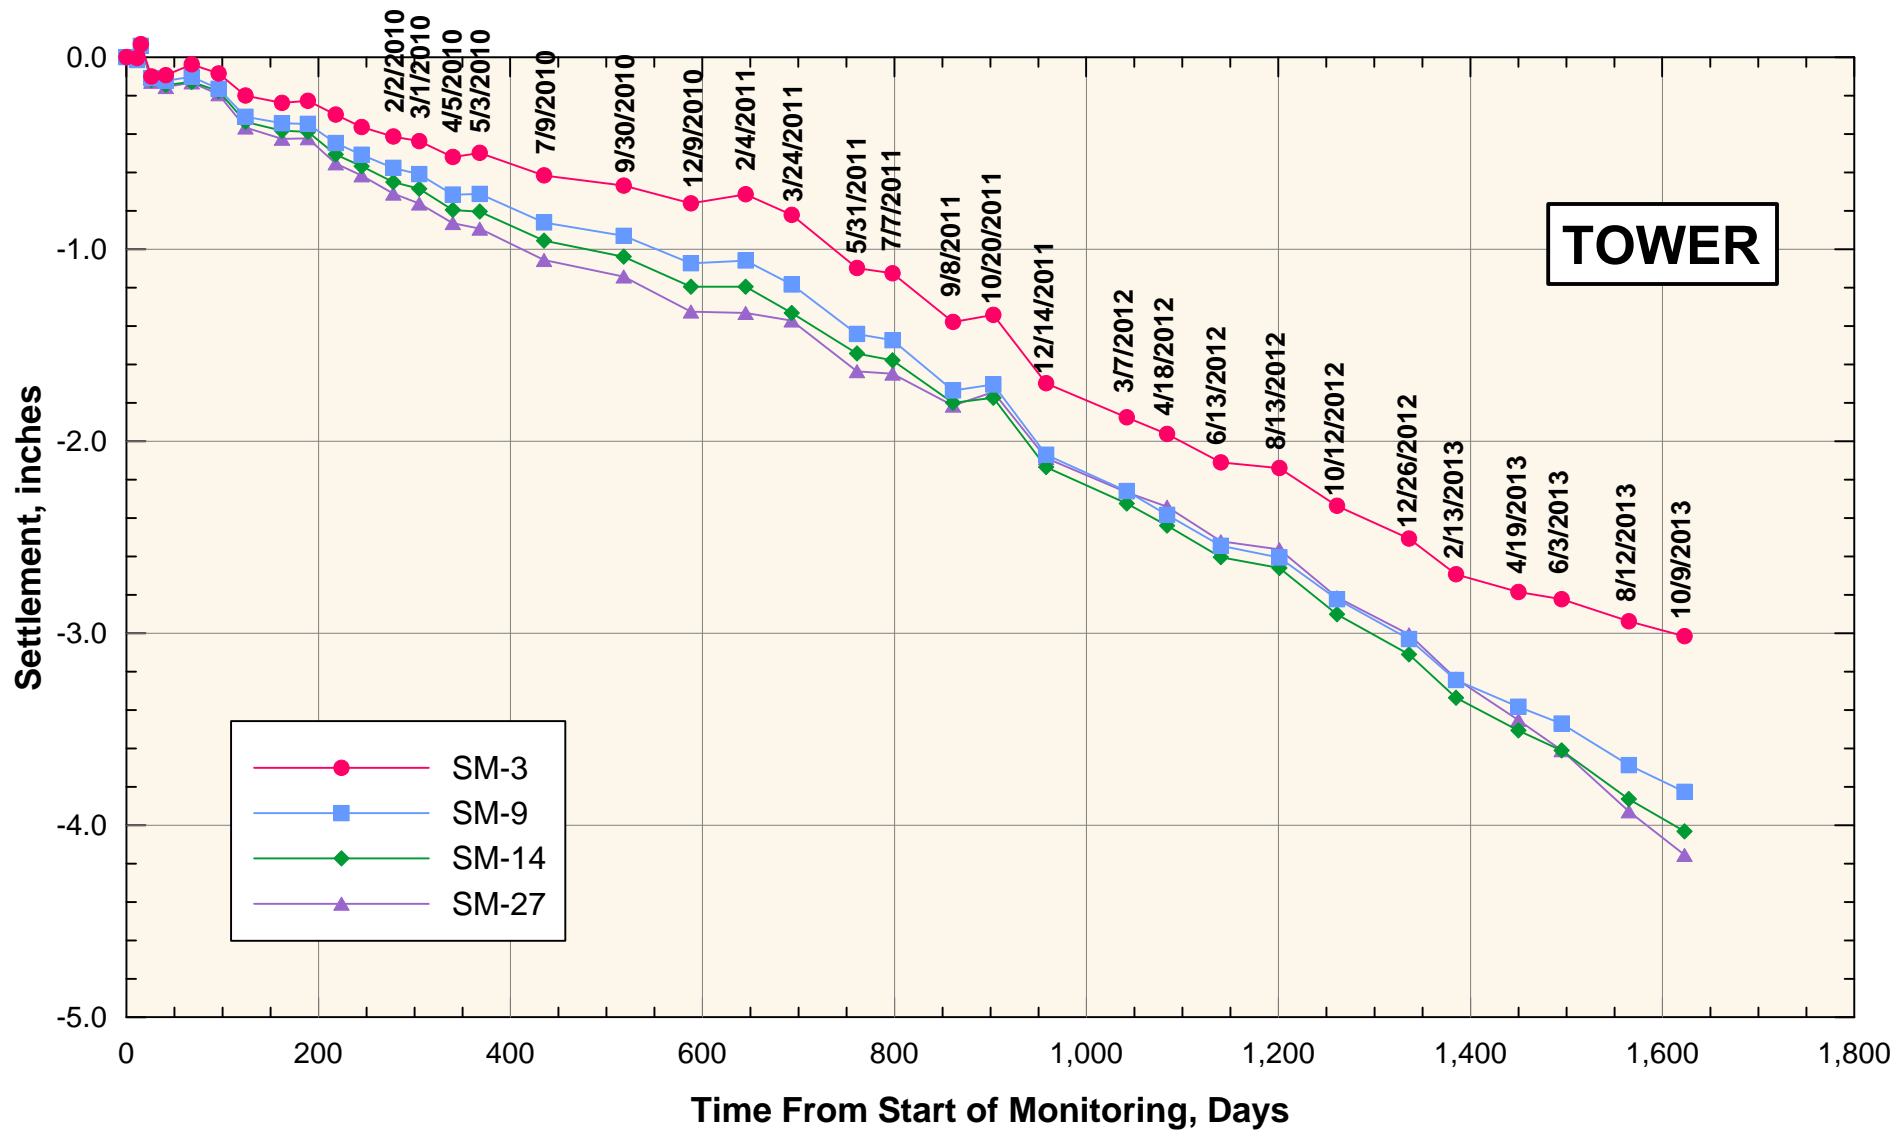
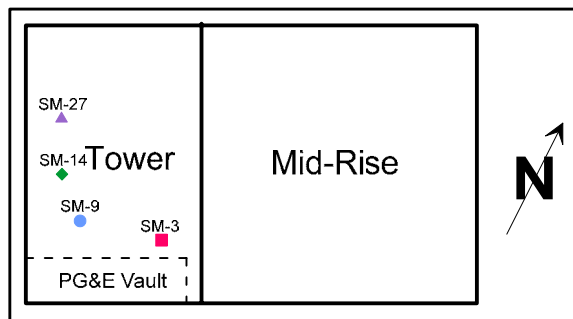
Note:
Initial (Baseline) reading
taken on 04/30/09

**SETTLEMENT OVER TIME
FLOOR ELEVATIONS AT LEVEL B-1
OF 301 MISSION PROPERTY- TOWER:
APRIL 30, 2009 THROUGH OCTOBER 9, 2013**
