*Board of Supervisors
City and County of San Francisco*

Government Audit and Oversight Committee

Supplemental Report for Foundation Settlement Investigation

**SUPPLEMENTAL REPORT
FOUNDATION SETTLEMENT INVESTIGATION
301 MISSION STREET
SAN FRANCISCO, CALIFORNIA**

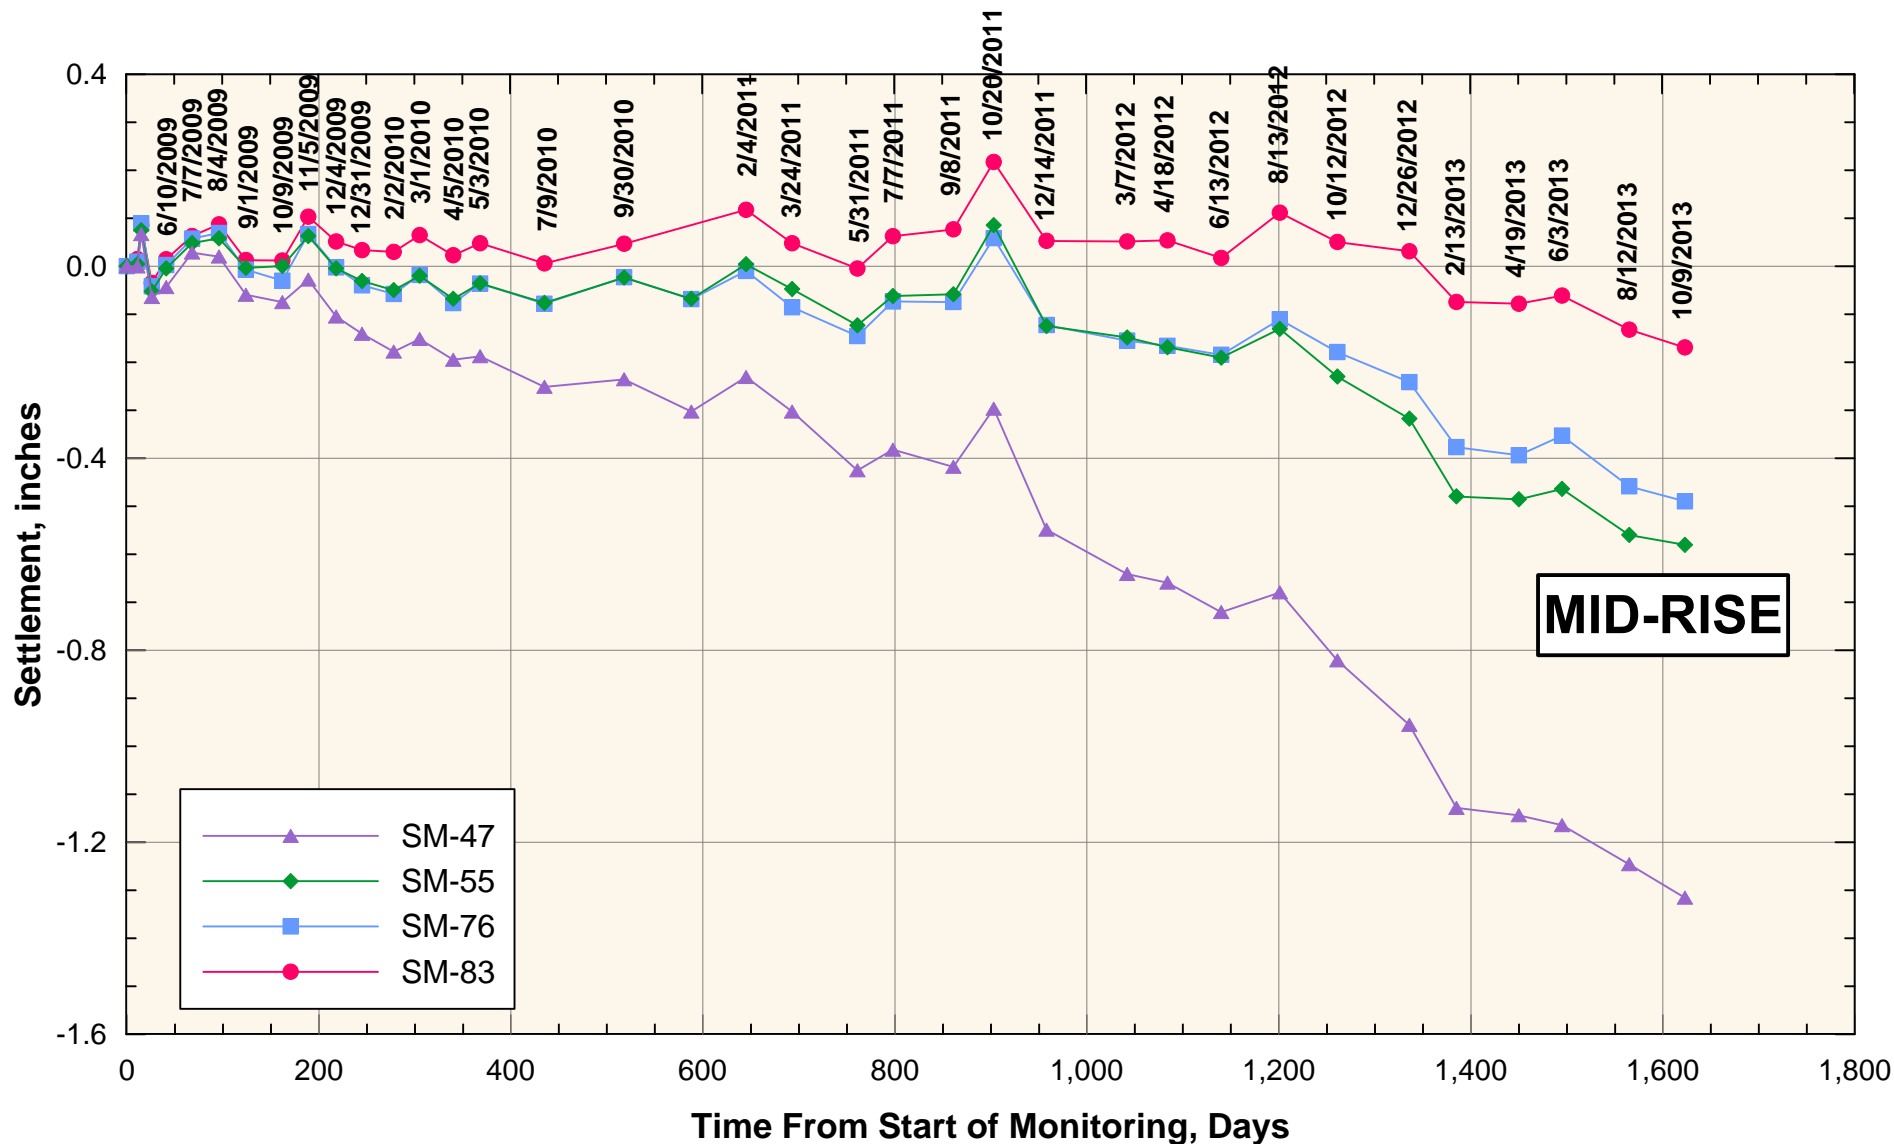
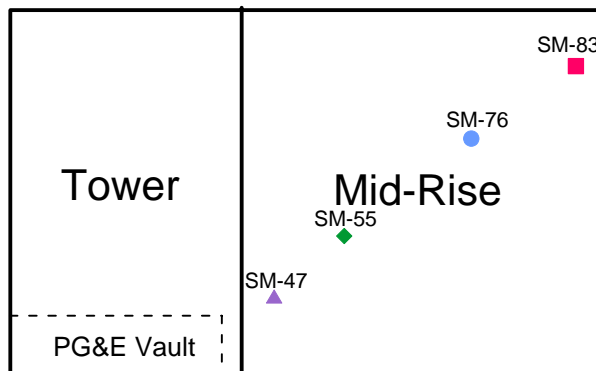
PLATE 5

Note:
Initial (Baseline) reading
taken on 04/30/09

**SETTLEMENT OVER TIME
FLOOR ELEVATIONS AT LEVEL B-1
OF 301 MISSION PROPERTY- MID-RISE:
APRIL 30, 2009 THROUGH OCTOBER 9, 2013**

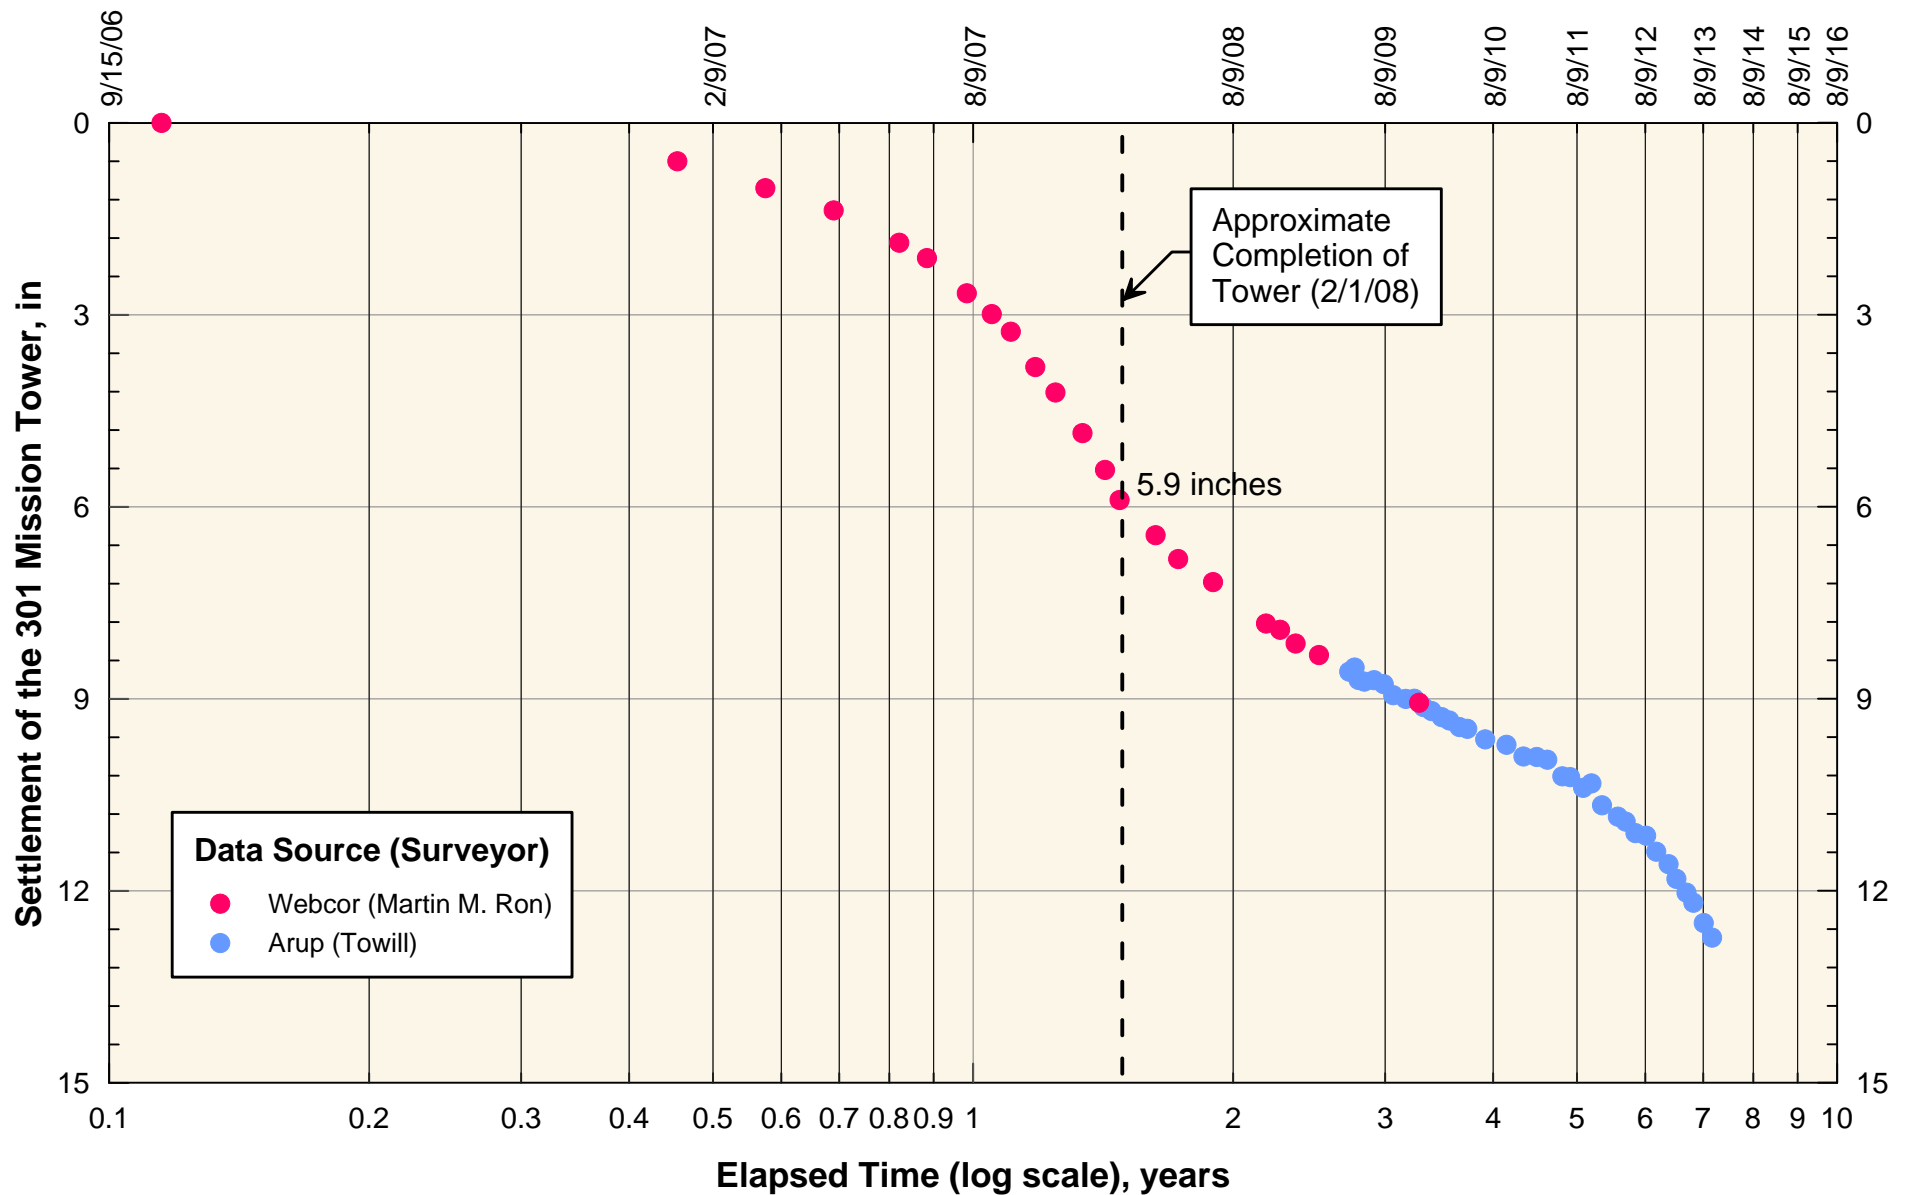
Beginning of Tower Construction: 8/9/06
 End of Tower Construction: 2/1/08
 Construction Duration: 542 days (1.5 years)

**SETTLEMENTS OF THE 301 MISSION TOWER
 INCLUDING MONITORING DURING CONSTRUCTION**

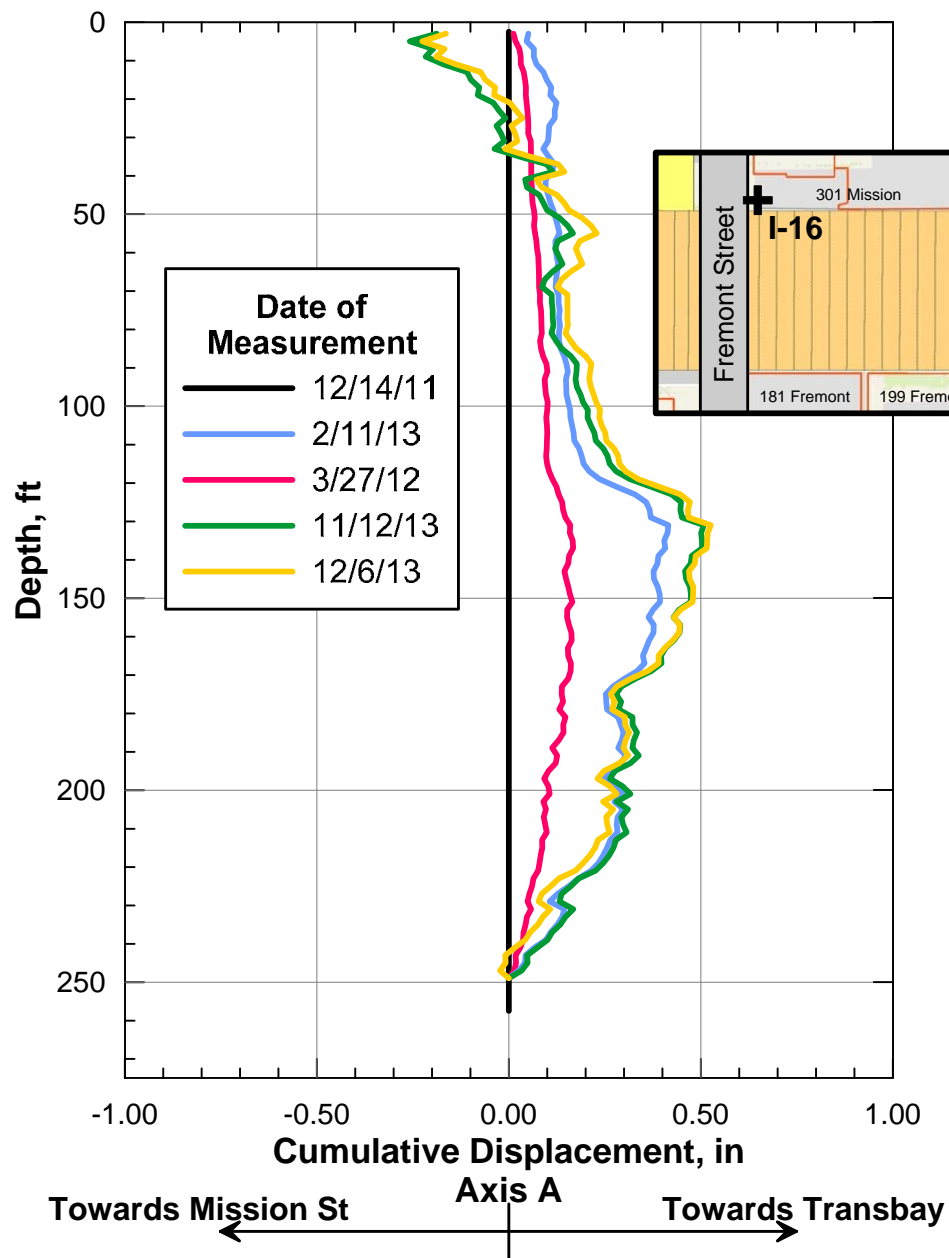
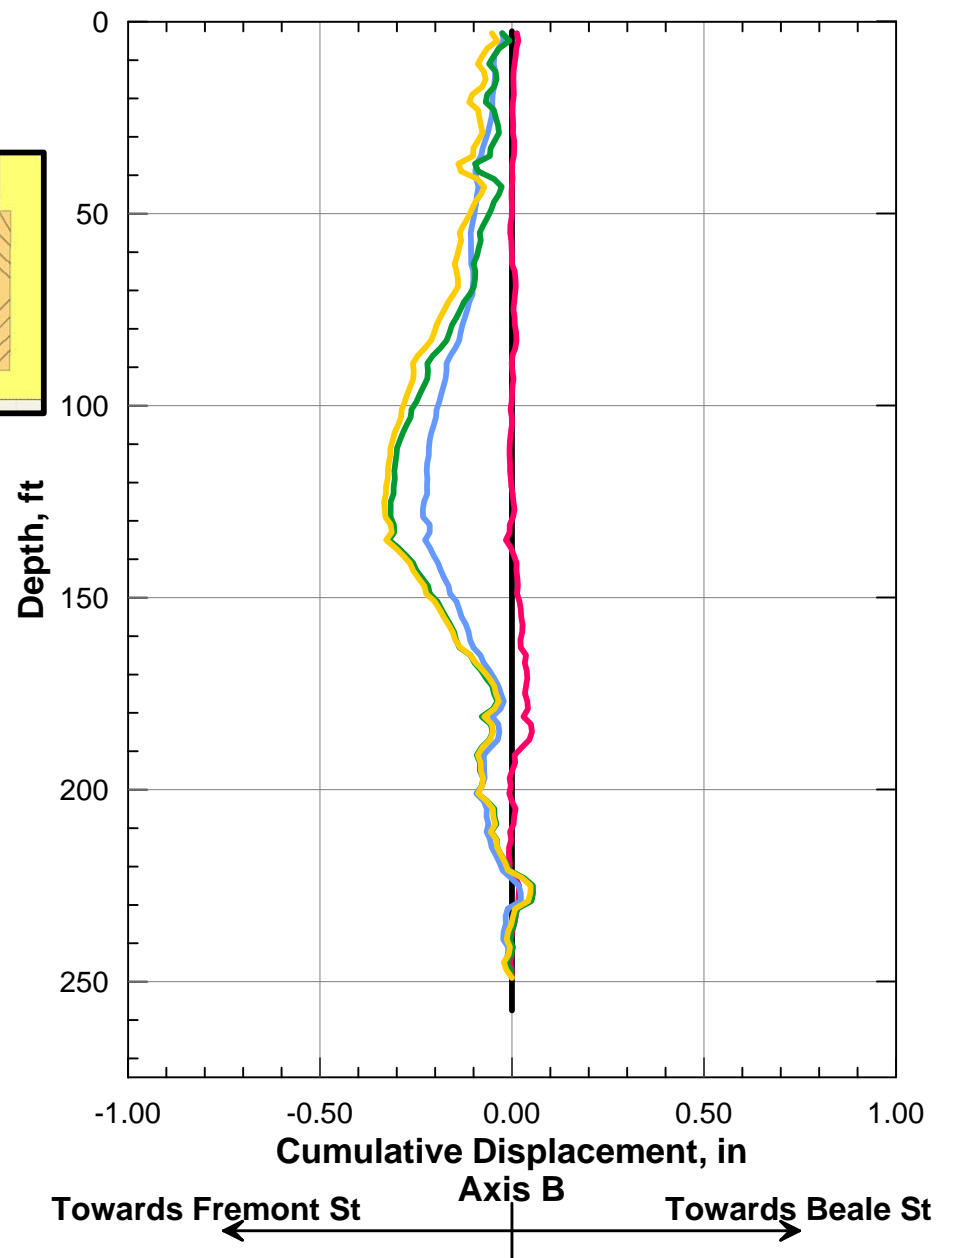
PLATE 2

MEASUREMENTS TAKEN AT INCLINOMETER I-16

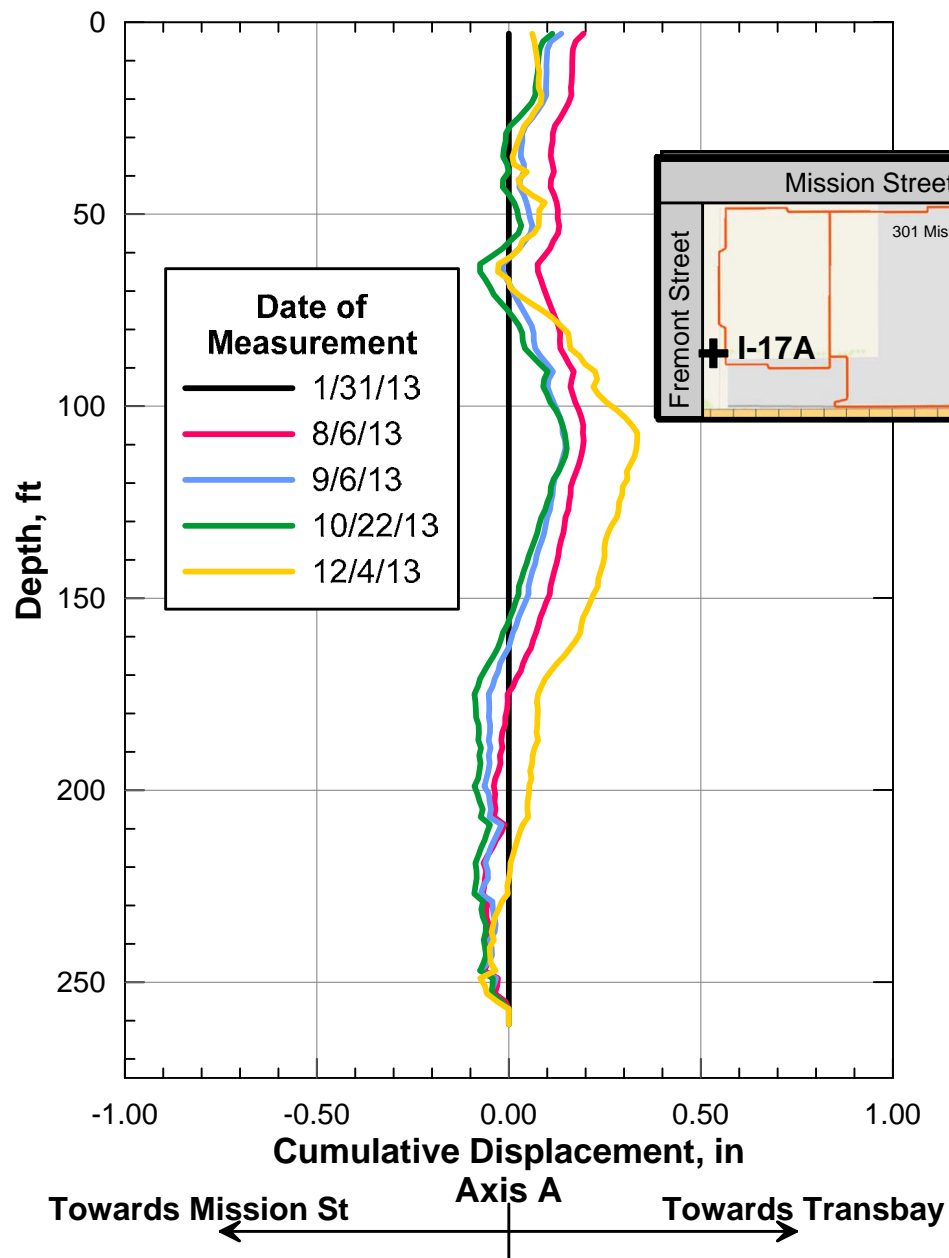
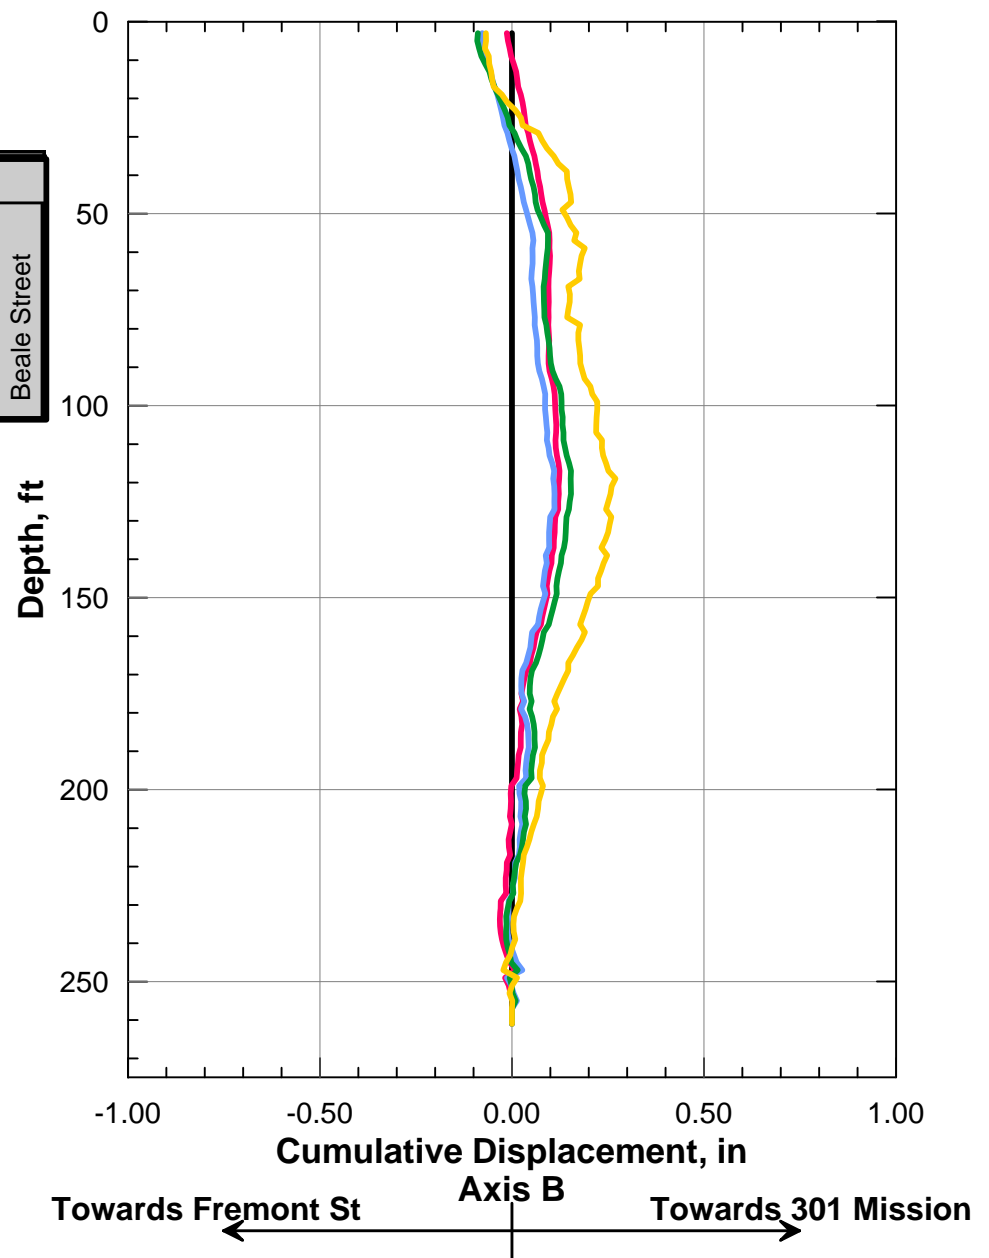
Note - The axes were rotated 30 degrees in order to reflect the directions orthogonal to the excavation.

MEASUREMENTS TAKEN AT INCLINOMETER I-17A

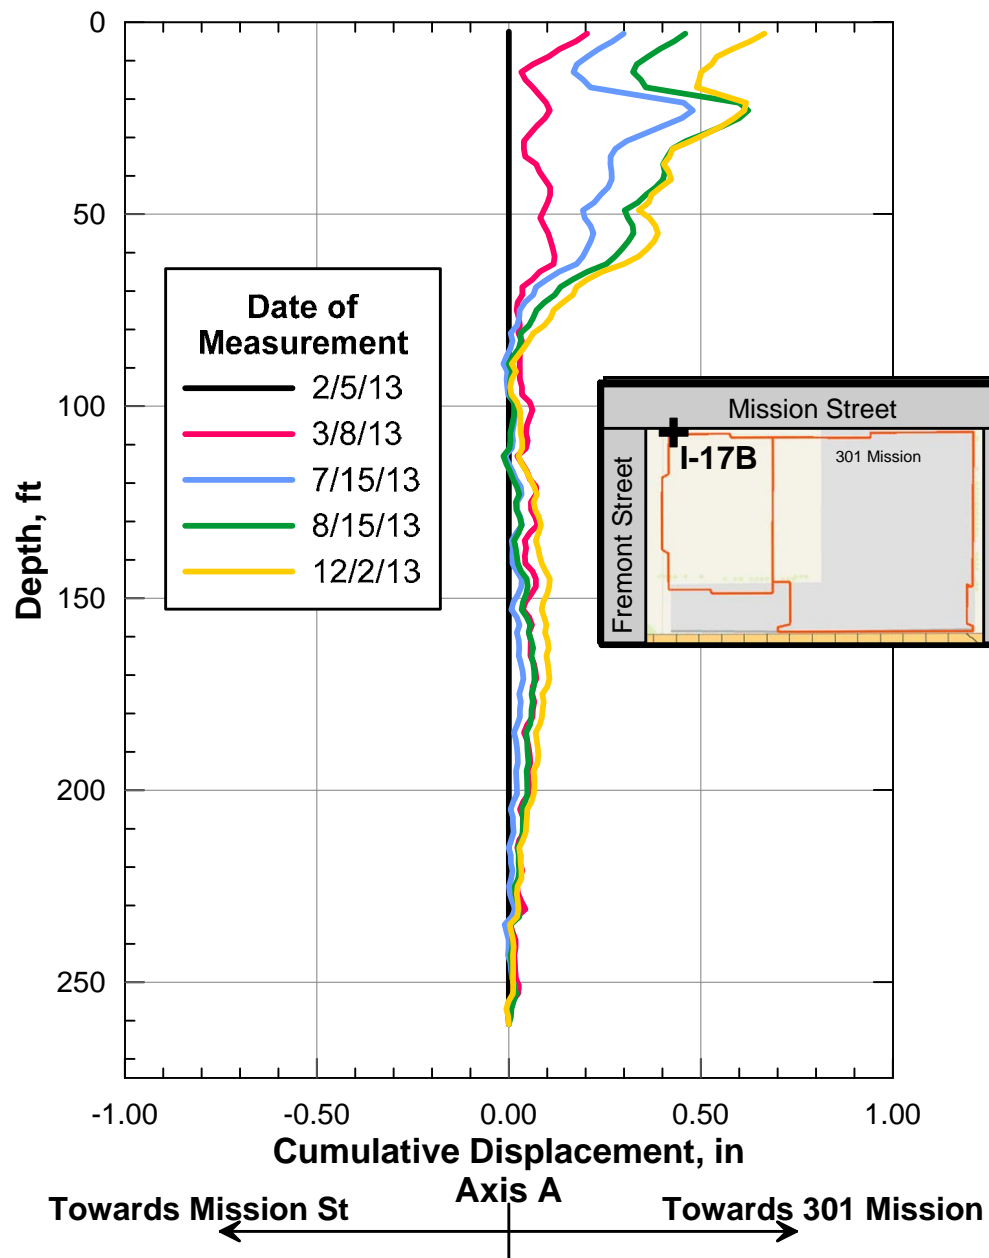
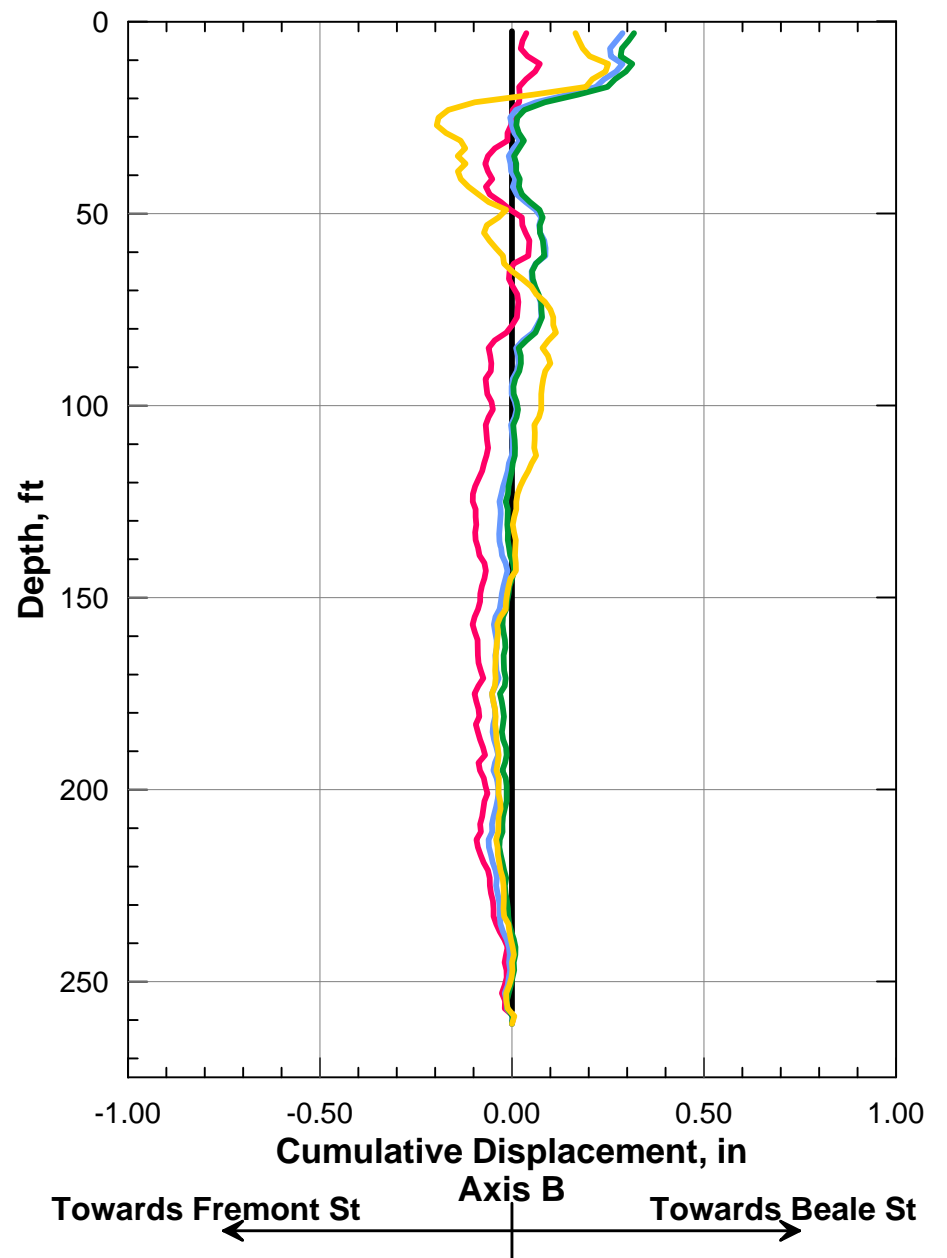
Note - The axes were rotated 30 degrees in order to reflect the directions orthogonal to the excavation.

MEASUREMENTS TAKEN AT INCLINOMETER I-17B

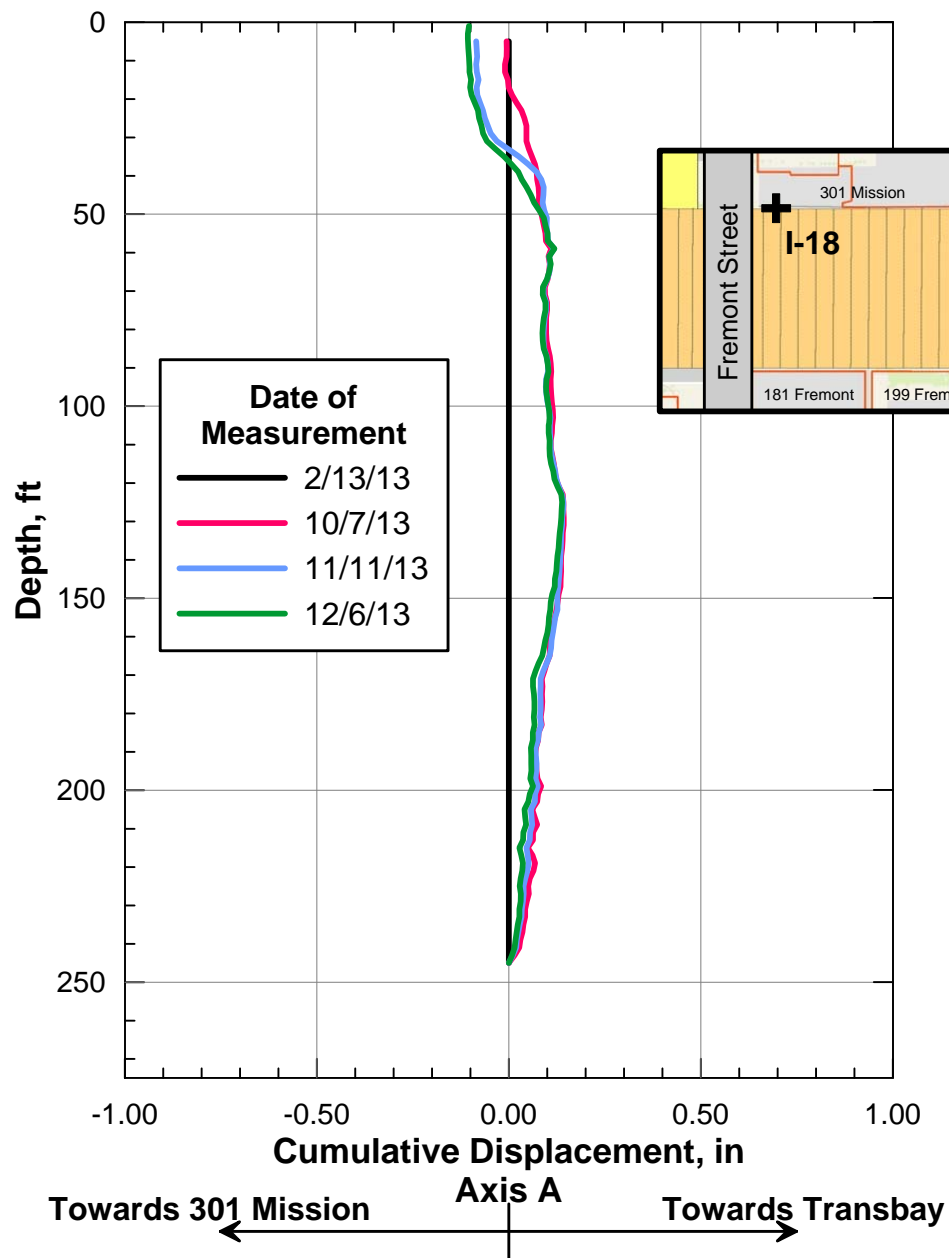
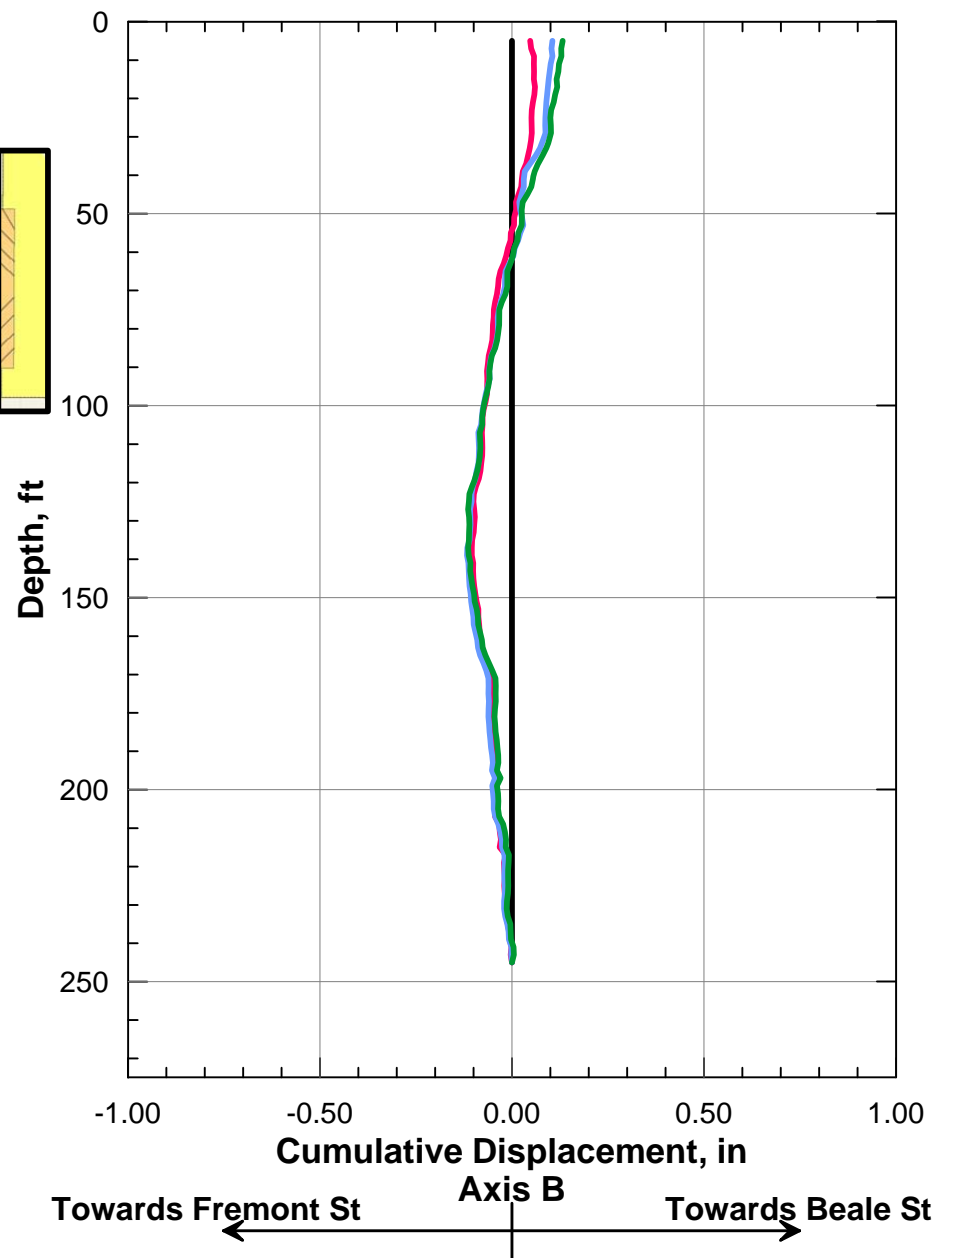
MEASUREMENTS TAKEN AT INCLINOMETER I-18

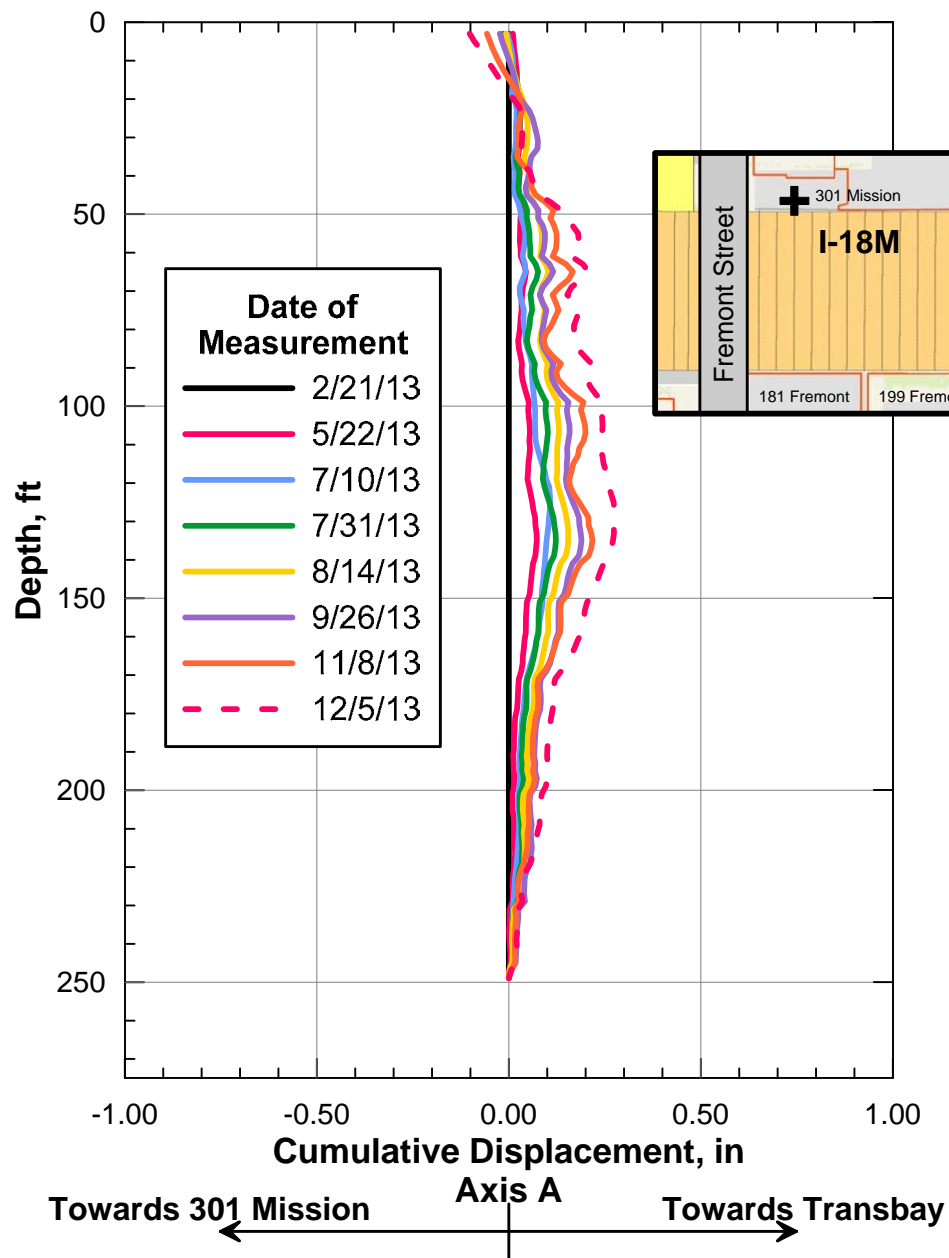
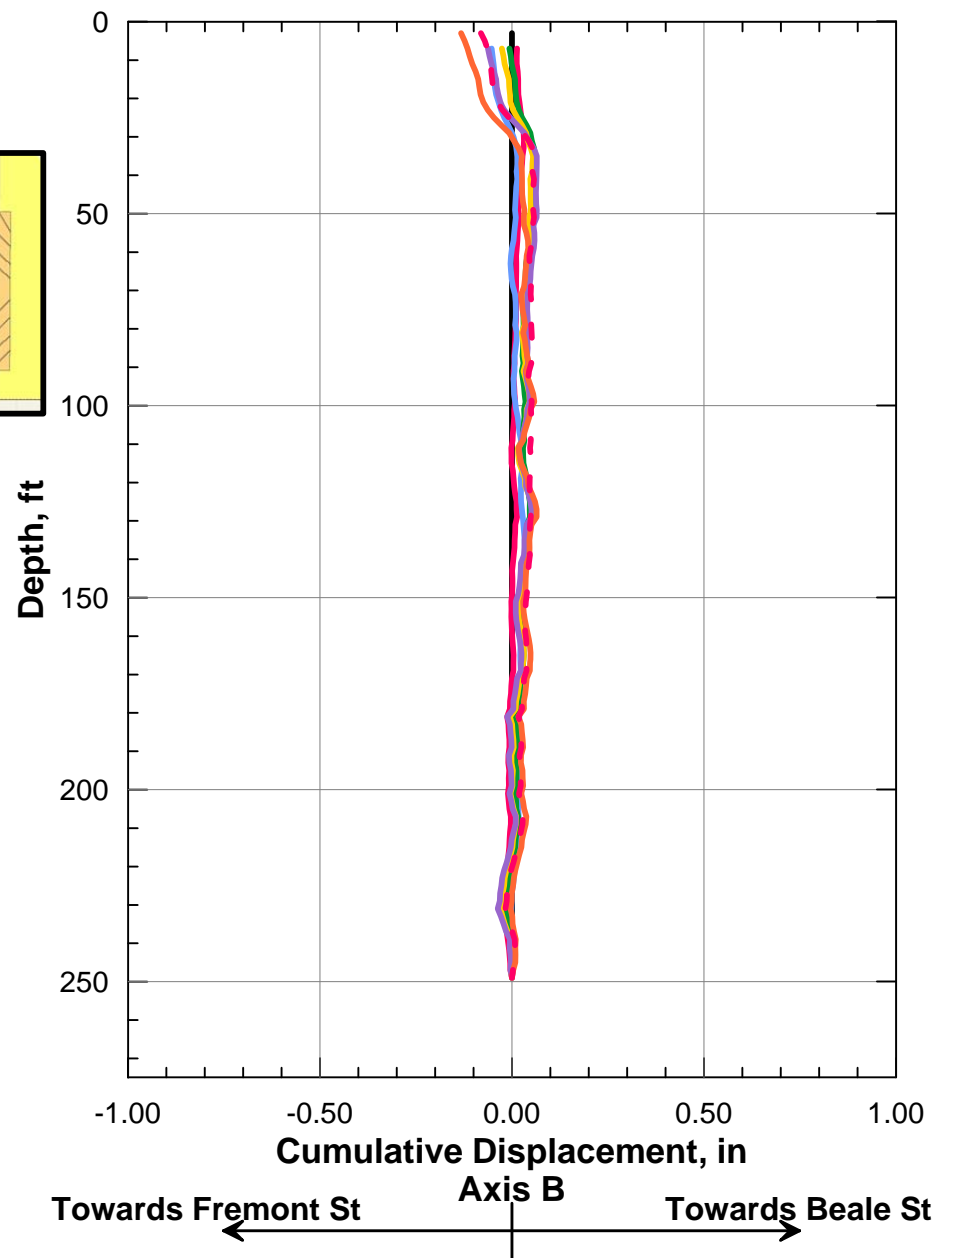
MEASUREMENTS TAKEN AT INCLINOMETER I-18M

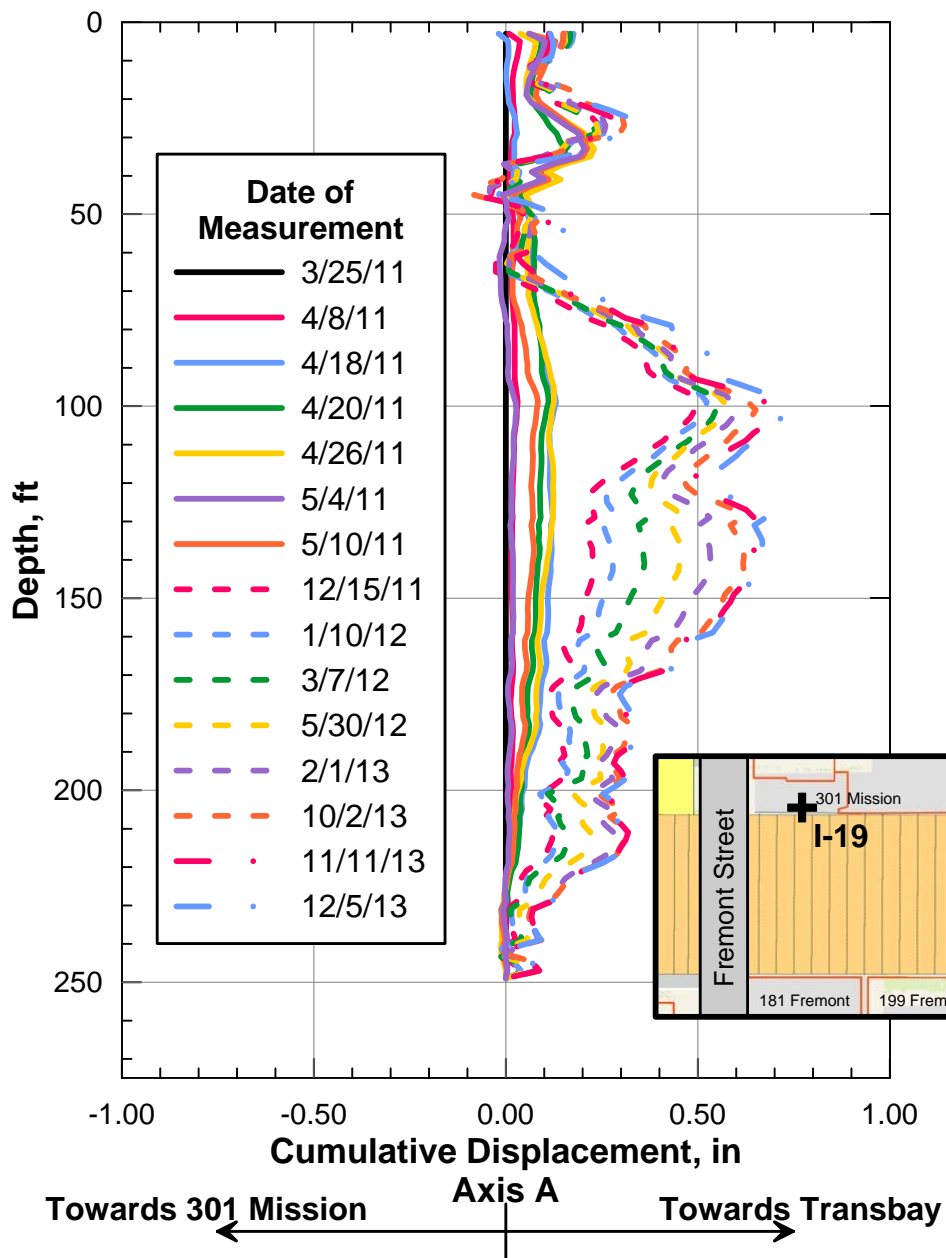
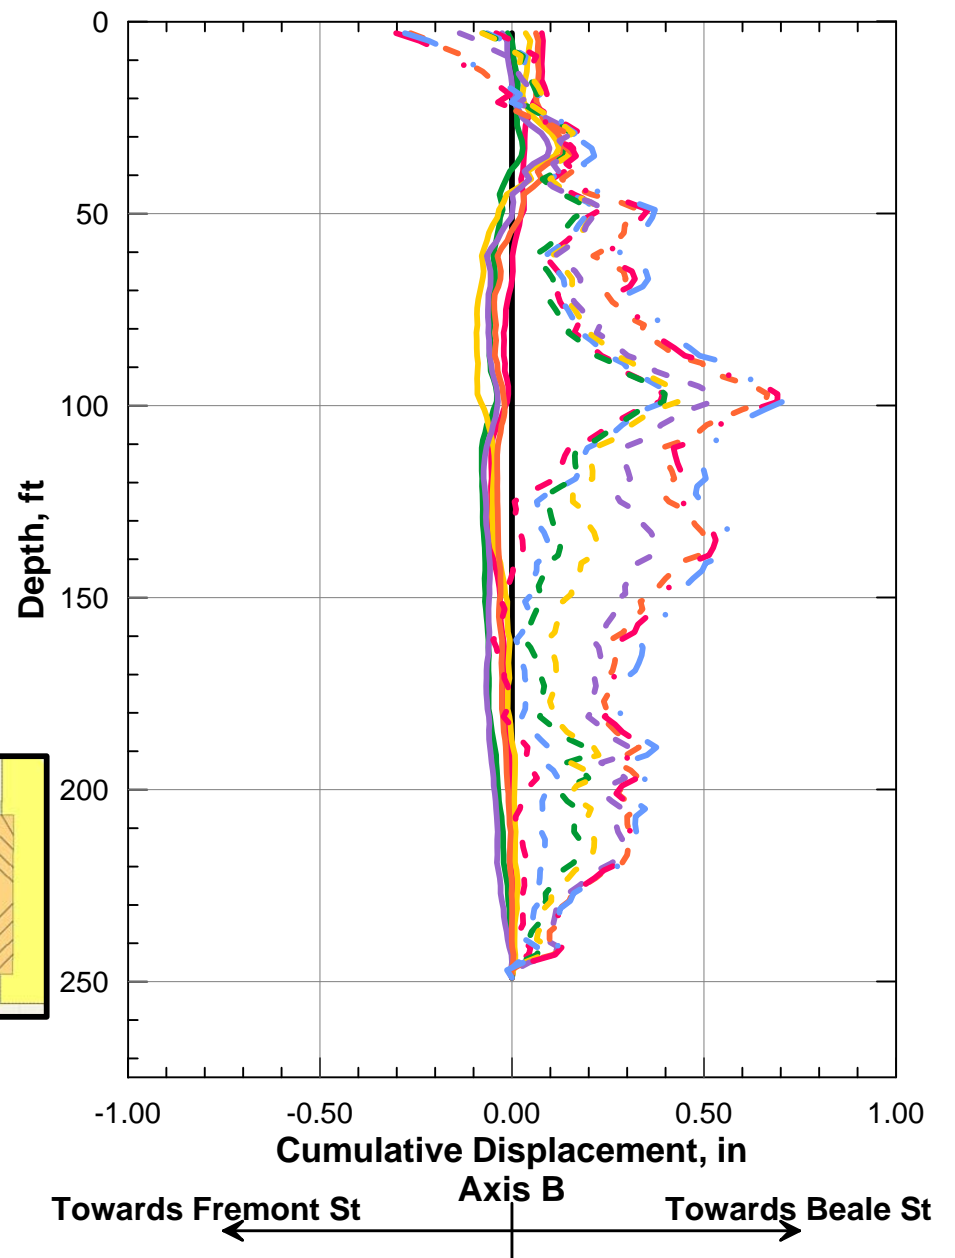
PLATE 7

MEASUREMENTS TAKEN AT INCLINOMETER I-19

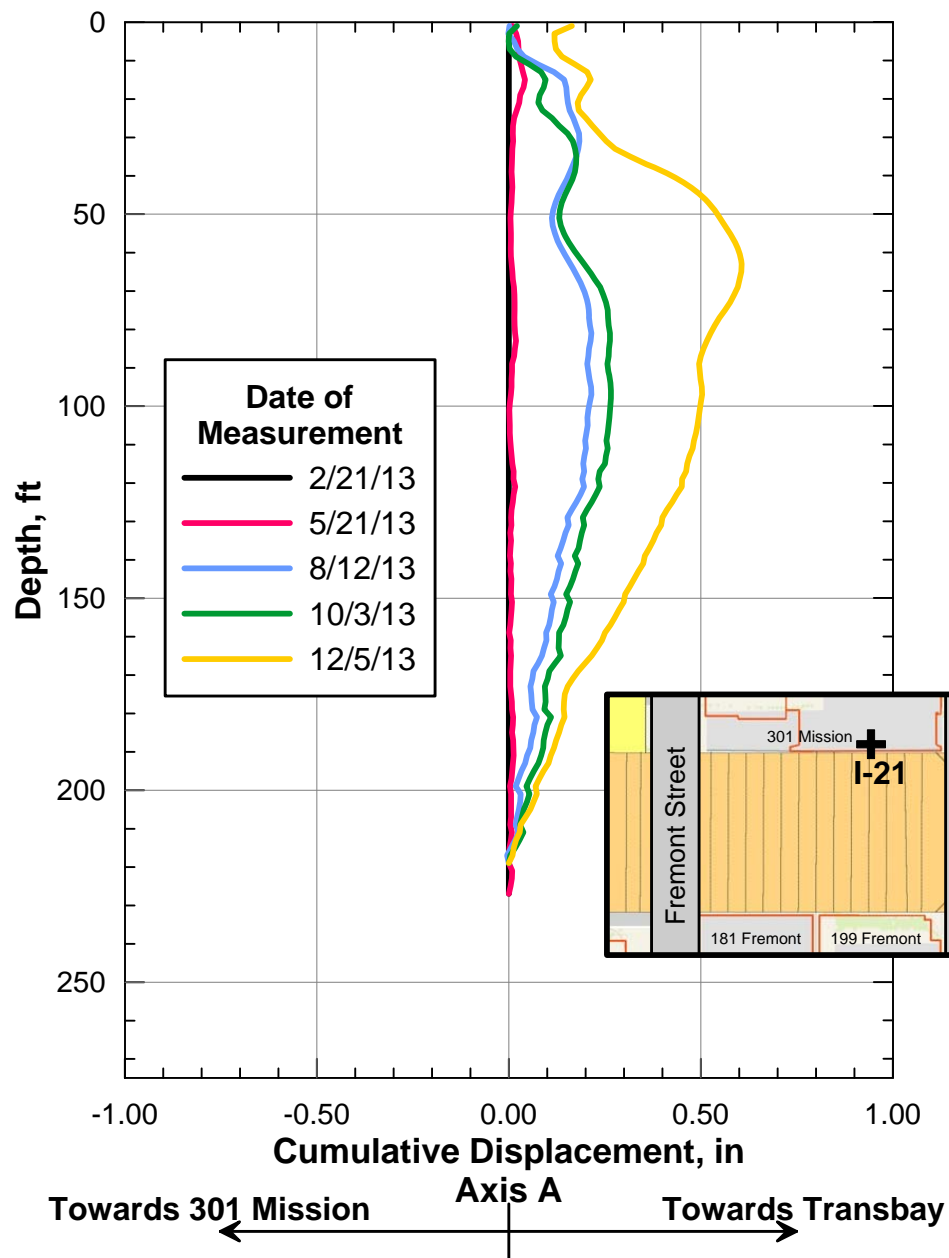
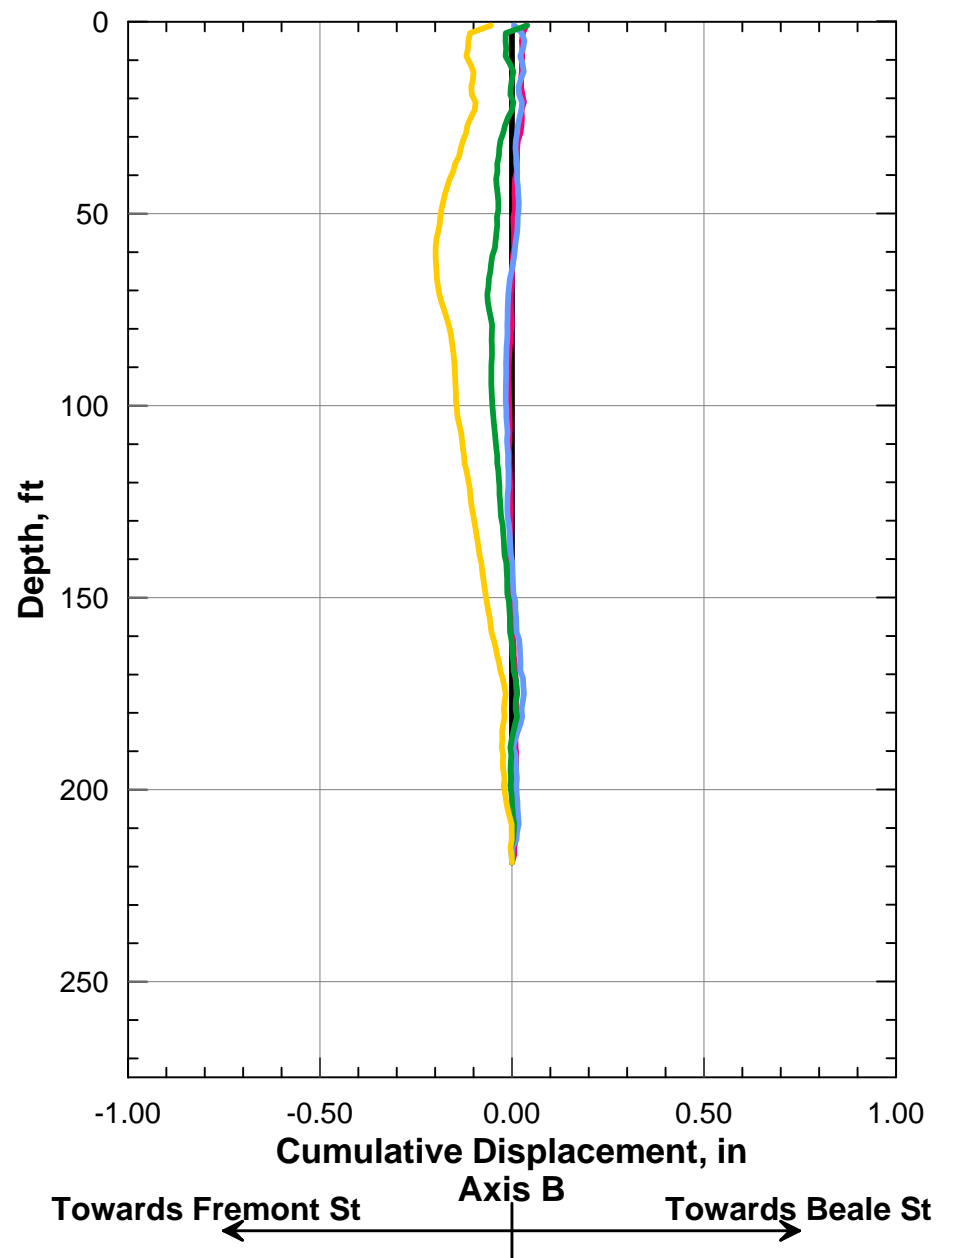
PLATE 8

MEASUREMENTS TAKEN AT INCLINOMETER I-21
