*Board of Supervisors
City and County of San Francisco*

Government Audit and Oversight Committee

Supplemental Report for Foundation Settlement Investigation

**SUPPLEMENTAL REPORT
FOUNDATION SETTLEMENT INVESTIGATION
301 MISSION STREET
SAN FRANCISCO, CALIFORNIA**

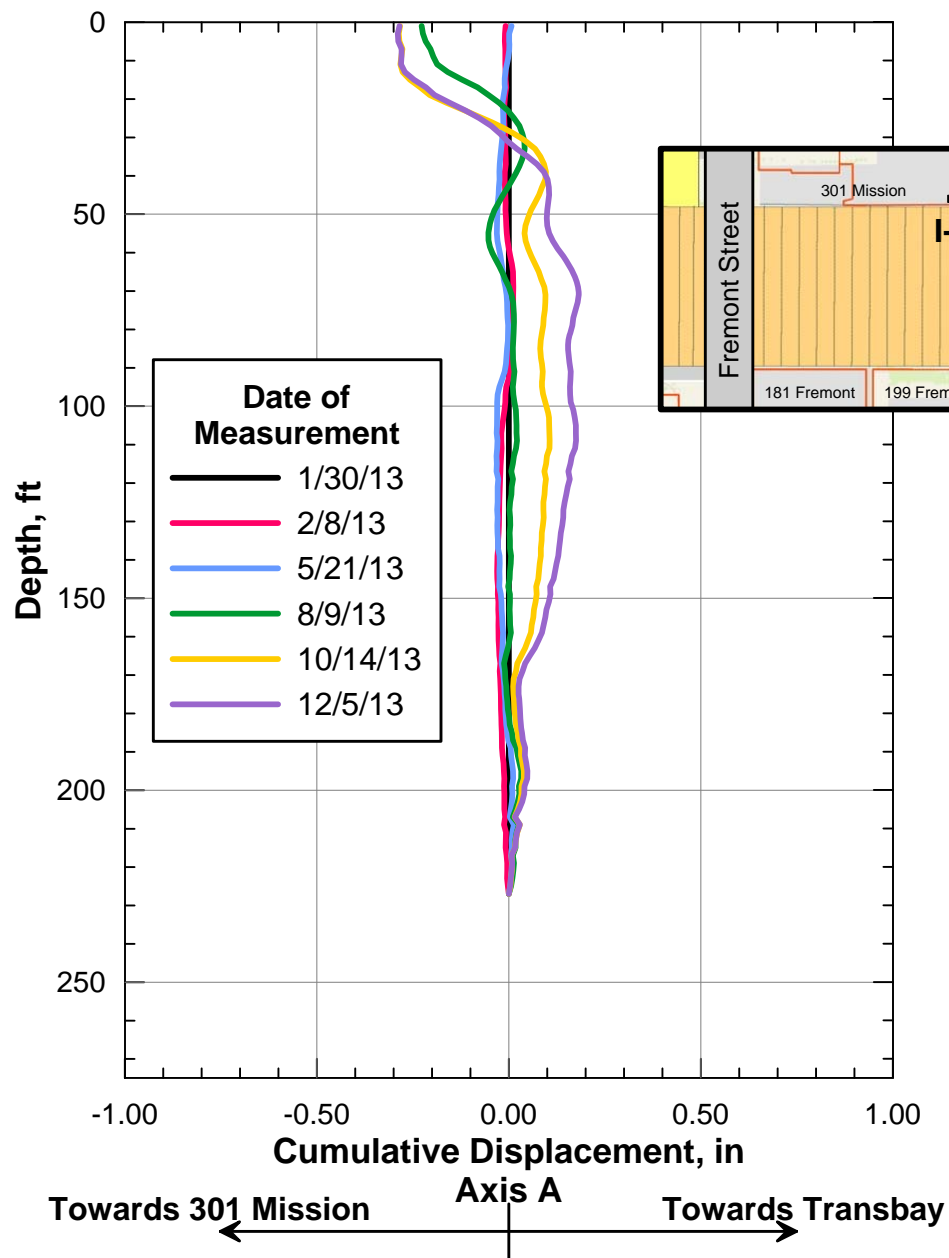
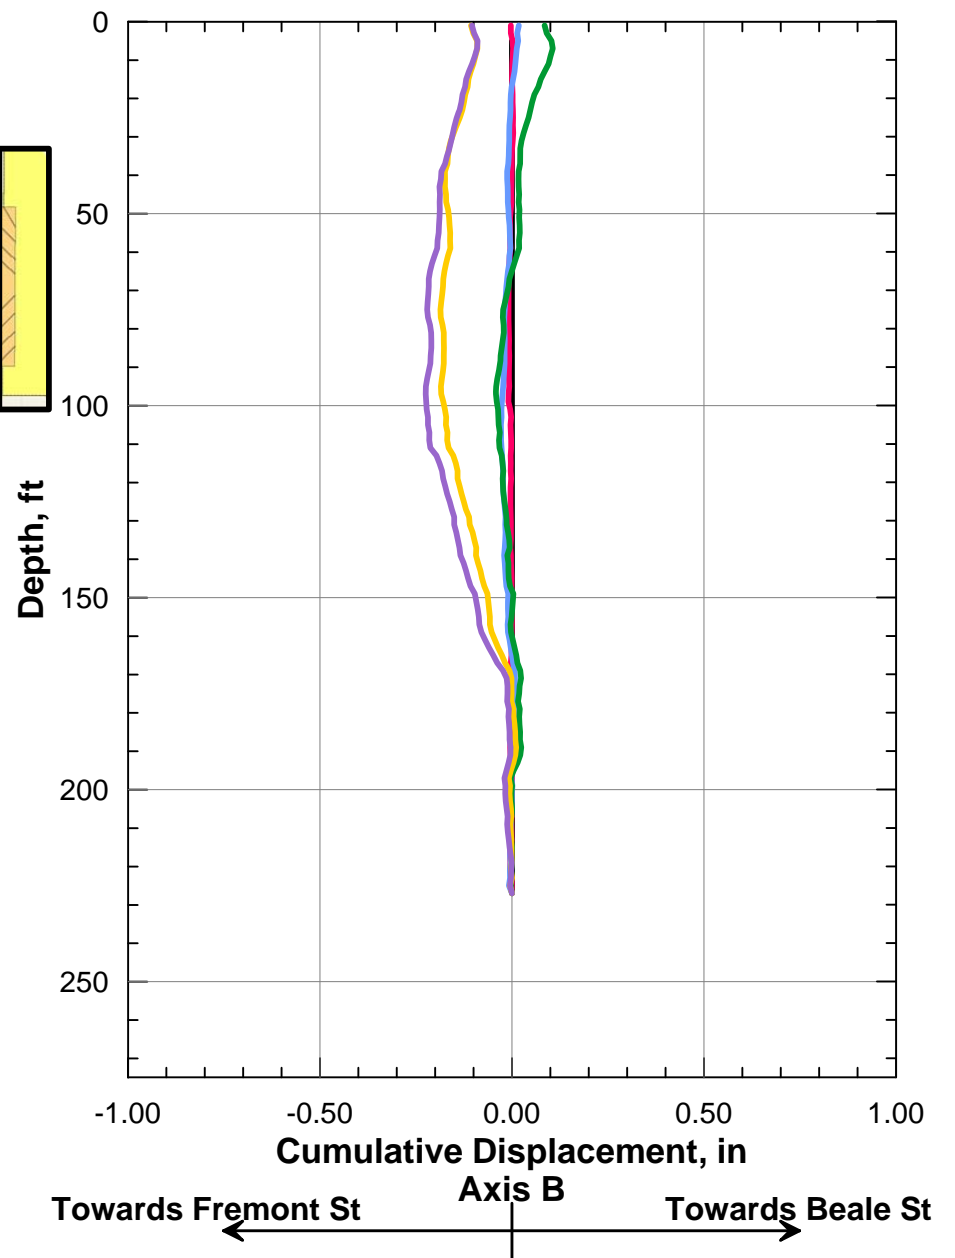
MEASUREMENTS TAKEN AT INCLINOMETER I-22

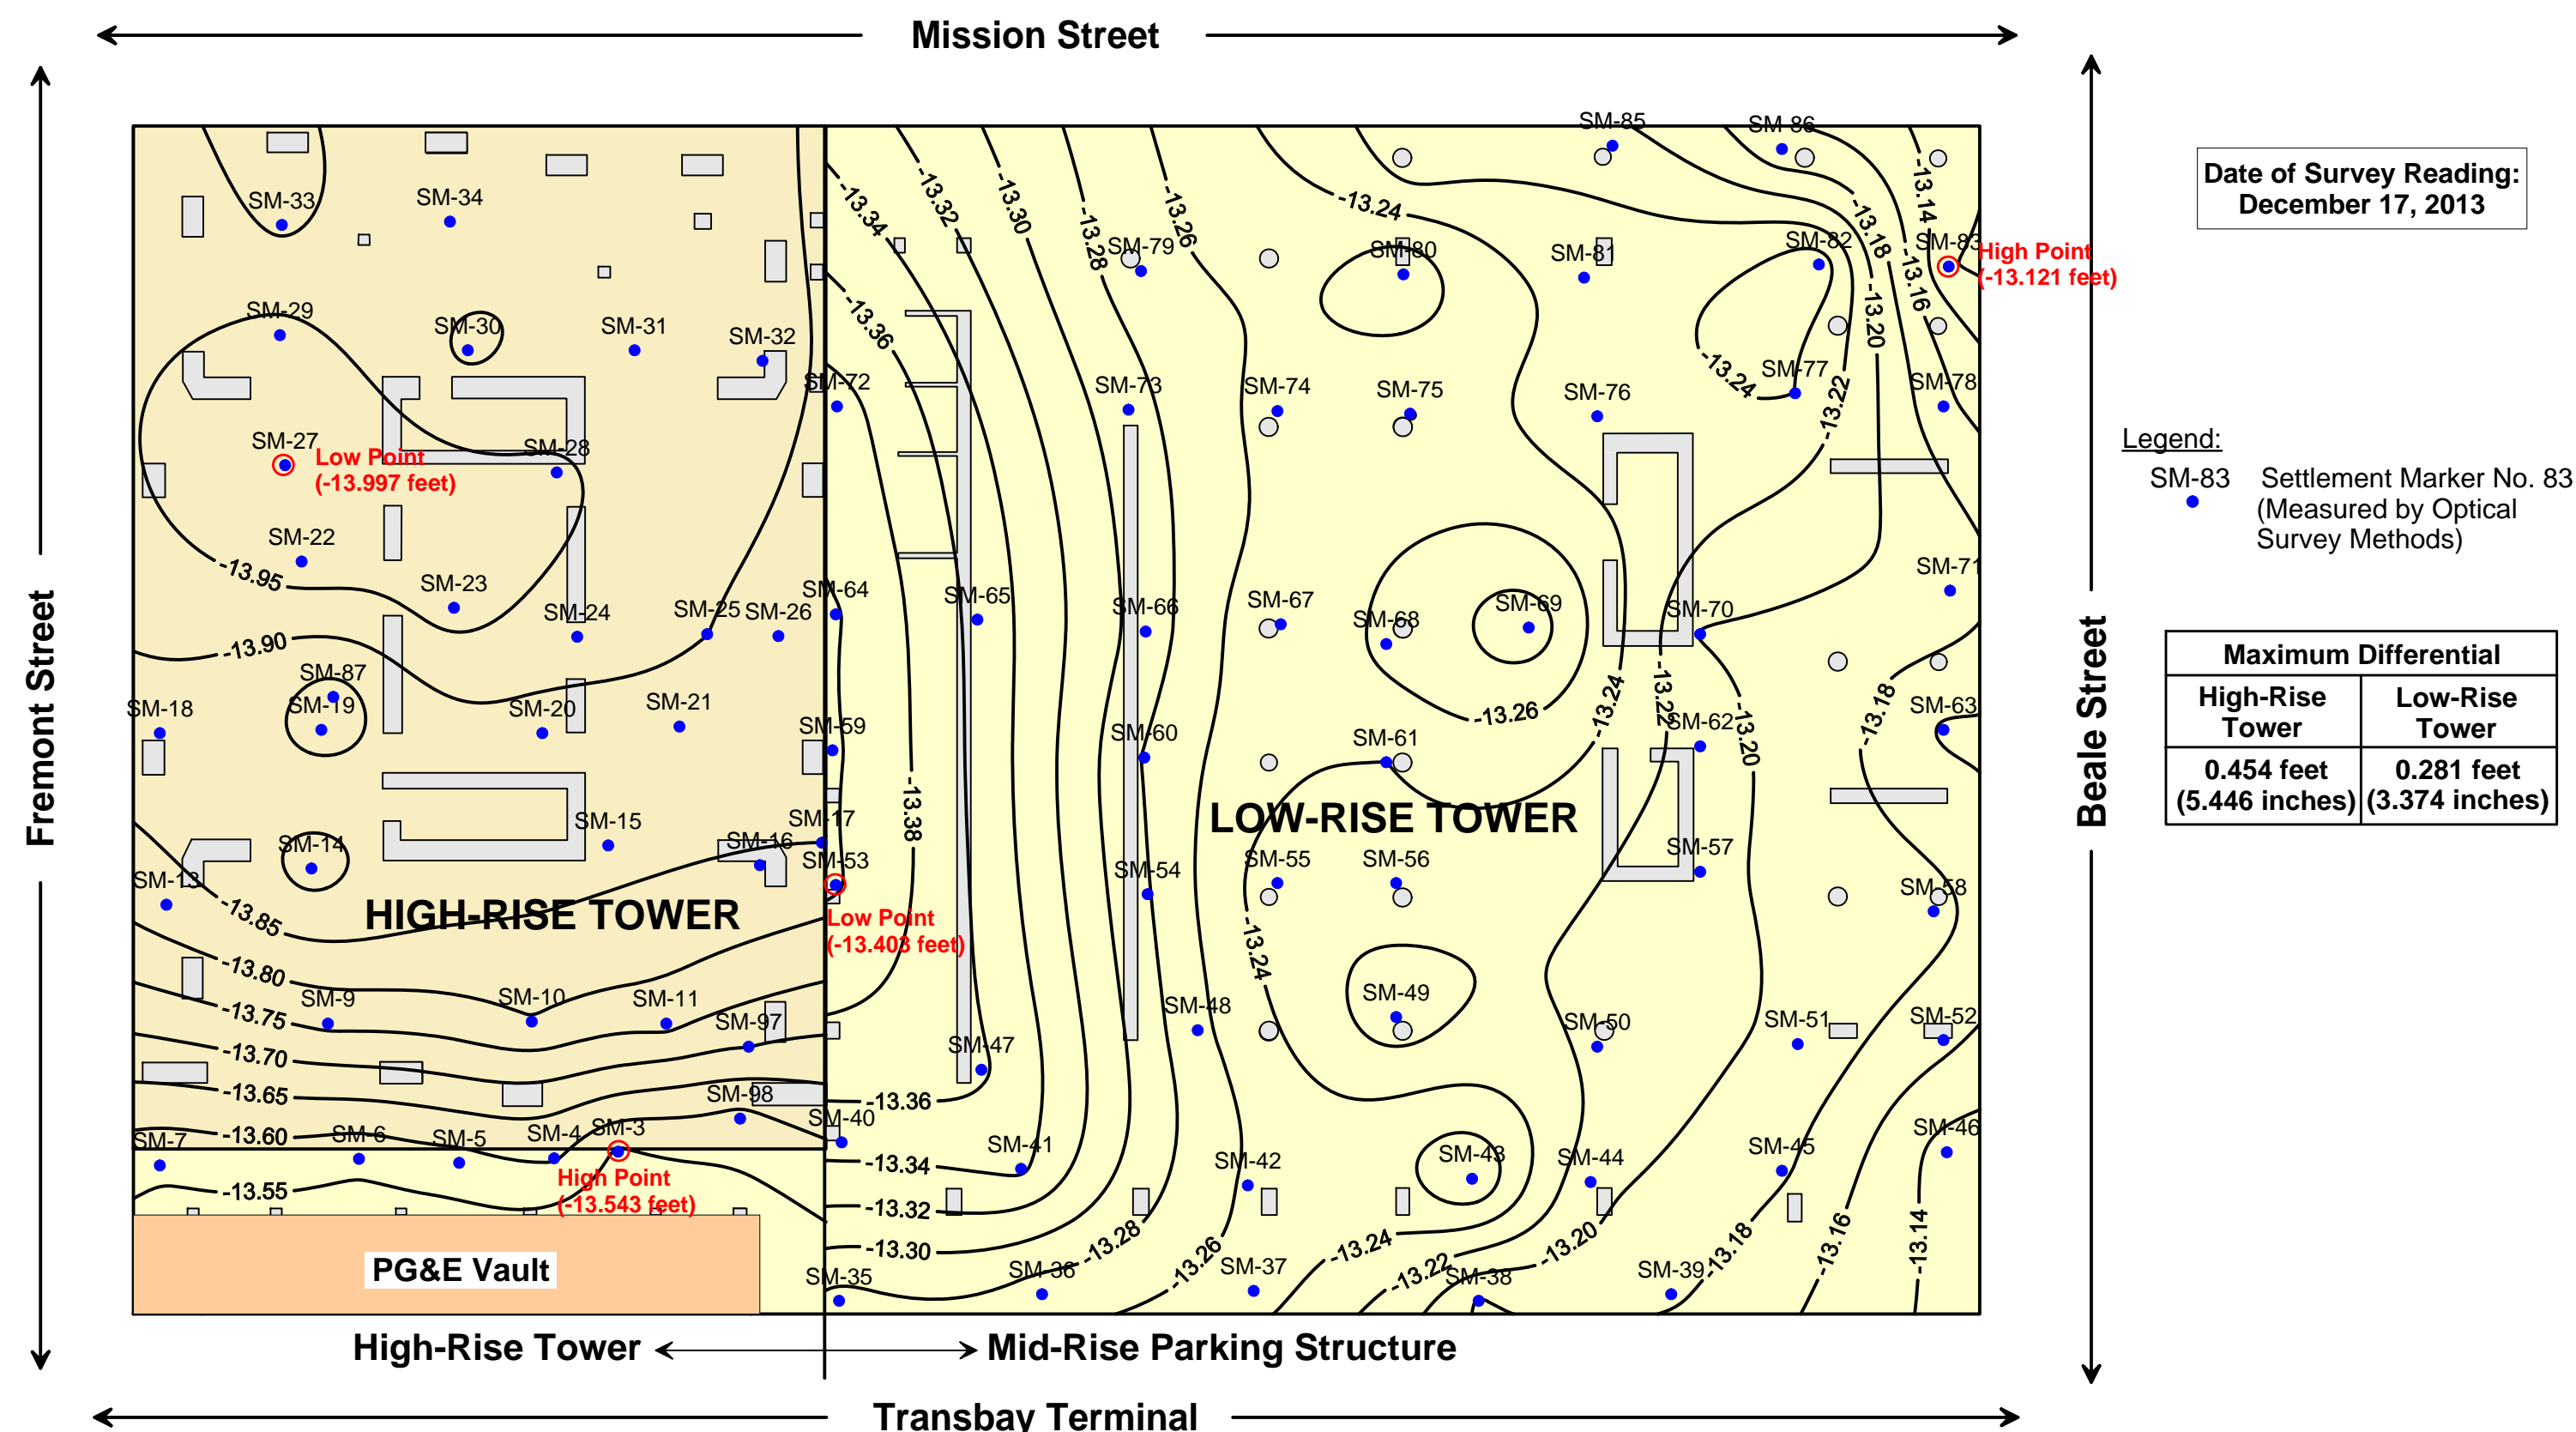
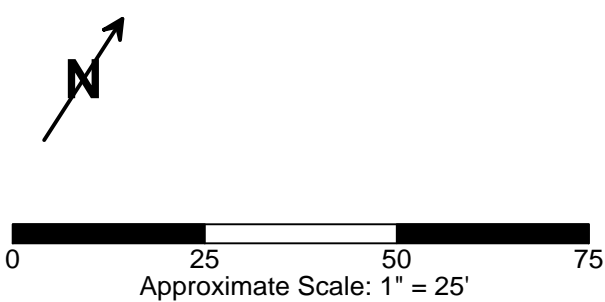
Maximum Differential	
High-Rise Tower	Low-Rise Tower
0.454 feet (5.446 inches)	0.281 feet (3.374 inches)

Notes:
Contours represent elevation, in feet (CCSF Datum), from survey readings taken on December 17, 2013.
Level B-1 at Mid-Rise Parking portion of survey site is approximately 4 inches higher than Level B-1 at High-Rise Tower portion.
The PG&E vault is inaccessible for monitoring.

FLOOR ELEVATIONS AT LEVEL B-1
OF 301 MISSION PROPERTY:
PERIODIC SURVEY - DECEMBER 17, 2013

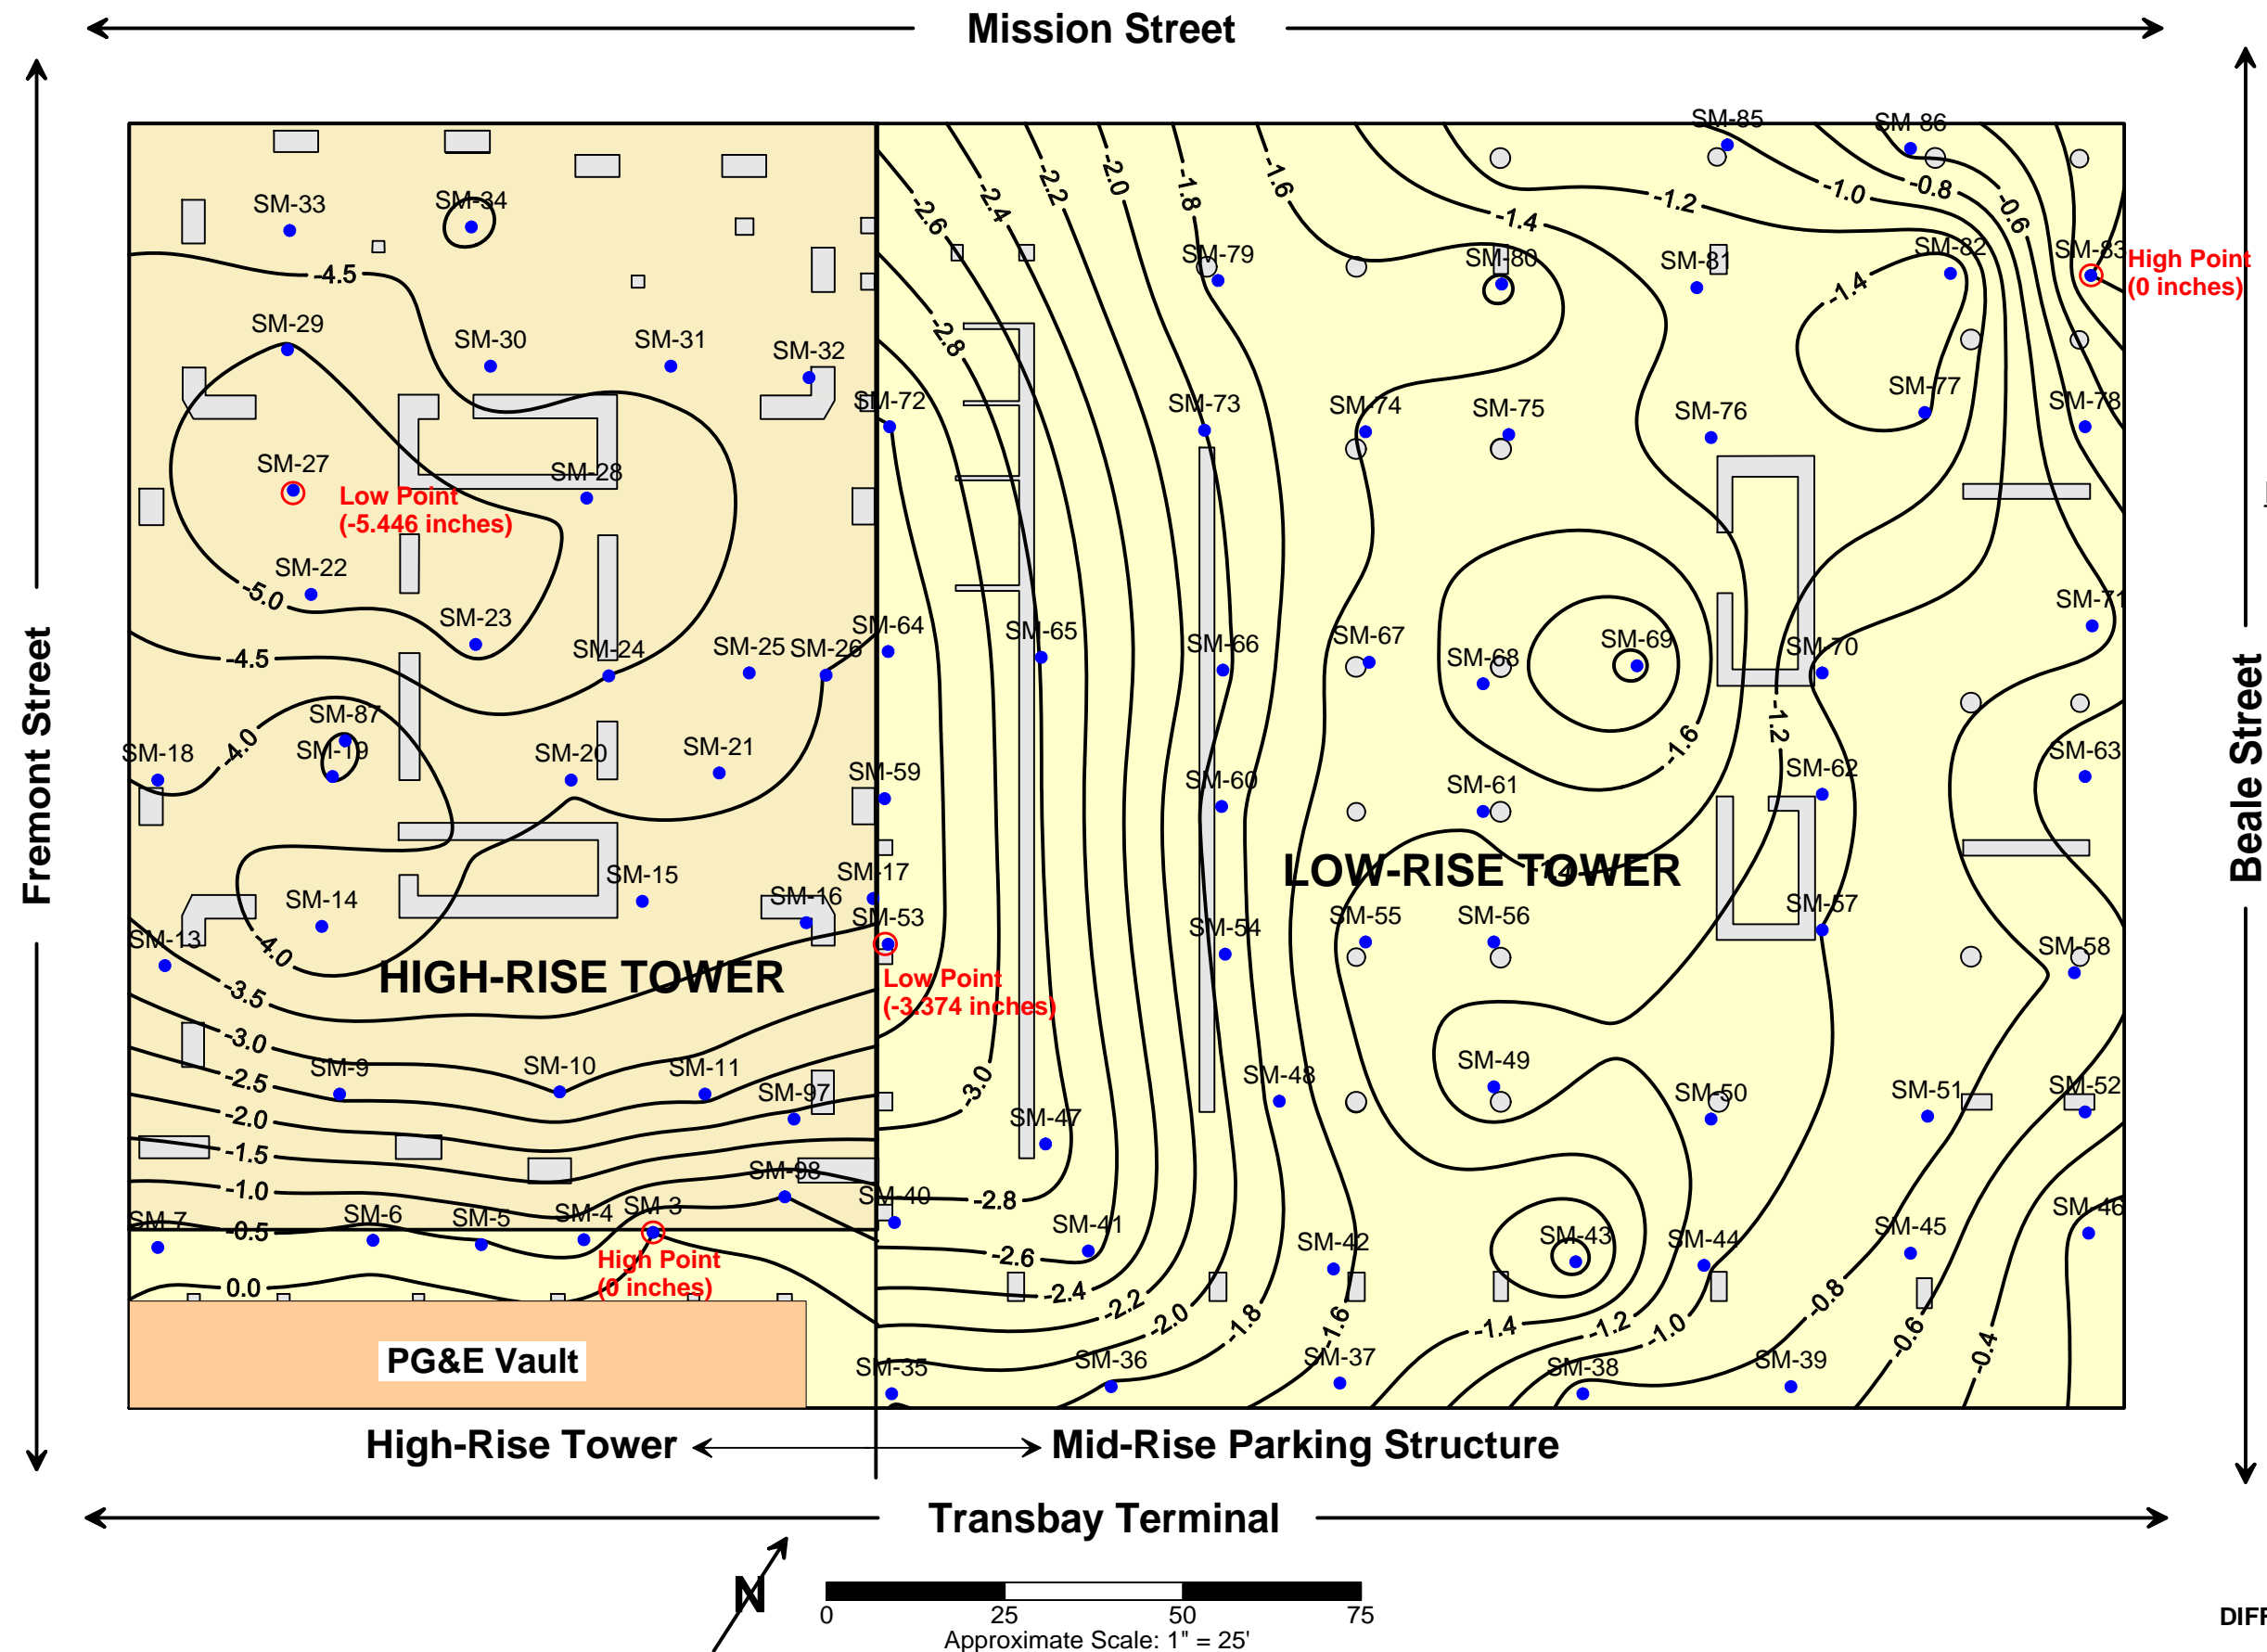
PLATE 2

DIFFERENTIAL FLOOR ELEVATIONS (INCHES)
DECEMBER 17, 2013 SURVEY

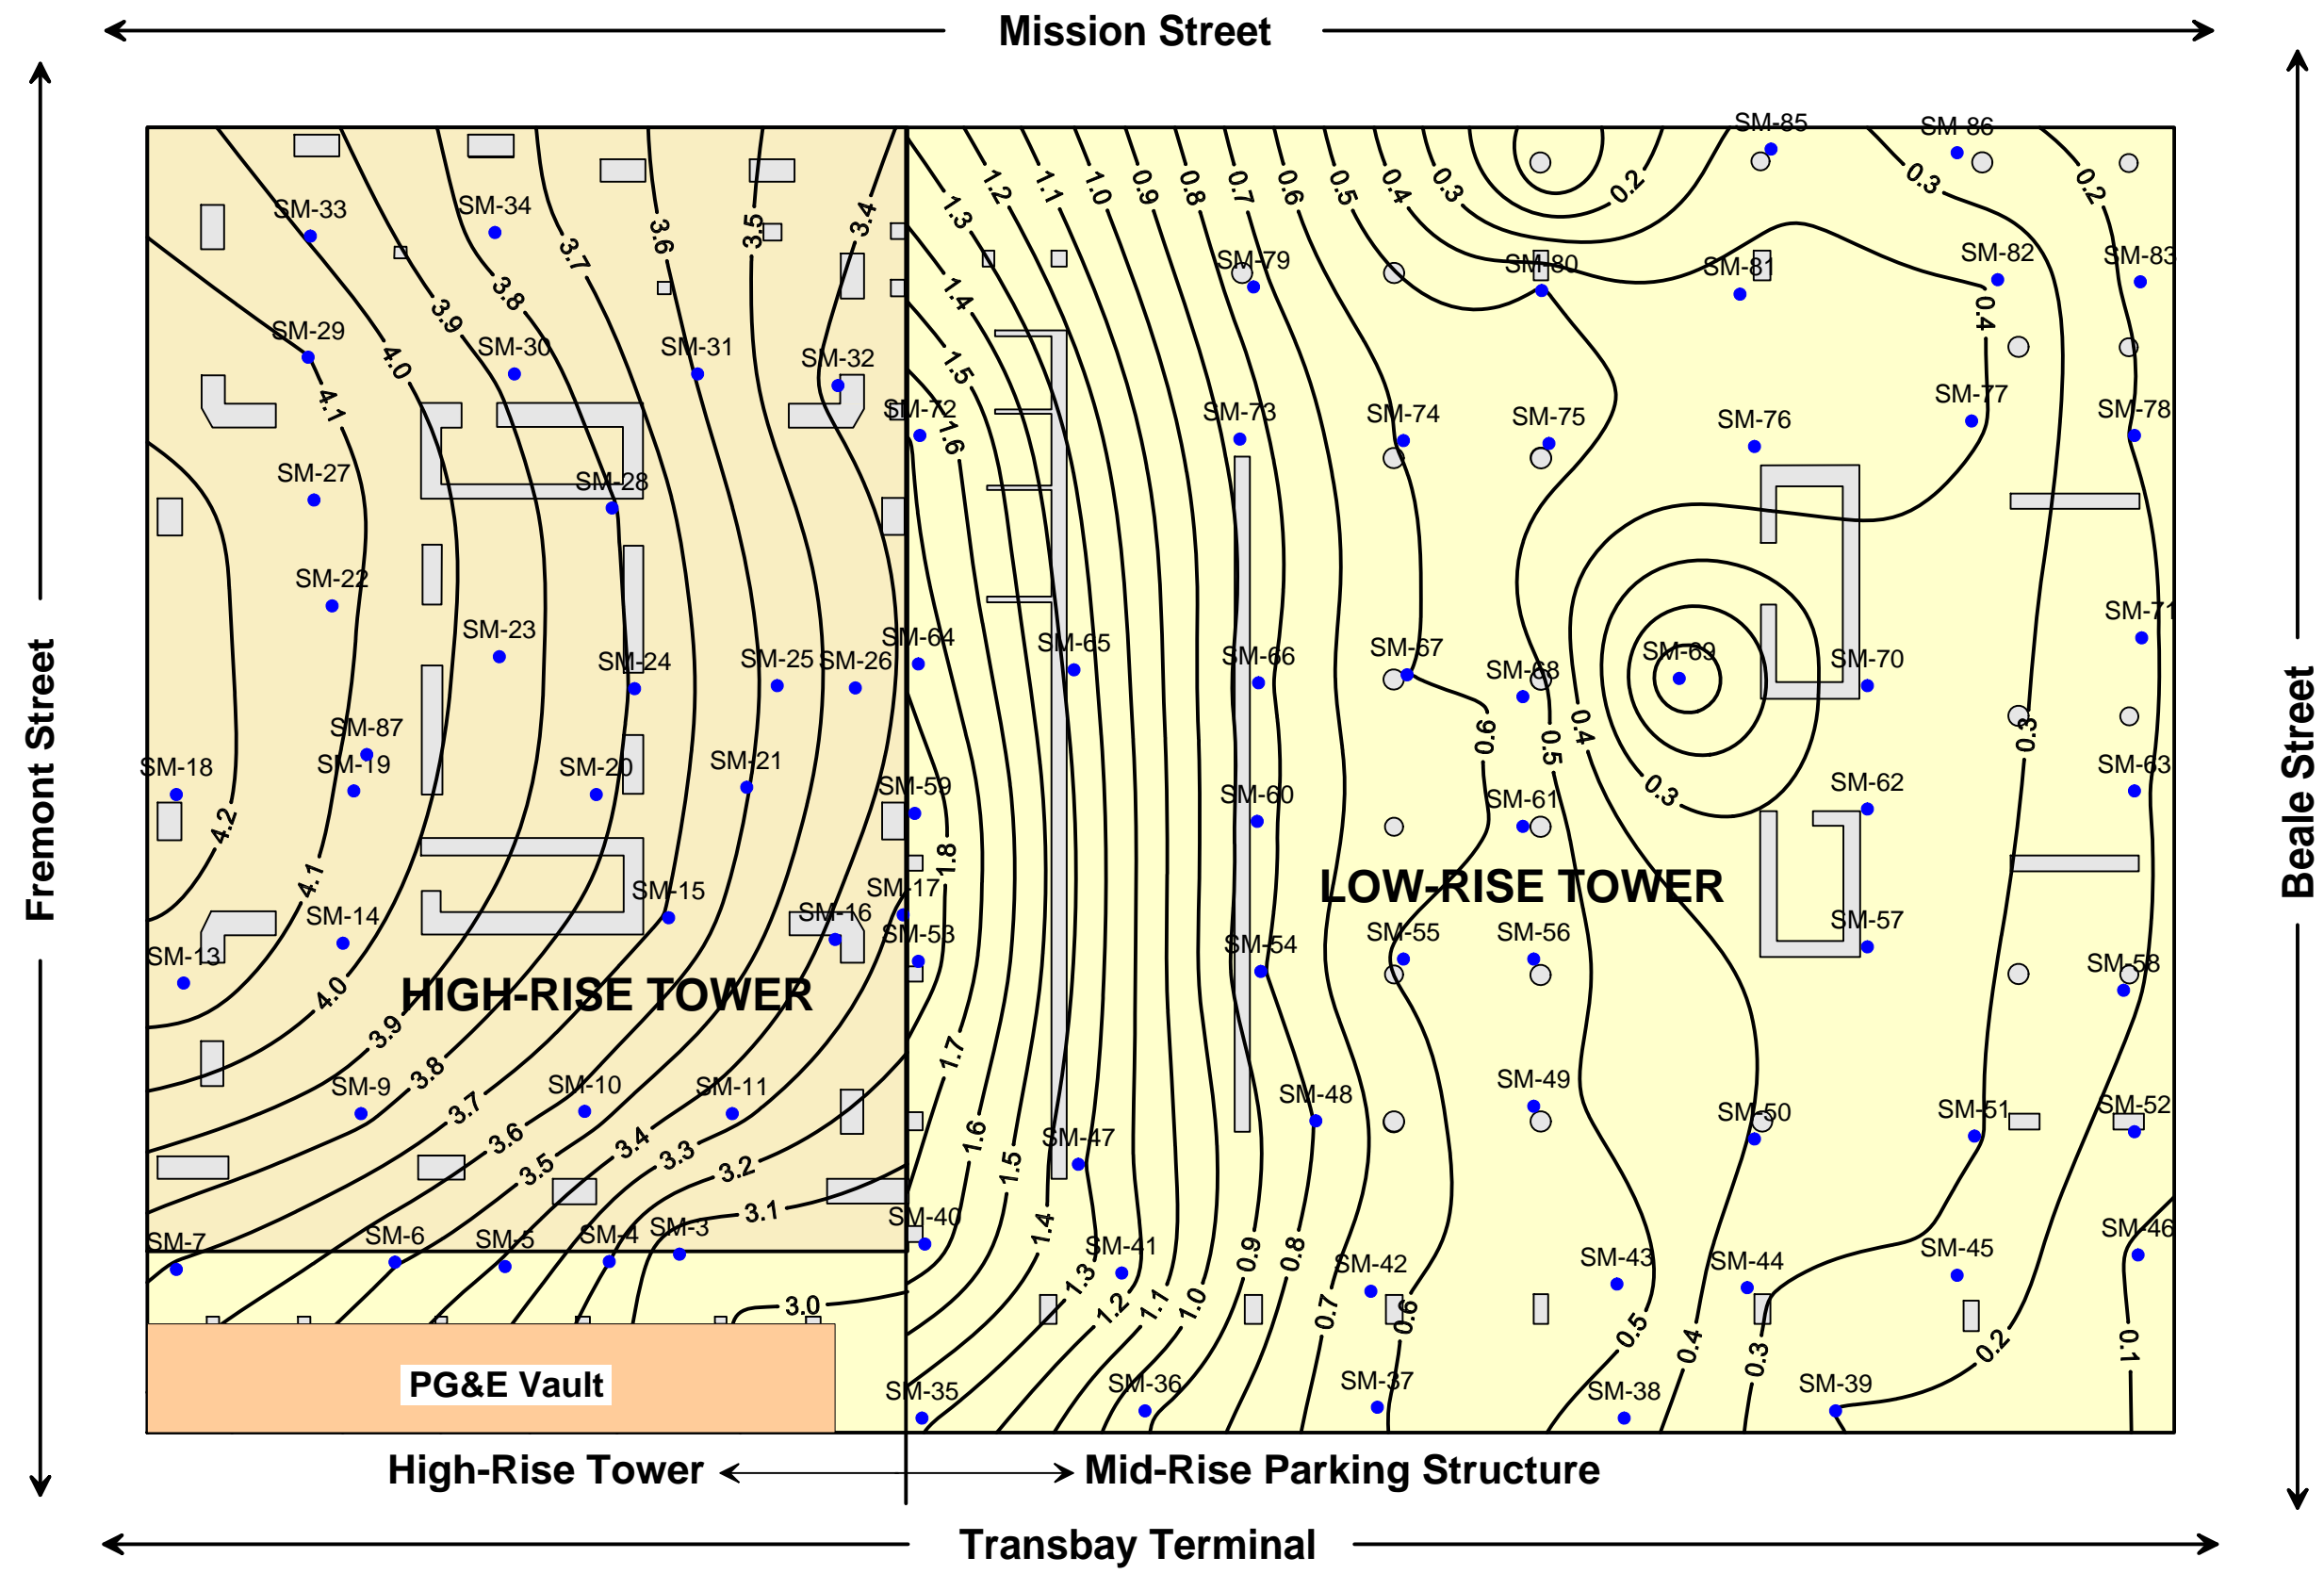
Notes:
 Contours represent elevation change, in inches, between Baseline survey (April 30, 2009) and readings taken on December 17, 2013.
 Level B-1 at Mid-Rise Parking portion of survey site is approximately 4 inches higher than Level B-1 at High-Rise Tower portion.
 The PG&E vault is inaccessible for monitoring.
 Negative values of settlement (within Low-rise Tower) indicate uplift.

**CONTOURS OF SETTLEMENTS MEASURED AT THE
 1ST LEVEL BASEMENT OF THE 301 MISSION ST
 STRUCTURE BETWEEN 04/30/2009 & 12/17/2013**
 Transbay Transit Center
 301 Mission Monitoring
 Transbay Joint Powers Authority
 San Francisco, California
 January 2014

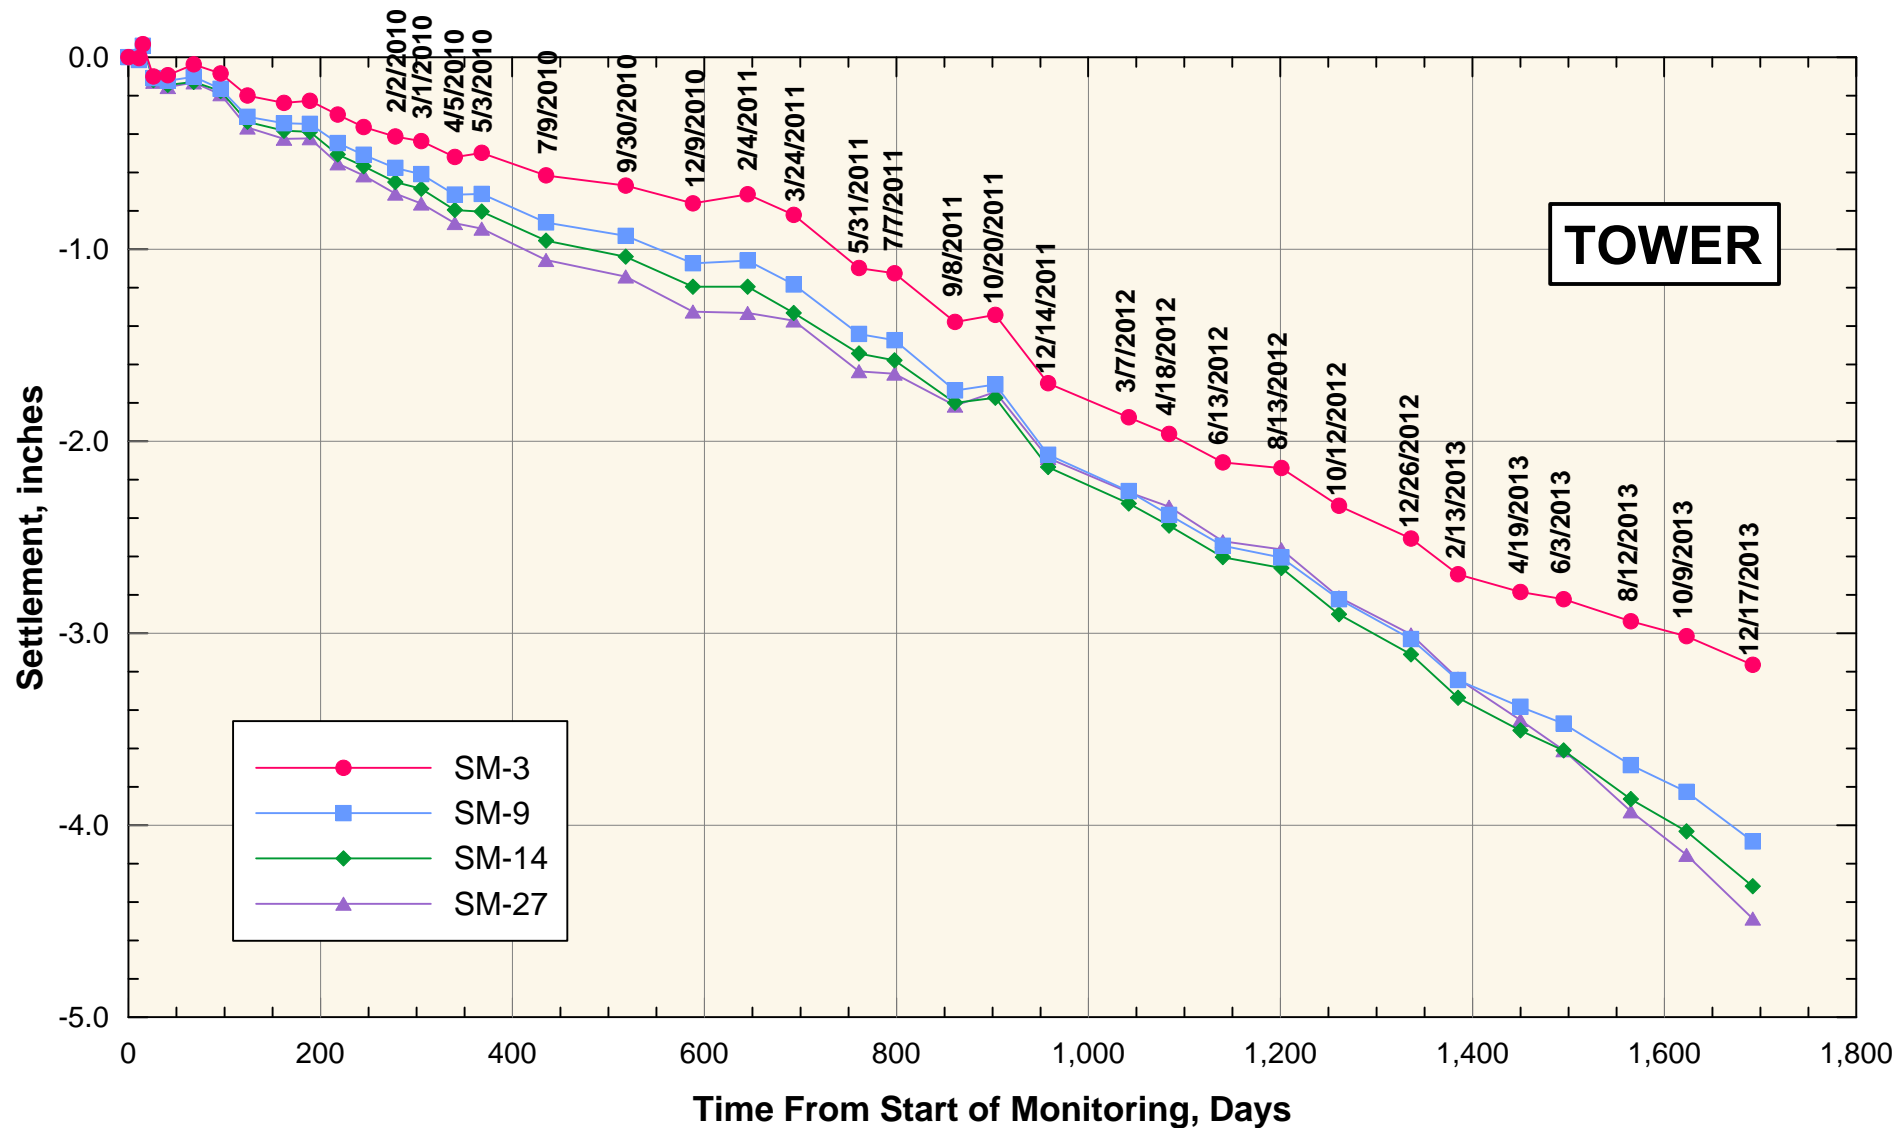
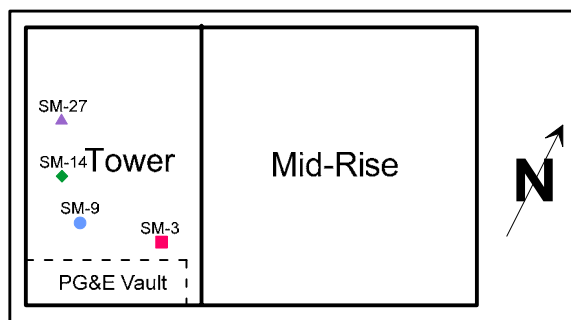
Note:
Initial (Baseline) reading
taken on 04/30/09

**SETTLEMENT OVER TIME
FLOOR ELEVATIONS AT LEVEL B-1
OF 301 MISSION PROPERTY- TOWER:
APRIL 30, 2009 THROUGH DECEMBER 17, 2013**

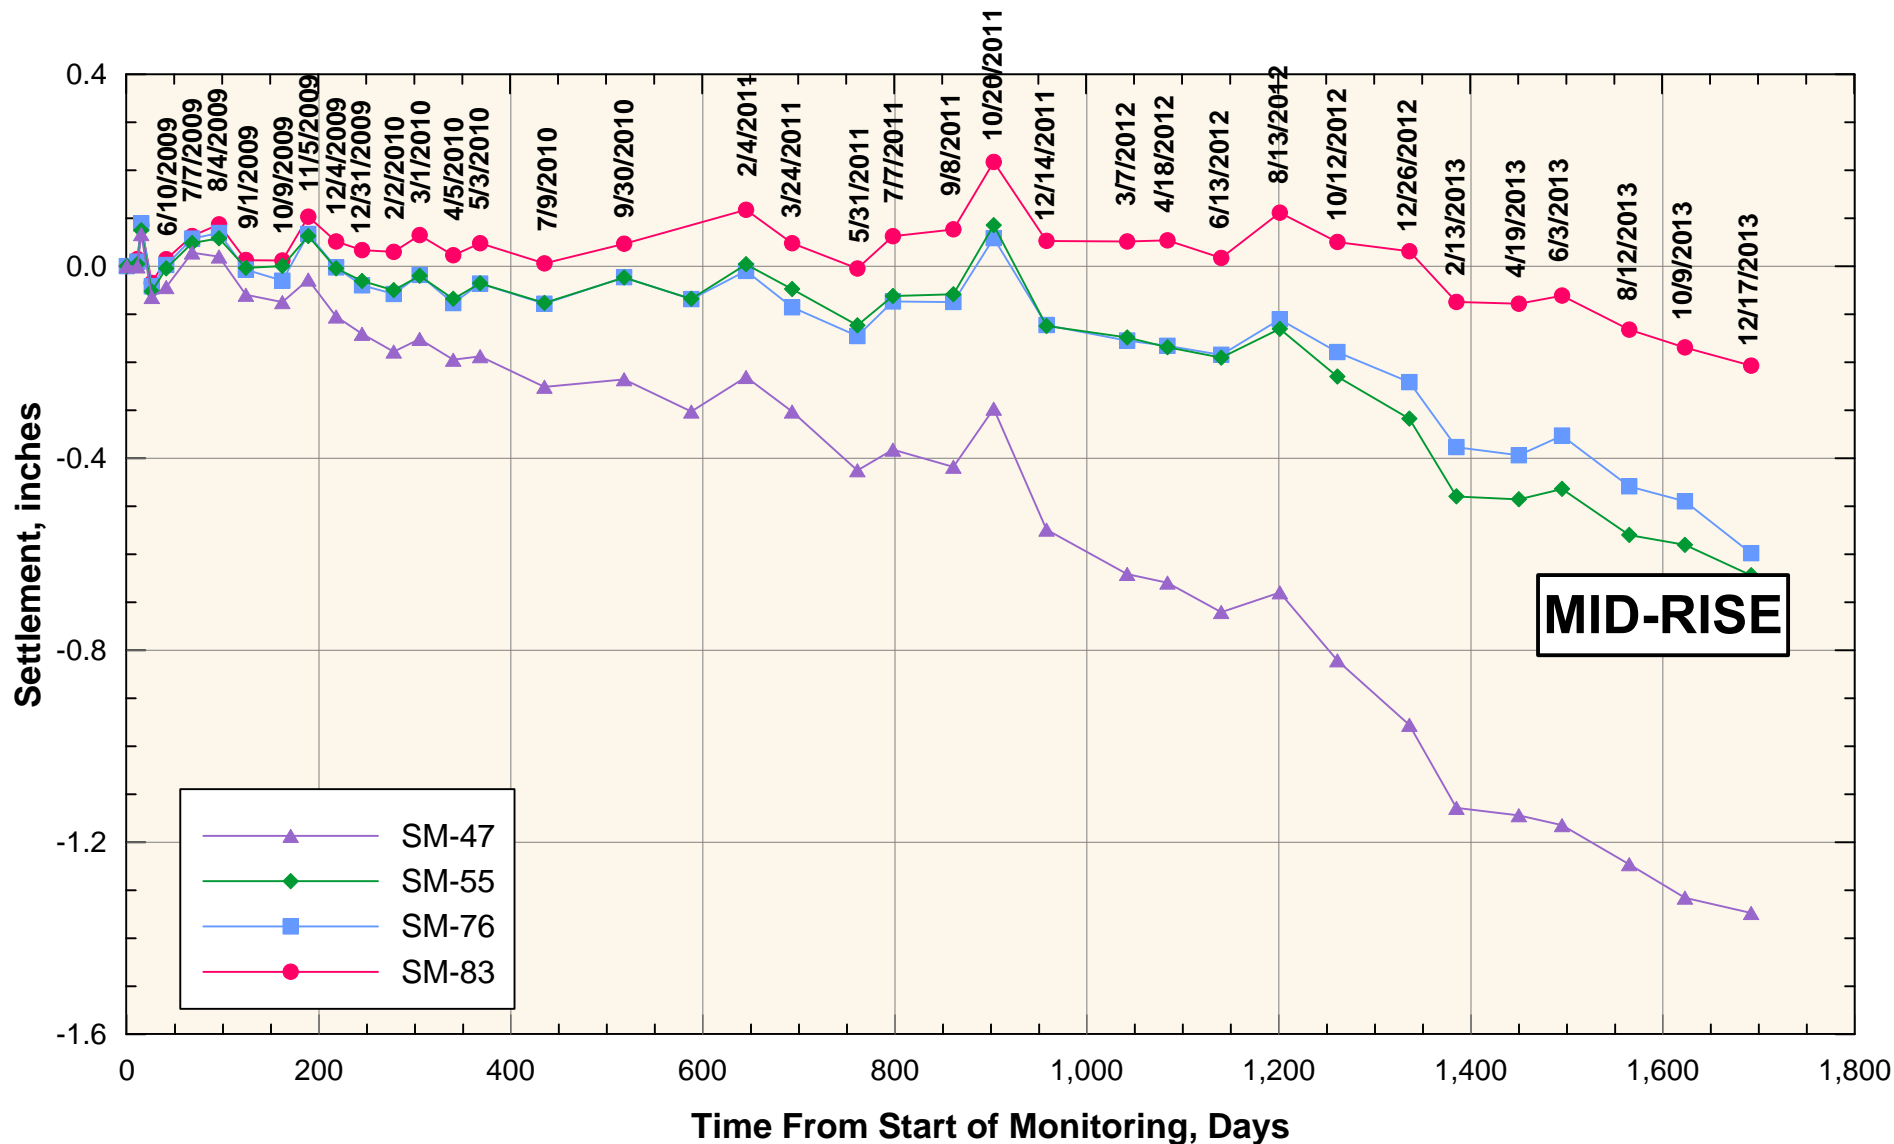
PLATE 5

Note:
Initial (Baseline) reading
taken on 04/30/09

**SETTLEMENT OVER TIME
FLOOR ELEVATIONS AT LEVEL B-1
OF 301 MISSION PROPERTY- MID-RISE:
APRIL 30, 2009 THROUGH DECEMBER 17, 2013**

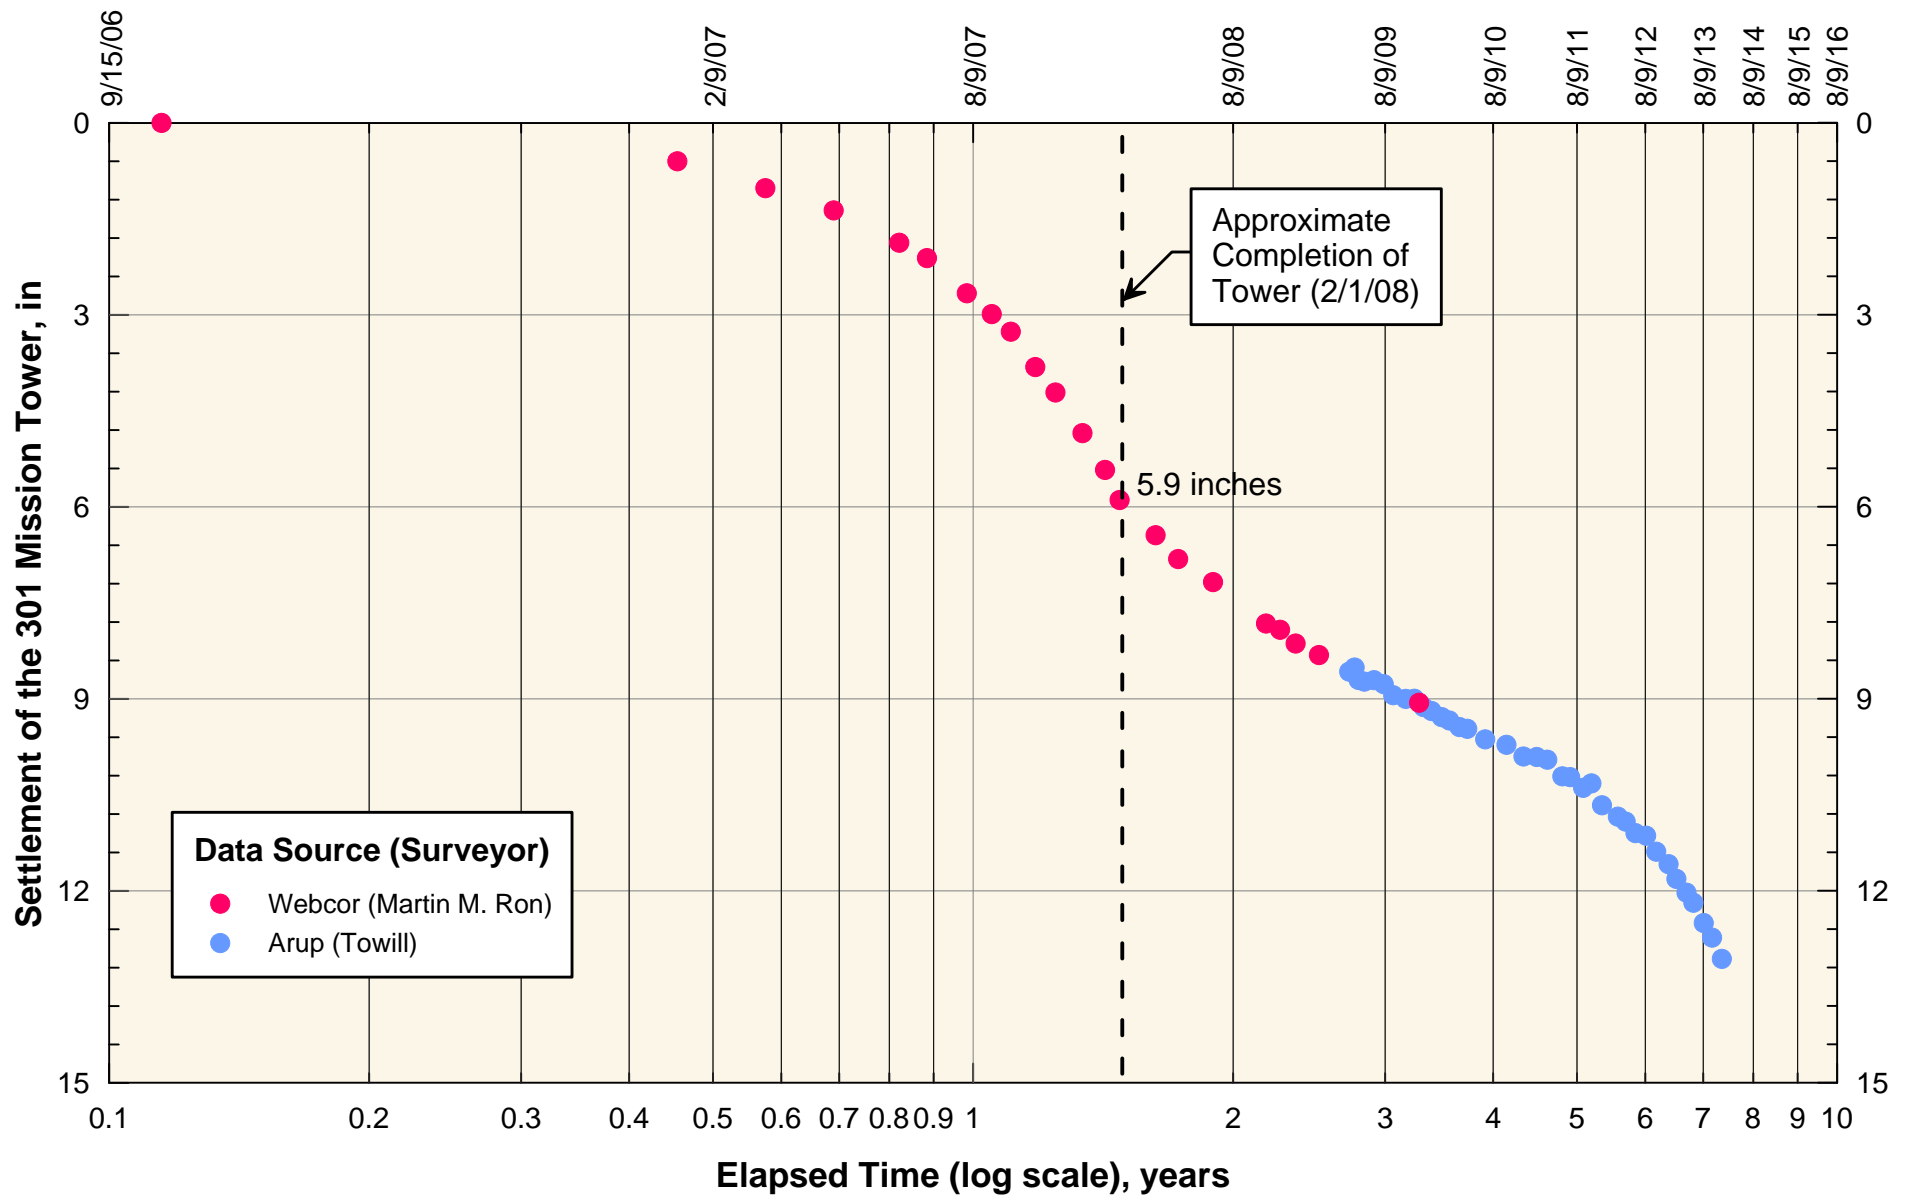
Beginning of Tower Construction: 8/9/06
 End of Tower Construction: 2/1/08
 Construction Duration: 542 days (1.5 years)

**SETTLEMENTS OF THE 301 MISSION TOWER
 INCLUDING MONITORING DURING CONSTRUCTION**
