*Board of Supervisors
City and County of San Francisco*

Government Audit and Oversight Committee

Supplemental Report for Foundation Settlement Investigation

**SUPPLEMENTAL REPORT
FOUNDATION SETTLEMENT INVESTIGATION
301 MISSION STREET
SAN FRANCISCO, CALIFORNIA**

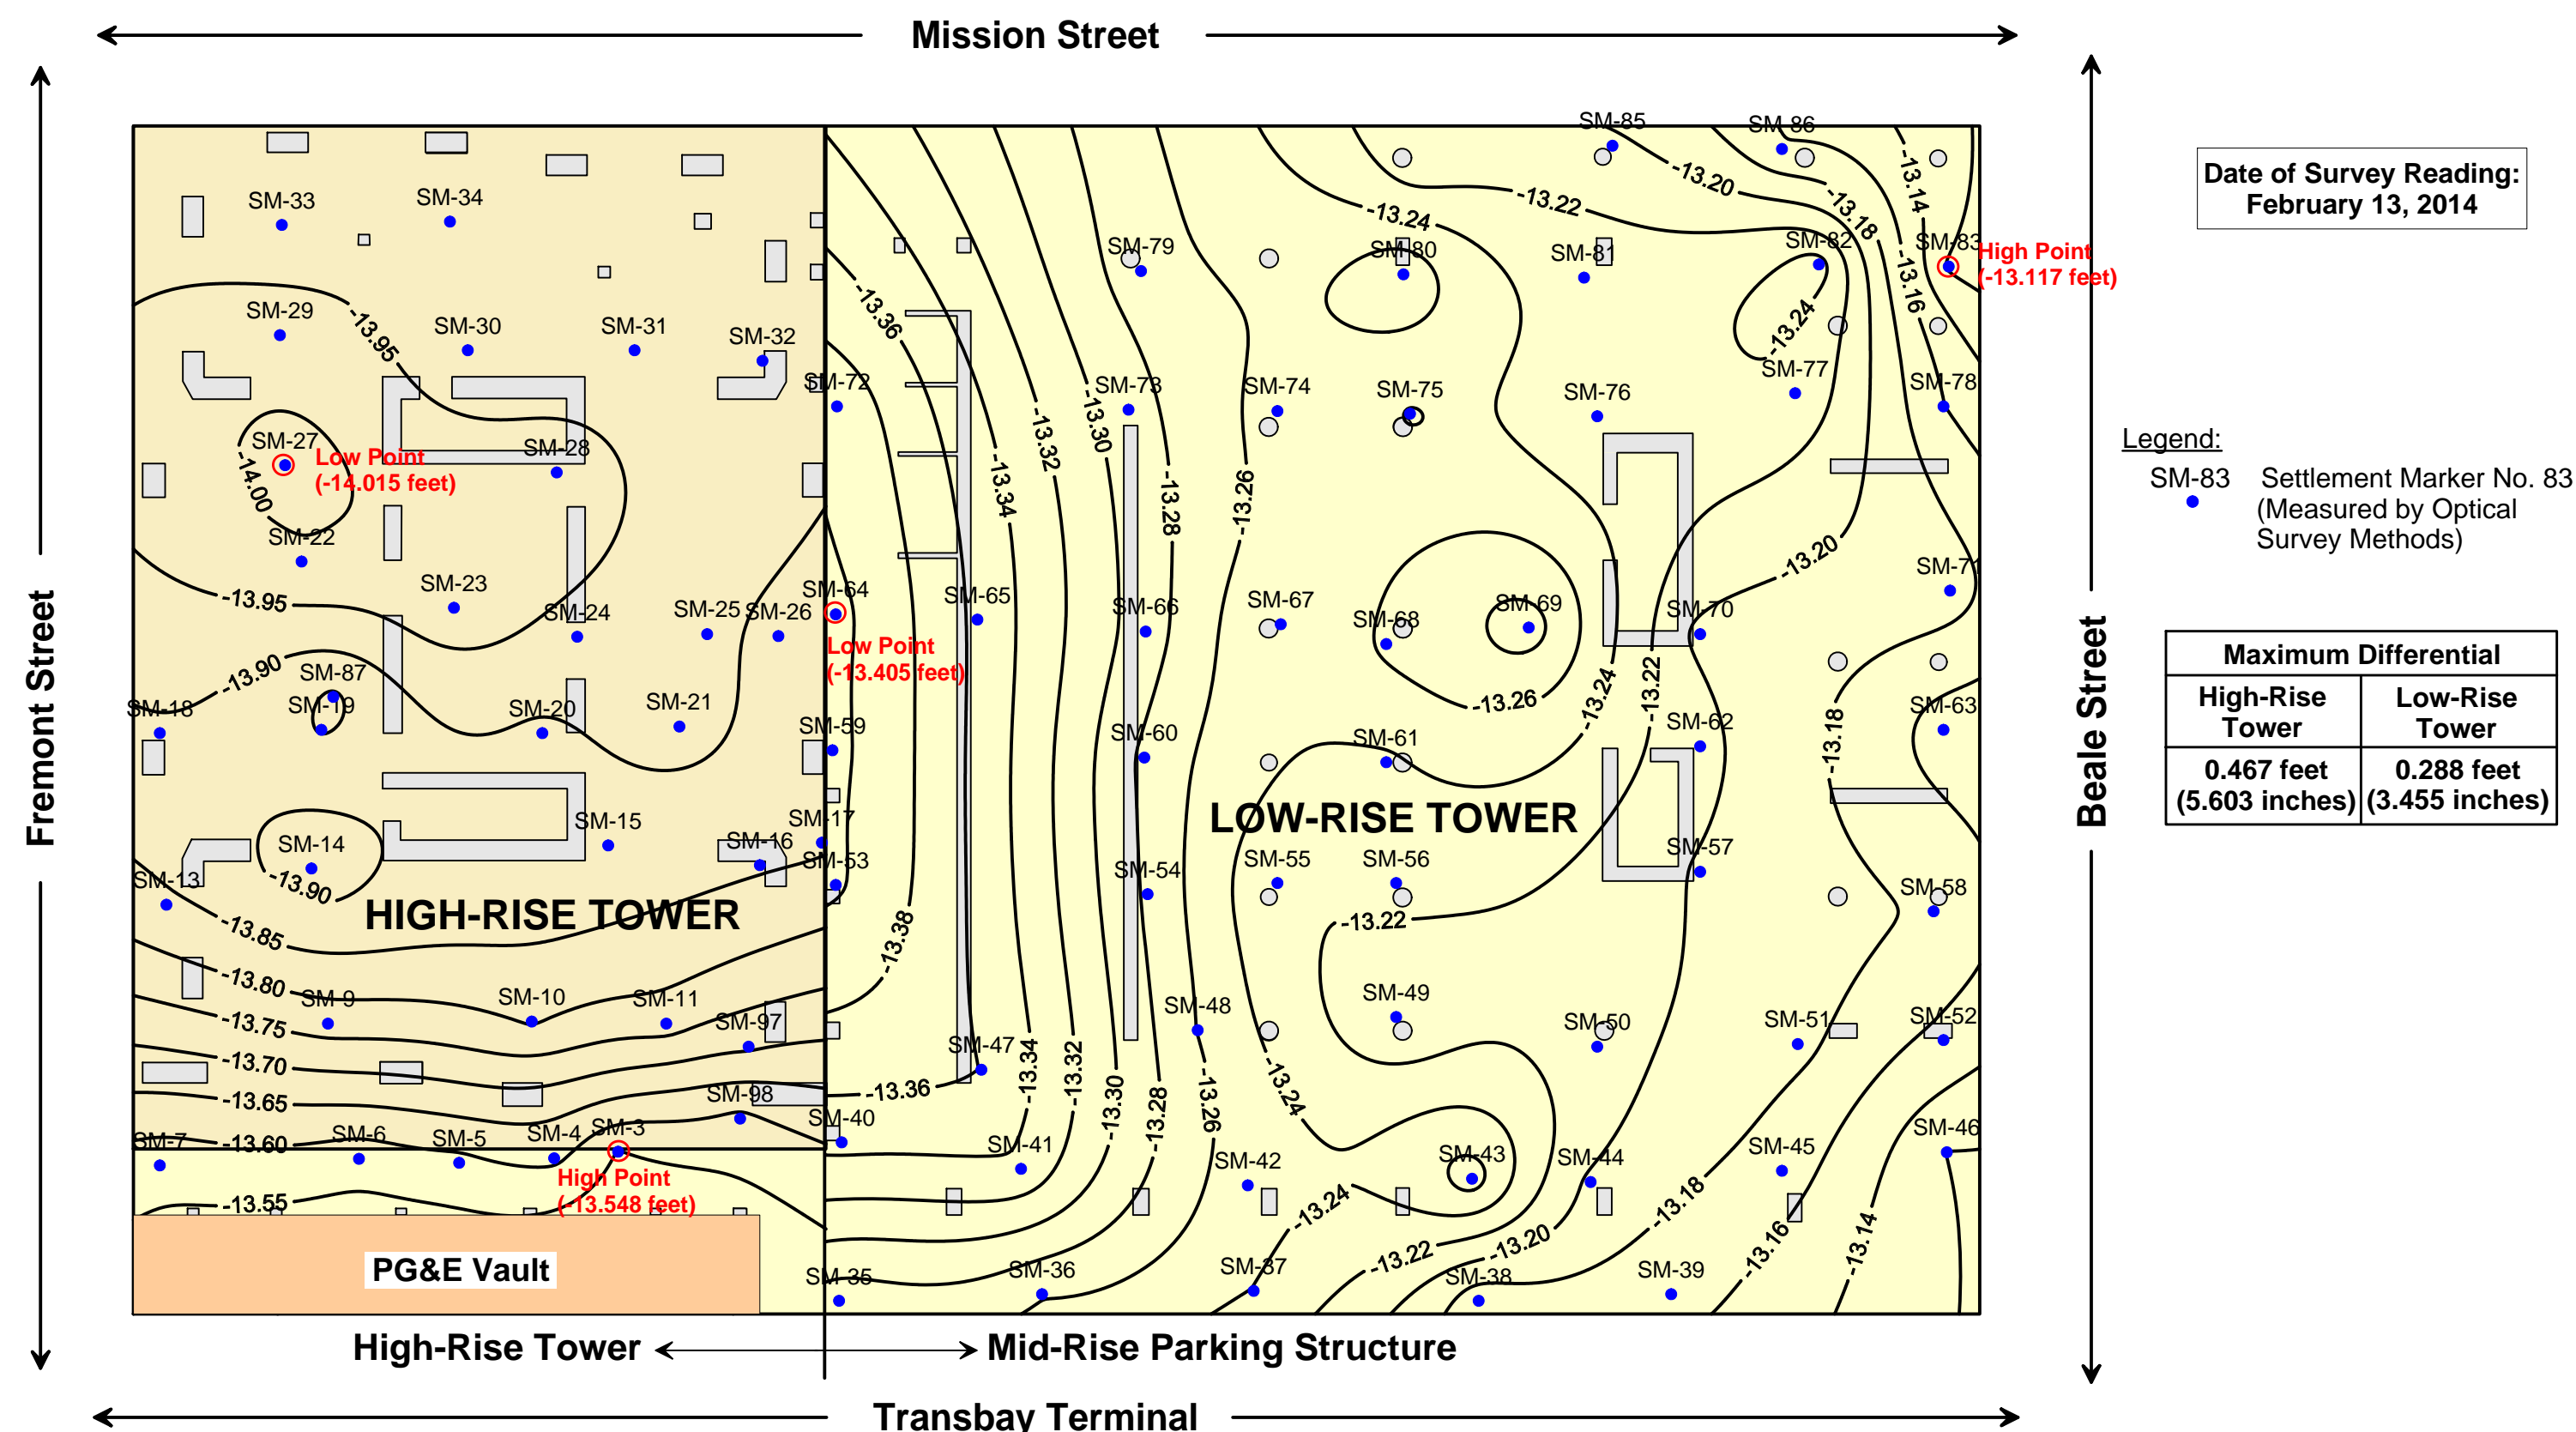
Notes:
Contours represent elevation, in feet (CCSF Datum), from survey readings taken on February 13, 2014.
Level B-1 at Mid-Rise Parking portion of survey site is approximately 4 inches higher than Level B-1 at High-Rise Tower portion.
The PG&E vault is inaccessible for monitoring.

FLOOR ELEVATIONS AT LEVEL B-1
OF 301 MISSION PROPERTY:
PERIODIC SURVEY - FEBRUARY 13, 2014
Transbay Transit Center
301 Mission Monitoring
Transbay Joint Powers Authority
San Francisco, California
February 2014

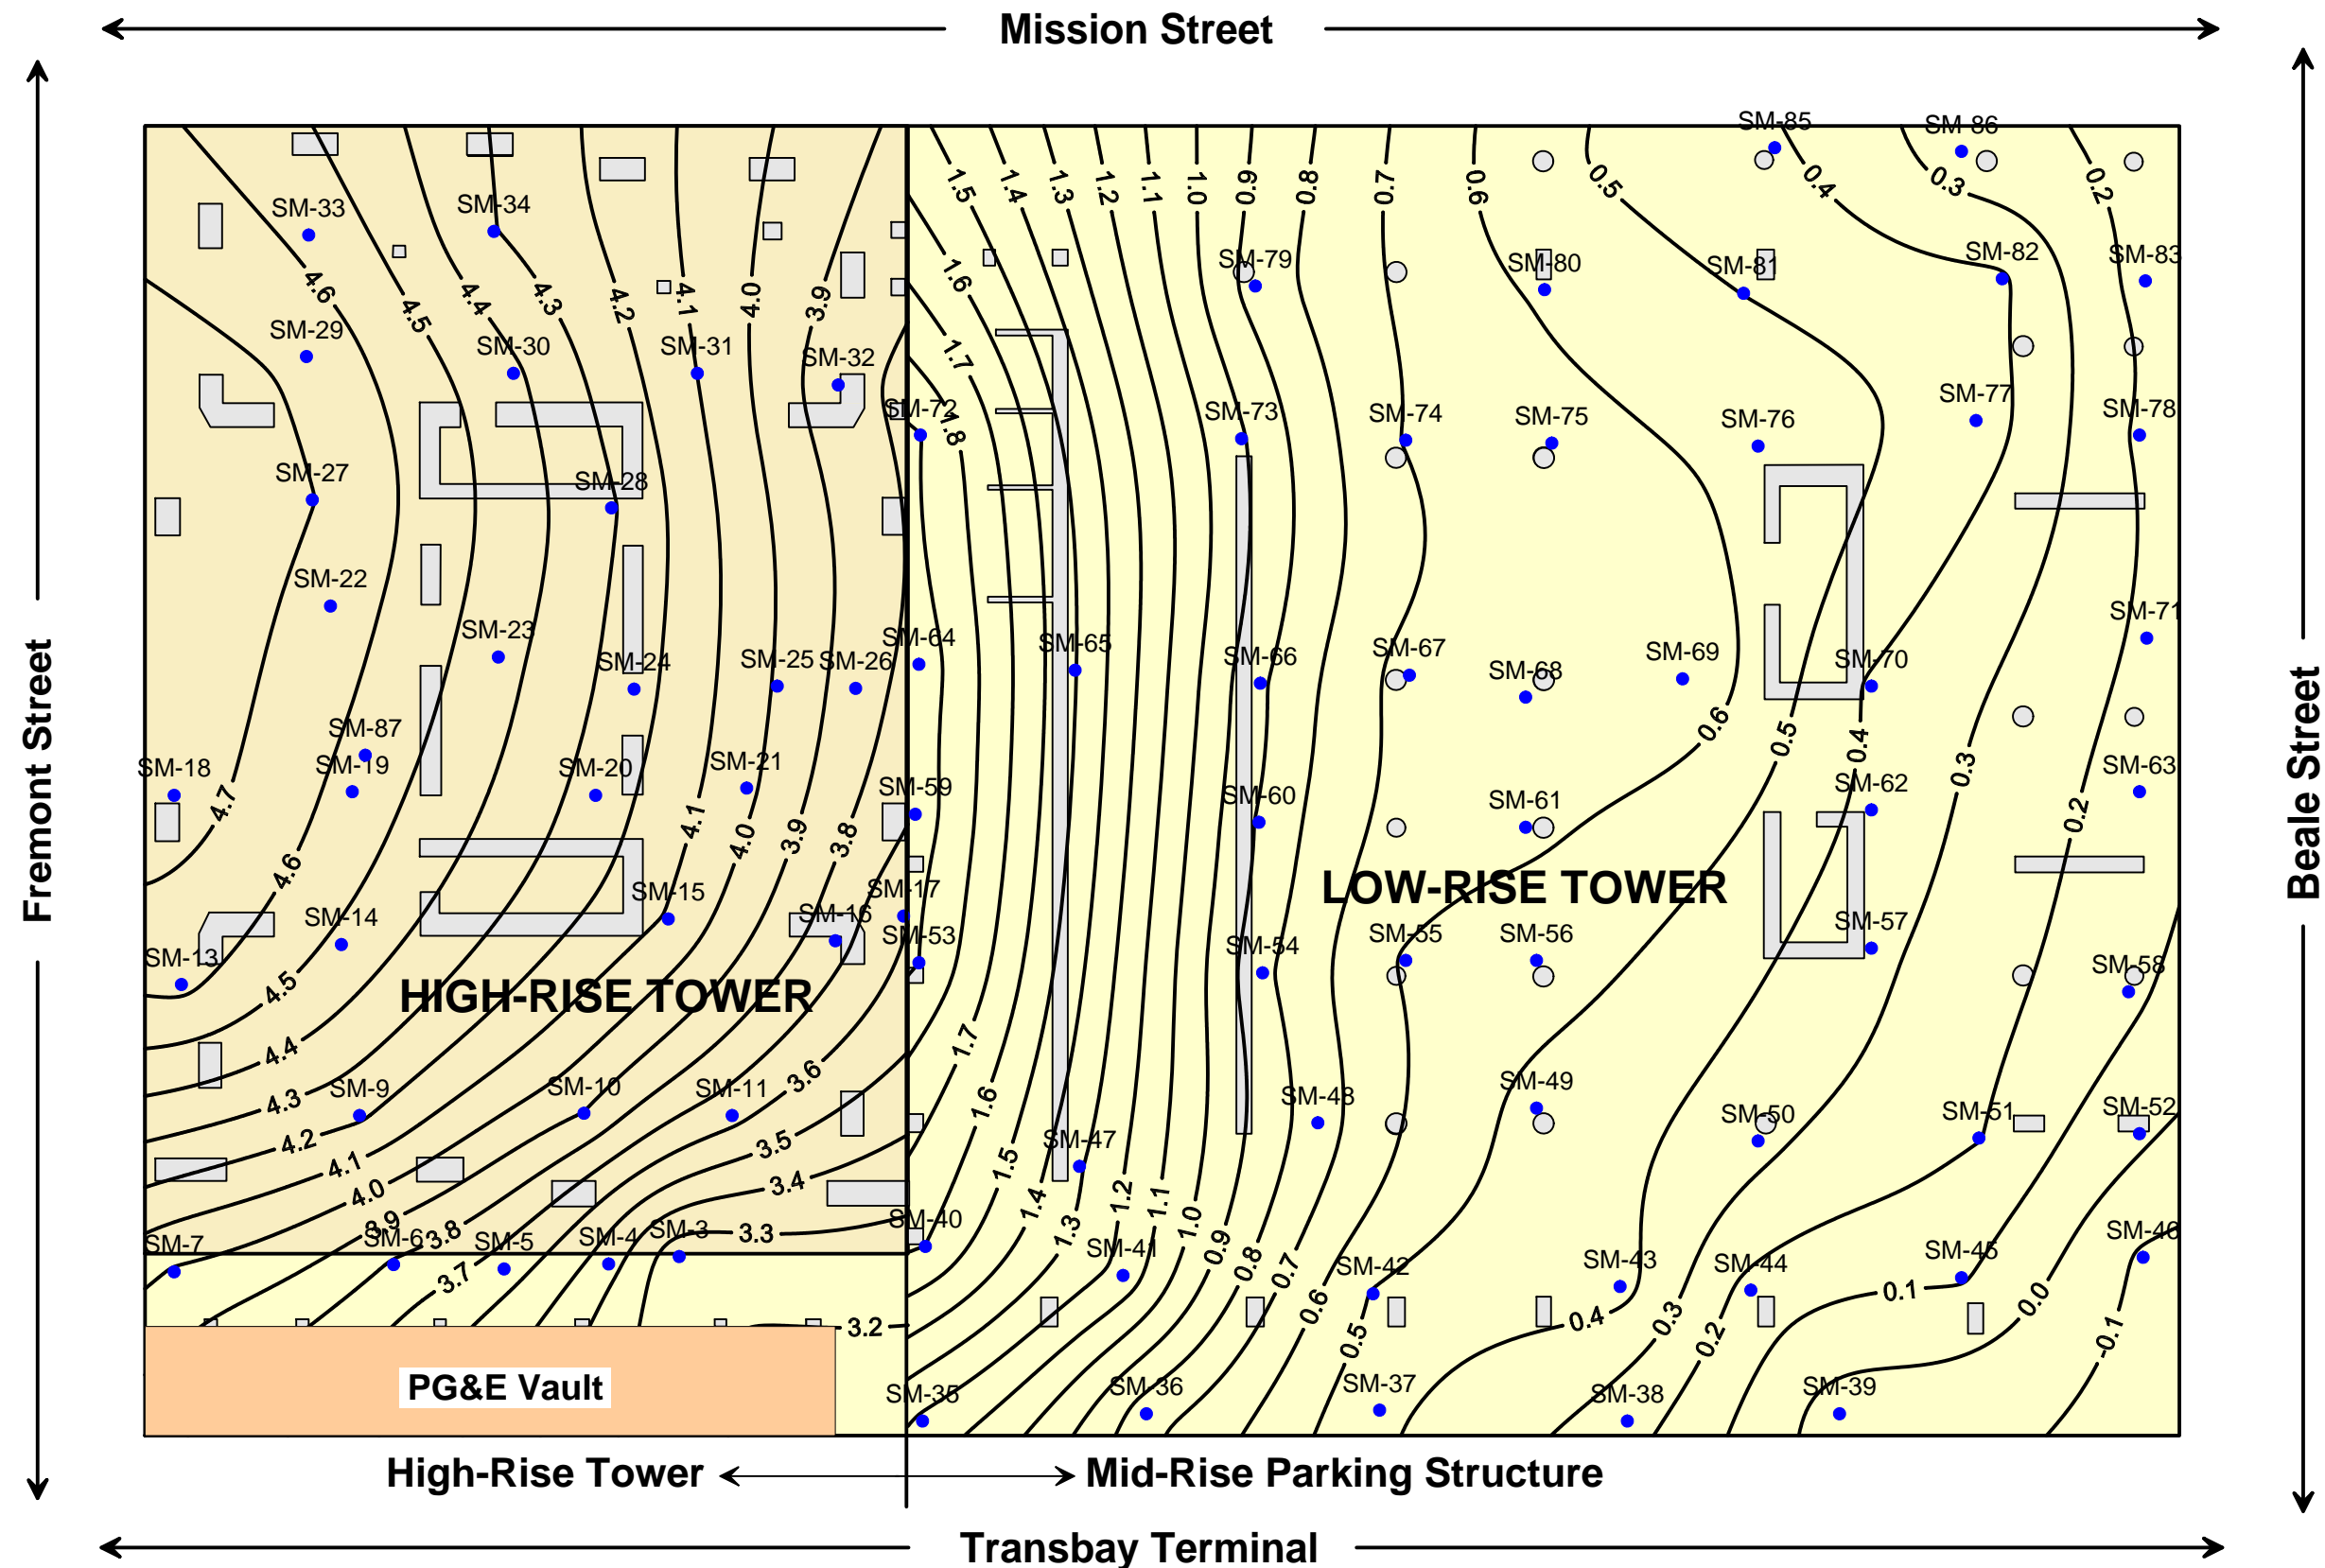
PLATE 3

Notes:
 Contours represent elevation change, in inches, between Baseline survey (April 30, 2009) and readings taken on February 13, 2014.
 Level B-1 at Mid-Rise Parking portion of survey site is approximately 4 inches higher than Level B-1 at High-Rise Tower portion.
 The PG&E vault is inaccessible for monitoring.
 Negative values of settlement (within Low-rise Tower) indicate uplift.

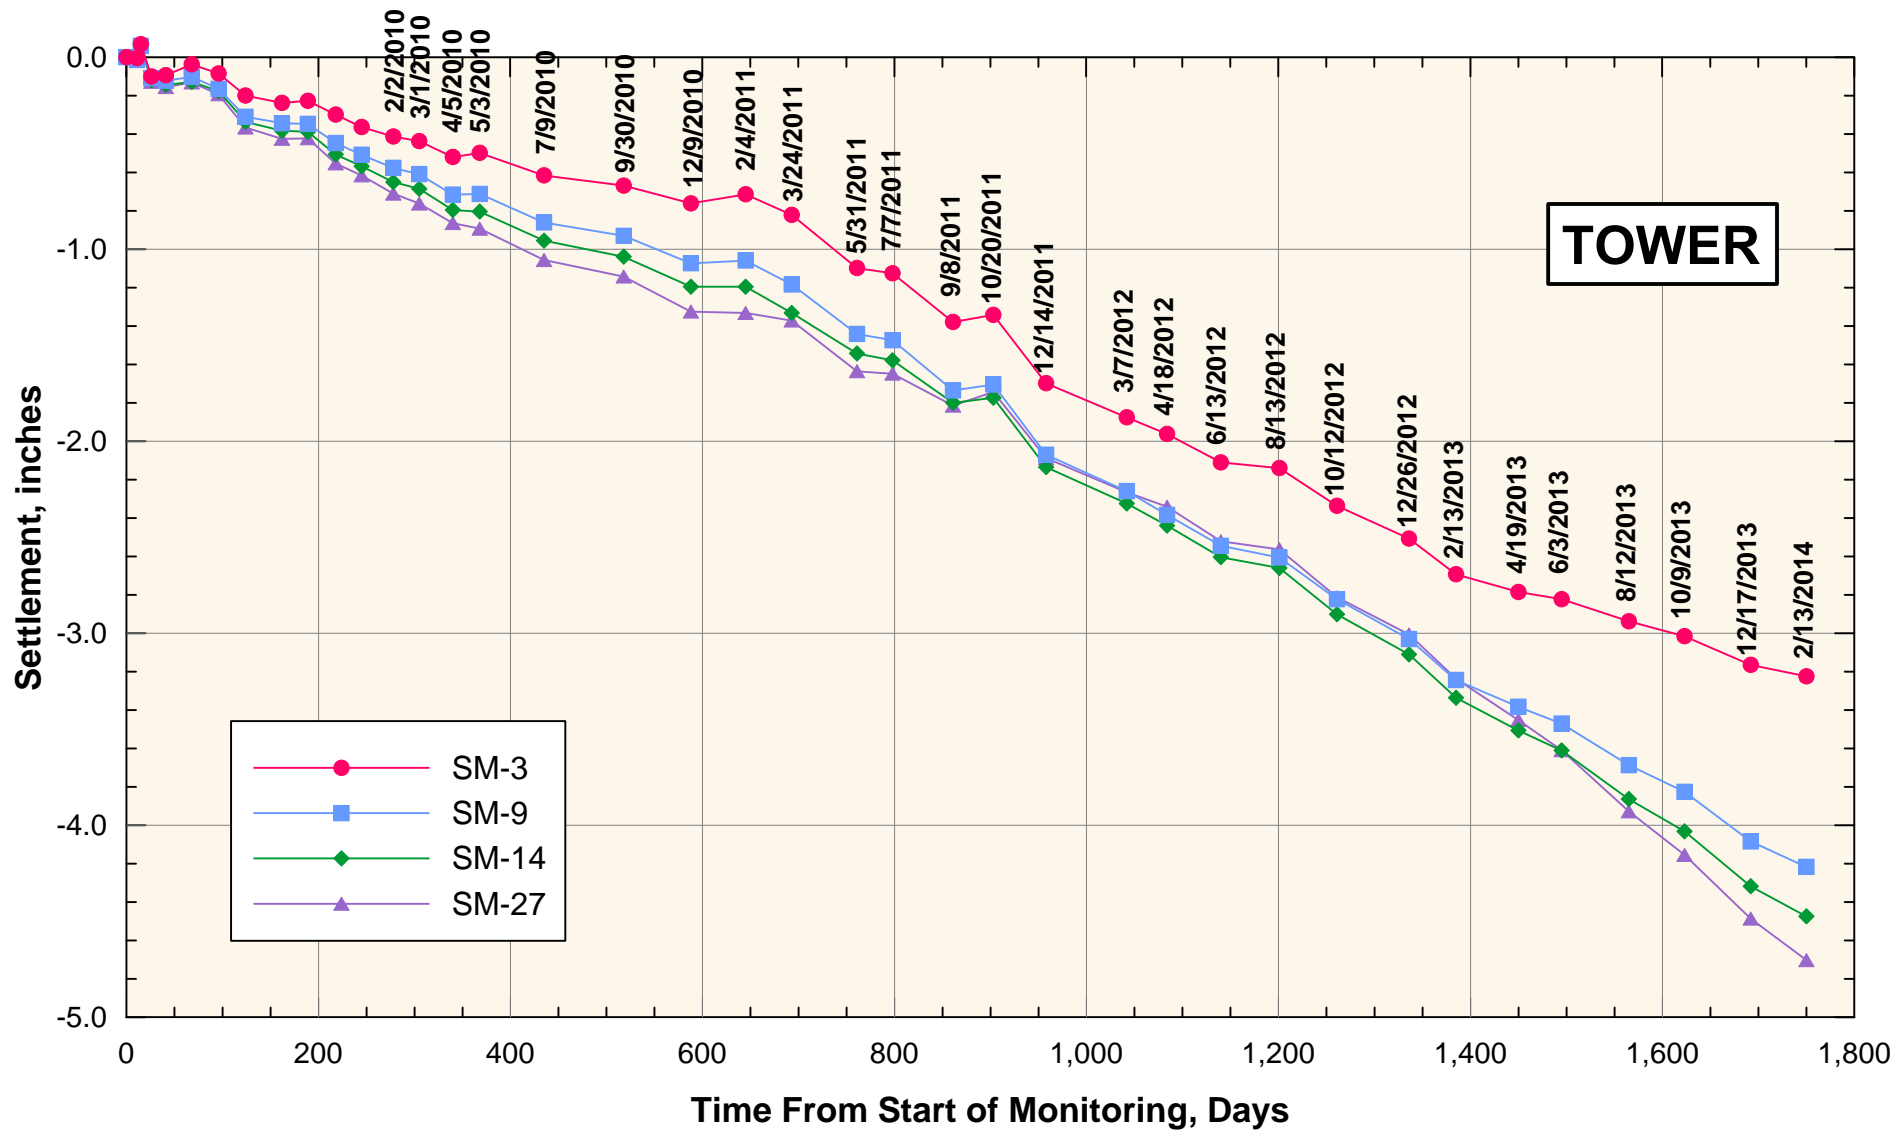
**SETTLEMENT OVER TIME
FLOOR ELEVATIONS AT LEVEL B-1
OF 301 MISSION PROPERTY- TOWER:
APRIL 30, 2009 THROUGH FEBRUARY 13, 2014**

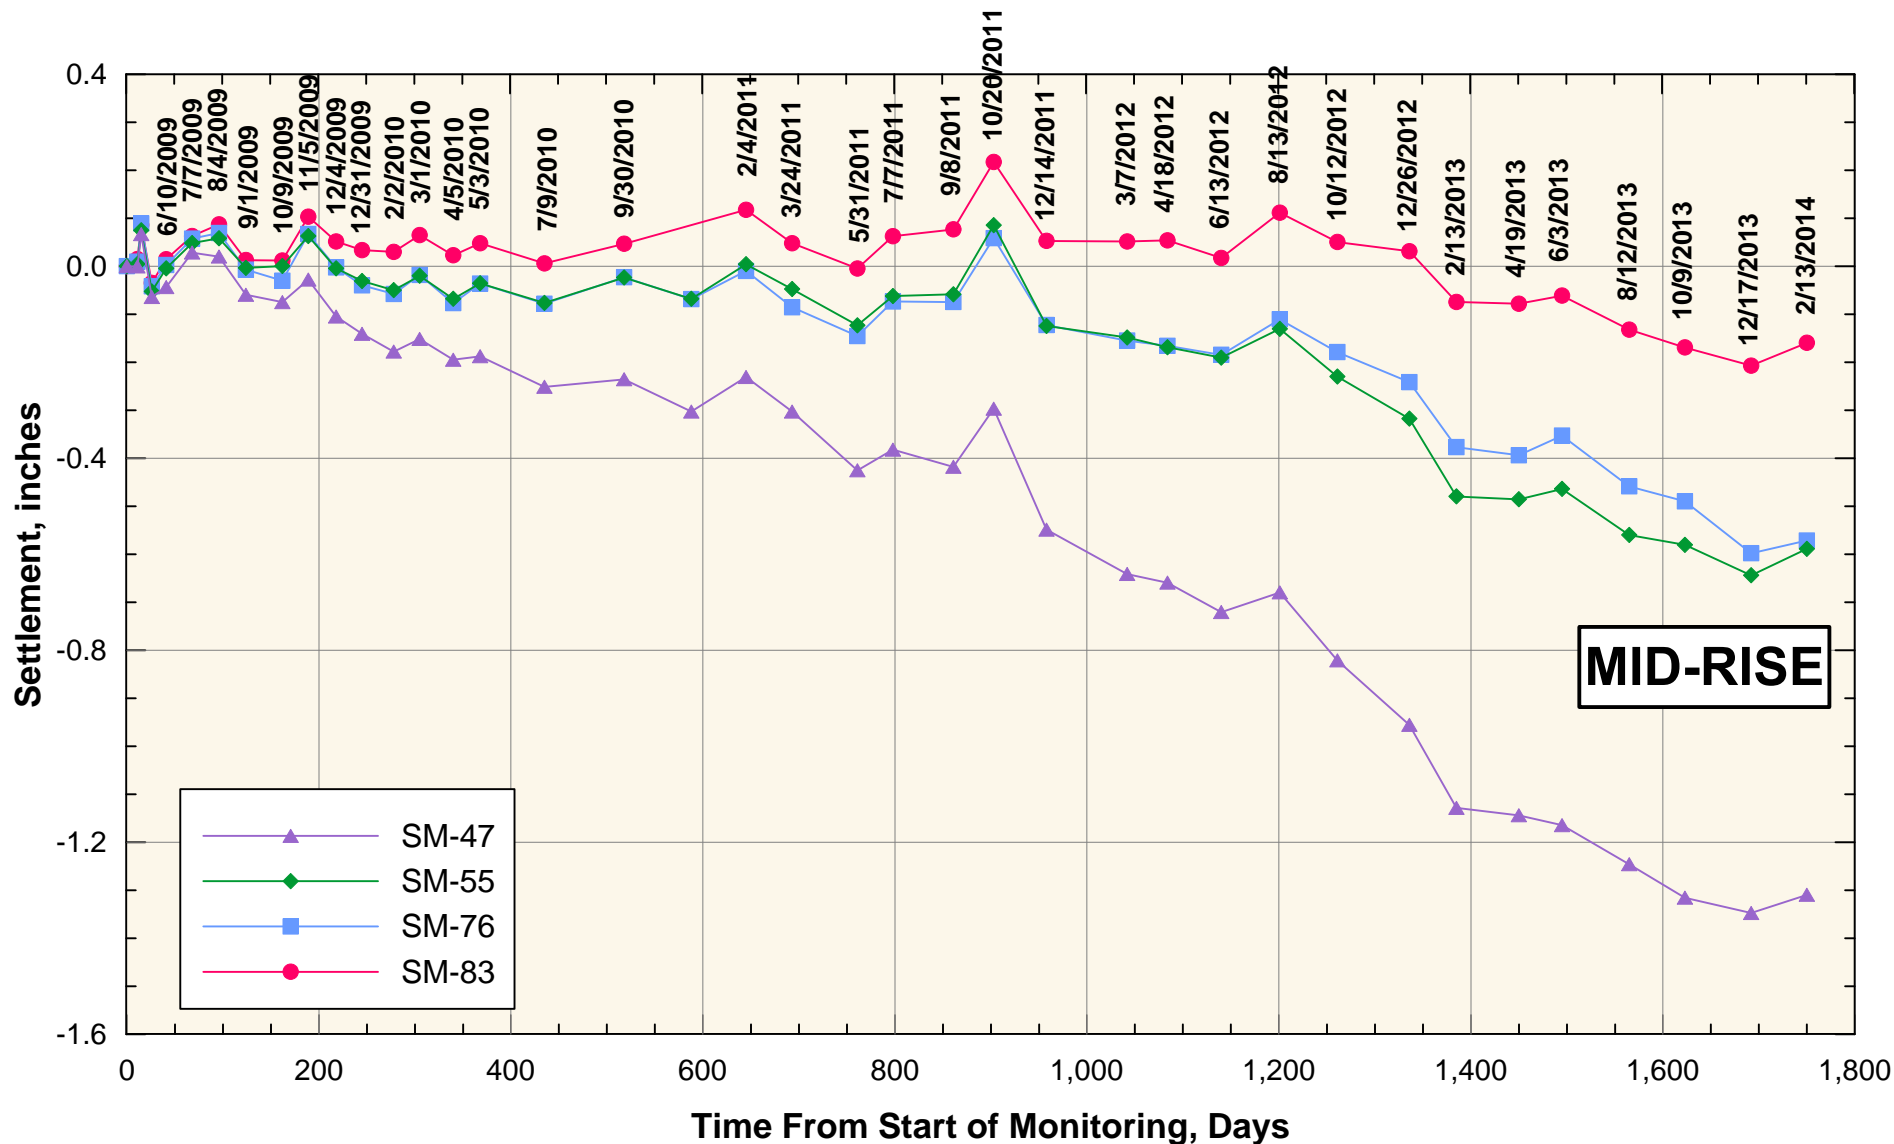
PLATE 5

**SETTLEMENT OVER TIME
FLOOR ELEVATIONS AT LEVEL B-1
OF 301 MISSION PROPERTY- MID-RISE:
APRIL 30, 2009 THROUGH FEBRUARY 13, 2014**

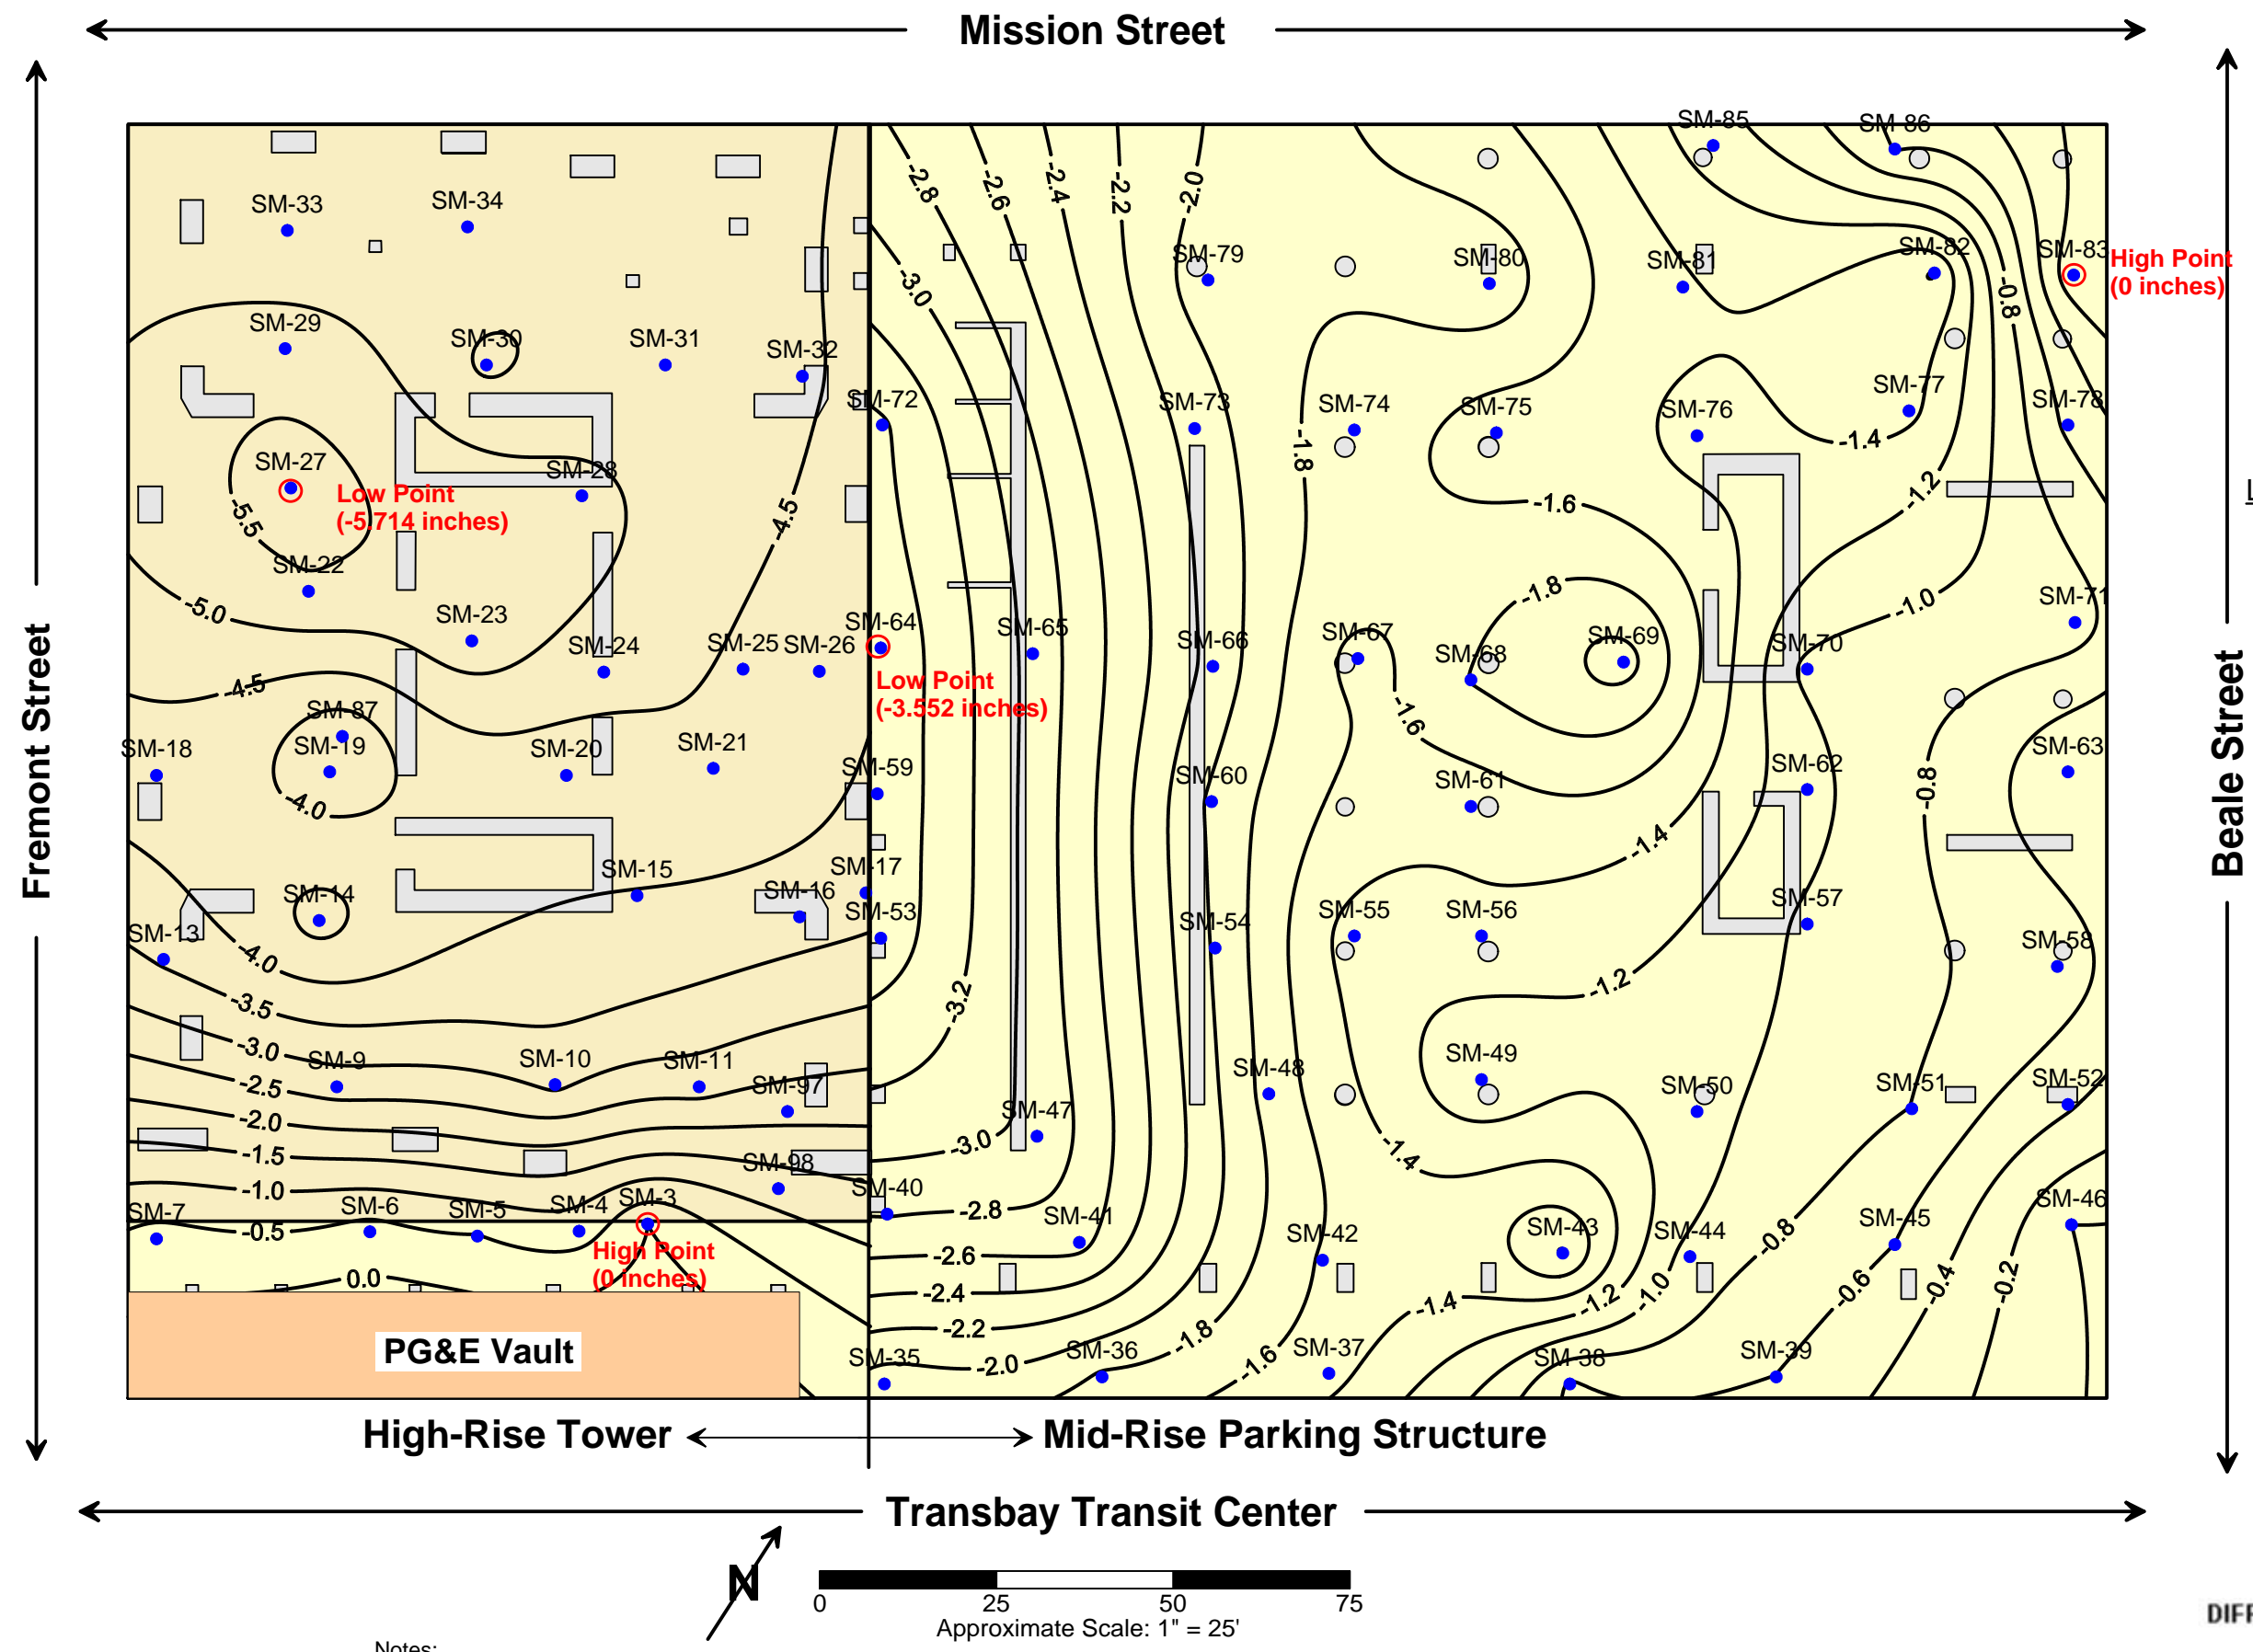
Notes:
 Contours represent differential elevation, in inches, between the highest point and all other points taken on April 11, 2014.
 Level B-1 at Mid-Rise Parking portion of survey site is approximately 4 inches higher than Level B-1 at High-Rise Tower portion.
 The PG&E vault is inaccessible for monitoring.
 Contour intervals are different between the High-Rise Tower and the Low-Rise Tower.

DIFFERENTIAL FLOOR ELEVATIONS (INCHES)
APRIL 11, 2014 SURVEY
 Transbay Transit Center
 301 Mission Monitoring
 Transbay Joint Powers Authority
 San Francisco, California

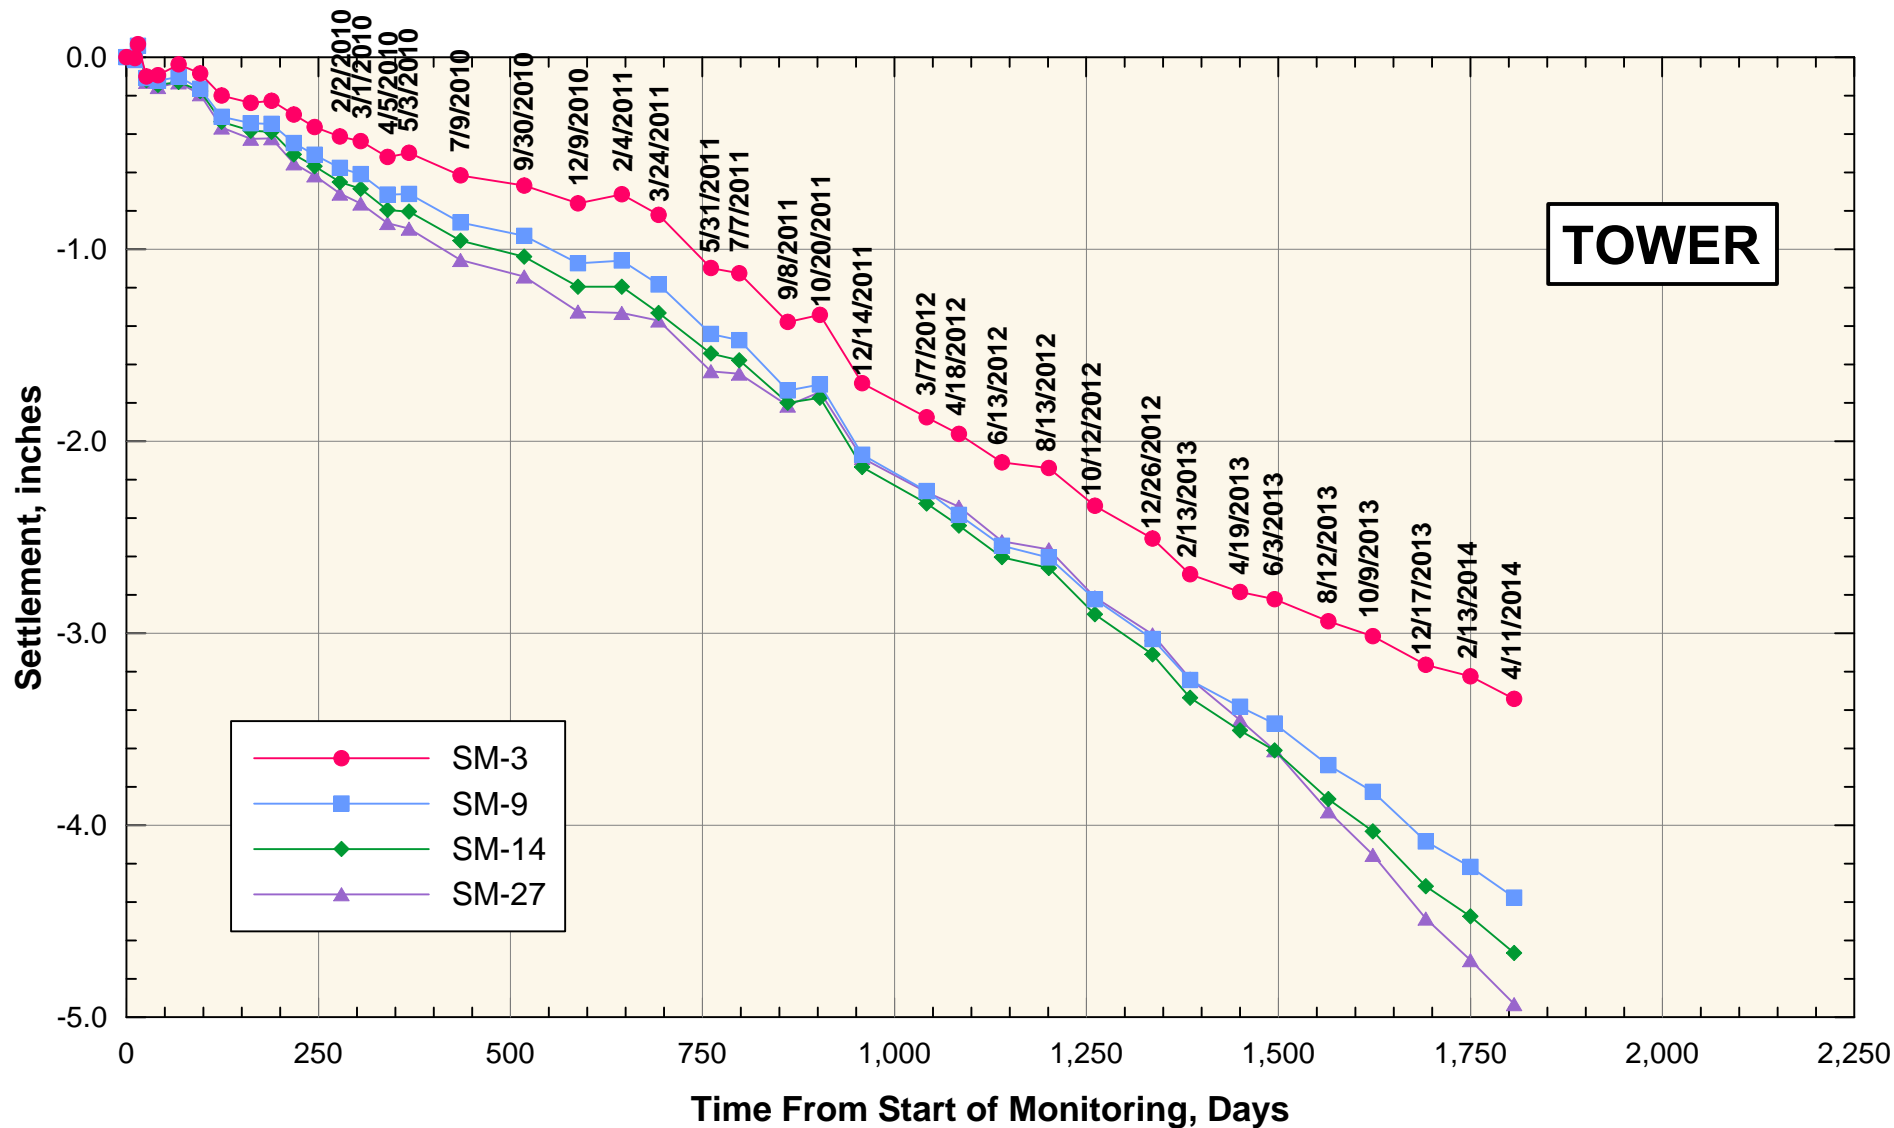
PLATE 4

**SETTLEMENT OVER TIME
FLOOR ELEVATIONS AT LEVEL B-1
OF 301 MISSION PROPERTY- TOWER:
APRIL 30, 2009 THROUGH APRIL 11, 2014**

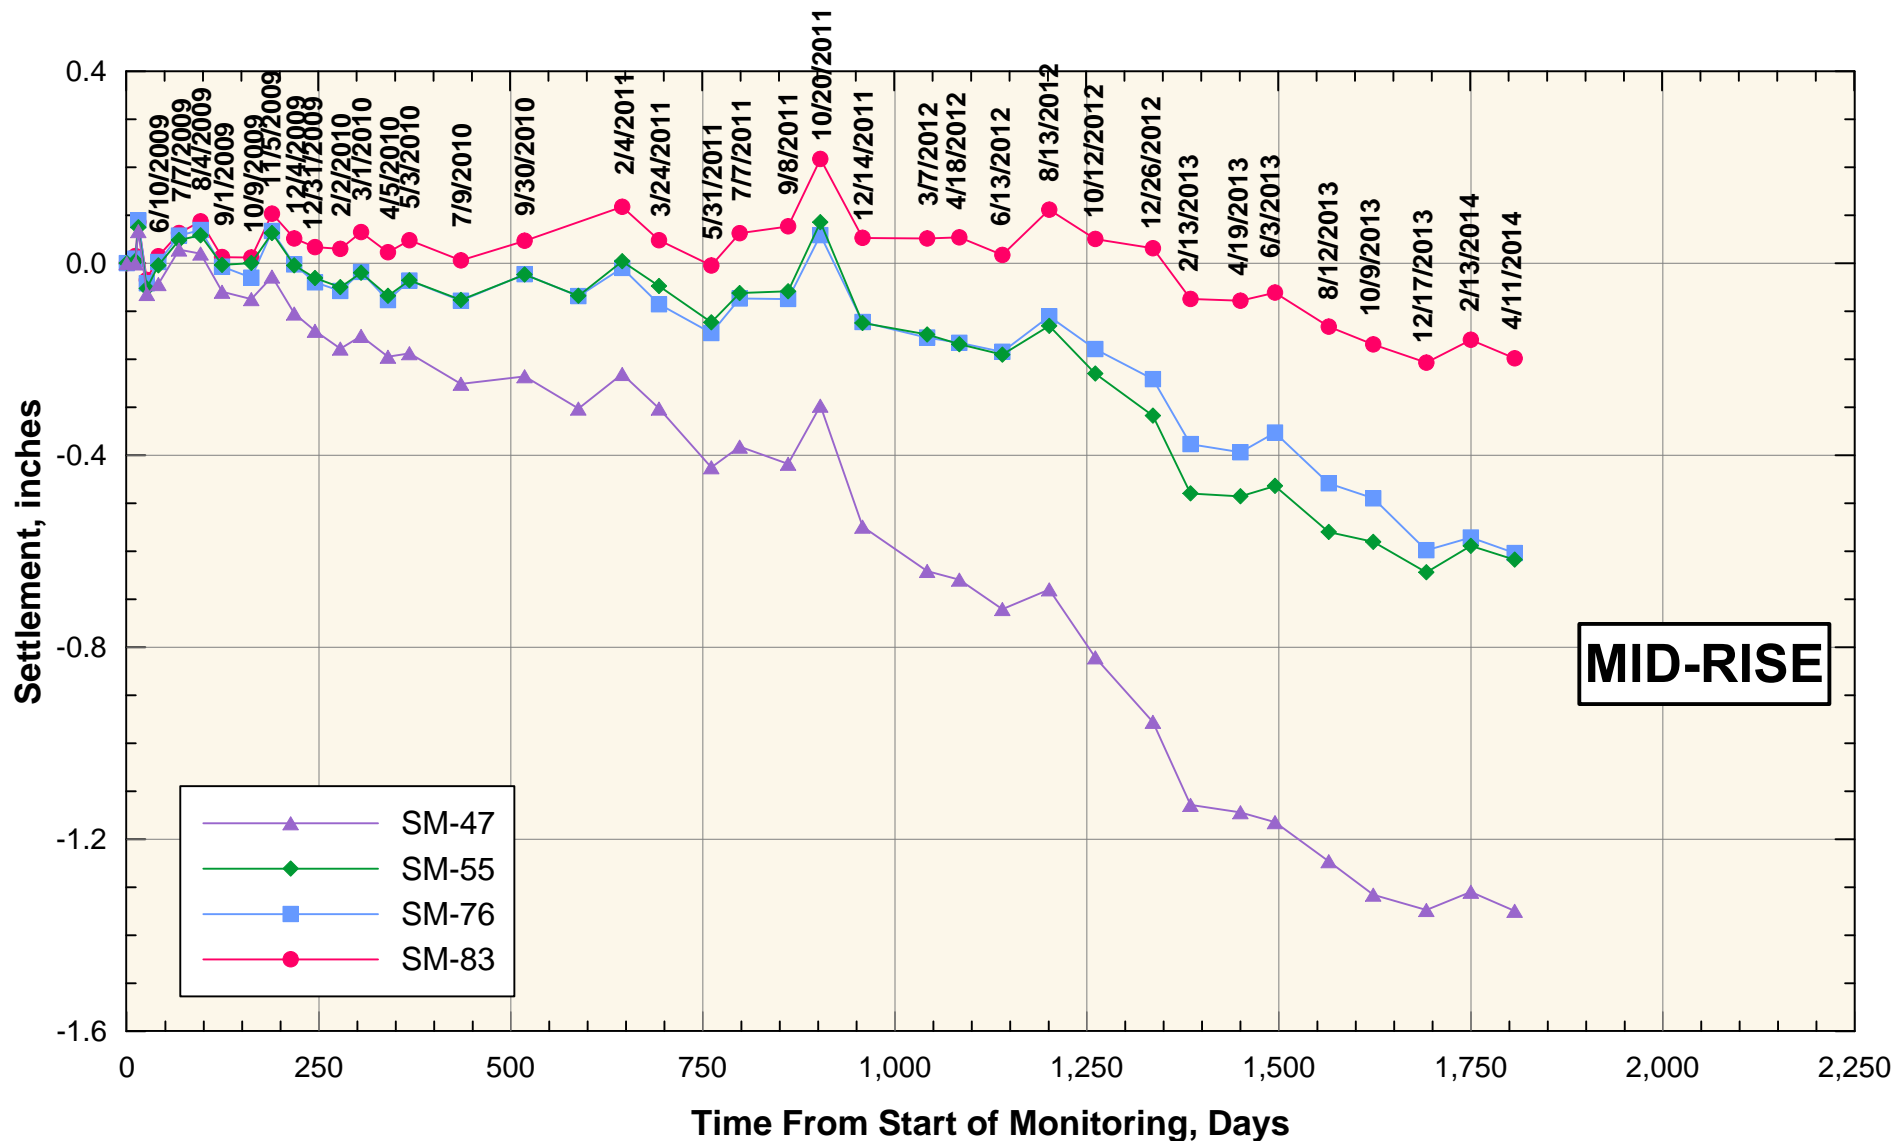
PLATE 5

**SETTLEMENT OVER TIME
FLOOR ELEVATIONS AT LEVEL B-1
OF 301 MISSION PROPERTY- MID-RISE:
APRIL 30, 2009 THROUGH APRIL 11, 2014**

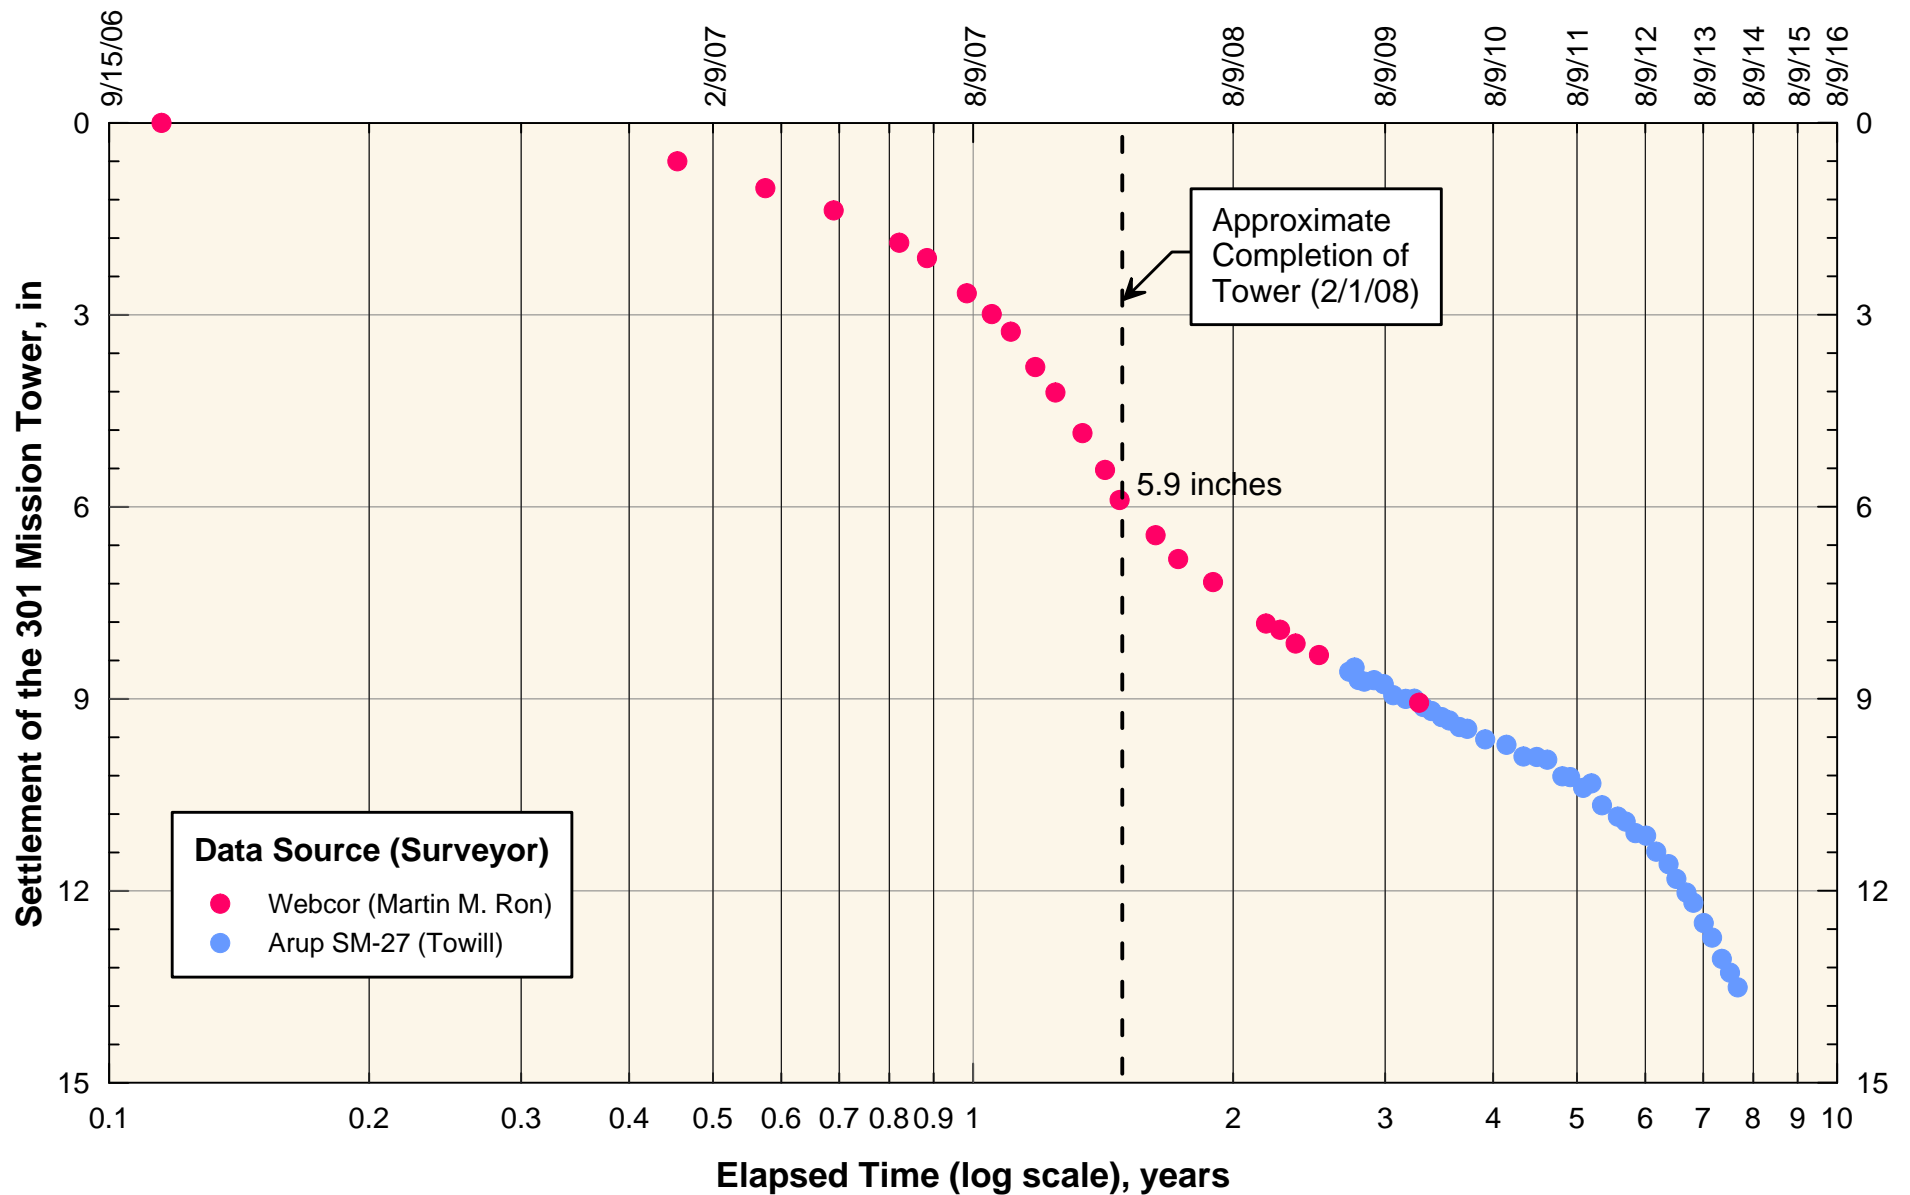
Beginning of Tower Construction: 8/9/06
 End of Tower Construction: 2/1/08
 Construction Duration: 542 days (1.5 years)

**SETTLEMENTS OF THE 301 MISSION TOWER
 INCLUDING MONITORING DURING CONSTRUCTION**
