*Board of Supervisors
City and County of San Francisco*

Government Audit and Oversight Committee

Supplemental Report for Foundation Settlement Investigation

**SUPPLEMENTAL REPORT
FOUNDATION SETTLEMENT INVESTIGATION
301 MISSION STREET
SAN FRANCISCO, CALIFORNIA**

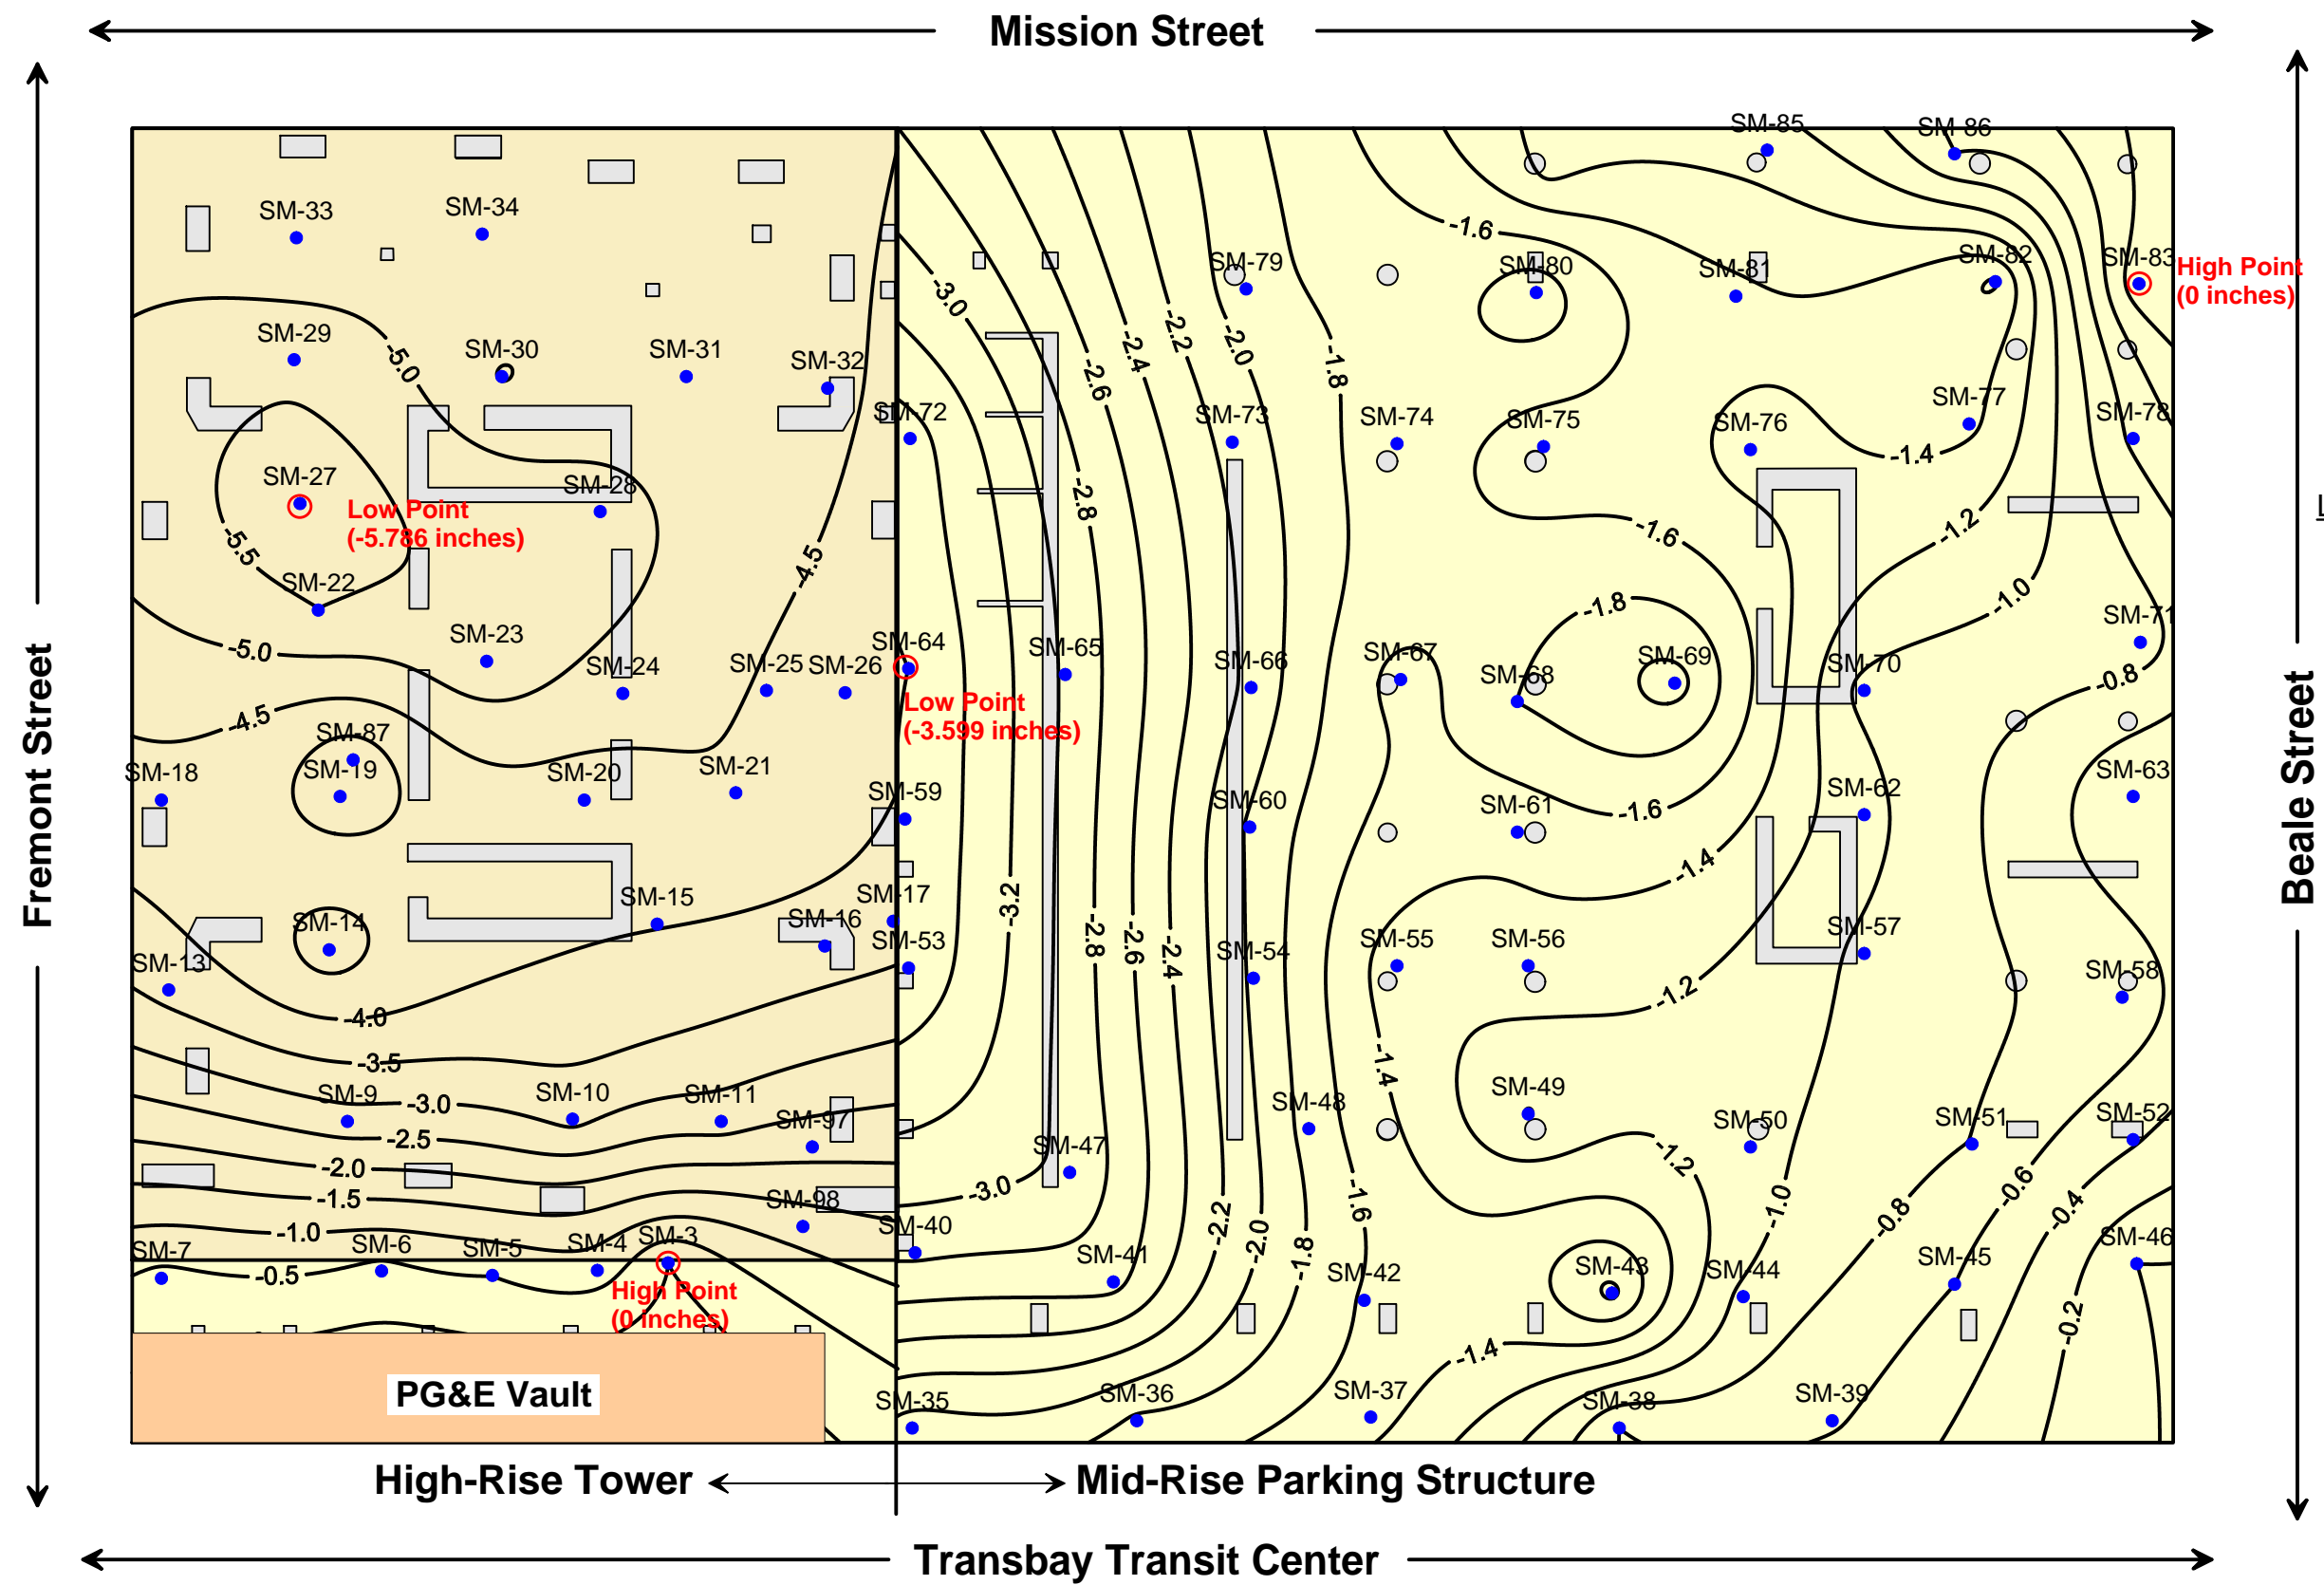
PLATE 2

Notes:
Contours represent differential elevation, in inches, between the highest point and all other points taken on June 11, 2014.
Level B-1 at Mid-Rise Parking portion of survey site is approximately 4 inches higher than Level B-1 at High-Rise Tower portion.
The PG&E vault is inaccessible for monitoring.
Contour intervals are different between the High-Rise Tower and the Low-Rise Tower.

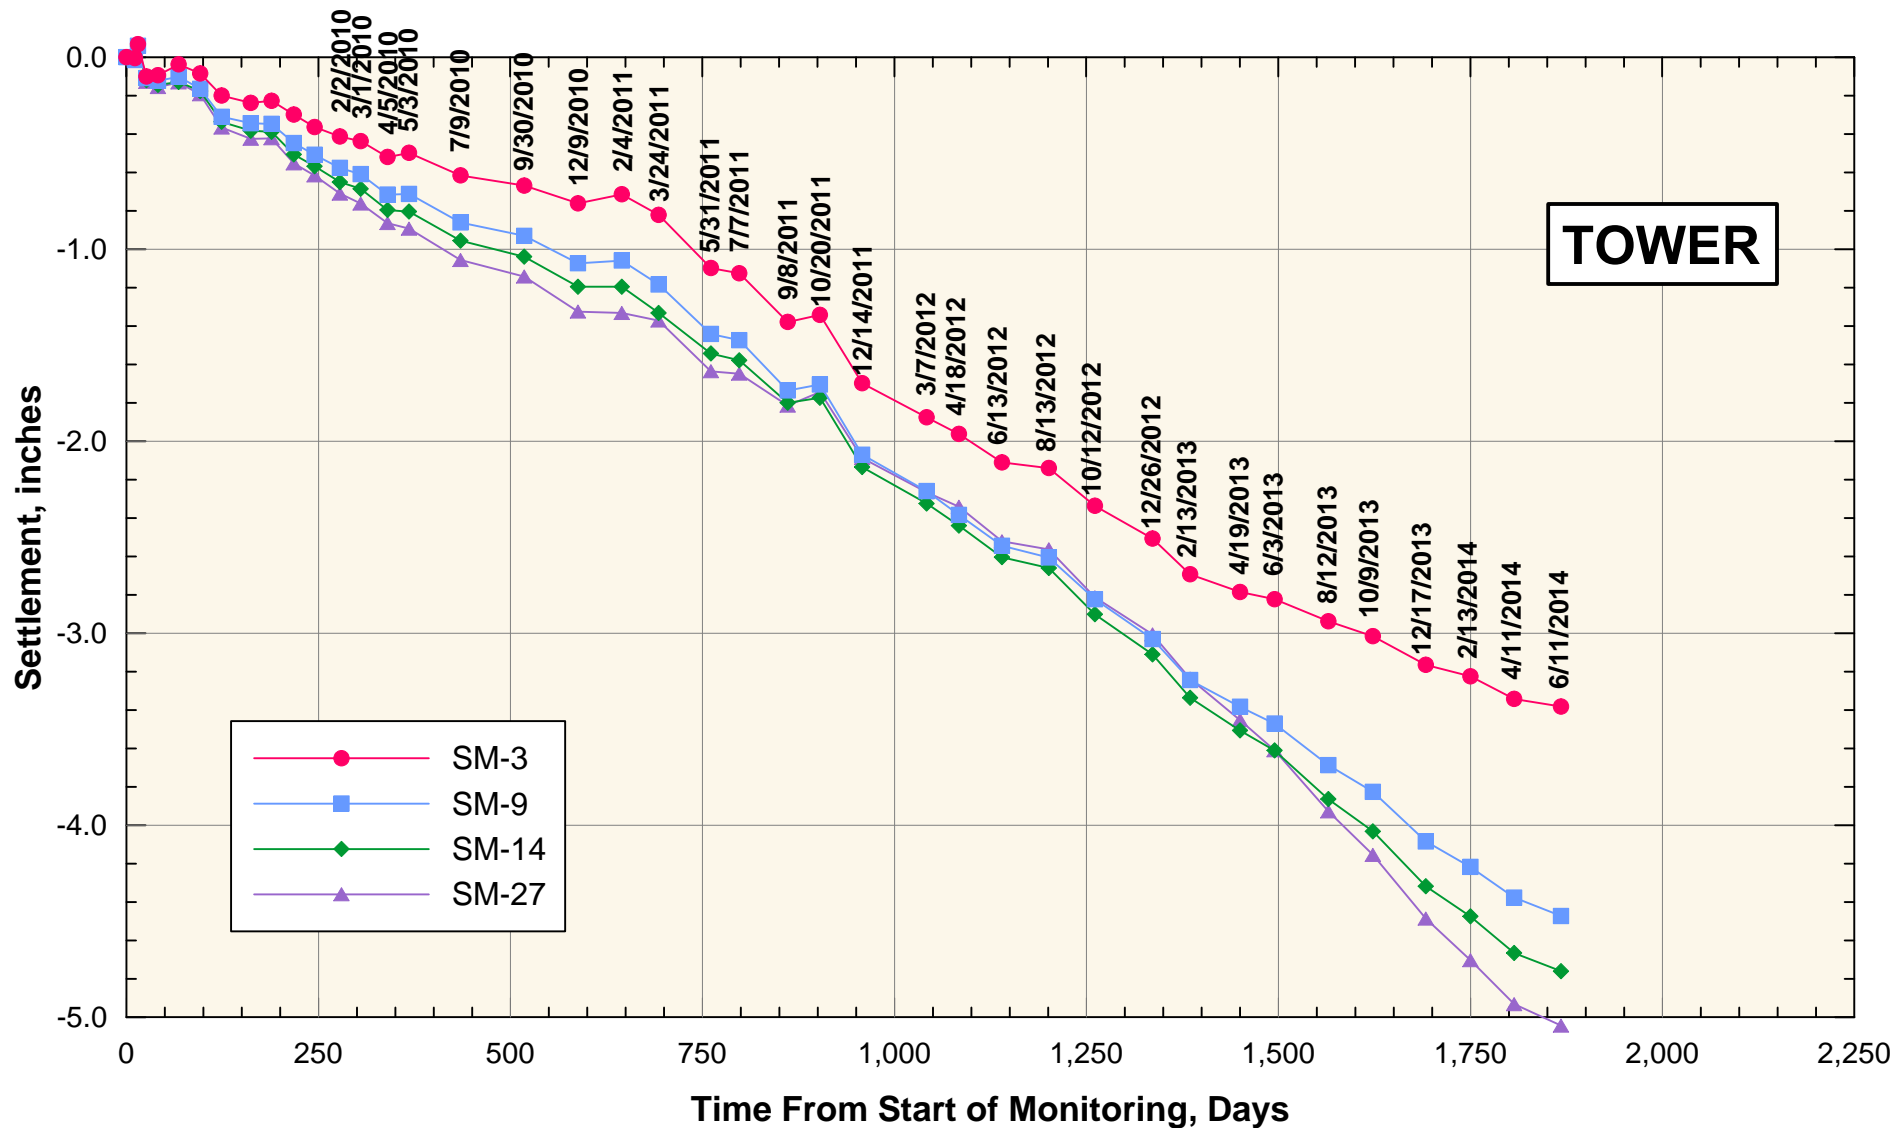
PLATE 4

**SETTLEMENT OVER TIME
FLOOR ELEVATIONS AT LEVEL B-1
OF 301 MISSION PROPERTY- TOWER:
APRIL 30, 2009 THROUGH JUNE 11, 2014**

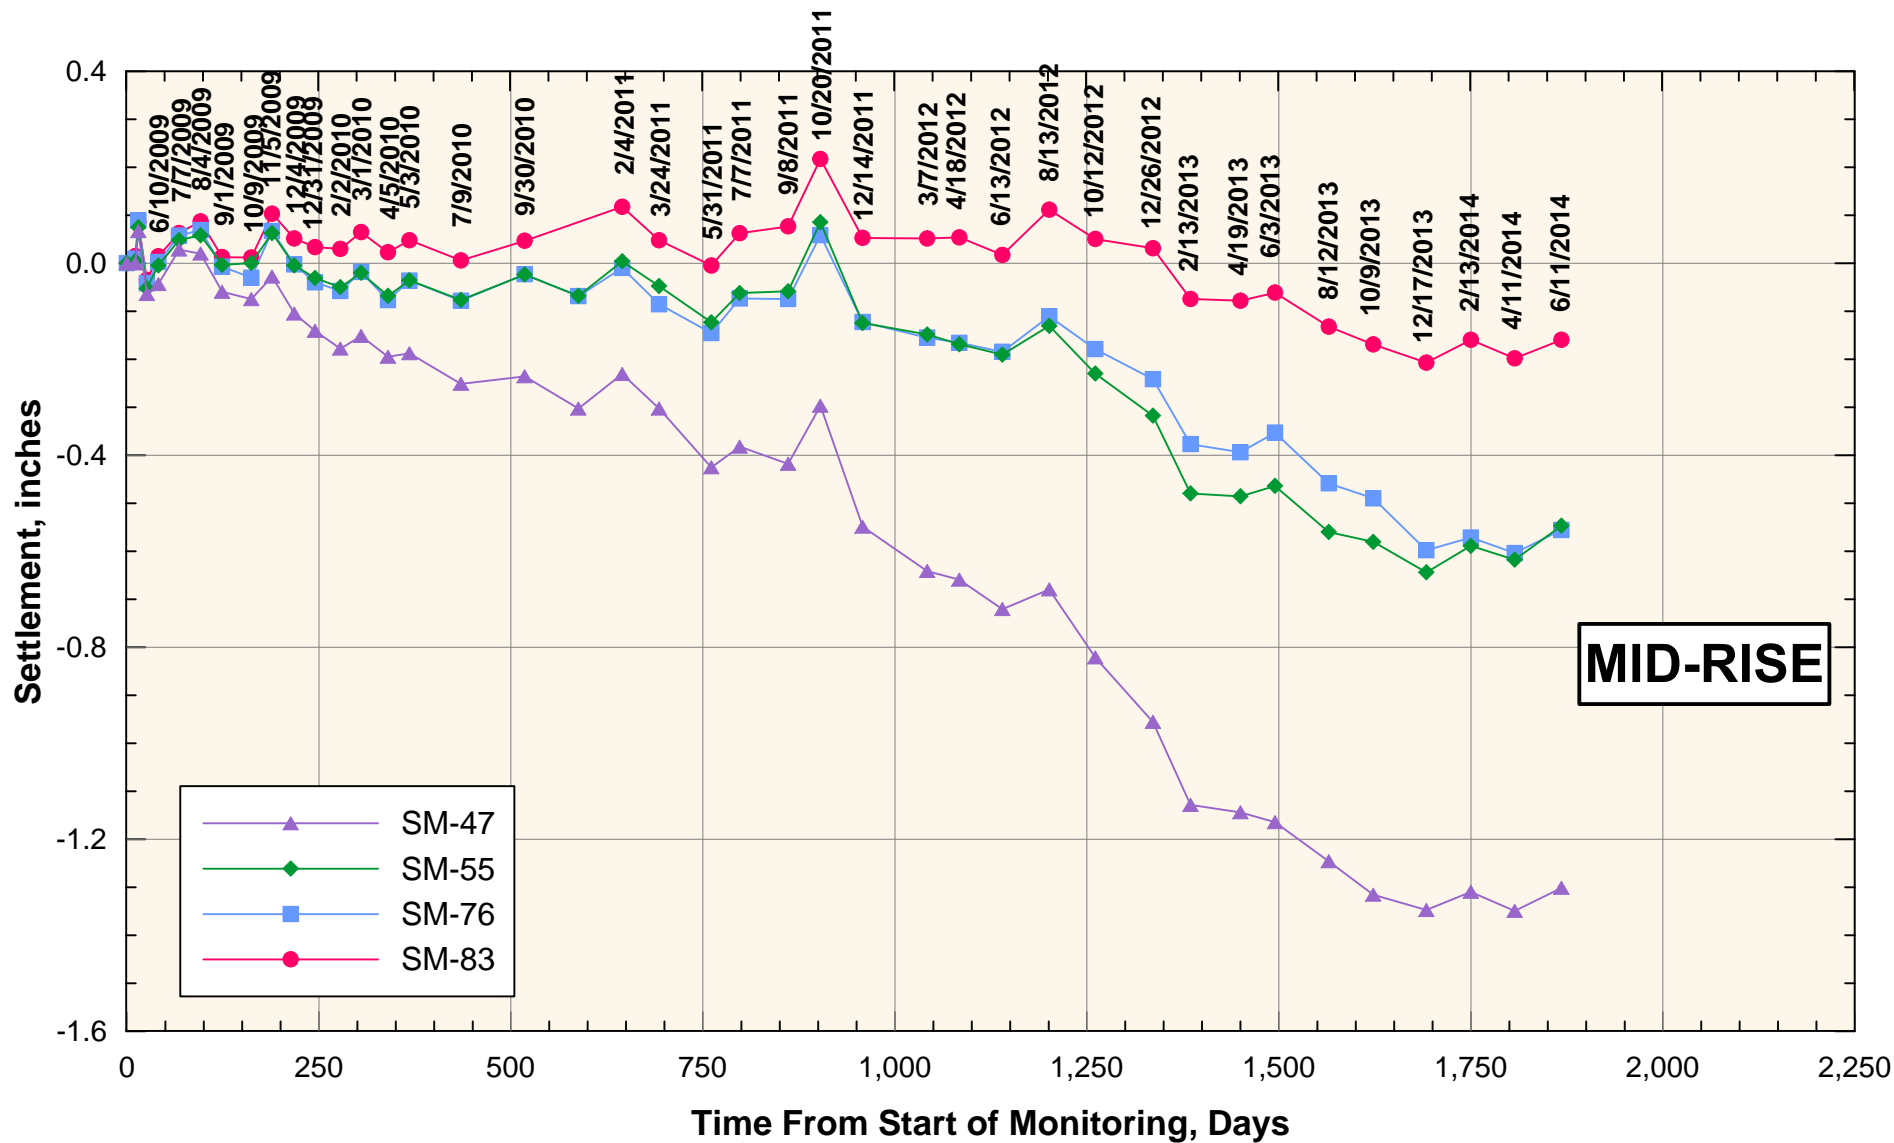
PLATE 5

**SETTLEMENT OVER TIME
FLOOR ELEVATIONS AT LEVEL B-1
OF 301 MISSION PROPERTY- MID-RISE:
APRIL 30, 2009 THROUGH JUNE 11, 2014**

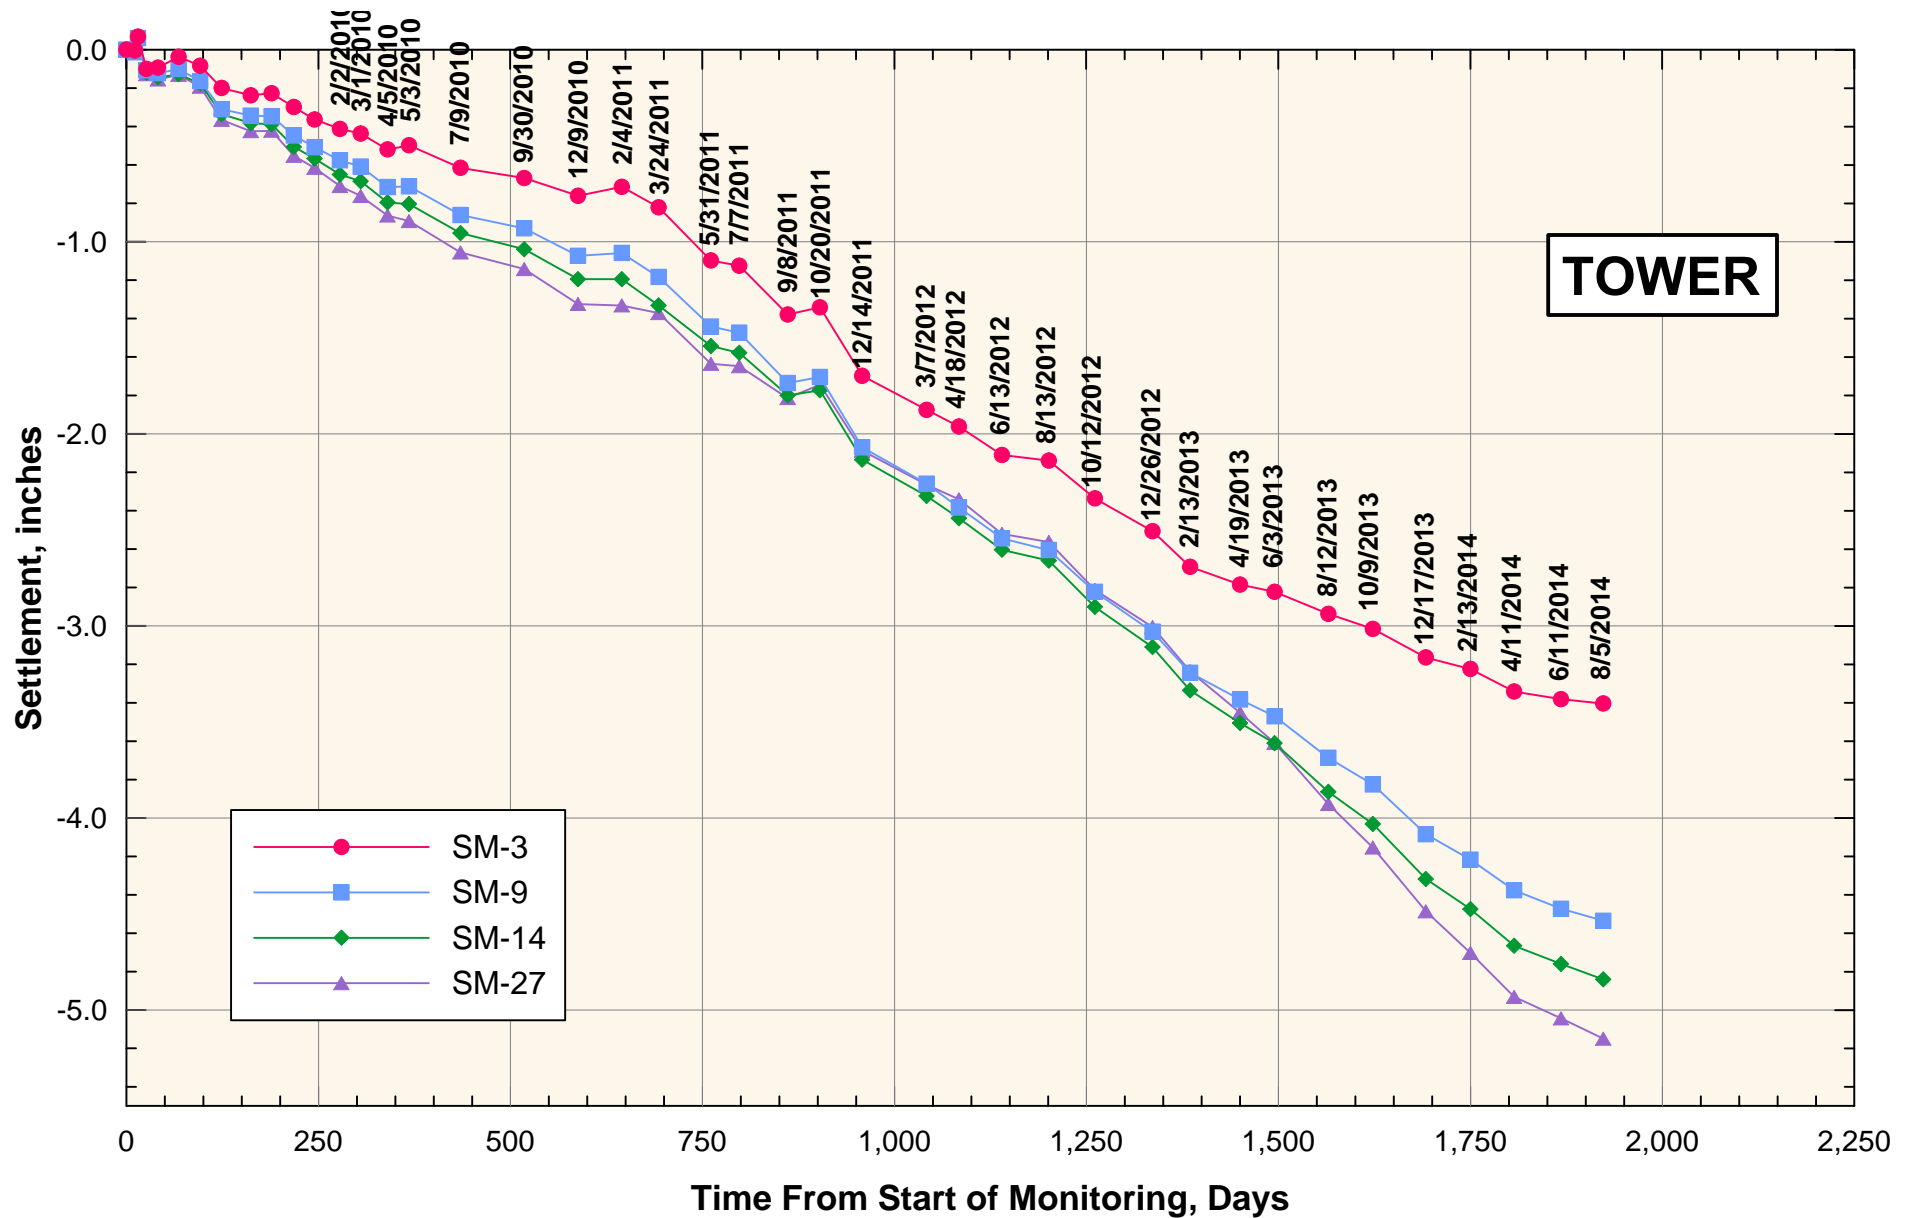
**SETTLEMENT OVER TIME
FLOOR ELEVATIONS AT LEVEL B-1
OF 301 MISSION PROPERTY- TOWER:
APRIL 30, 2009 THROUGH AUGUST 5, 2014**

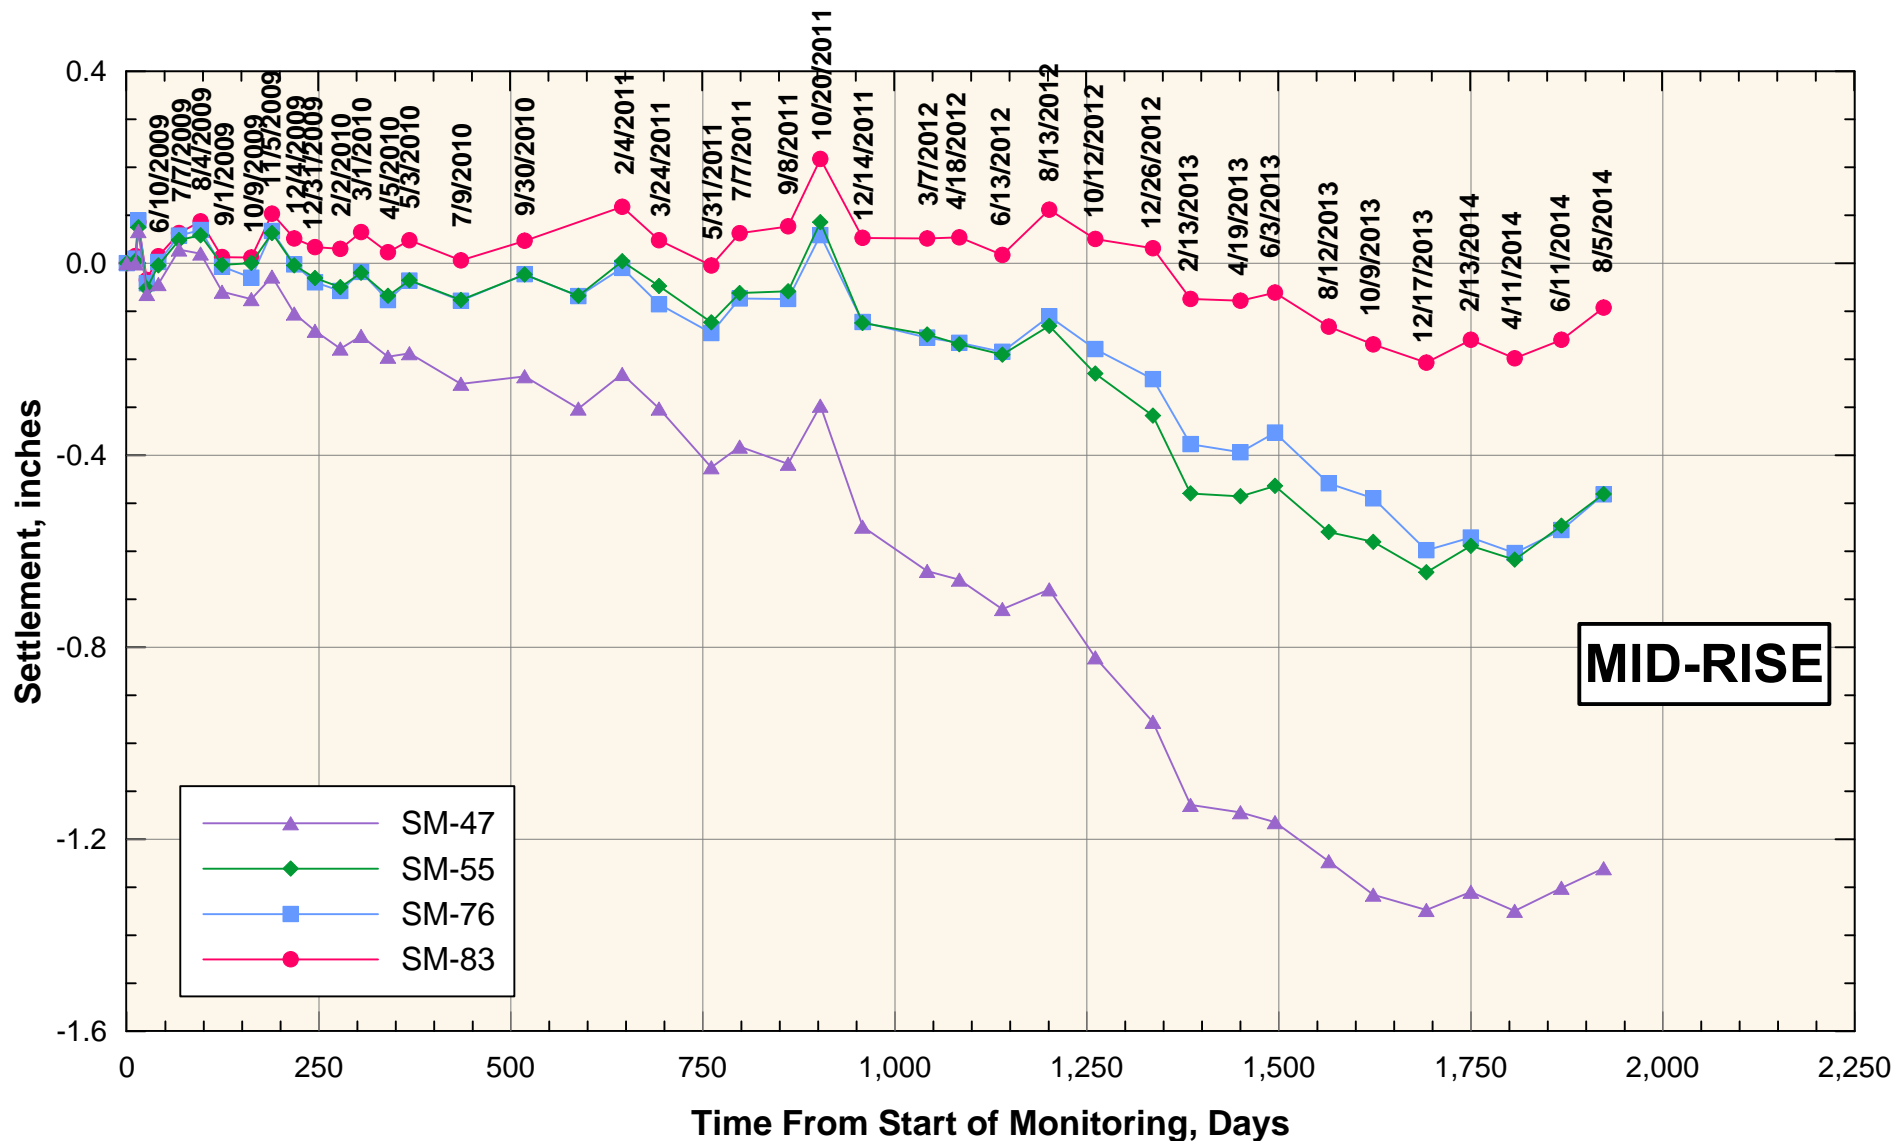
**SETTLEMENT OVER TIME
FLOOR ELEVATIONS AT LEVEL B-1
OF 301 MISSION PROPERTY- MID-RISE:
APRIL 30, 2009 THROUGH AUGUST 5, 2014**

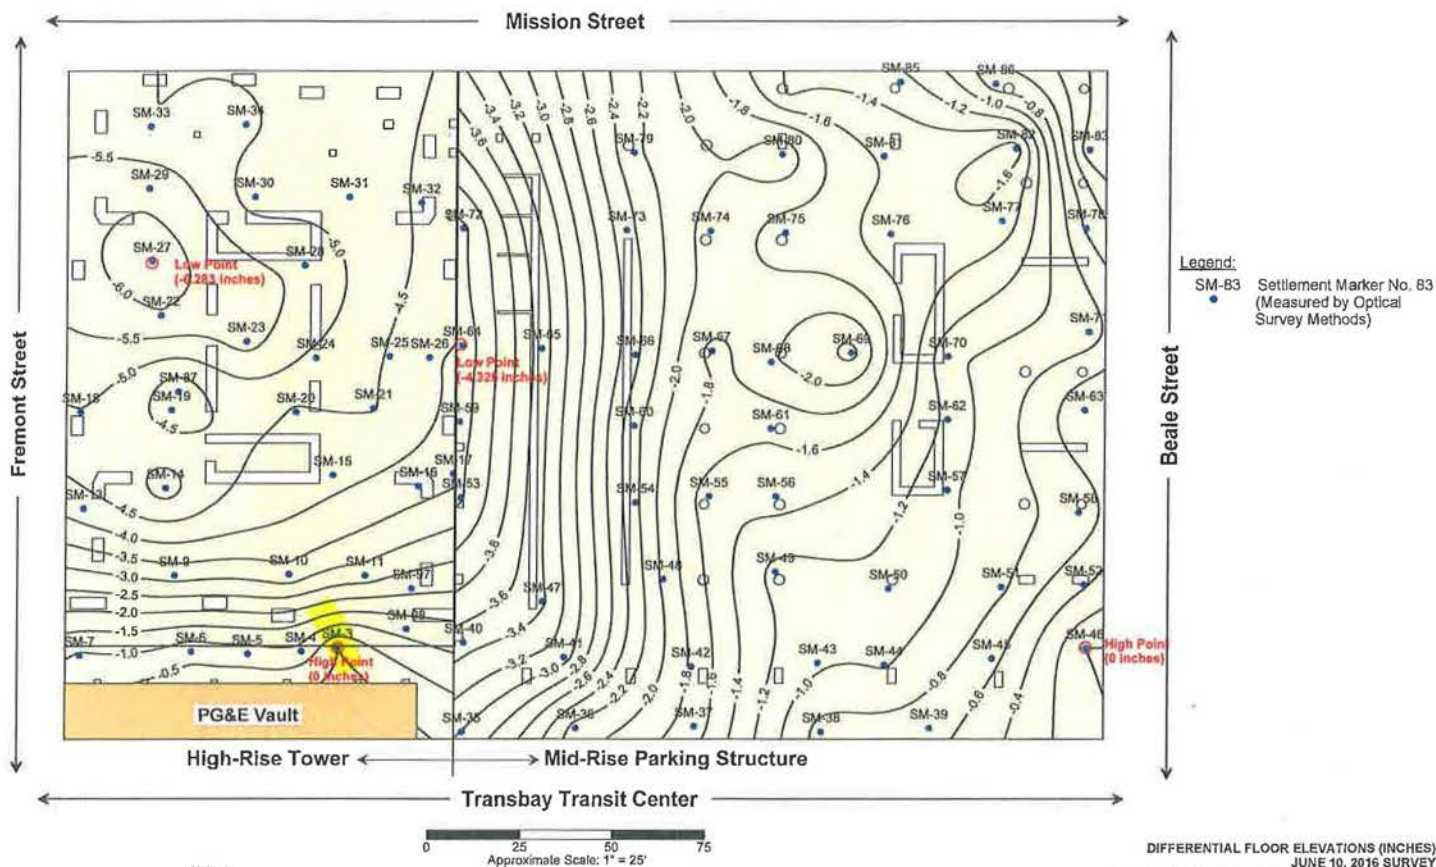
PLATE 2

Contours represent differential elevation, in inches, between the highest point and all other points taken on June 10, 2016.
 Level B-1 at Mid-Rise Parking portion of survey site is approximately 4 inches higher than Level B-1 at High-Rise Tower portion.
 The PG&E vault is inaccessible for monitoring.
 Contour intervals are different between the High-Rise Tower and the Low-Rise Tower.

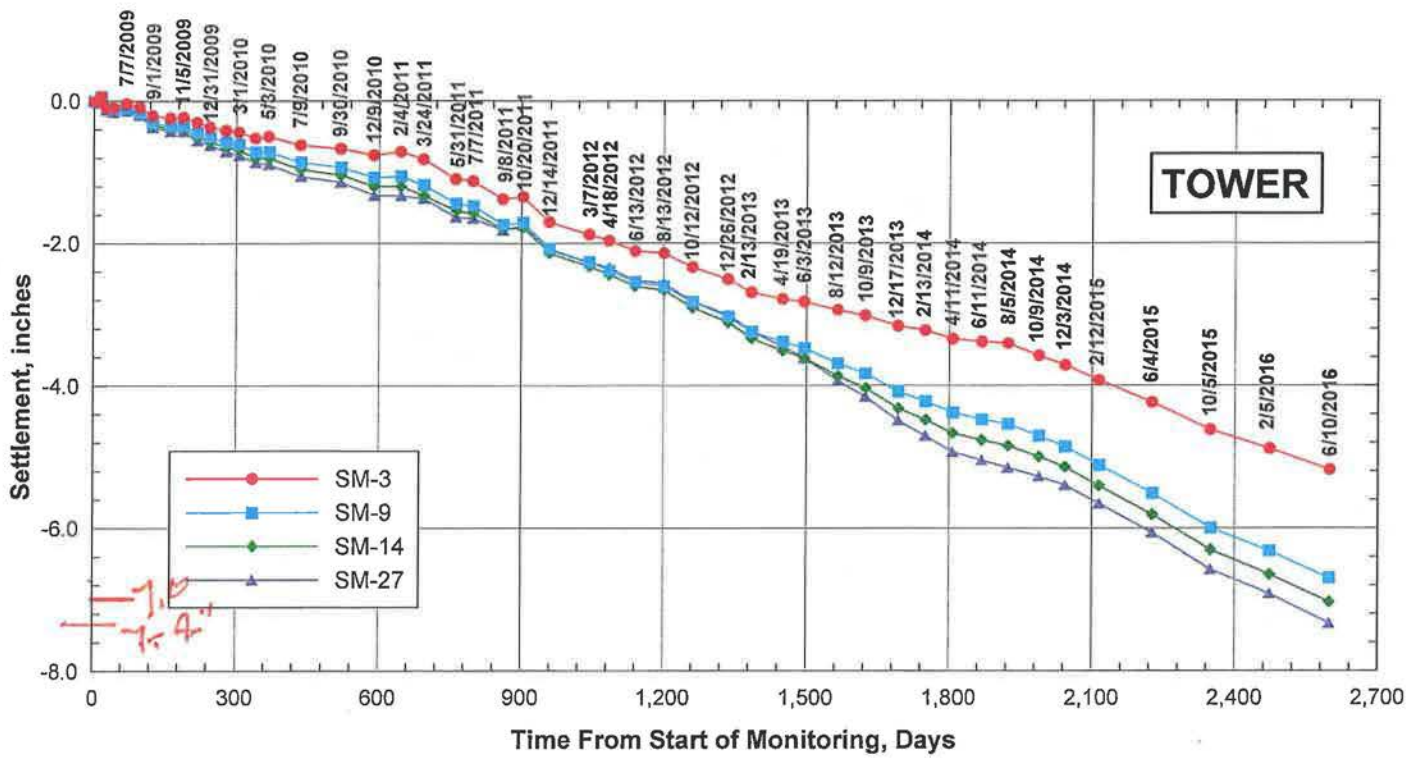
PLATE 4

**SETTLEMENT OVER TIME
FLOOR ELEVATIONS AT LEVEL B-1
OF 301 MISSION PROPERTY- TOWER:
APRIL 30, 2009 THROUGH JUNE 10, 2016**

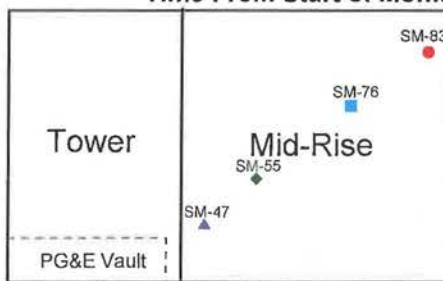
PLATE 5

**SETTLEMENT OVER TIME
FLOOR ELEVATIONS AT LEVEL B-1
OF 301 MISSION PROPERTY- MID-RISE:
APRIL 30, 2009 THROUGH JUNE 10, 2016**

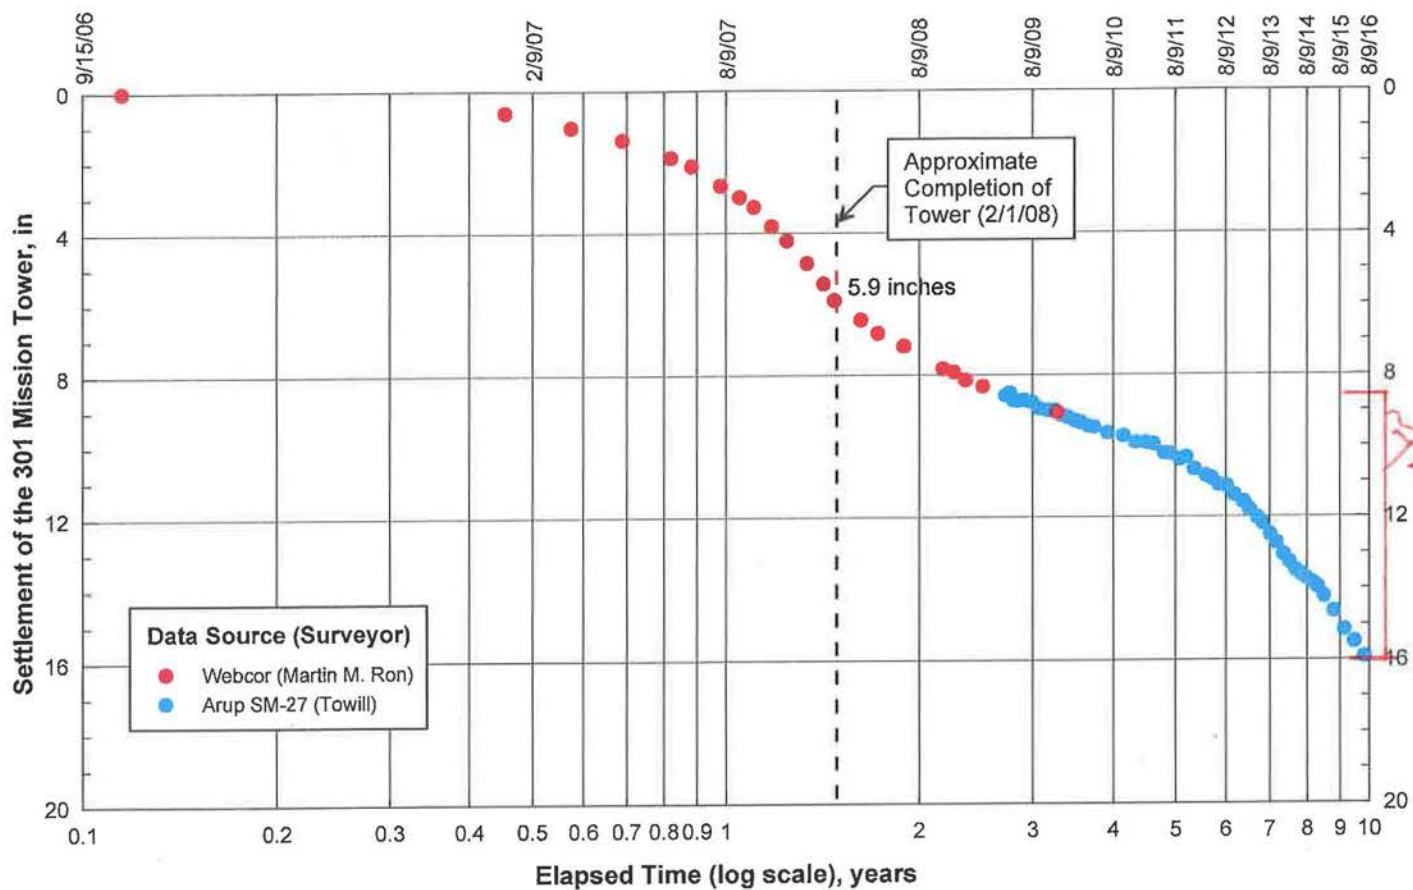
PLATE 6

Beginning of Tower Construction: 8/9/06
 End of Tower Construction: 2/1/08
 Construction Duration: 542 days (1.5 years)

**SETTLEMENTS OF THE 301 MISSION TOWER
INCLUDING MONITORING DURING CONSTRUCTION**
