*Board of Supervisors
City and County of San Francisco*

Government Audit and Oversight Committee

Supplemental Report for Foundation Settlement Investigation

**SUPPLEMENTAL REPORT
FOUNDATION SETTLEMENT INVESTIGATION
301 MISSION STREET
SAN FRANCISCO, CALIFORNIA**

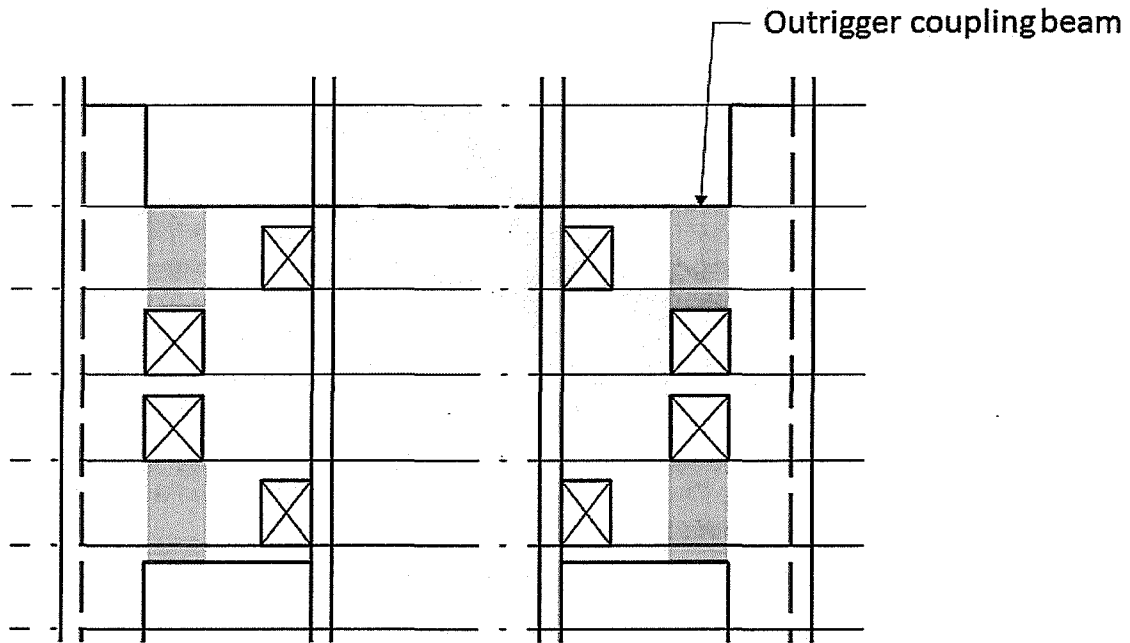
Figure 12. Outrigger Elevation Showing Coupling Beams

Our 3 October 2016 report documents the three-dimensional, nonlinear, PERFORM-3D, analytical model we developed to simulate the 301 Mission Street building's response to foundation settlement and earthquake ground motions. At the request of the City-appointed review panel, we modified our analytical model to incorporate strength degradation for the low-aspect ratio coupling beams located in outriggers at Levels 8 through 12, 17 through 21 and 42 through 48, along framing Lines C and F. Figure 12 presents an elevation of a typical outrigger indicating the locations of these low aspect ratio beams.

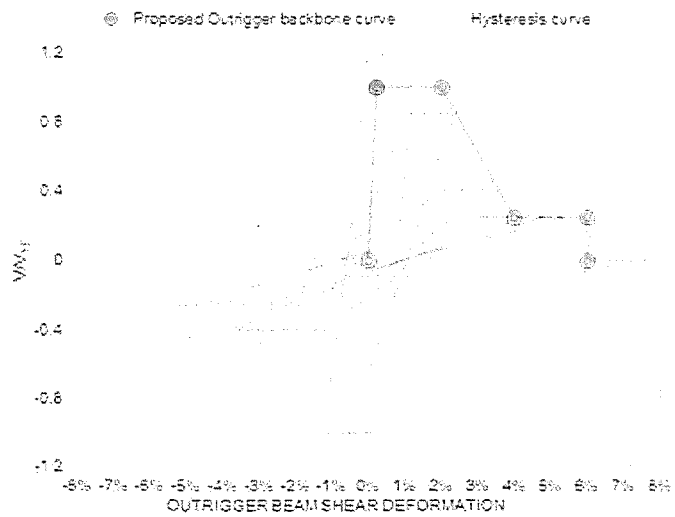
Figure 13. Coupling Beam Degrading Hysteretic Model

For these elements, we implemented the degrading hysteretic model illustrated in Figure 13. The cyclic backbone for this model maintains elastic-perfectly-plastic behavior through a shear deformation of 2% radians then degrades to a residual strength equal to 25% of the yield strength at a shear deformation of 4% radians. The model retains this residual displacement through shear deformation of 6% radians, after which it has nil residual strength. Figure 14 shows an overlay of the response obtained from this hysteretic model with that recorded in the University of Michigan testing discussed in Section 2.1.2 of this report. The hysteretic model conservatively represents the behavior obtained in the test and exhibits greater strength and stiffness degradation than did the tested specimen.

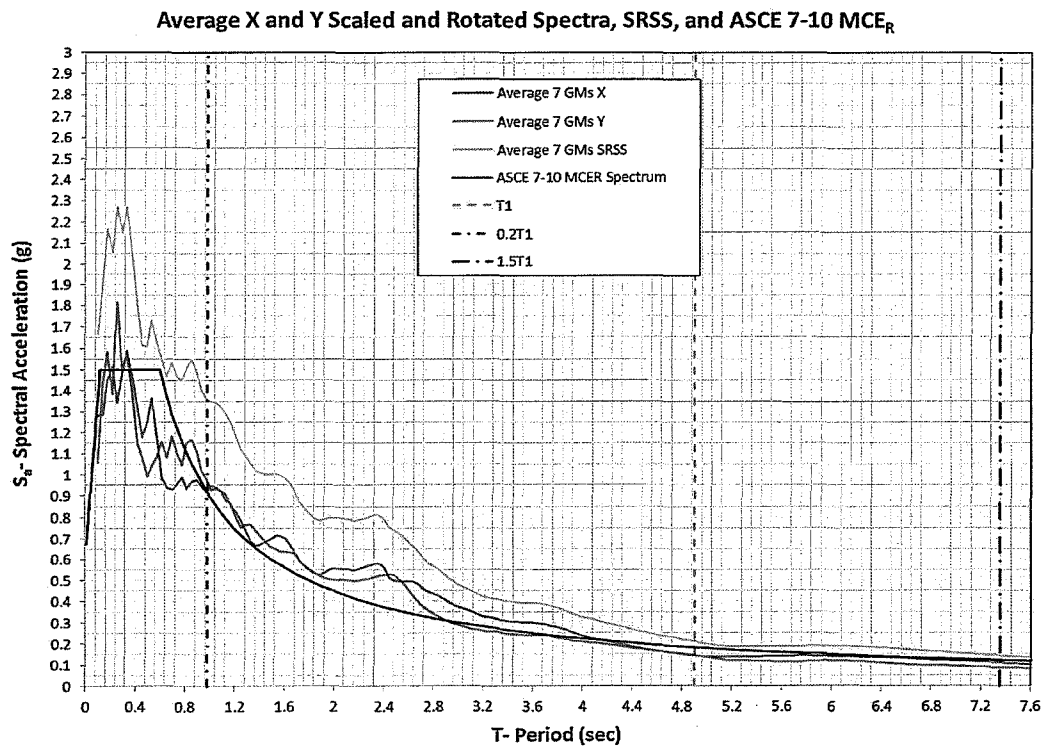
Figure 15. Comparison of Scaled Spectra and Target Spectrum

Table 1 indicates the seven records we selected and scaled for our analysis. The table indicates for each record the earthquake event, station name, fault mechanism, magnitude, distance of the recording station from the site and scale factor we applied. Figure 15 overlays plots of the scaled SRSS spectra for the seven records with the MCE_R spectrum specified in ASCE 7 Section 11.4.5; the average of the scaled SRSS spectra; and the period range ($0.2T$ to $1.5T$) over which the average SRSS spectrum is required to envelope the MCE_R spectrum. Figure 16 compares the average X and Y components of the records, as they were applied to the model against the MCE_R spectrum.

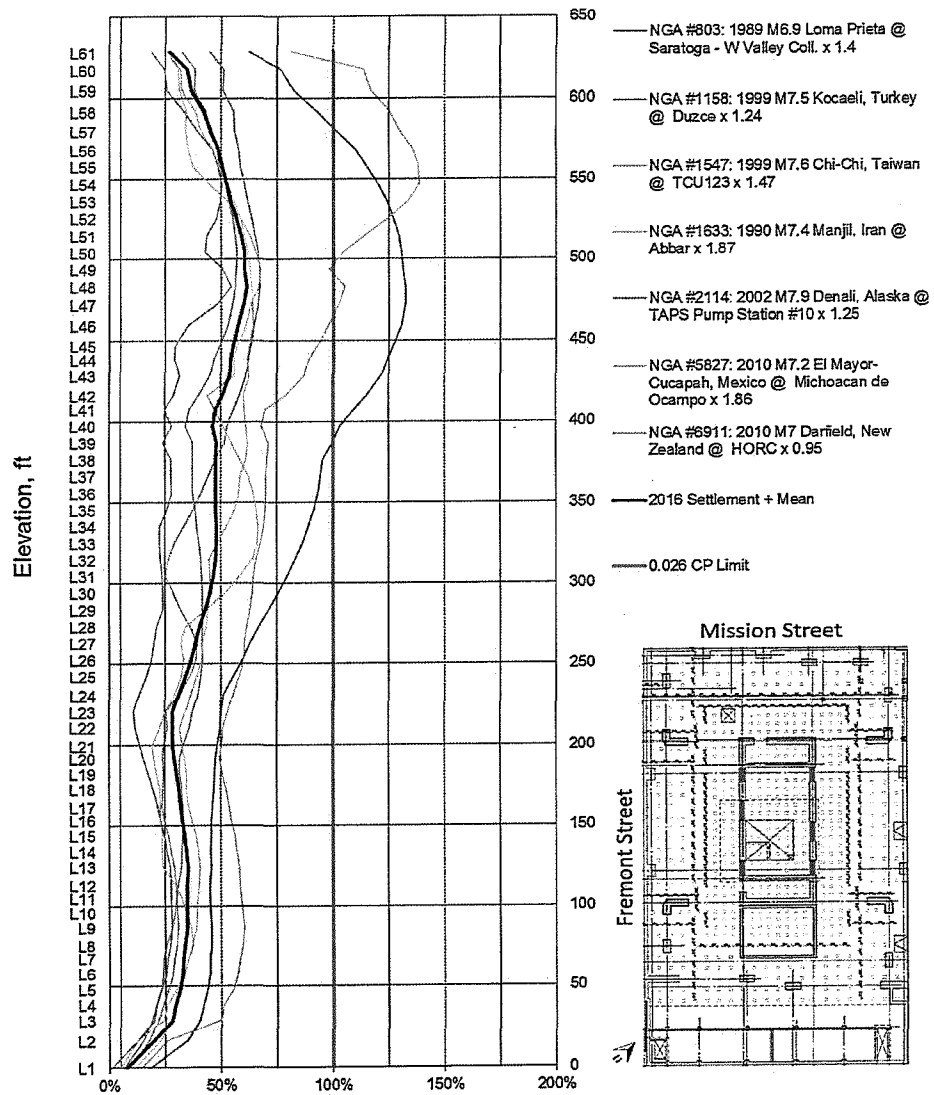
Figure 33. Demand to Capacity Ratios, Steel Coupling Beams, Fixed Translation Model

Figure 33 presents demand to capacity ratios for steel coupling beams. A value of 100% corresponds to a plastic hinge rotation of 0.03 radians. Mean demands are substantially less than this amount although two ground motions do produce locally somewhat higher demands at upper levels. The predicted demands are within the valid modeling range at all levels for all ground motions.

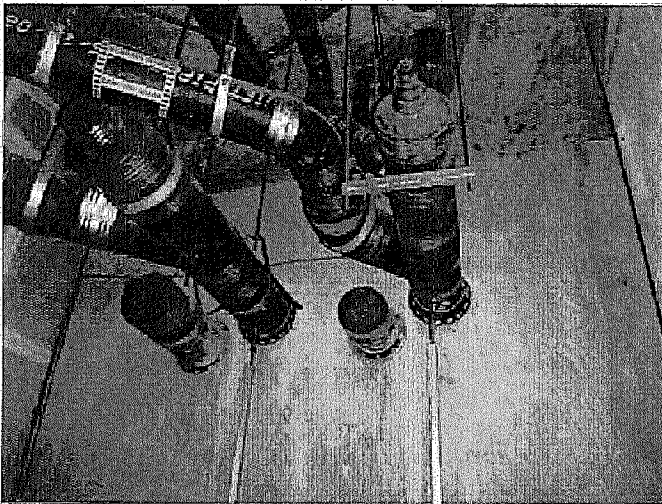
UP-4 Mission Street Elevation: Storm, Sanitary

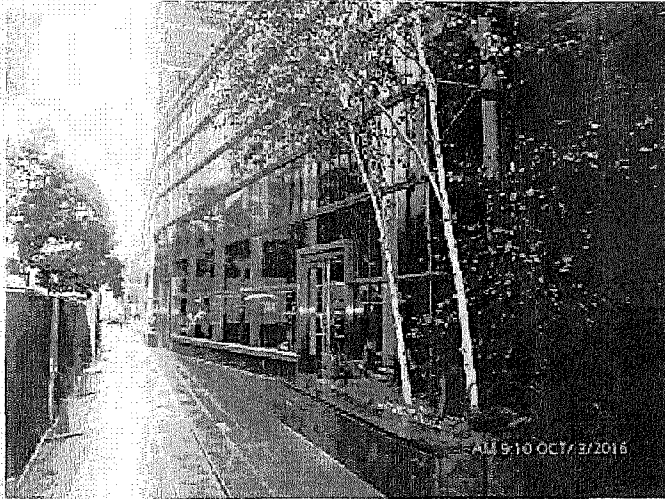
UP-5 Mission Street Elevation: Storm and Sanitary

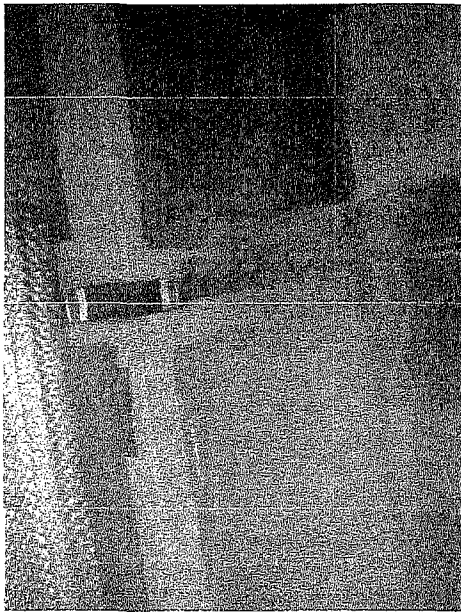
1. At site ST1;
Large gaps on the interior surface of the exterior wall (curtain wall) within the cavity behind the heat pump [HP-C]. This condition exists on both floors 30B and 31B. The location of air leak is directly across from the intake of the forced air heat pump unit. The odor transfer is enhanced and further distributed into the residence with the operation of the heat pump fan.
2. At site ST5;
Gaps around the hydronic-piping floor penetrations in the closet of heat pump [HP-B]. Here too the location of air leaks are close to the intake of the forced air heat pump unit. The odor transfer again is enhanced and further distributed into the residence with the operation of the heat pump fan.

**AIR GAP IN CURTAIN
WALL**

Smoke test site ST1 in unit 31B

The recommended repair consists of providing an air tight seal of the identified air gaps causing leaks between Units 30B and 31B.

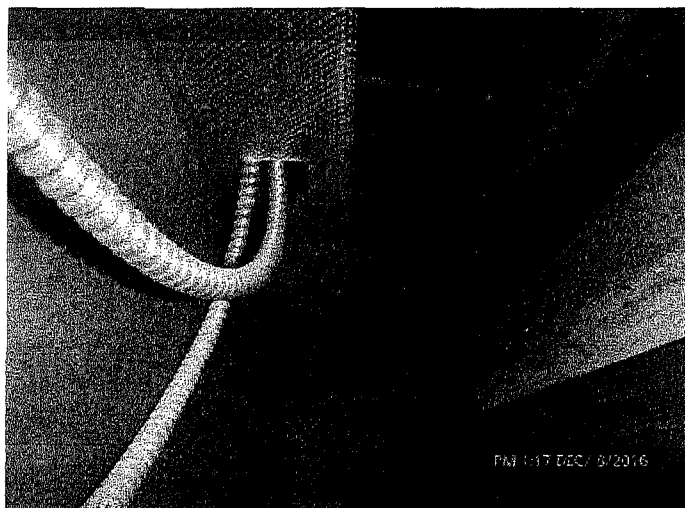
Pre-Test Conditions:
Test site ST5 in unit 31B heat pump closet.
Note pipe risers routed through closet floor

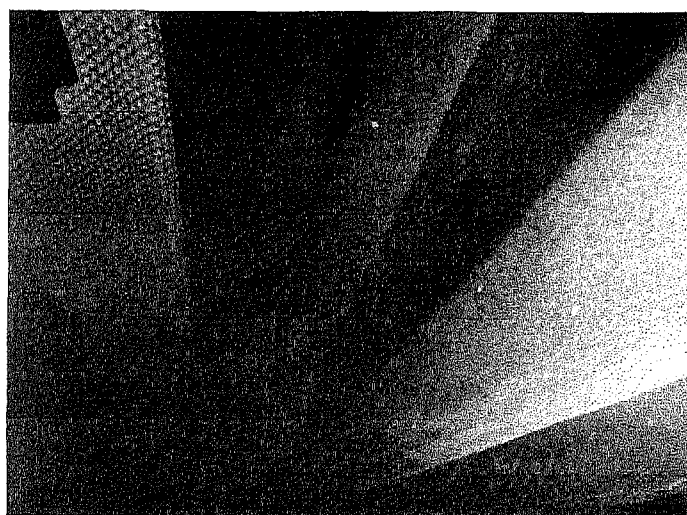
During Smoke Test Conditions – 1/2 minute from start:
Test site ST5 in unit 31B heat pump closet.
Note white test smoke at pipe risers routed through closet floor

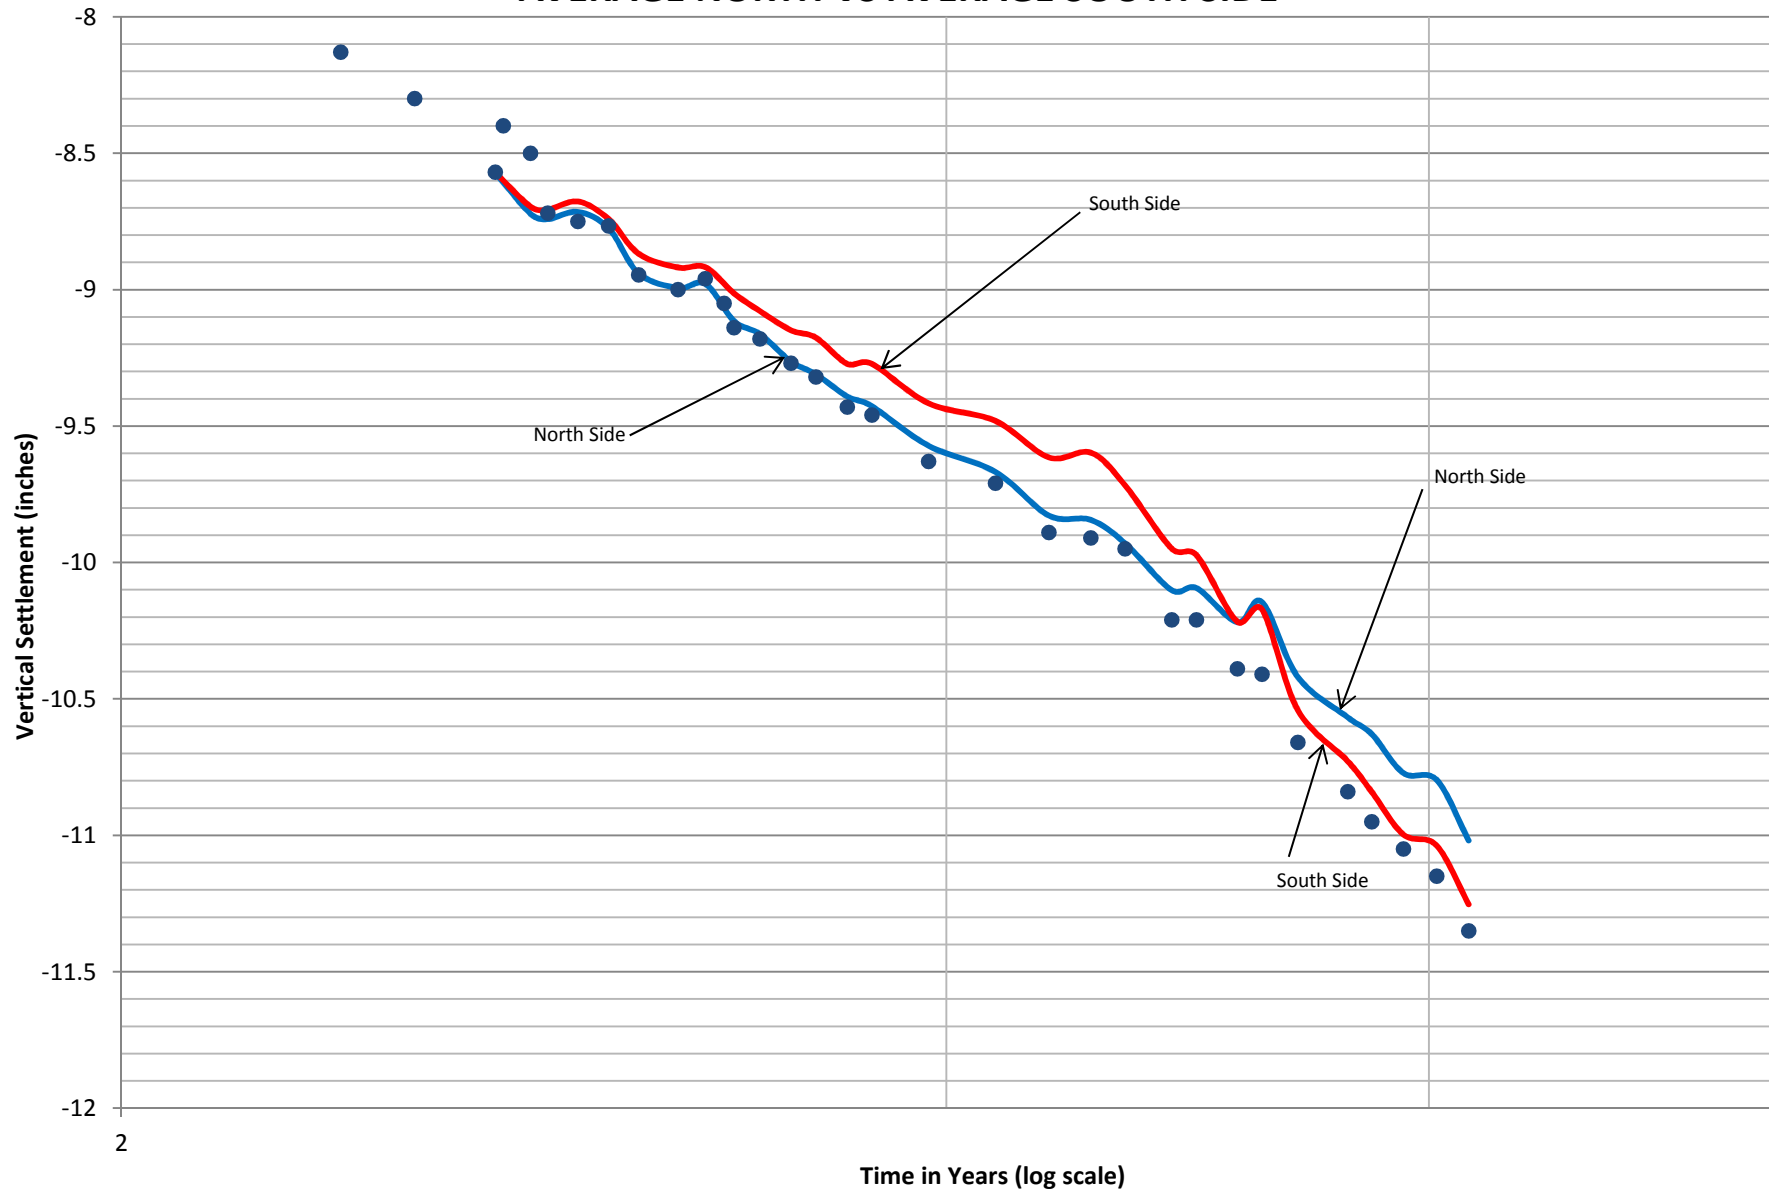
Figure 2

**SETTLEMENT OF 301 MISSION TOWER
AVERAGE NORTH VS AVERAGE SOUTH SIDE**

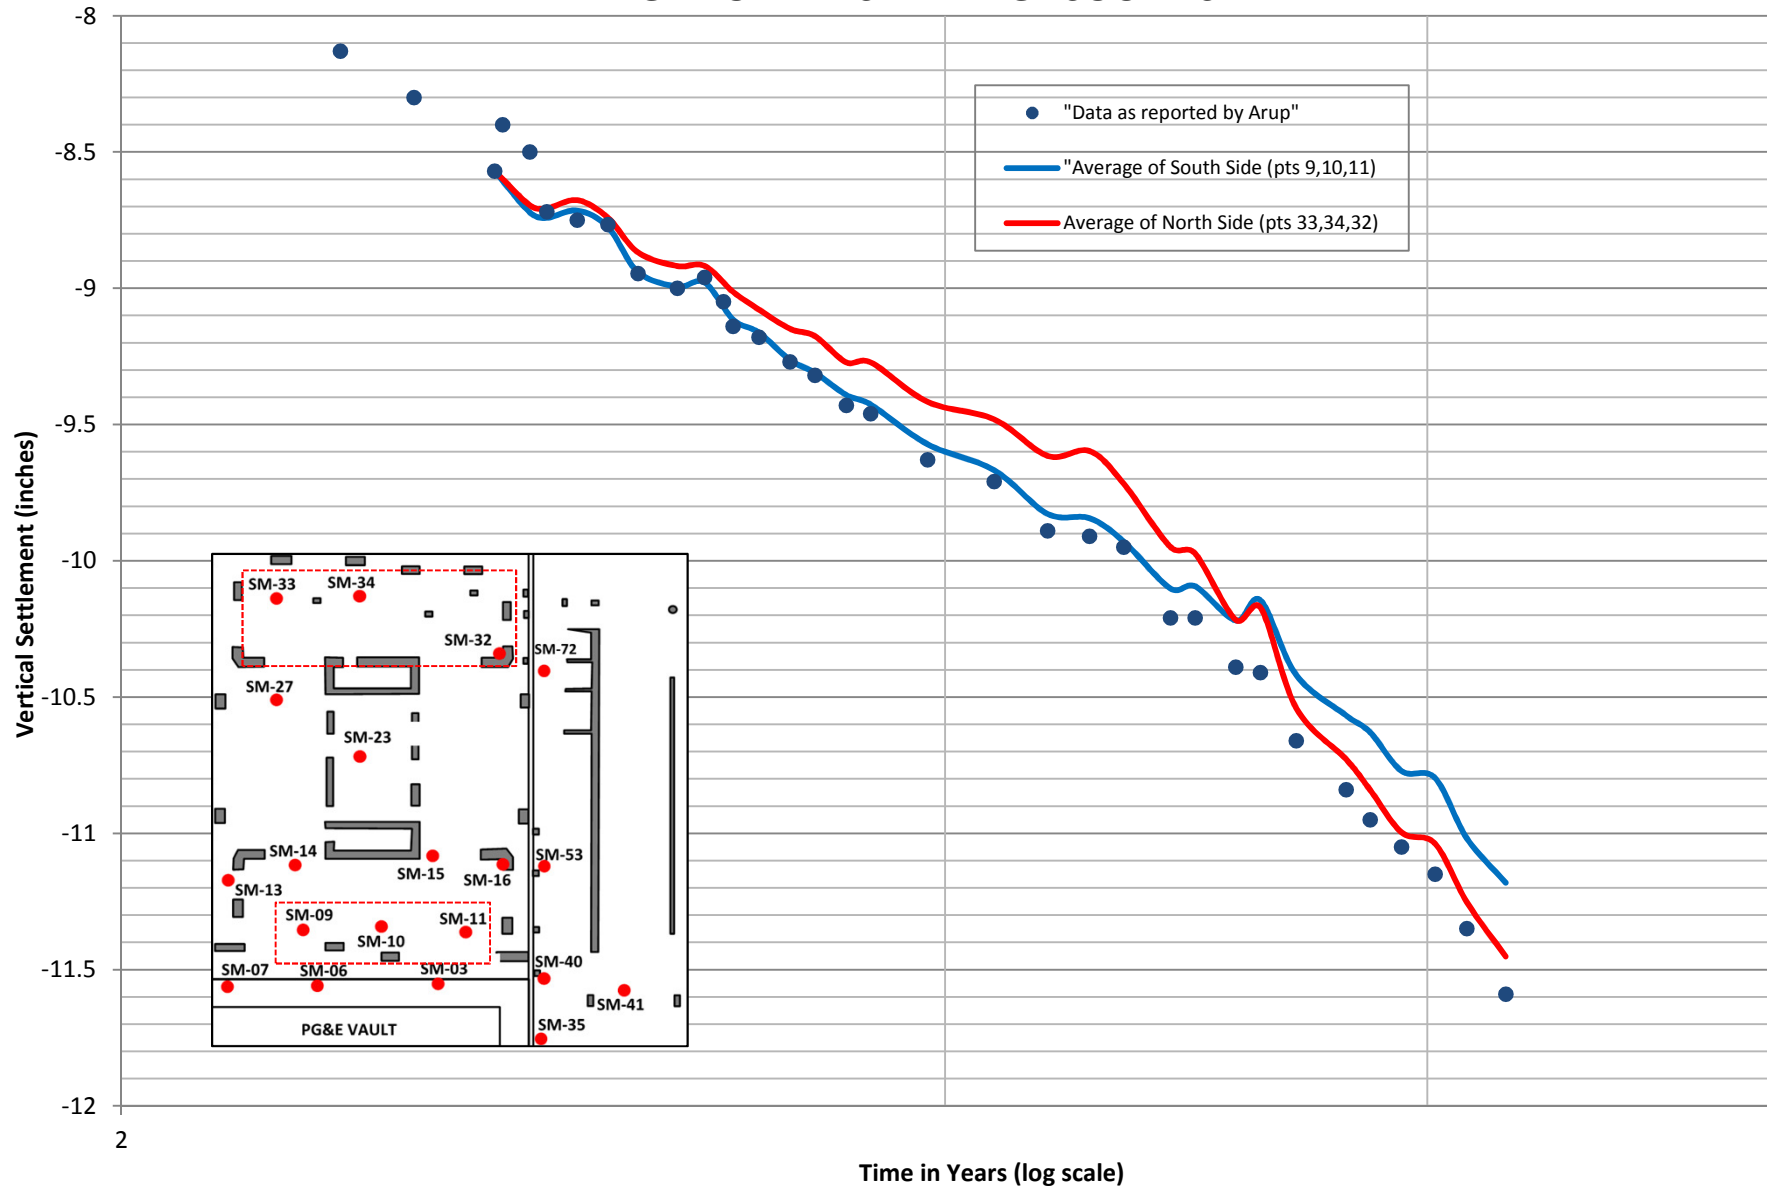
Figure 2

SETTLEMENT OF 301 MISSION TOWER AVERAGE NORTH VS AVERAGE SOUTH SIDE

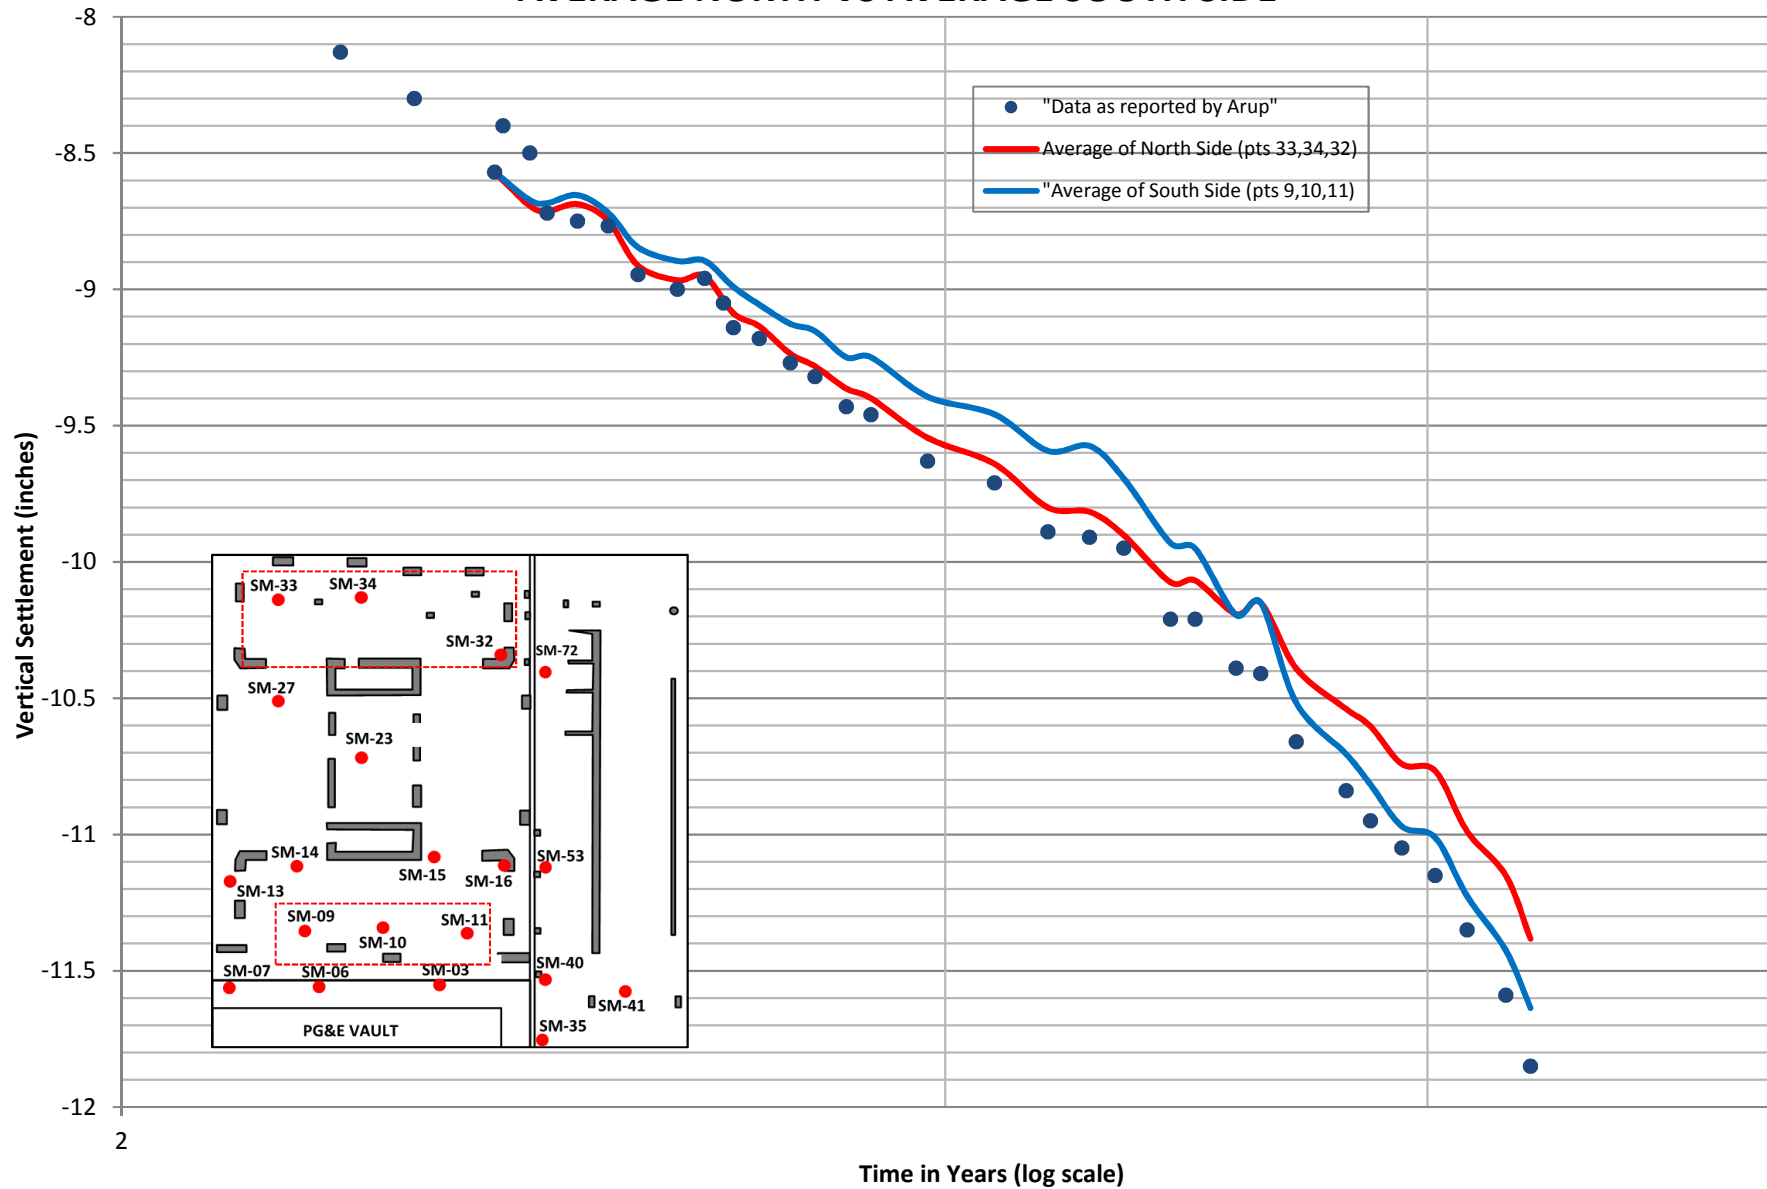
Figure 2 includes an average of settlement on the north side of the tower and on the south end of the tower. Before construction activities began at Transbay we observe that the north side had settled at a greater rate than the south. After construction activities started, we now observe a greater rate of settlement on the south side. The foundation has rotated slightly towards the Transbay project. Since the south end of the foundation seems now to be moving faster than the north, it follows that the activities at Transbay have caused the additional settlement.

Figure 2 also shows that the overall settlement reported by ARUP (and duplicated in Figure 1) is the worst case settlement anywhere across the foundation (about 11.85") and does not represent the average. Based on this plot, the average overall settlement on the site is currently about 11.5 overall inches.

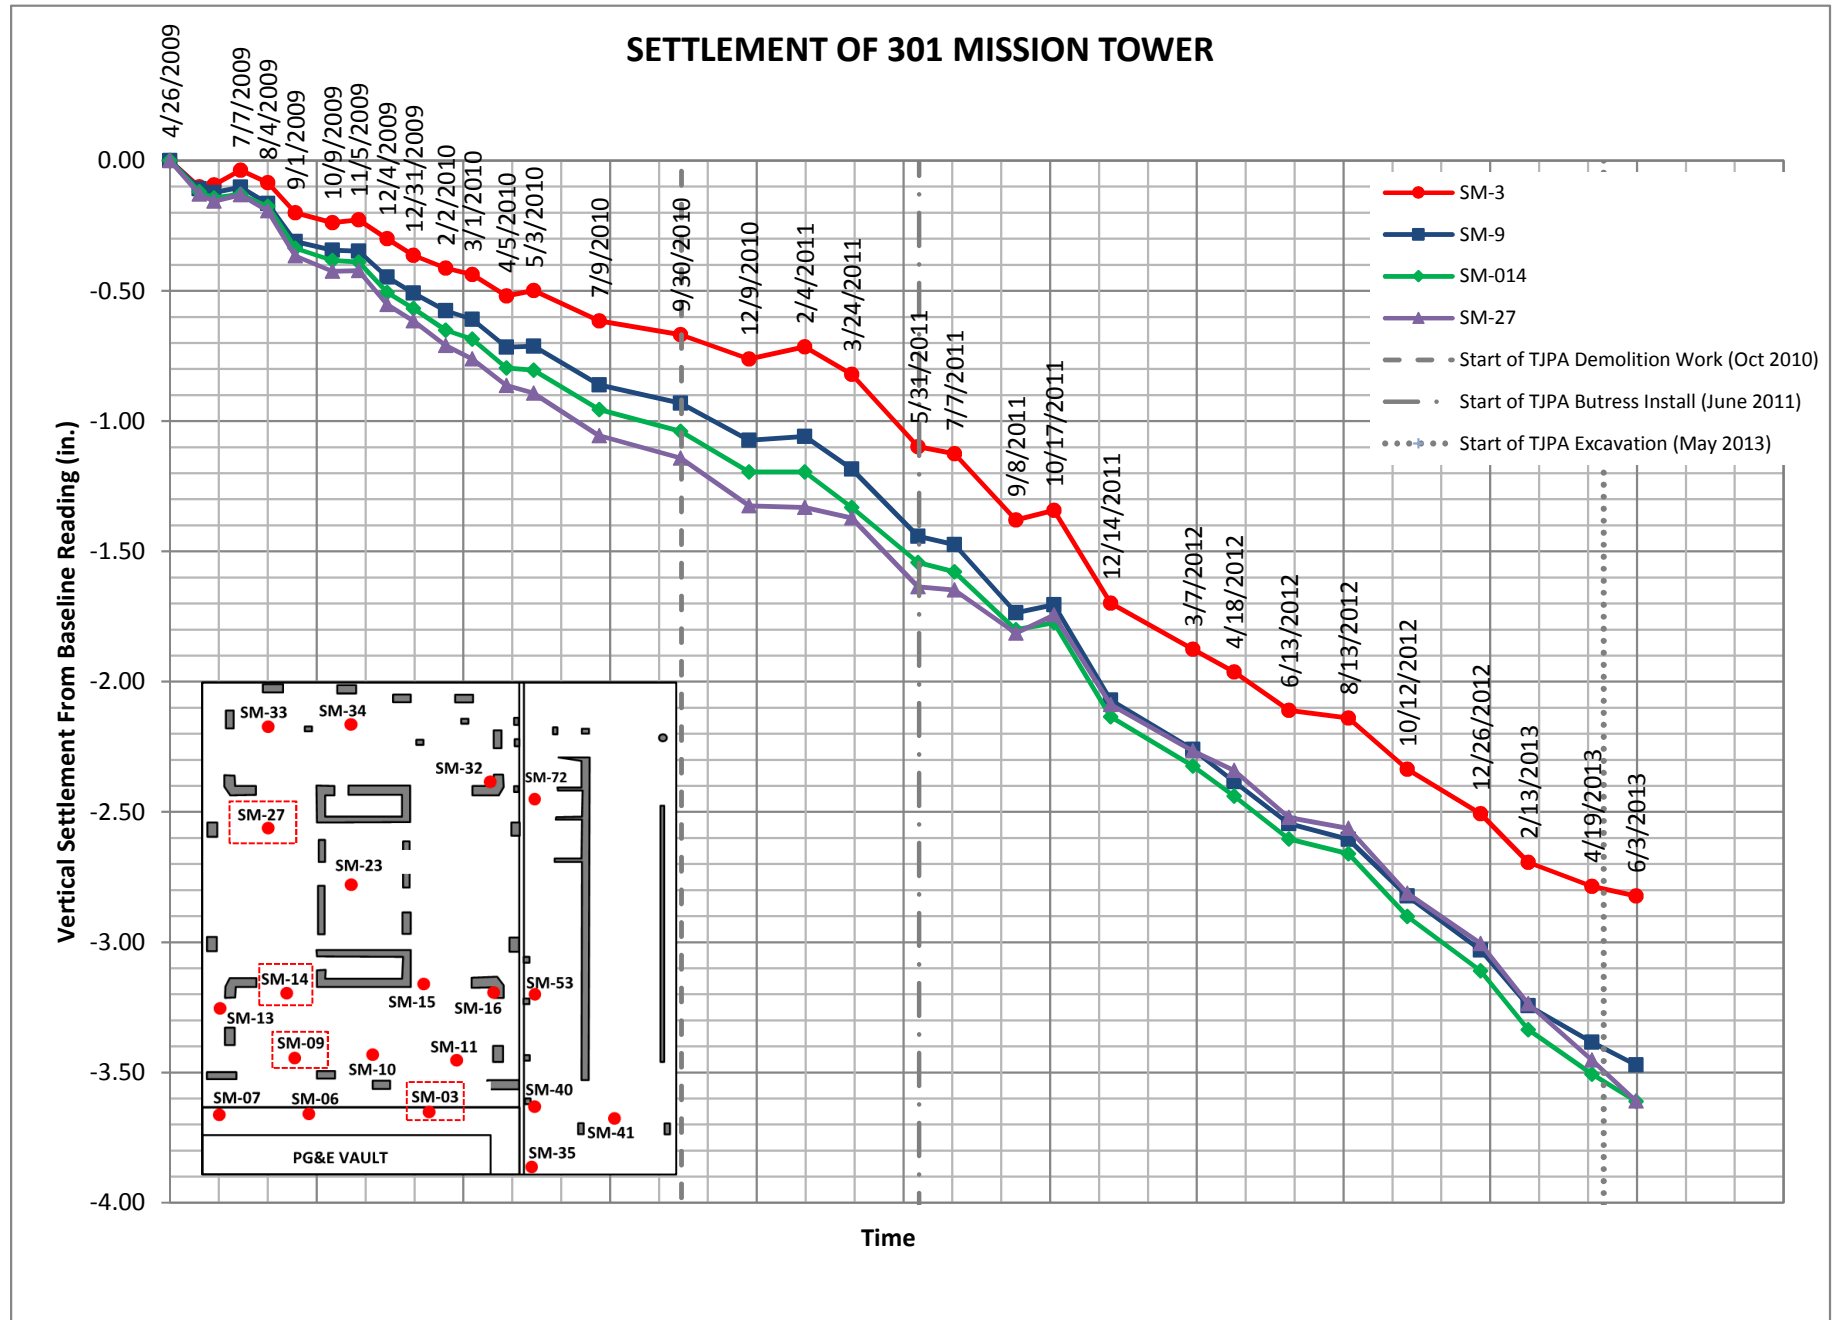
Figure 4

Settlement of the North vs. South Side of the Foundation (Figure 4)

Before construction at Transbay began, the North Side was settling more, and now, after construction has been going for some time, the south side is settling more. This seems to clearly show that the construction has caused a change. It is recommended that Millennium seek an explanation for this from Transbay.

It should also be noted that this figure shows differential movement across the foundation causing a tilt to the building. This kind of movement can cause damage to the structure which reduces the buildings reserve strength for earthquakes.

The last two readings show an overall slowing of settlement on the South side of the site while the North side of the site has had a steady increase in settlement. This change is coincidental with the finishing of the Transbay buttress installation and the lack of deep foundation work on site.

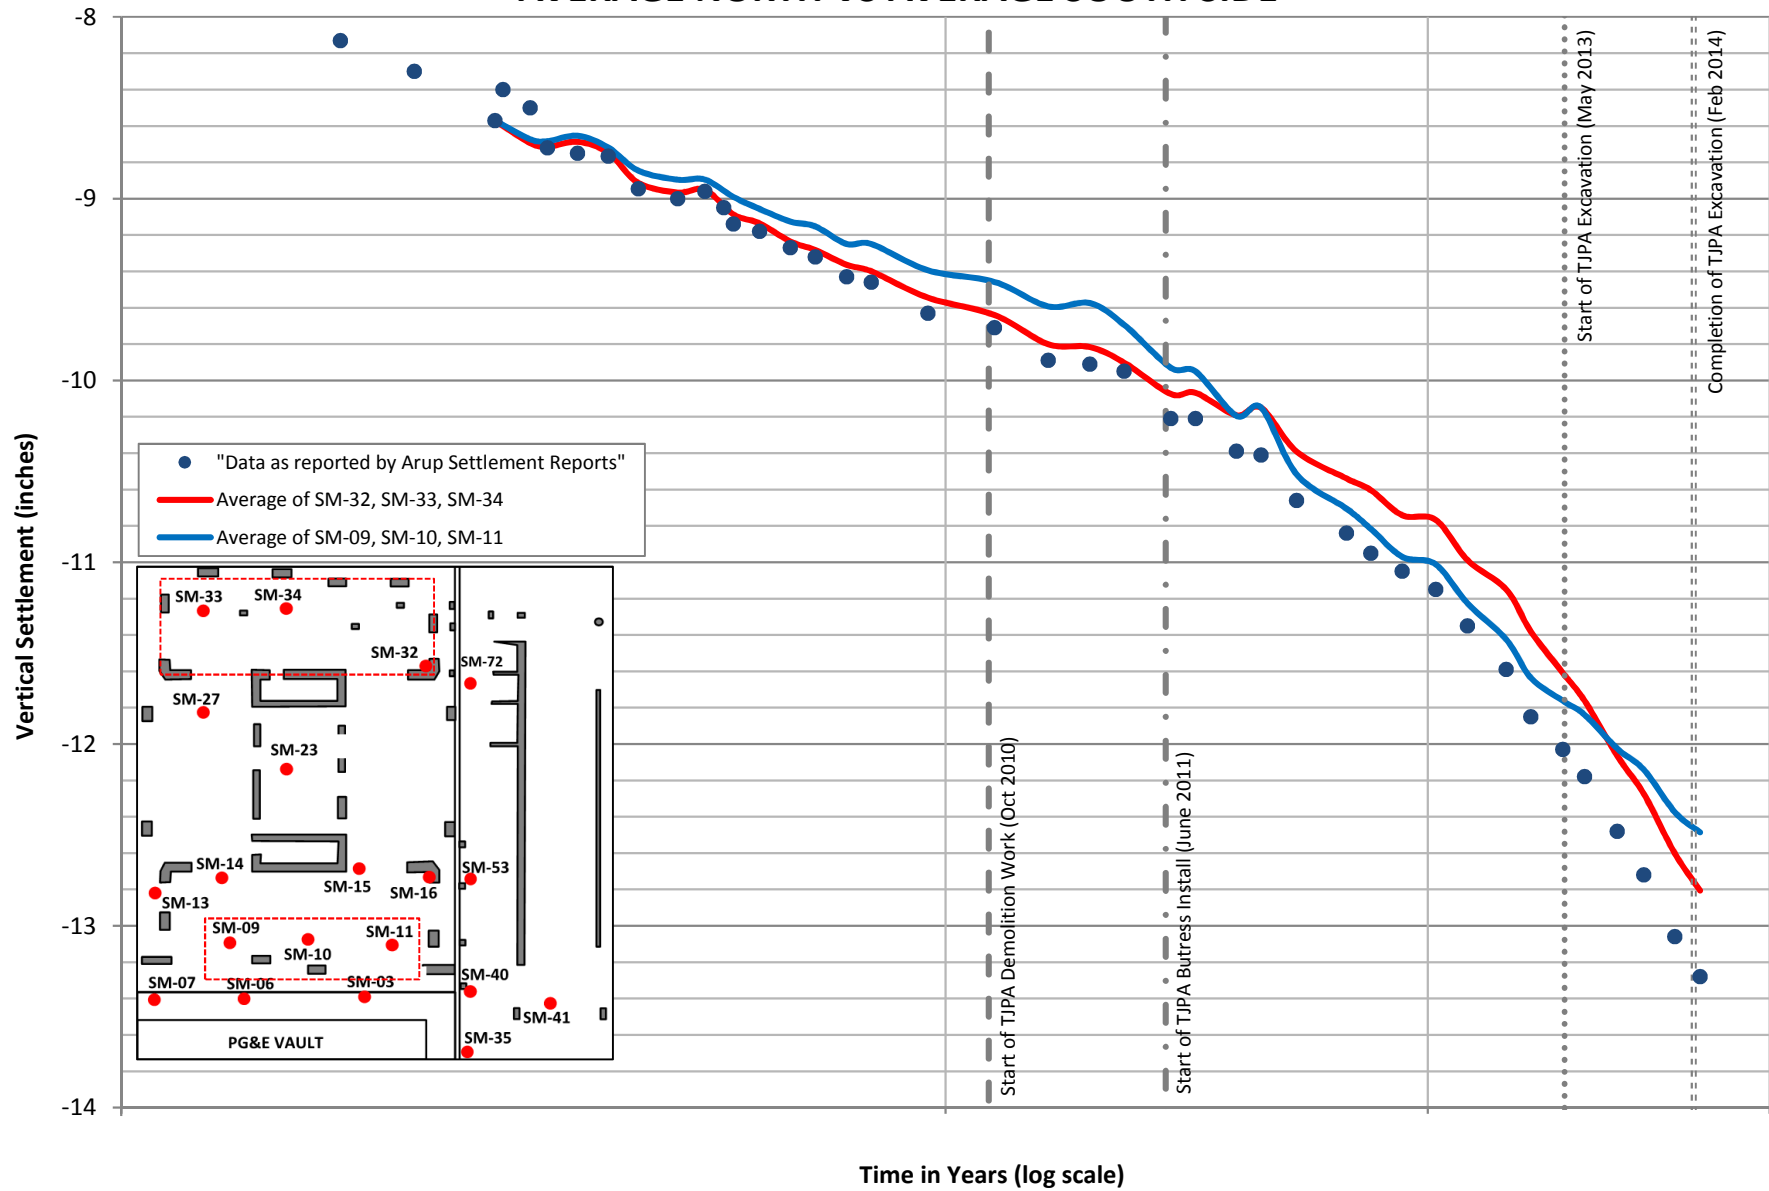
Figure 2 presents an average of settlement on the north side of the tower versus the south end of the tower, as measured in logarithmic scale. Before construction activities began at Transbay we observed that the north side had settled at a greater rate than the south. After buttress installation activities started, we observed a greater rate of settlement on the south side. After June 2013, the north side again shows a higher rate of settlement than the south side. The foundation has rotated slightly away from the south side.

Figure 2 also shows that the overall settlement reported by ARUP (duplicated in Figure 1) is the worst case settlement anywhere across the foundation (13.1 inches) and does not accurately represent the average. The average overall settlement for the north side currently shows about 12.8 inches. The average overall settlement for the south side currently shows about 12.5 inches.

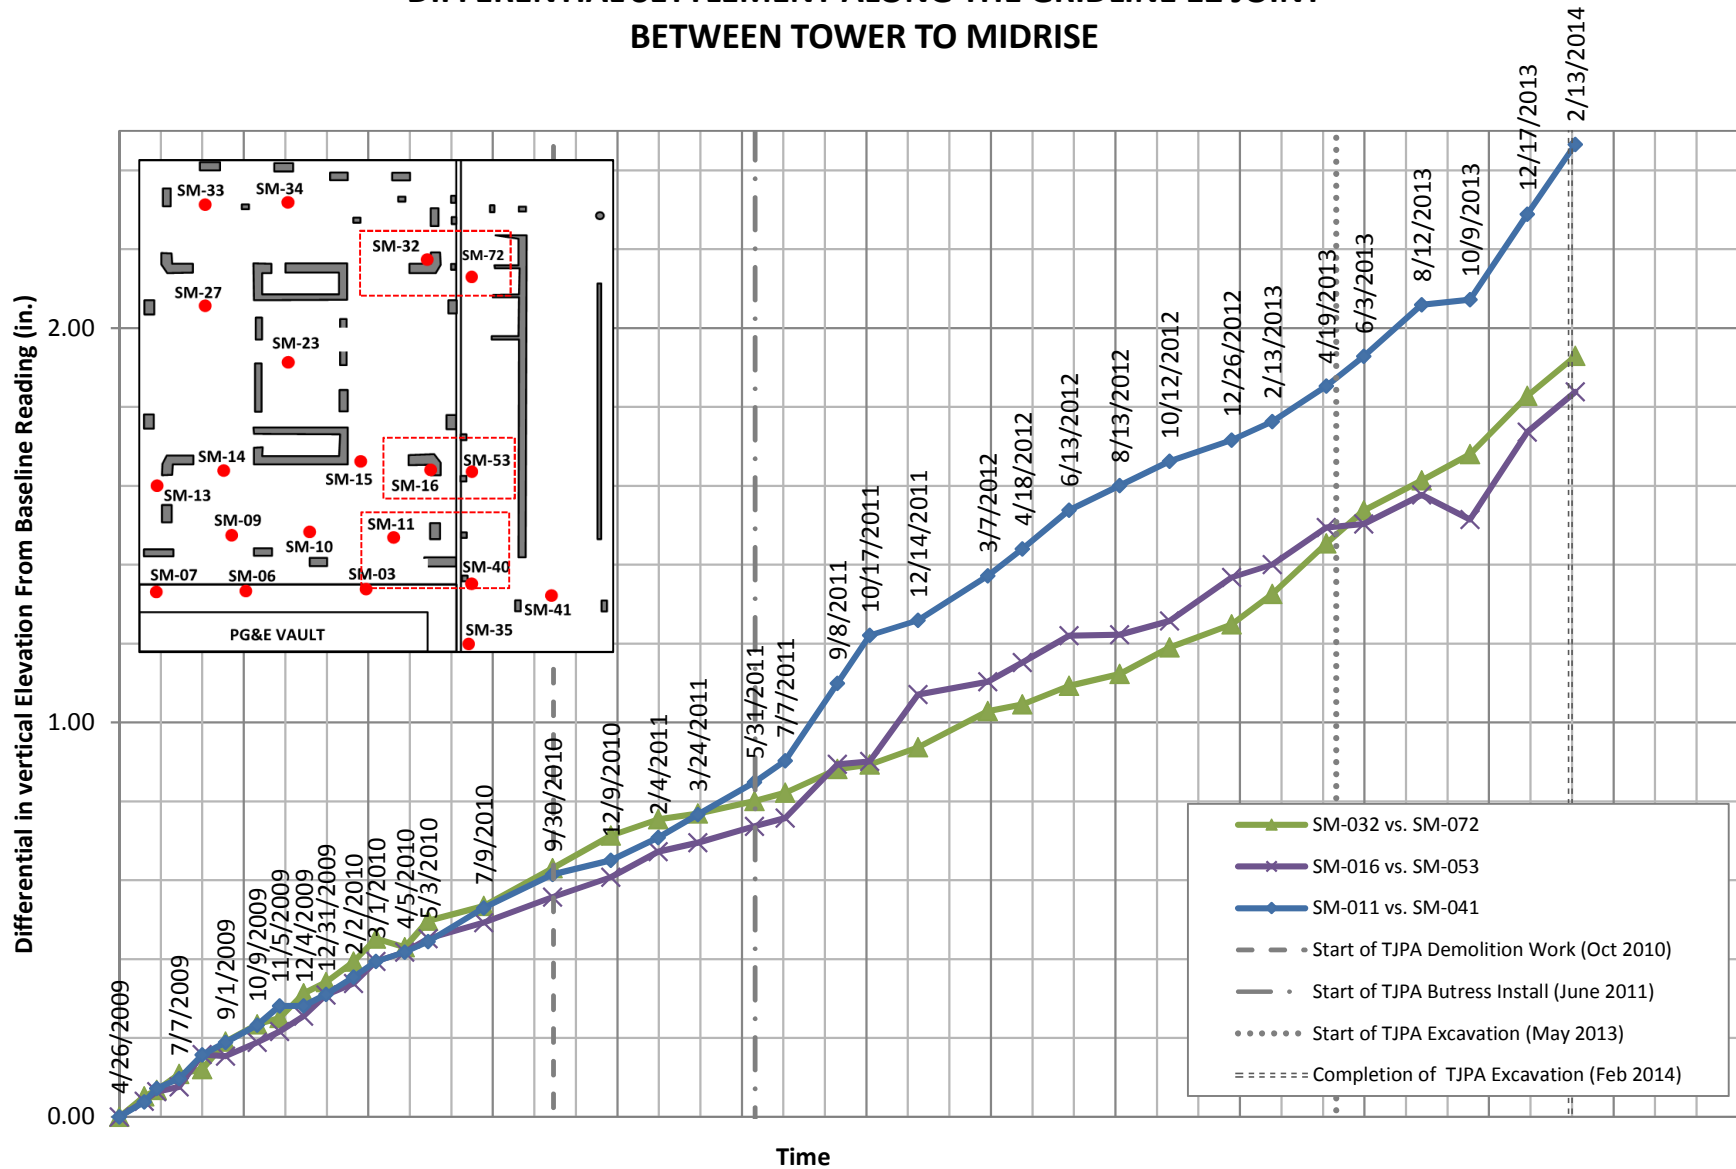
Several settlement markers were reviewed at the building separation joint between the Tower and Mid-Rise along gridline 12. It can be clearly observed in Figure 7 that since Transbay buttress installation activities have begun, that there is increasing differential settlement (increase in rate of settlement) across the joint. This settlement is more than what was naturally occurring prior to the beginning of Transbay construction.

The largest observed differential settlement across the joint is near the south side of the building, and less differential settlement on the north side. It does appear that the joint is performing as expected and allowing free movements between both structures. Continued on-site observation of the joint should be made to ensure its intended performance is being met.

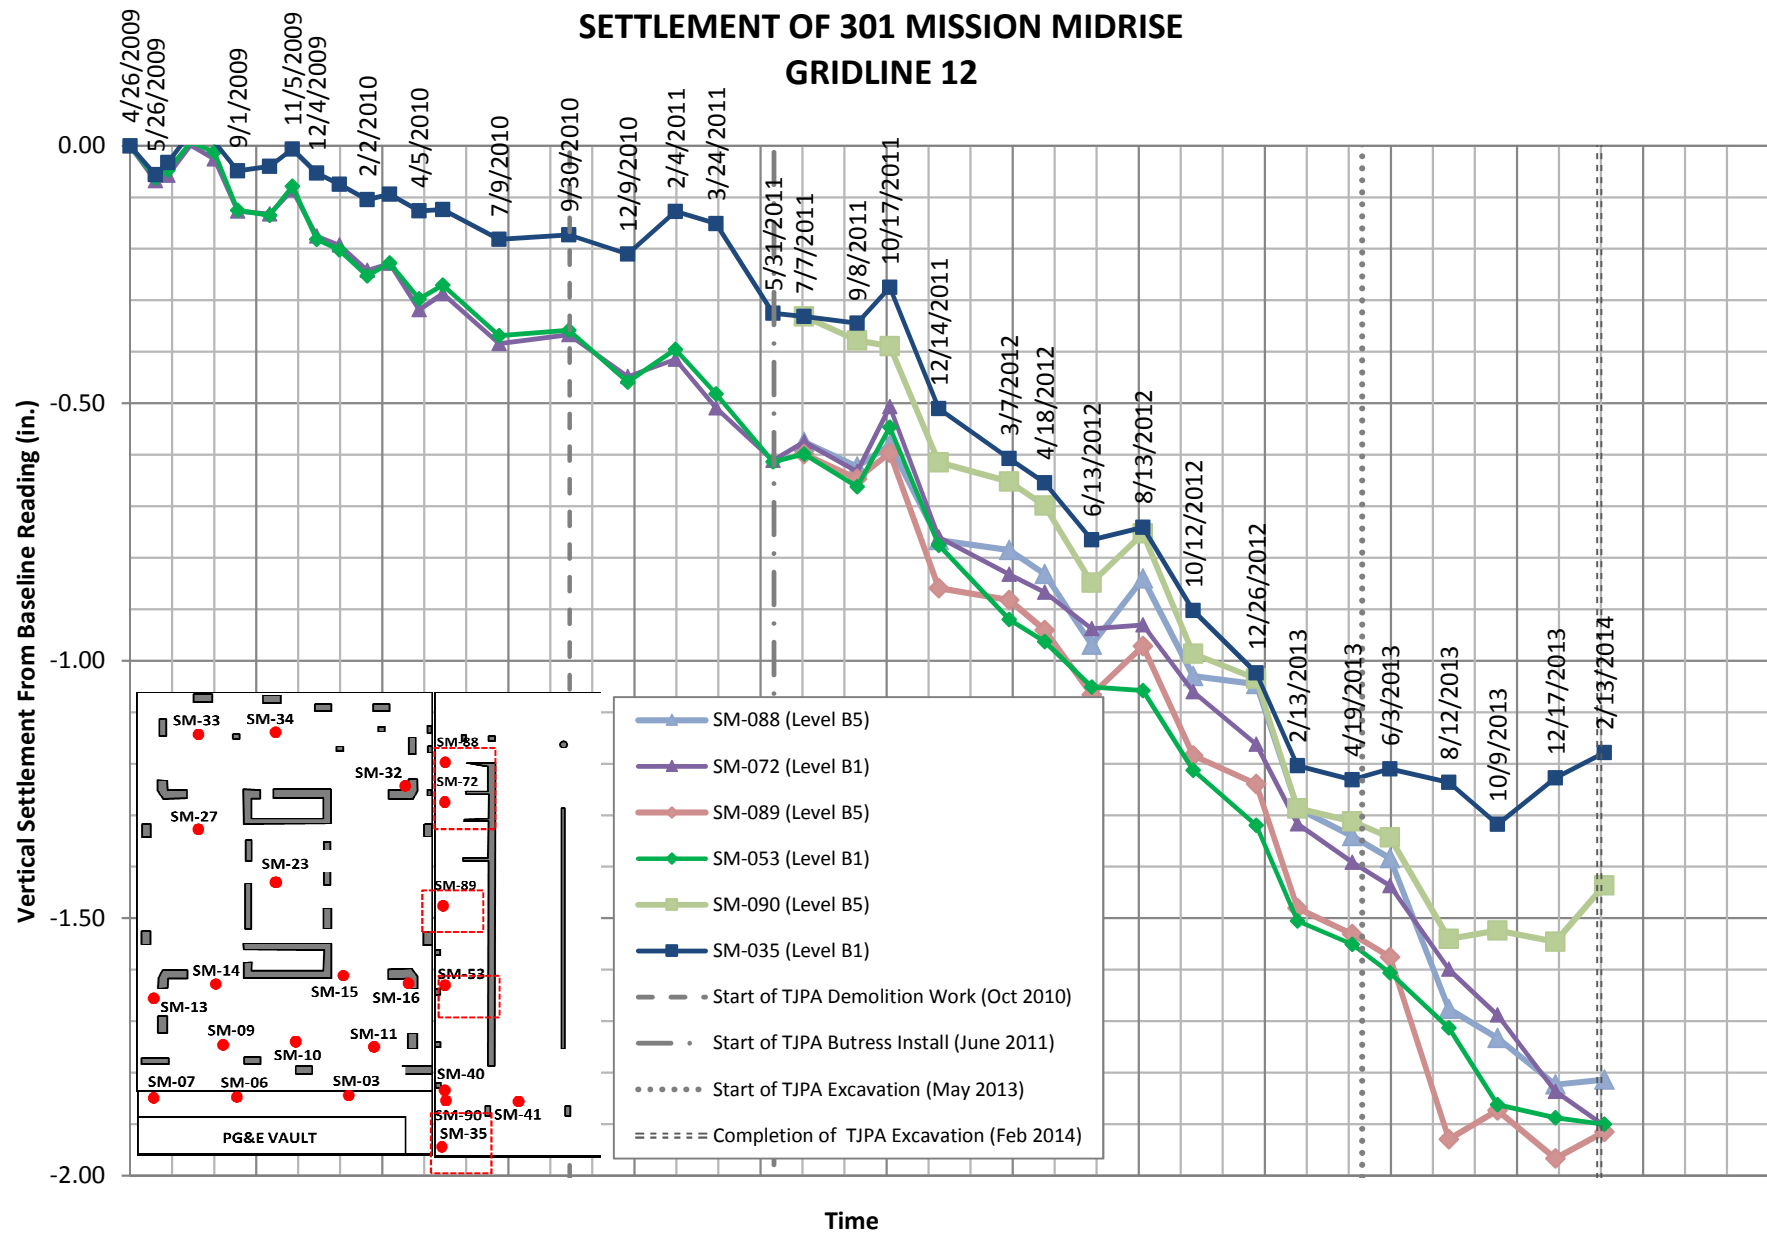
Figure 10

As can be seen in Figure 10, the foundation has settled along gridline 12 of the Mid-Rise since 2009. The highest level of settlement occurs near the middle of the site, with slightly less at the north and south edges. The settlement is of such a magnitude that the tie-downs may no longer be functioning as intended. DeSimone recommends that Langan Treadwell Rollo address this issue.
