*Board of Supervisors
City and County of San Francisco*

Government Audit and Oversight Committee

Supplemental Report for Foundation Settlement Investigation

**SUPPLEMENTAL REPORT
FOUNDATION SETTLEMENT INVESTIGATION
301 MISSION STREET
SAN FRANCISCO, CALIFORNIA**

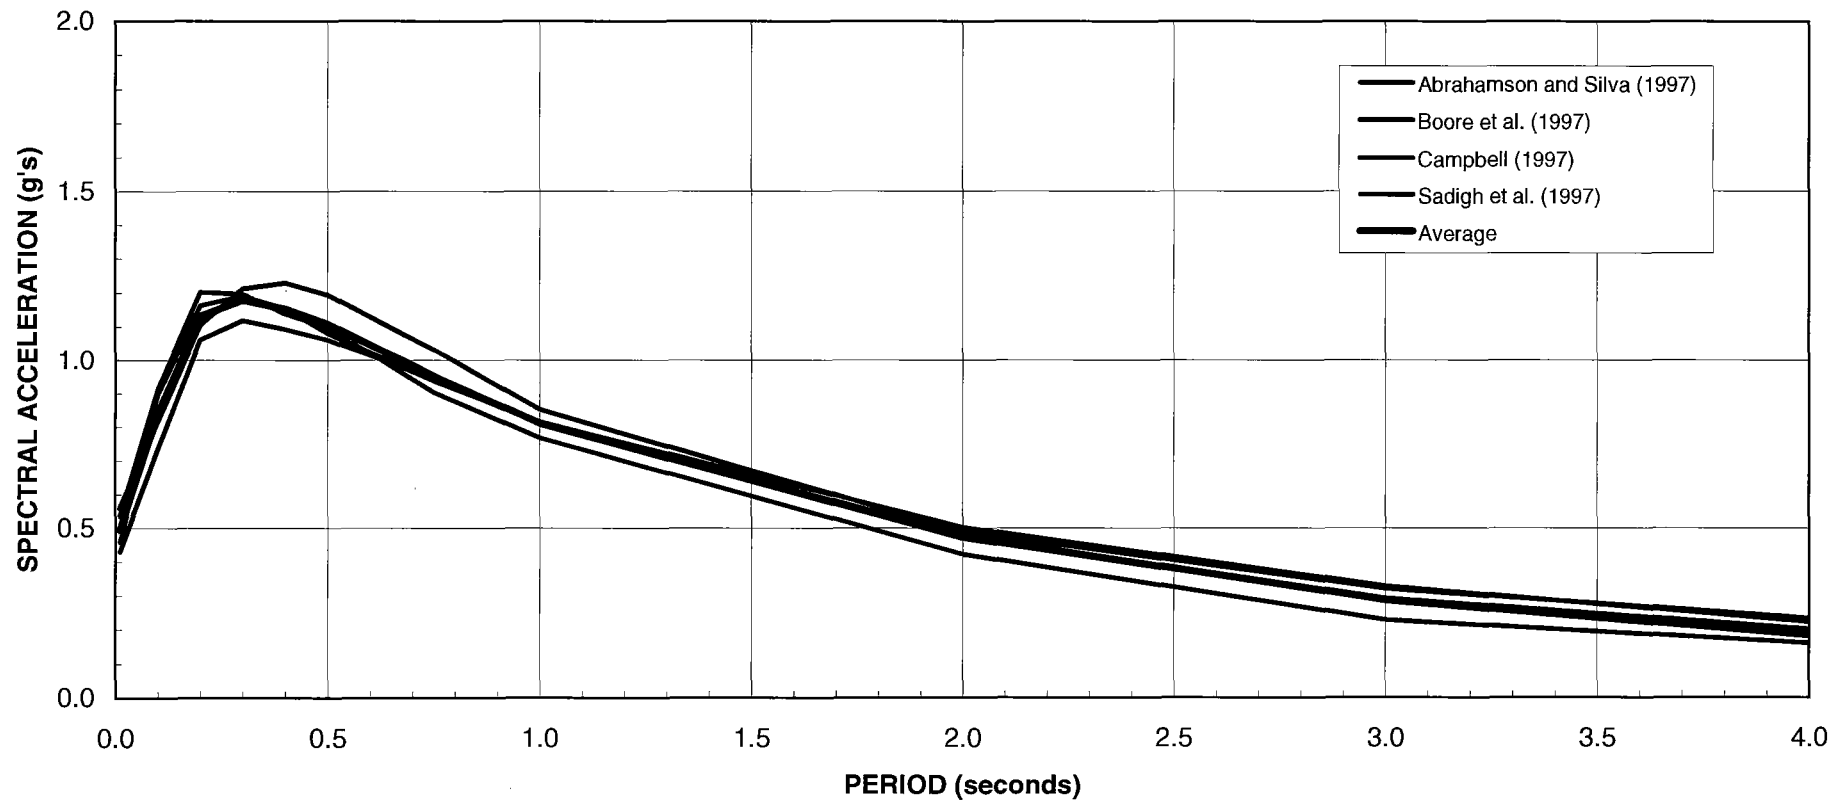
Figure D-1

The results of the PSHA for the DBE hazard level is shown on Figure D-1. The average of the attenuation relationships is also shown on the figure. Figure D-2 presents a comparison of the recommended surface spectra (DBE) with the corresponding 2001 SFBC soil profile type S_D spectra.

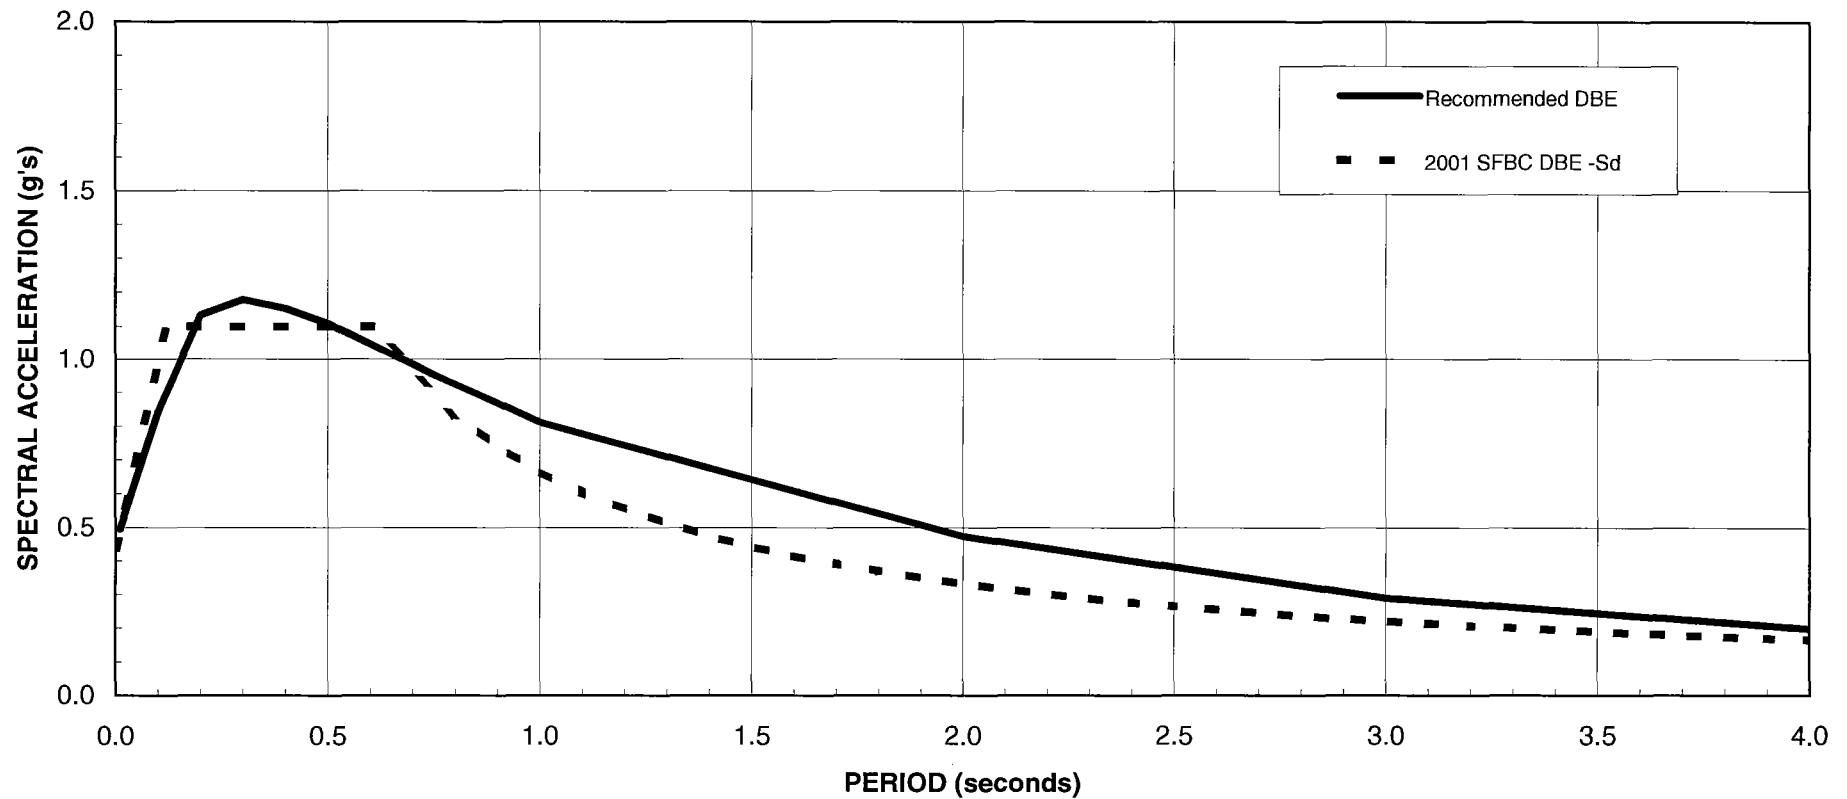
Figure D-2

**COMPARISON OF RECOMMENDED DBE SURFACE
AND 2001 SFBC SPECTRA**

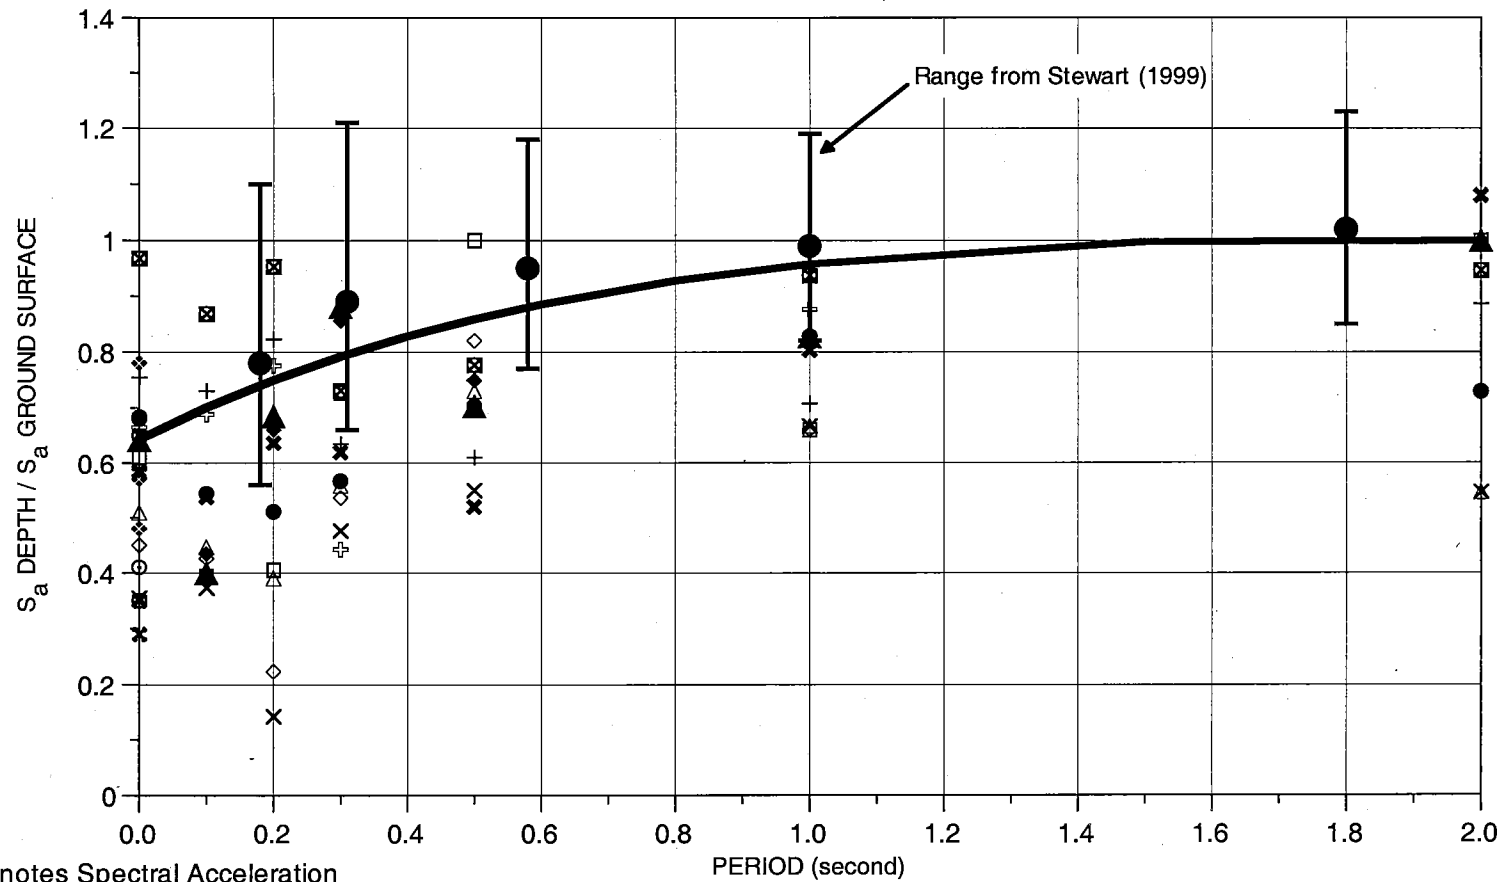
Date 01/04/05 | Project No. 3157.02 | Figure D-3

Golesorkhi and Gouchon (2000) developed recommended ratios between spectra at depth to surface spectra that can be used to modify surface spectra for basement/depth effects. Figure D-3 shows this ratio and also provides a comparison with recorded data. These ratios are based

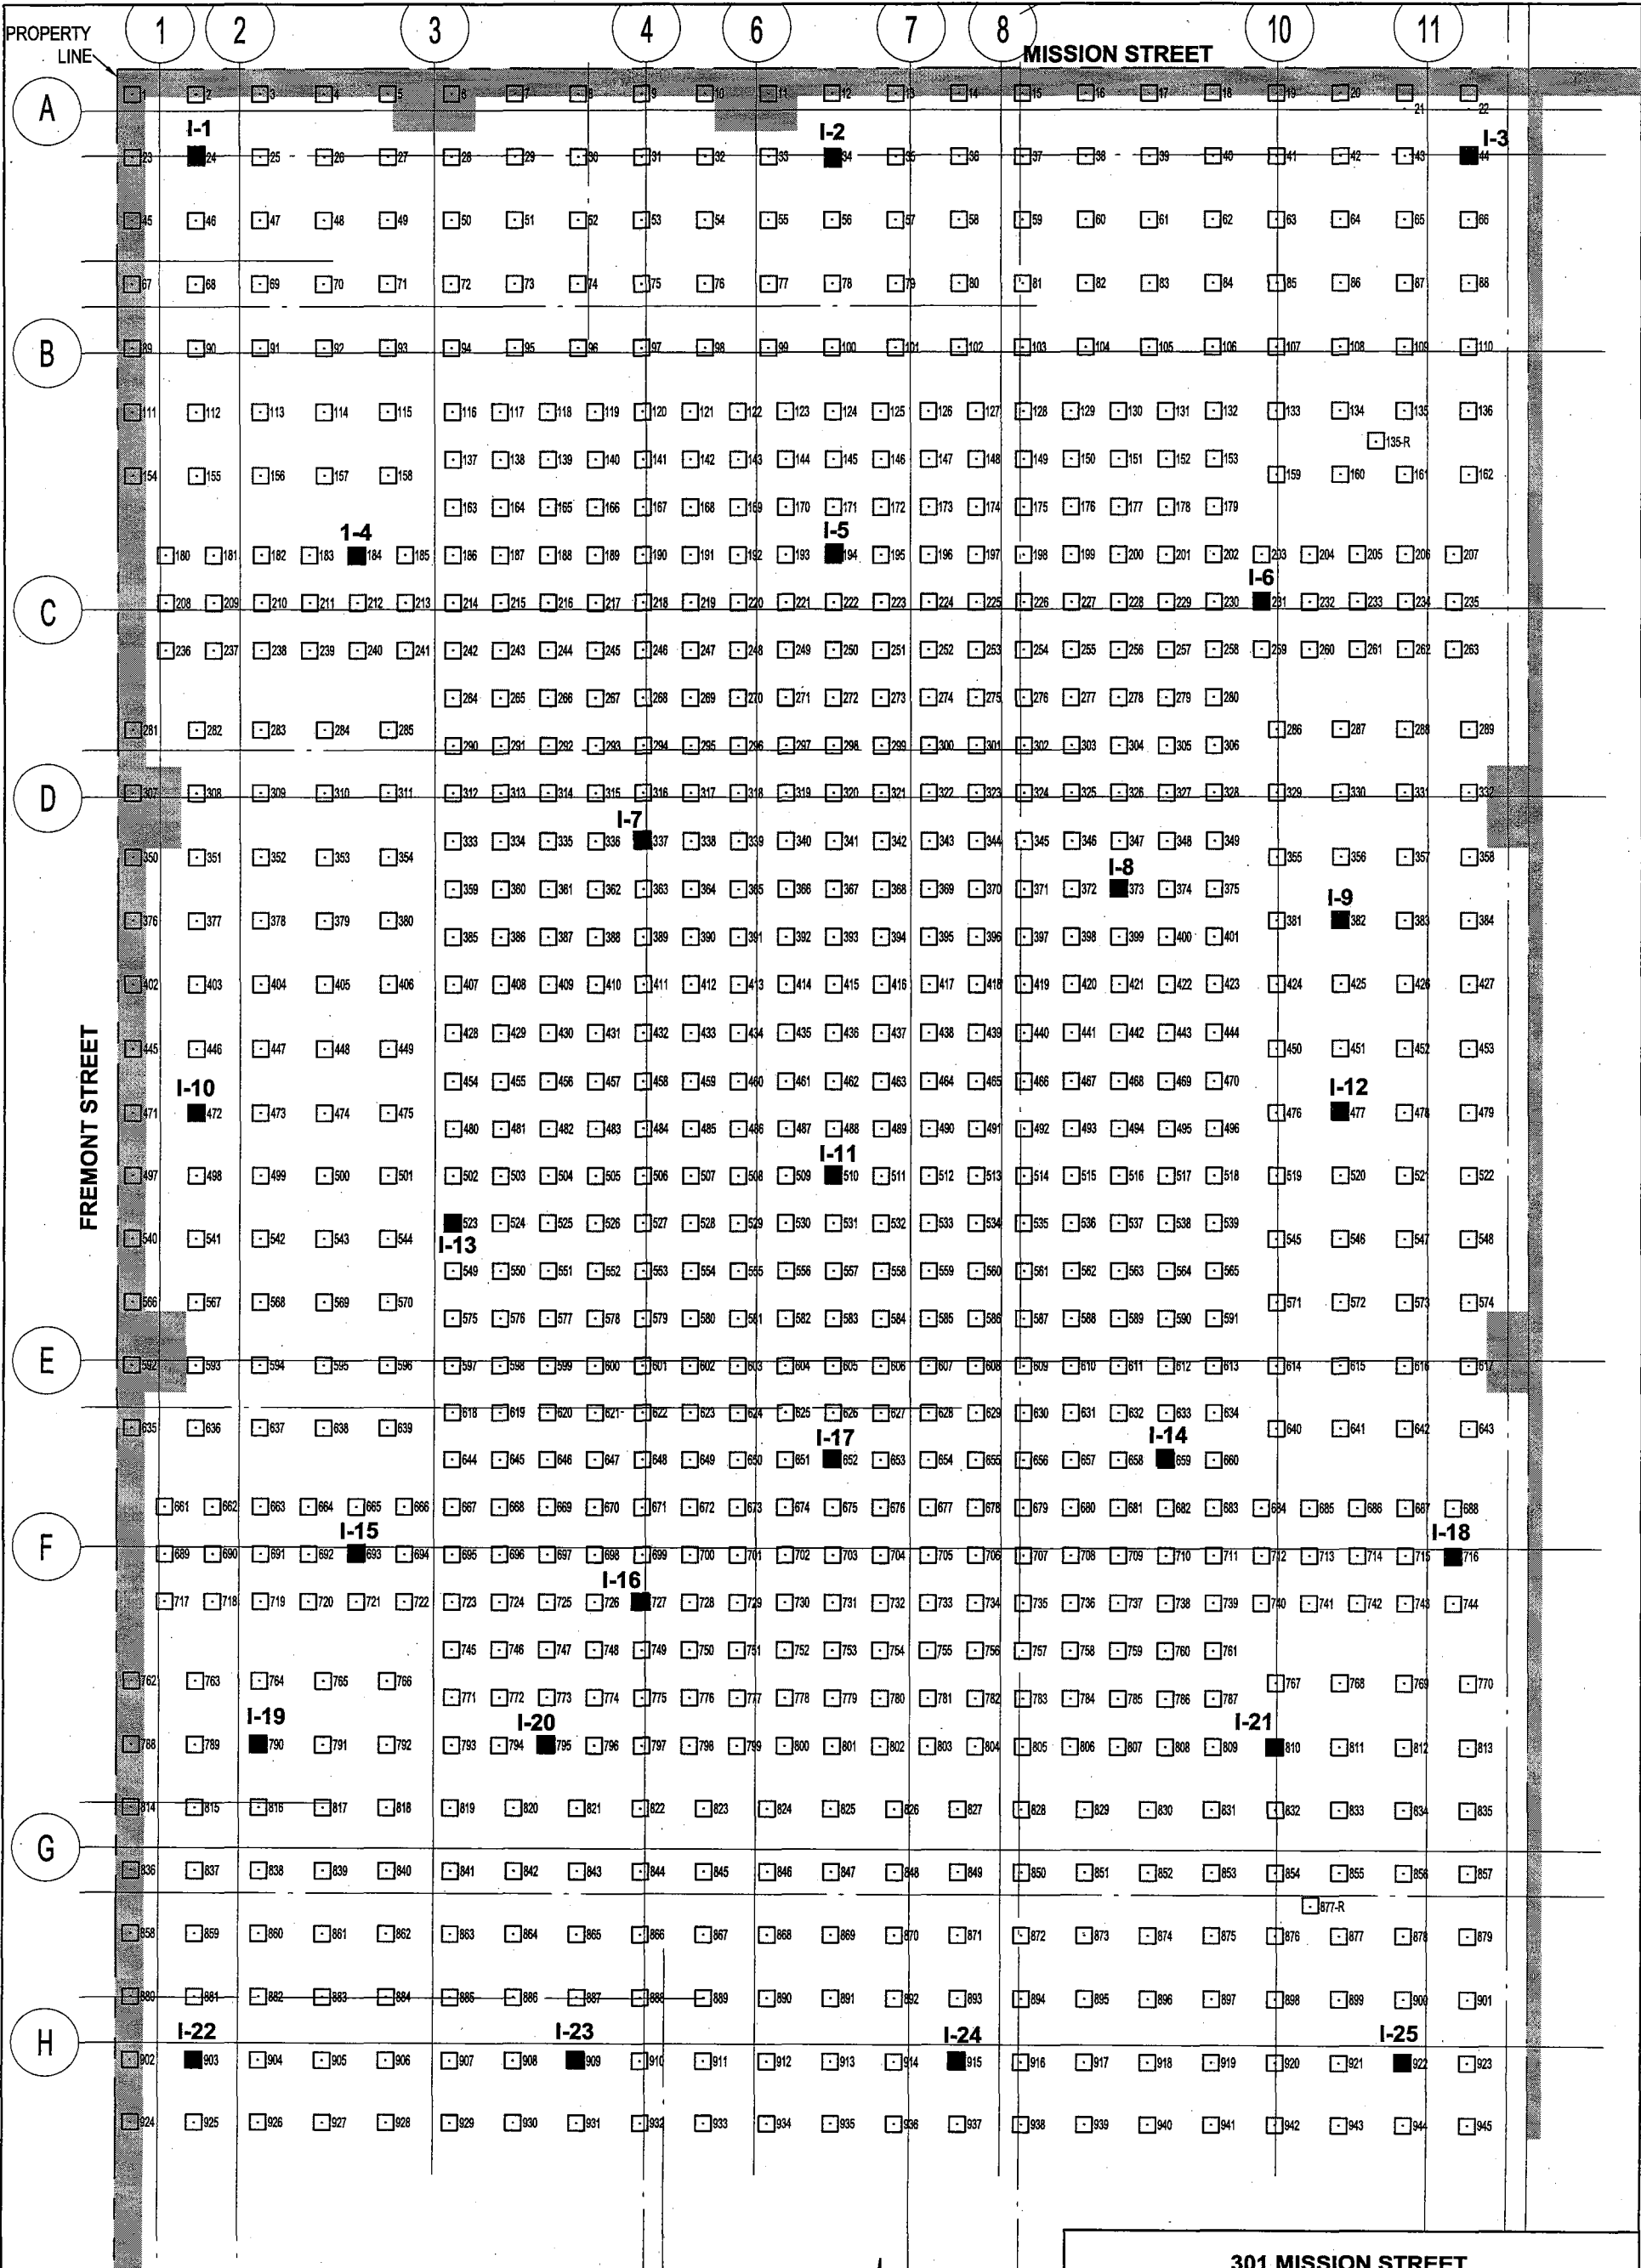
FOUNDATION PLAN
SHOWING PILE NUMBERING

The production piles were driven between 1 March and 22 April 2005. Our engineers were on site full-time to observe pile installation and record pile lengths, driving resistances, tip elevations, approximate cut-off lengths, and depth of predrilling. A total of 947 piles (25 indicator piles, 920 production piles and 2 replacement piles) were driven for the project. Driving records for each pile are retained in our files. A summary of the pile data including the blow counts for the last 5 feet of penetration is presented in Table 1, and locations of piles are shown on the accompanying foundation plan (Figure 1).

On the basis of our observations during the pile driving and our engineering analyses, we conclude the piles for the 301 Mission Street project were installed in accordance with the intent of project plans and our recommendations and are capable of carrying the design loads presented in our geotechnical report.

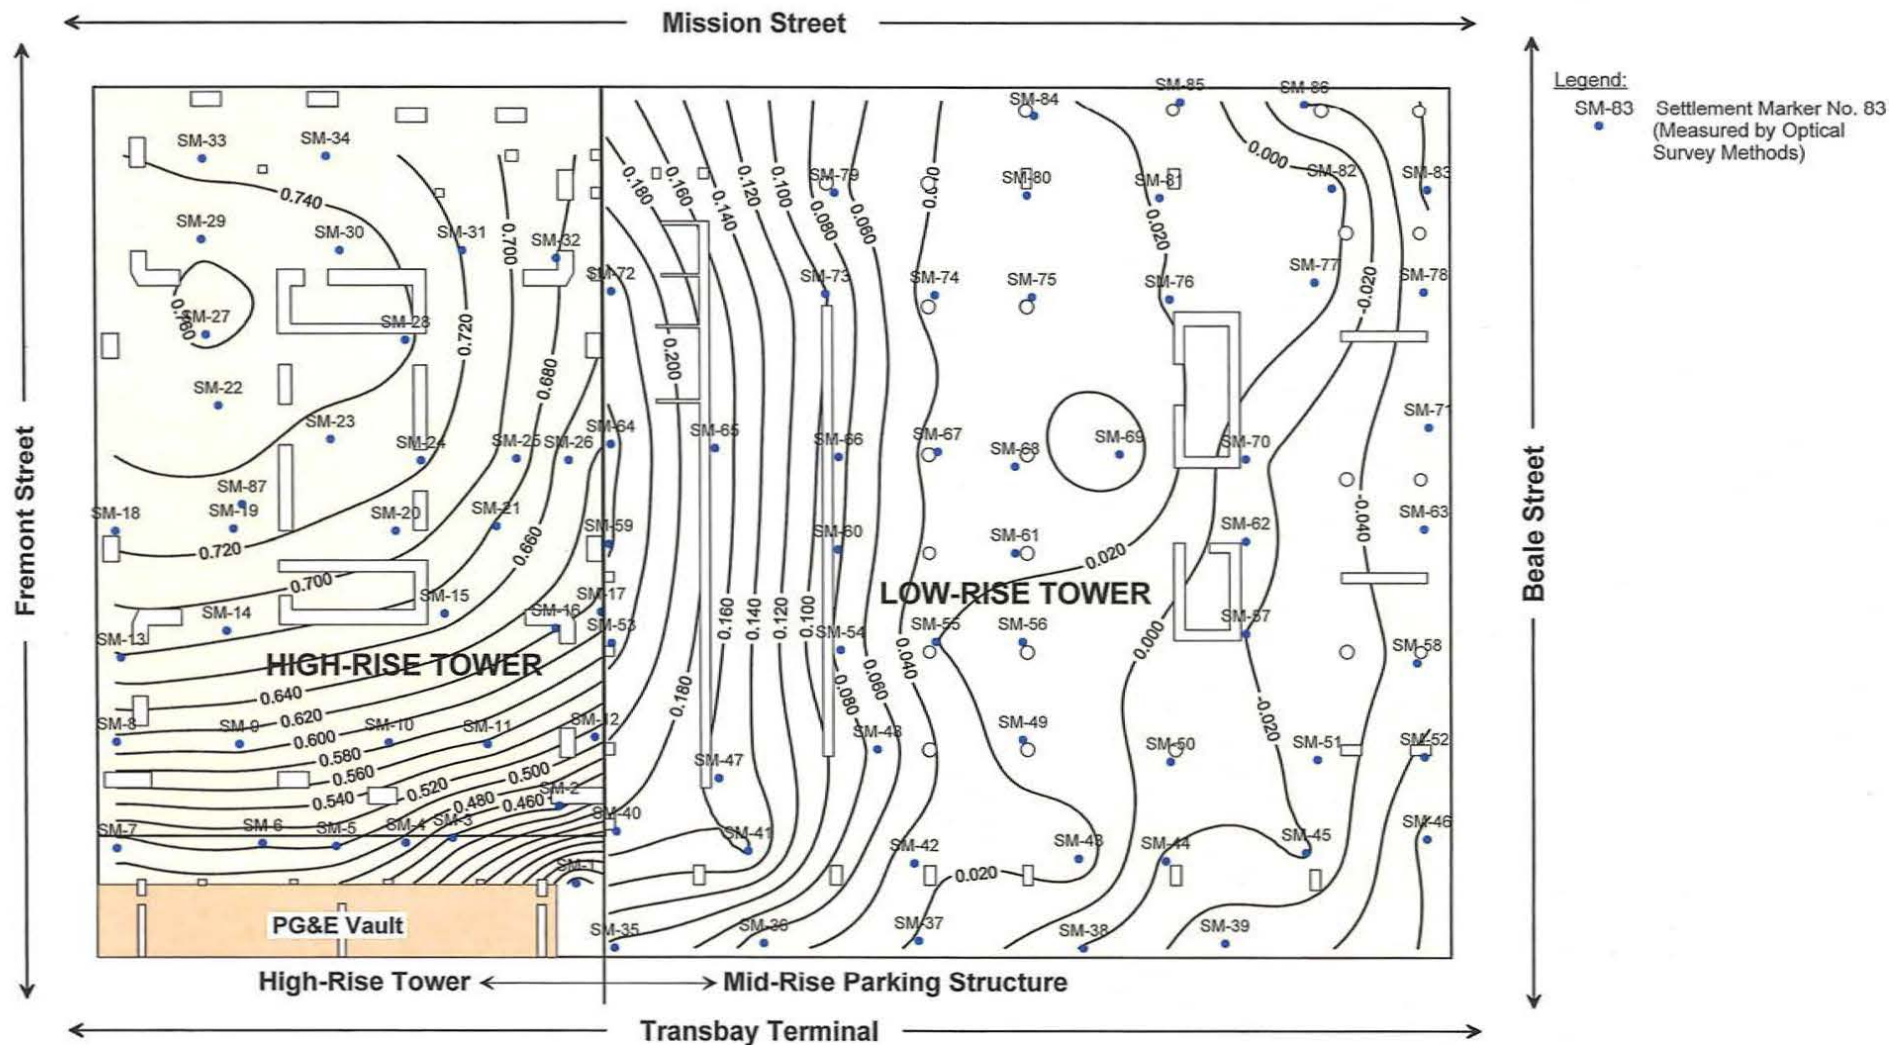
PLATE 3

Contours represent elevation change, in inches, between Baseline survey (April 30, 2009) and readings taken on March 1, 2010.

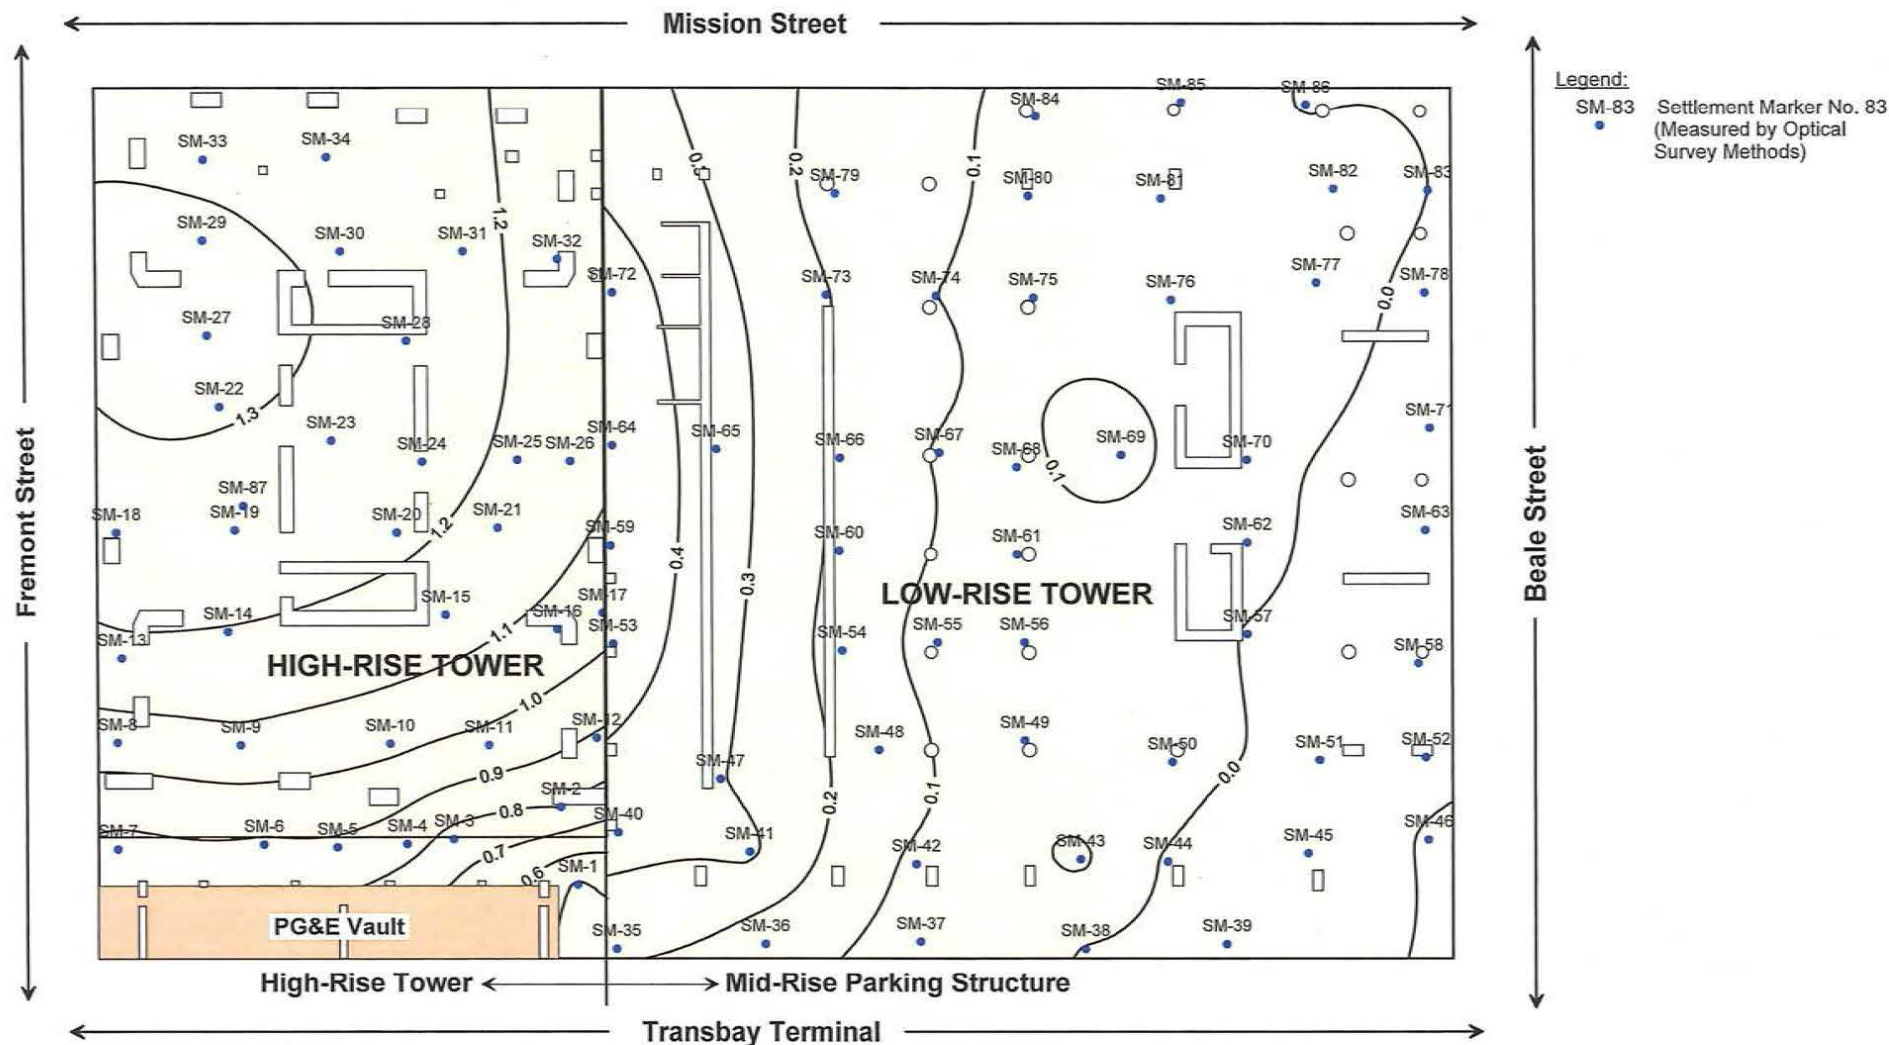
PLATE 3

Contours represent elevation change, in inches, between Baseline survey (April 30, 2009) and readings taken on December 9, 2010.

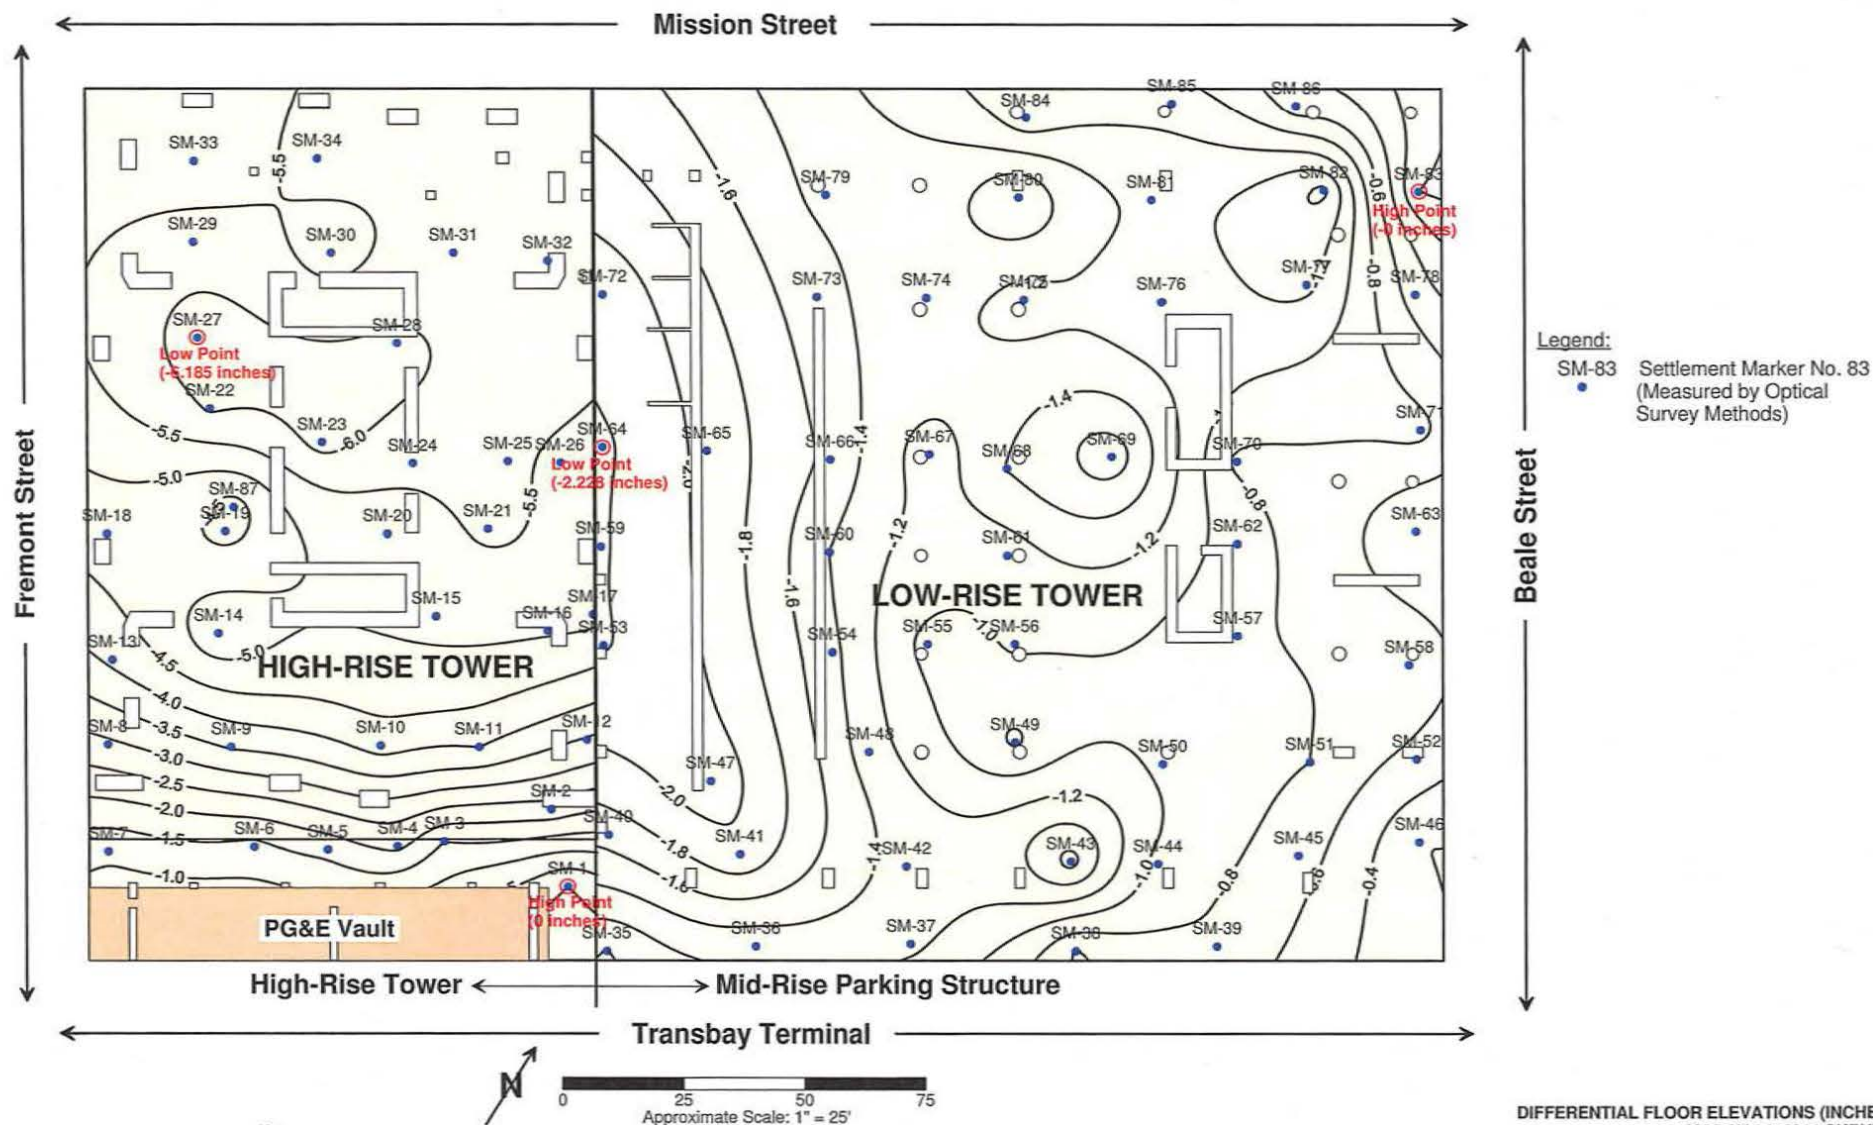
Contours represent differential elevation, in inches, between the highest point and all other points taken on March 24, 2011.
 Level B-1 at Mid-Rise Parking portion of survey site is approximately 4 inches higher than Level B-1 at High-Rise Tower portion.
 The PG&E vault is inaccessible for monitoring.
 Contour intervals are different between the High-Rise Tower and the Low-Rise Tower.

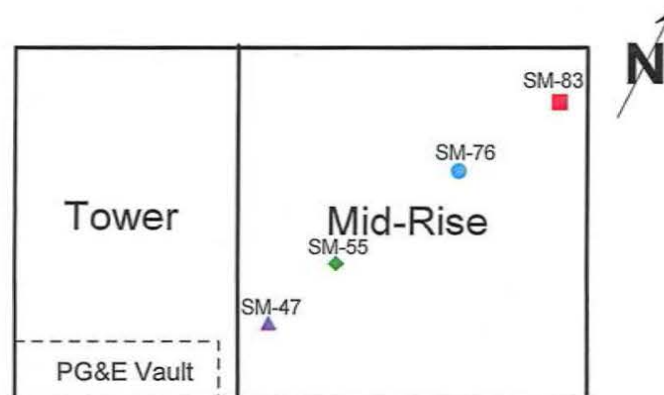
PLATE 4

**SETTLEMENT OVER TIME
FLOOR ELEVATIONS AT LEVEL B-1
OF 301 MISSION PROPERTY- MID-RISE:
APRIL 30, 2009 THROUGH JULY 7, 2011**

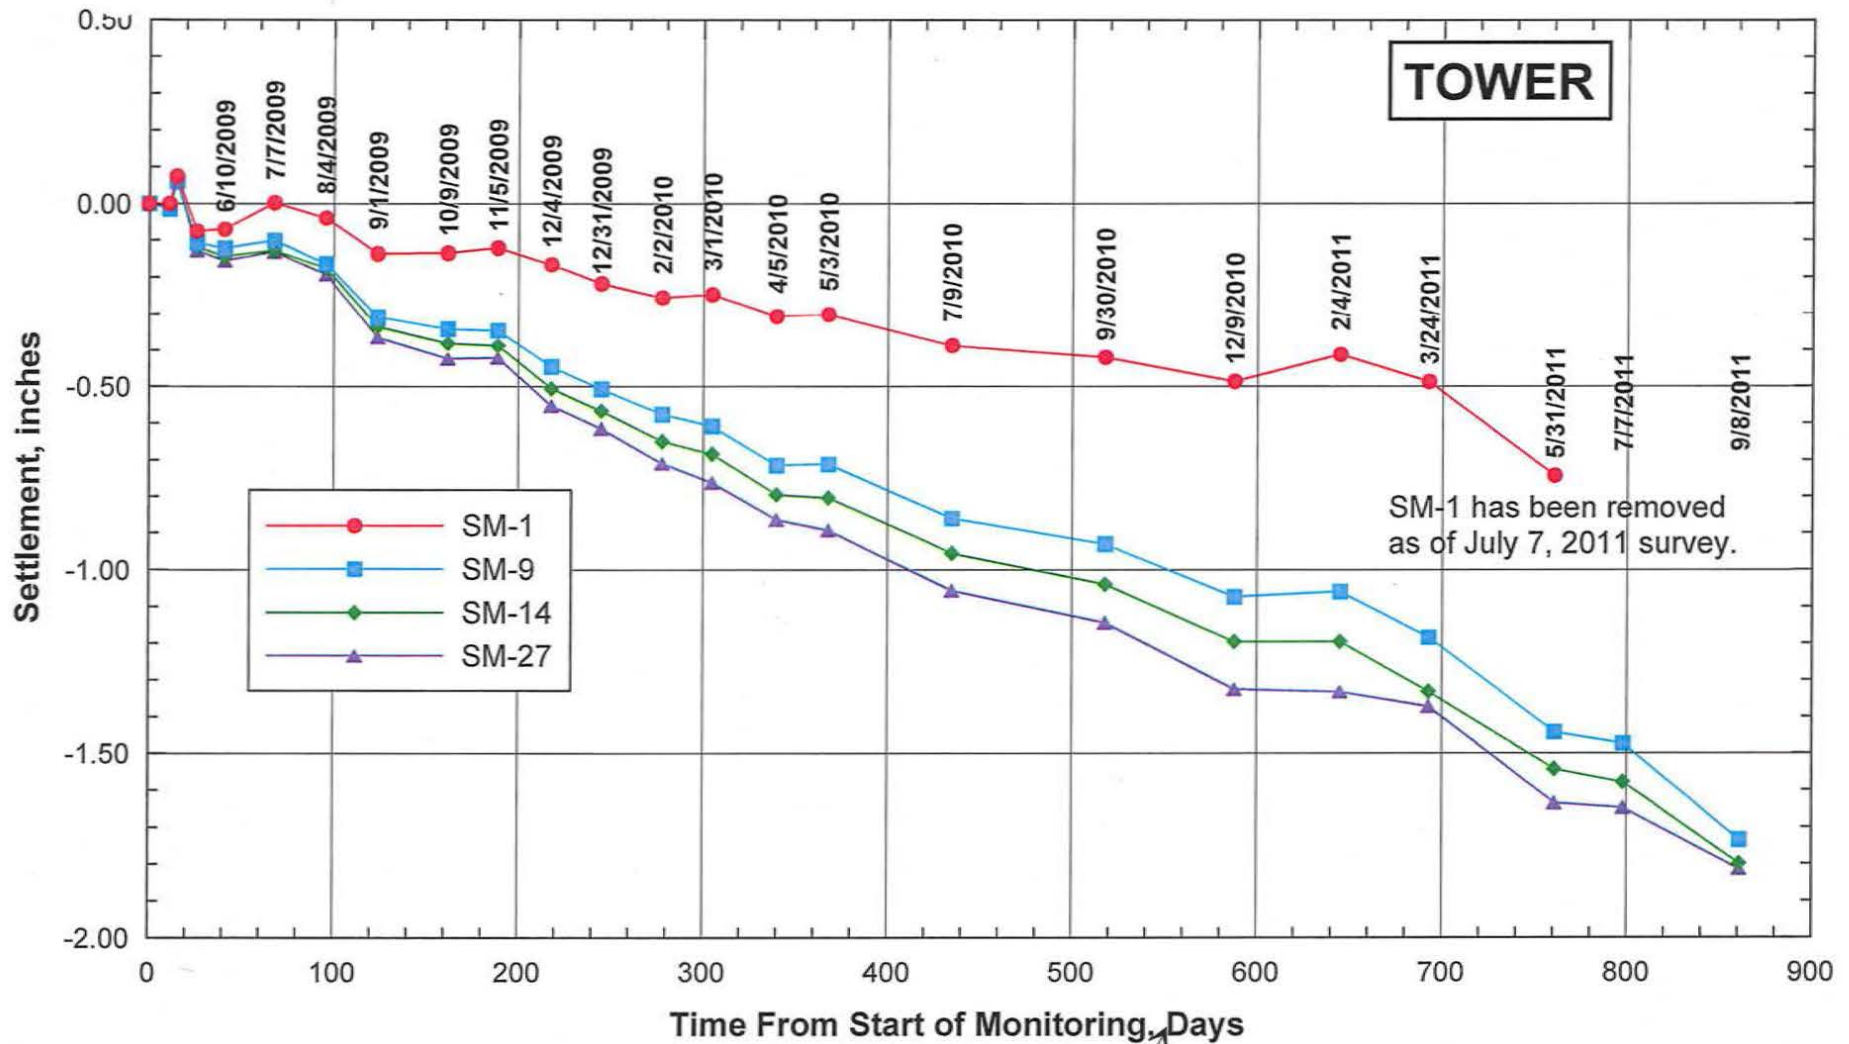
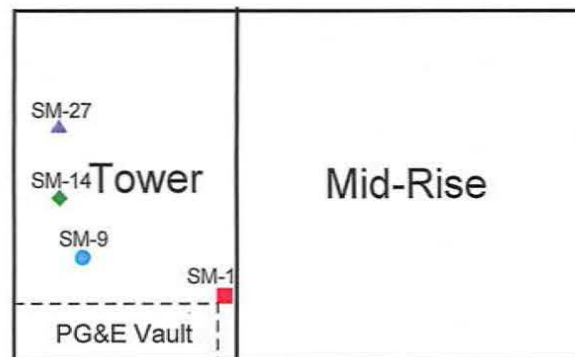
**SETTLEMENT OVER TIME
FLOOR ELEVATIONS AT LEVEL B-1
OF 301 MISSION PROPERTY- TOWER:
APRIL 30, 2009 THROUGH SEPTEMBER 8, 2011**

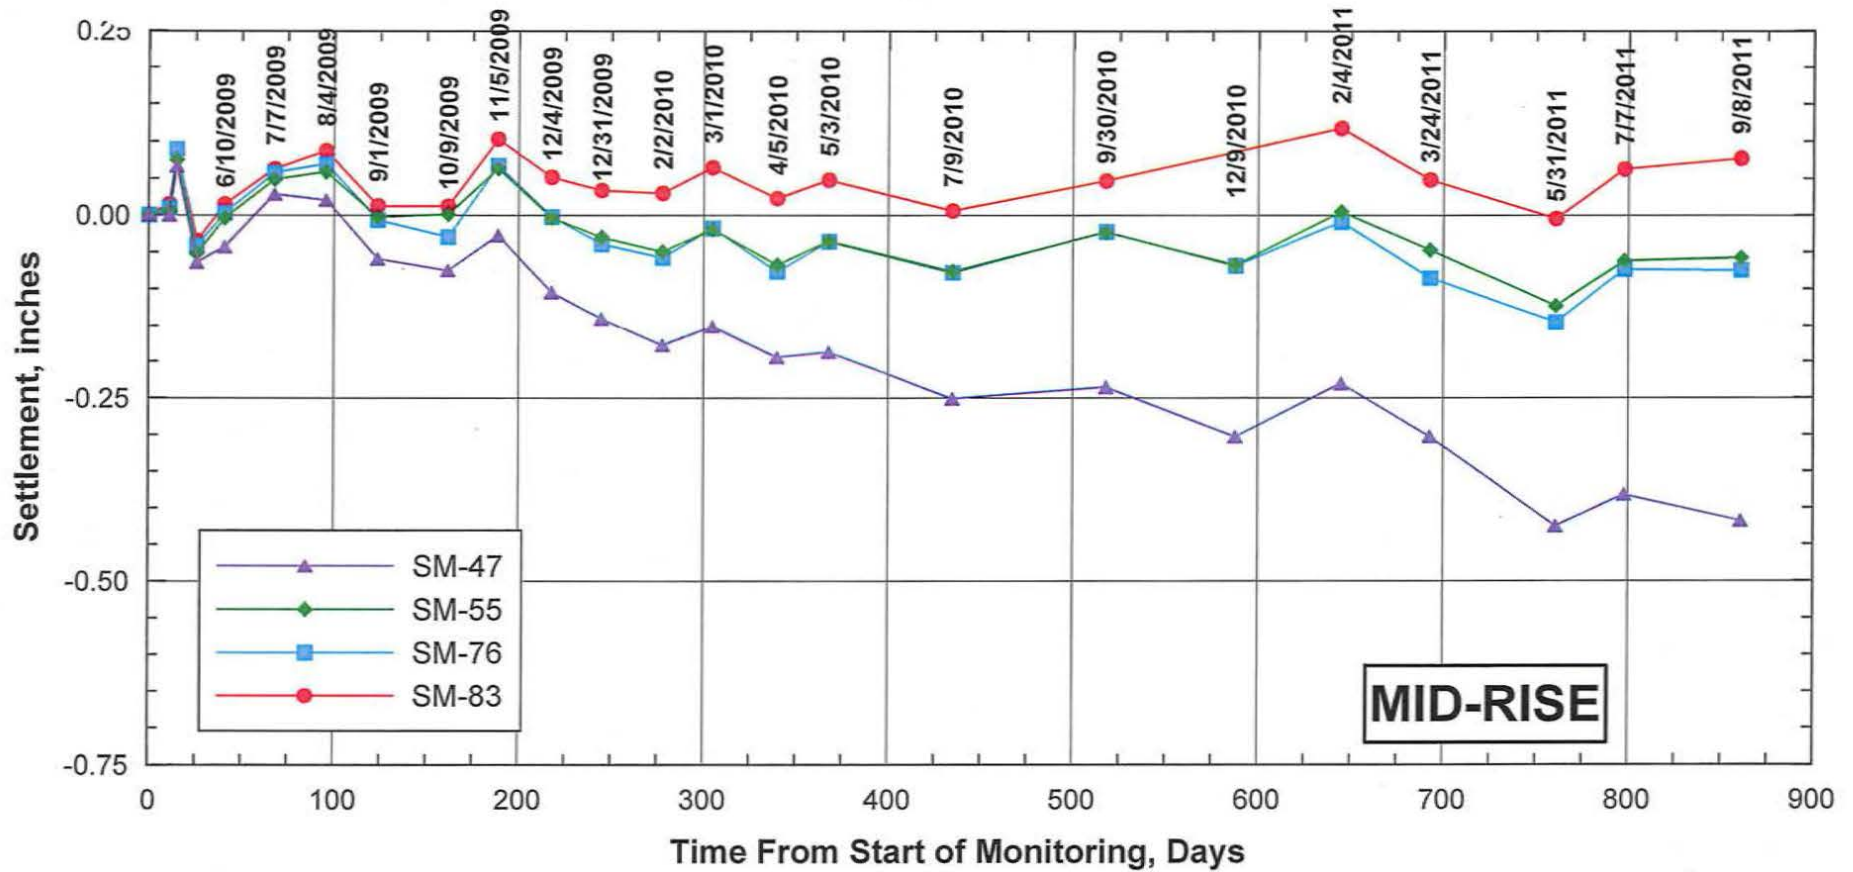
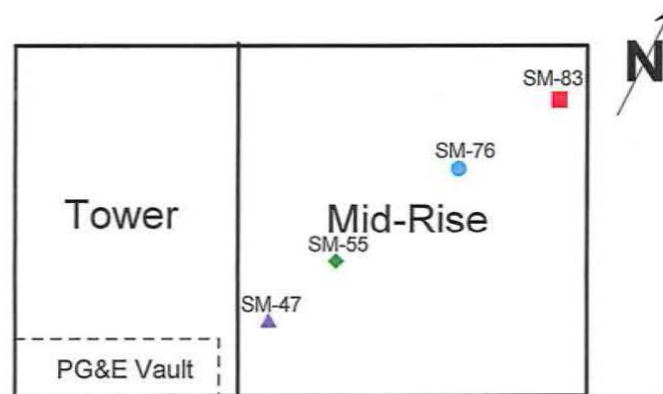
PLATE 4

SETTLEMENT OVER TIME
FLOOR ELEVATIONS AT LEVEL B-1
OF 301 MISSION PROPERTY- MID-RISE:
APRIL 30, 2009 THROUGH SEPTEMBER 8, 2011

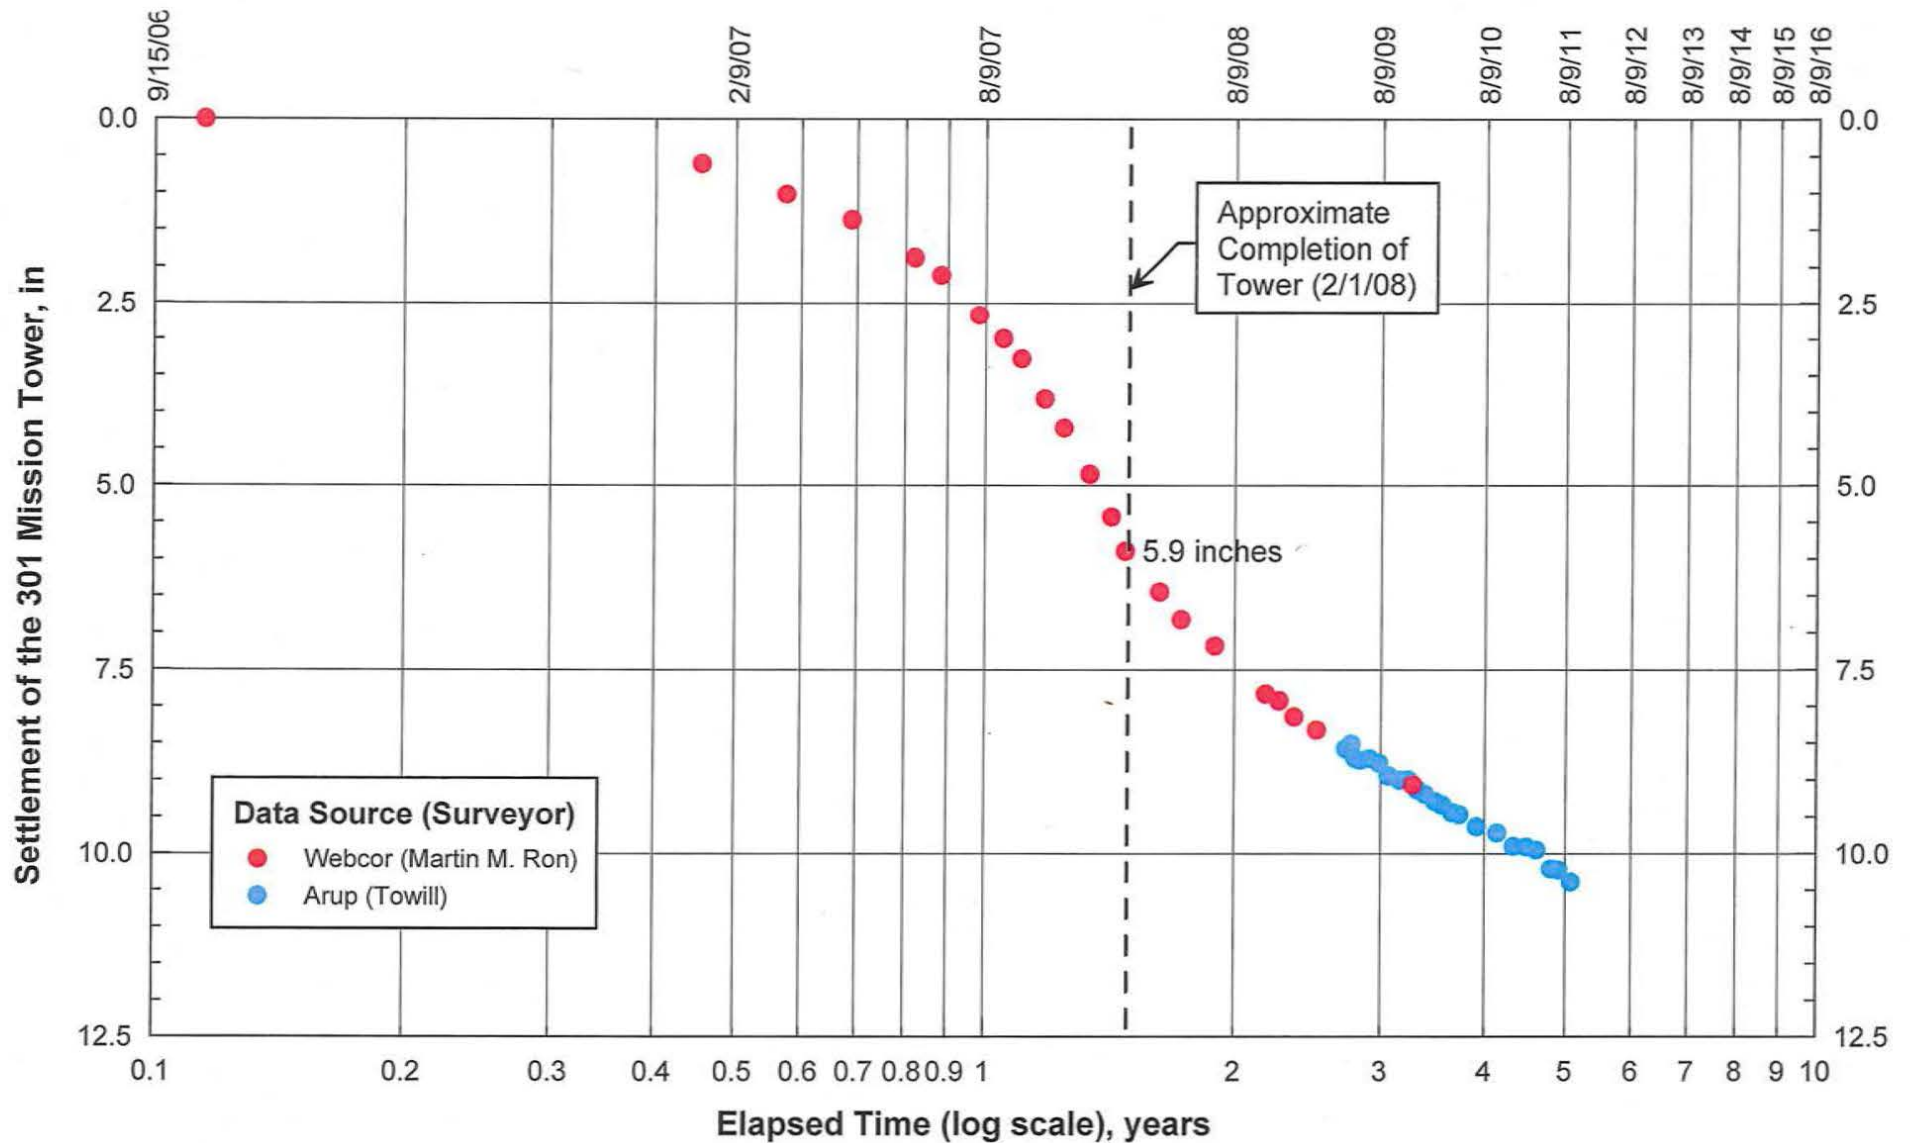
PLATE 5

**SETTLEMENTS OF THE 301 MISSION TOWER
 INCLUDING MONITORING DURING CONSTRUCTION**
