*Board of Supervisors
City and County of San Francisco*

Government Audit and Oversight Committee

Supplemental Report for Foundation Settlement Investigation

**SUPPLEMENTAL REPORT
FOUNDATION SETTLEMENT INVESTIGATION
301 MISSION STREET
SAN FRANCISCO, CALIFORNIA**

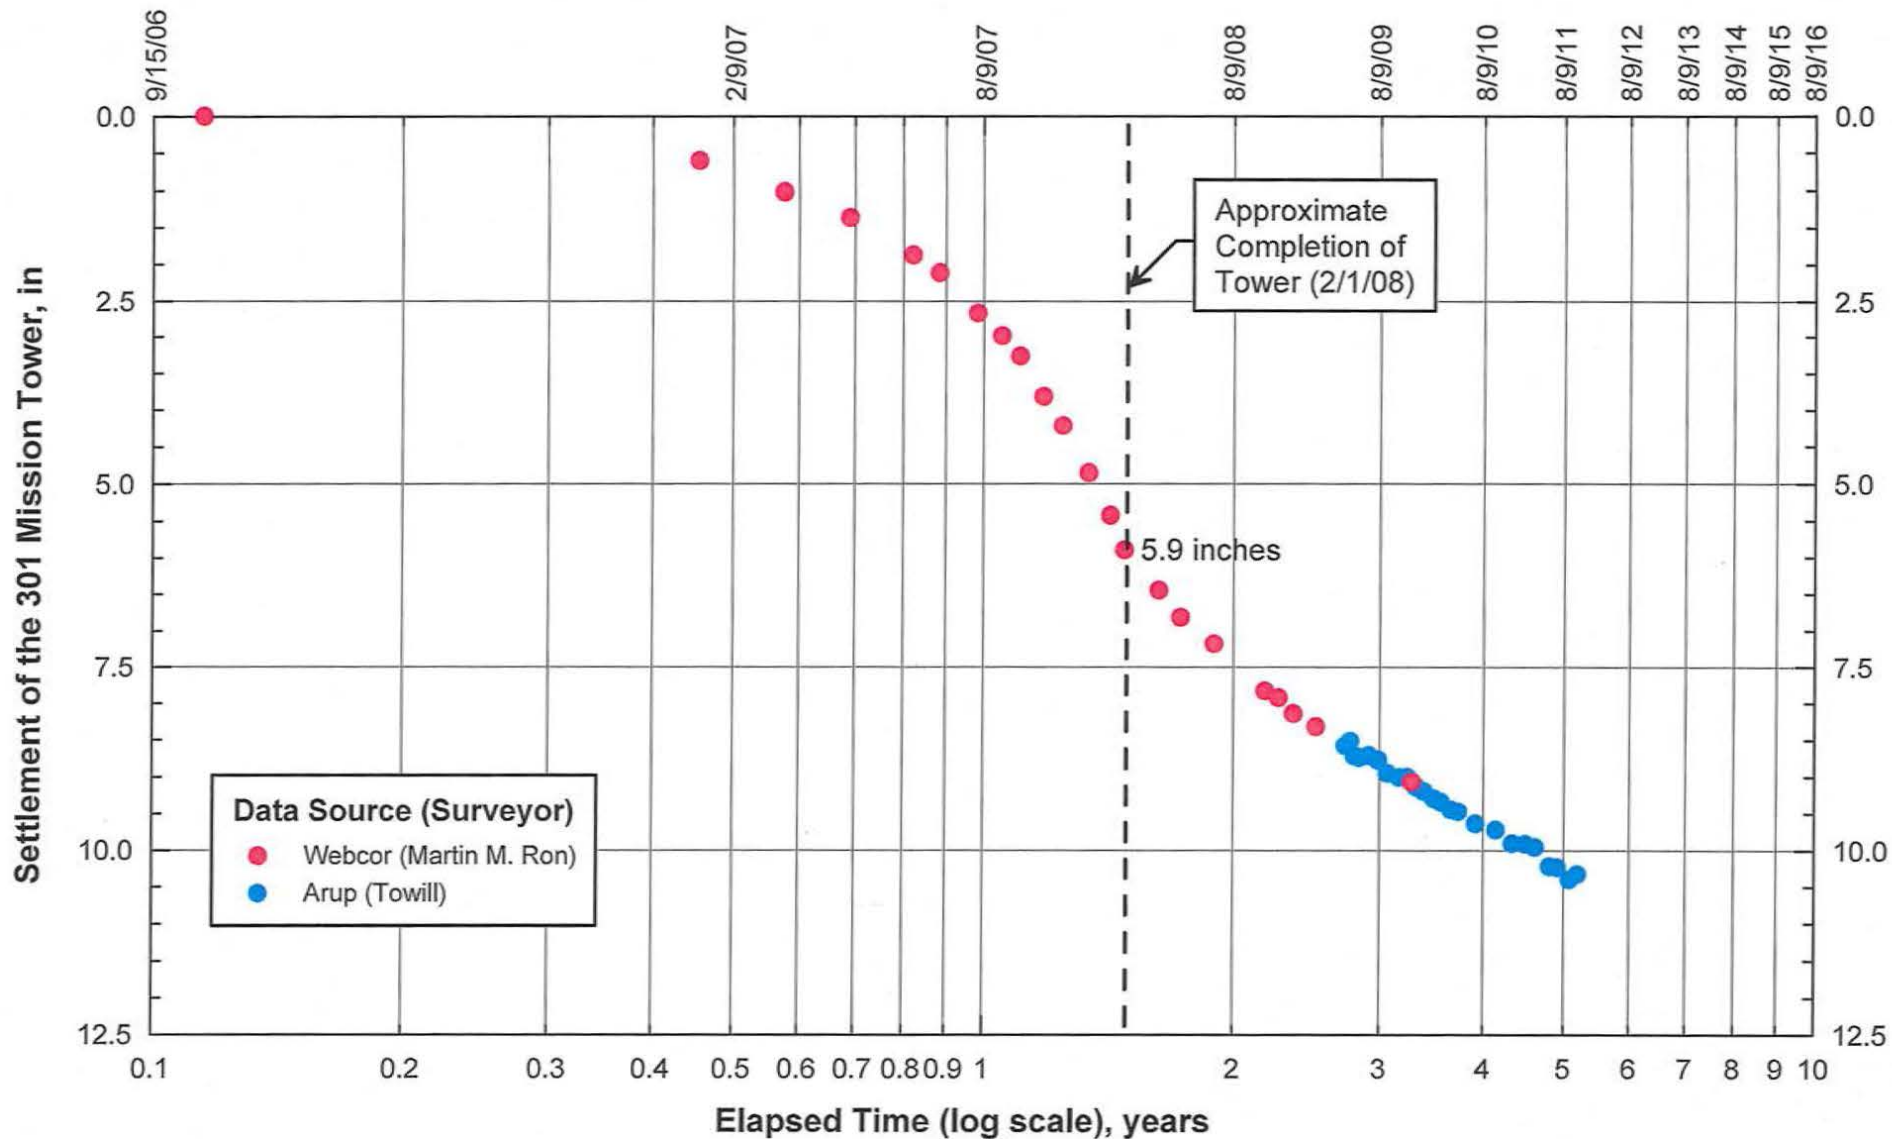
PLATE 5

**SETTLEMENTS OF THE 301 MISSION TOWER
 INCLUDING MONITORING DURING CONSTRUCTION**

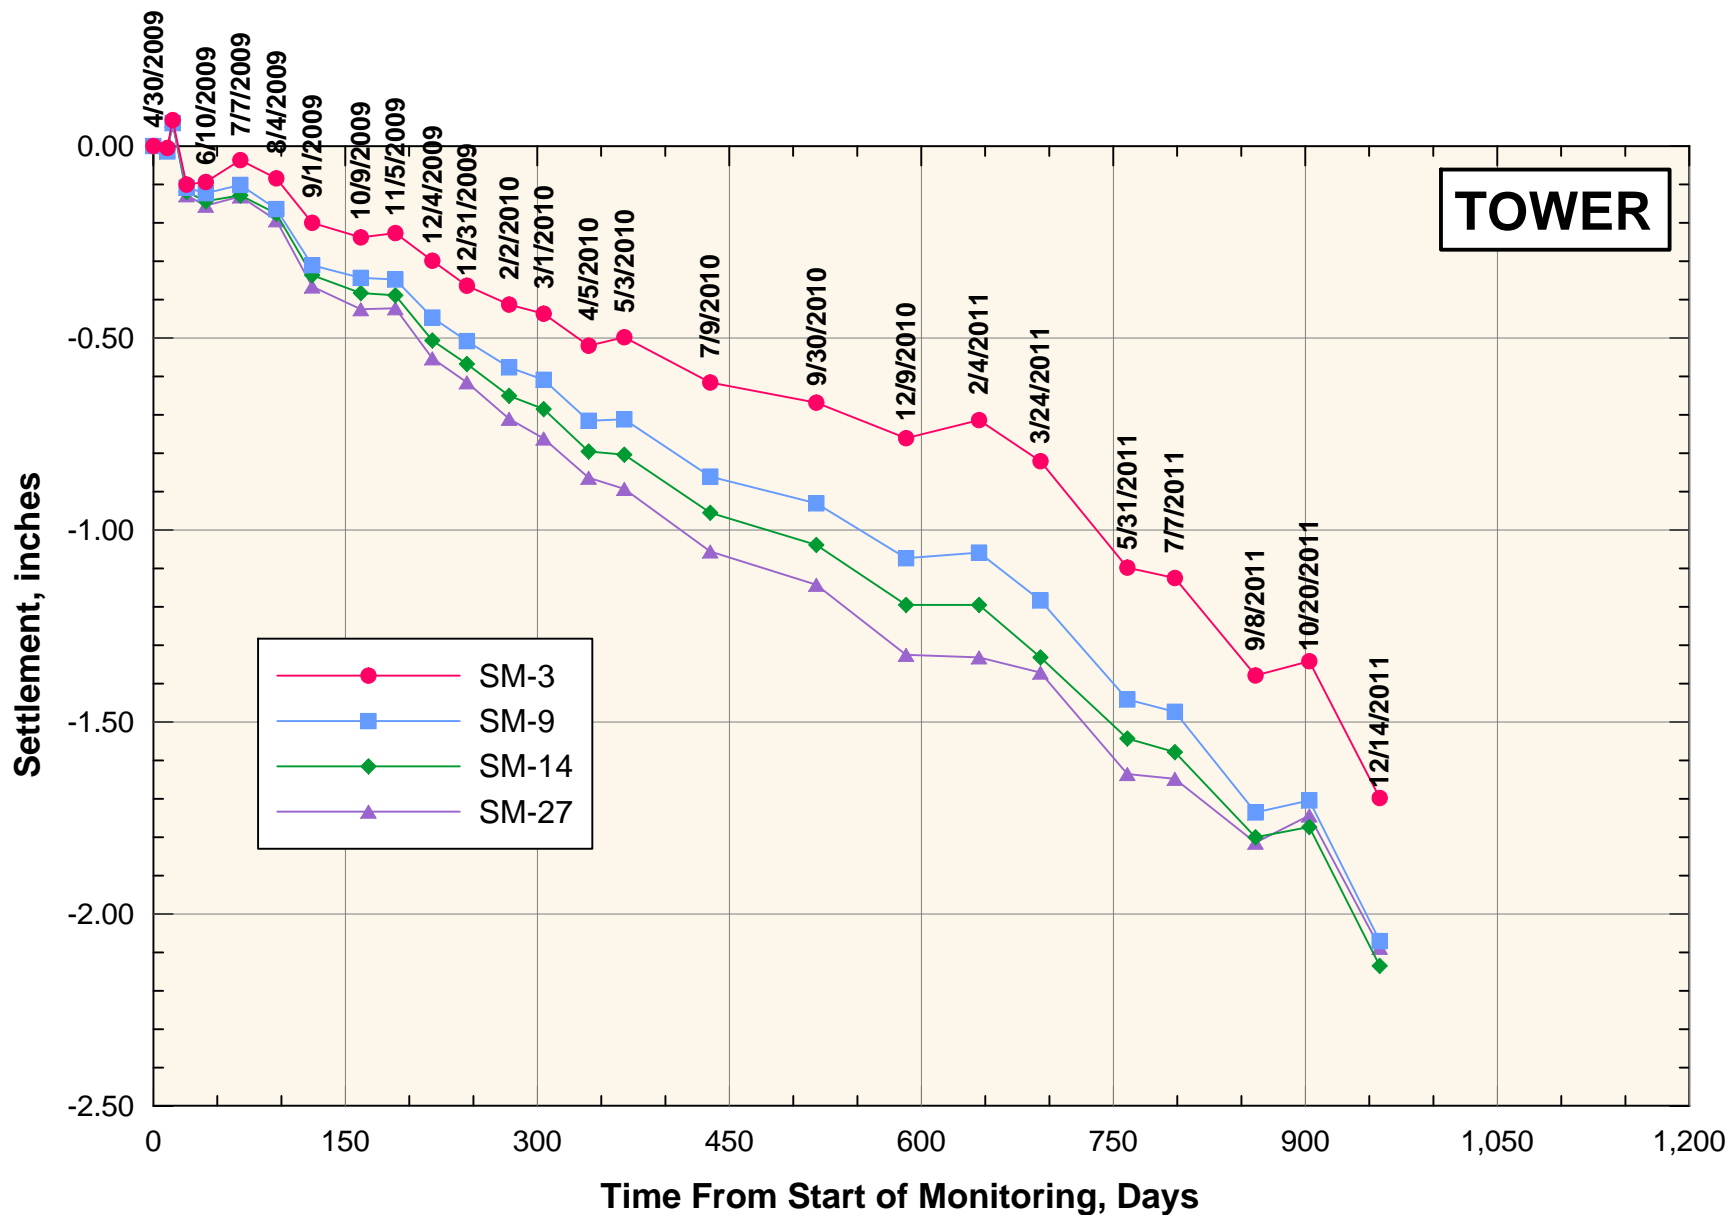
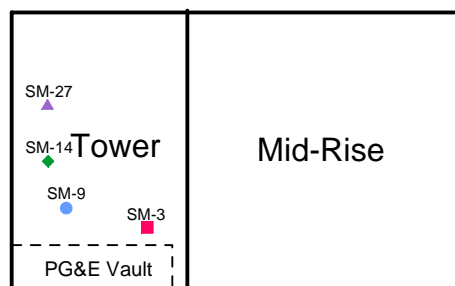
**SETTLEMENT OVER TIME
FLOOR ELEVATIONS AT LEVEL B-1
OF 301 MISSION PROPERTY- TOWER:
APRIL 30, 2009 THROUGH DECEMBER 14, 2011**

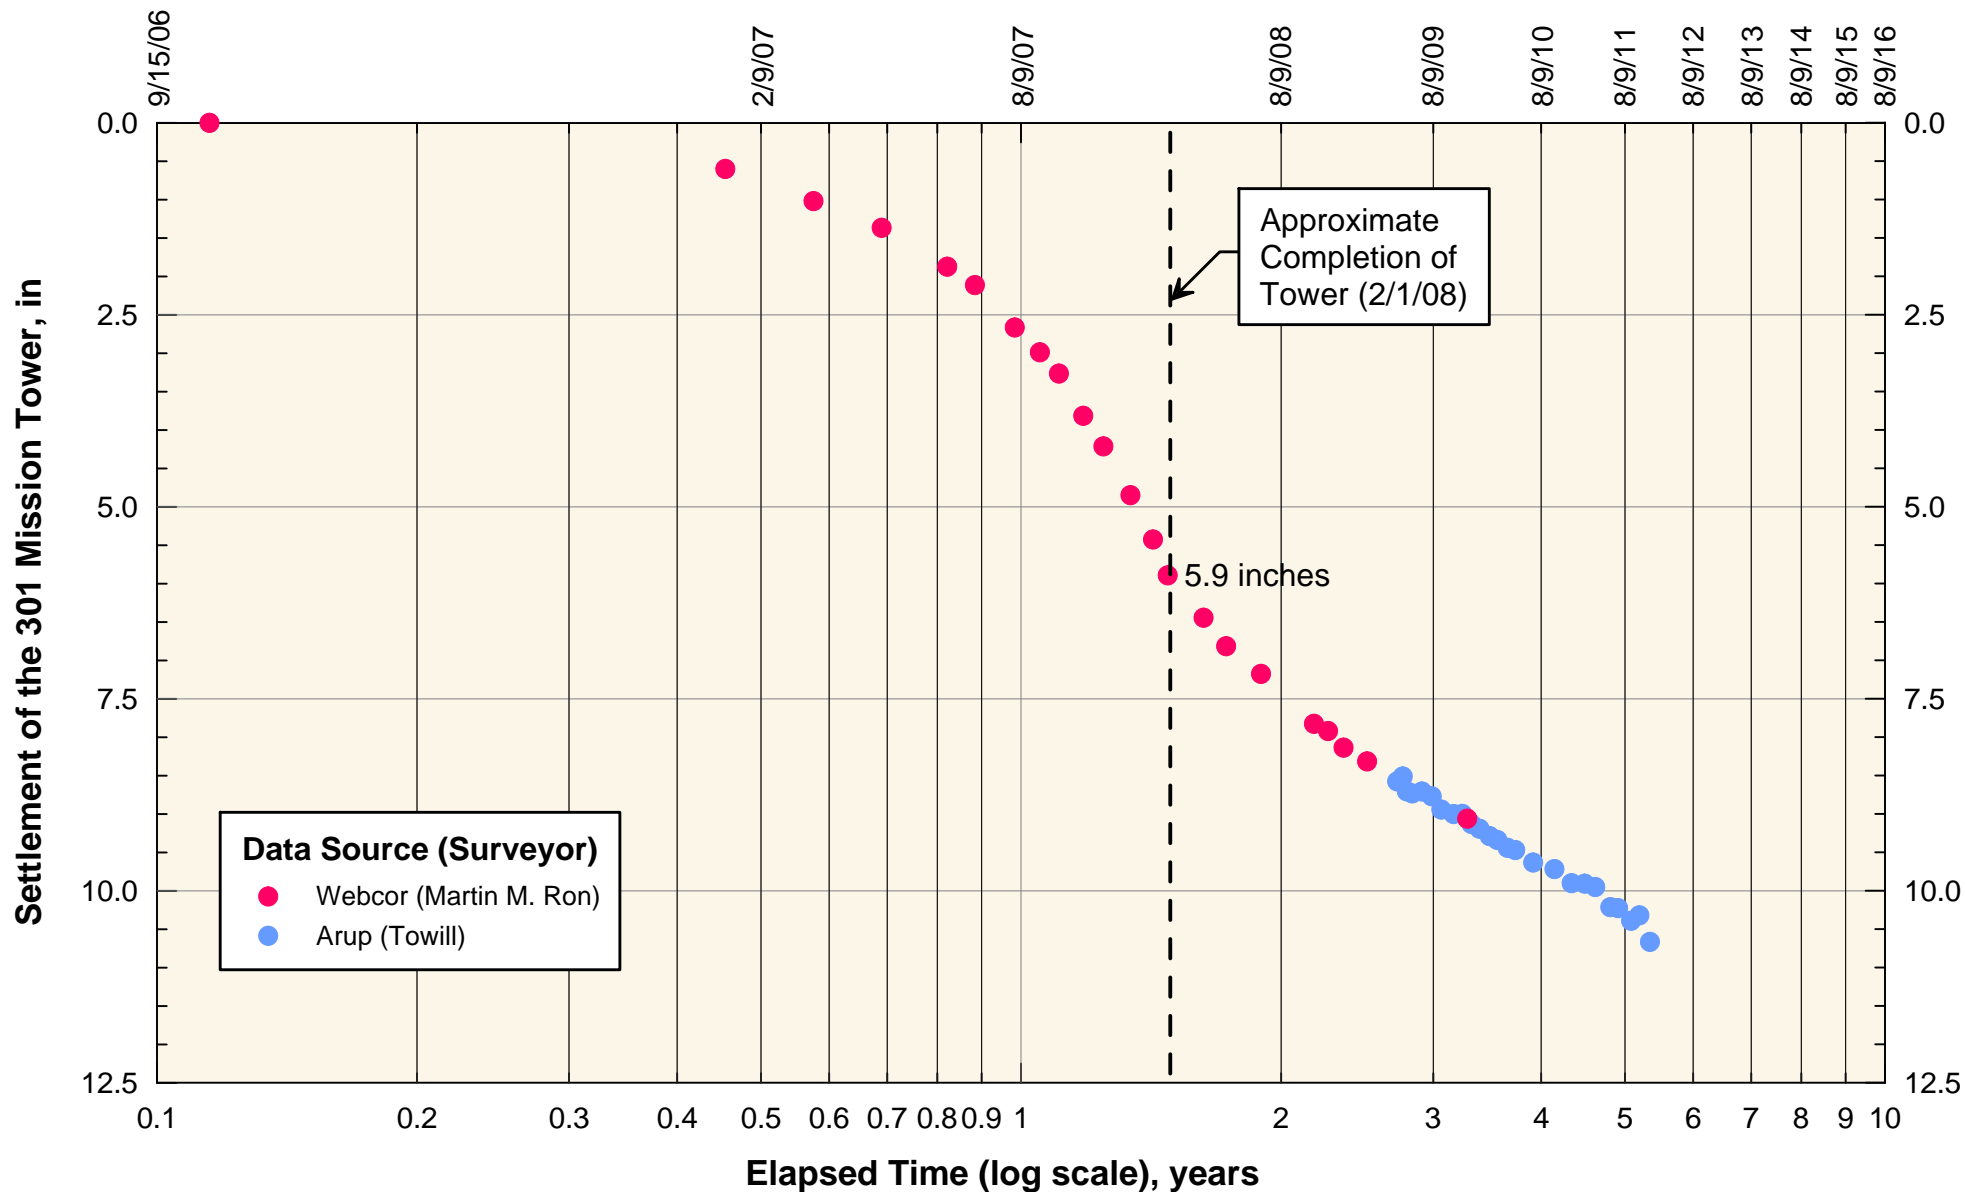
**SETTLEMENTS OF THE 301 MISSION TOWER
 INCLUDING MONITORING DURING CONSTRUCTION**

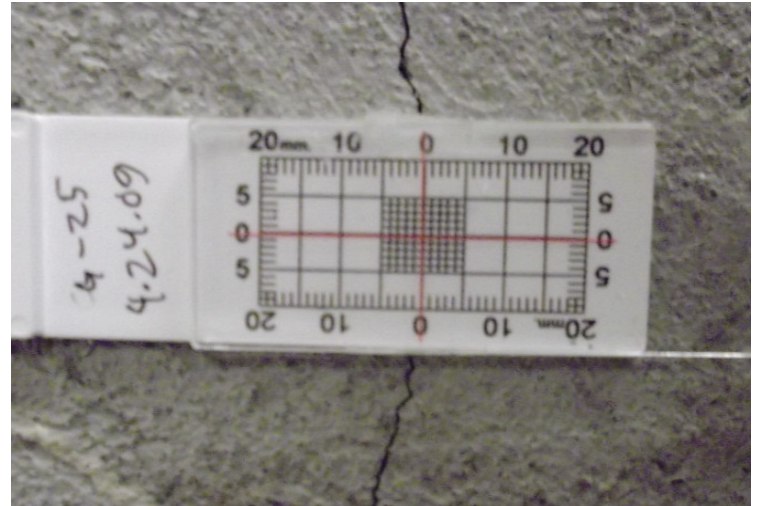
Crack Gauge	Distance of Movement	Direction of movement, relative to the Crack	Variation from previous reading	Picture of Movement
CG-25	0.5 mm	Parallel	+0.1 mm

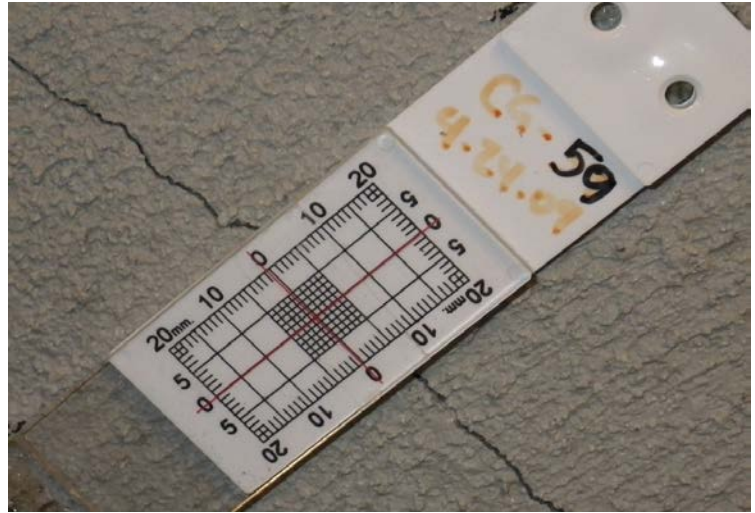
Crack Gauge	Distance of Movement	Direction of movement, relative to the Crack	Variation from previous reading	Picture of Movement
CG-59	0.5 mm	Perpendicular	+0.5 mm

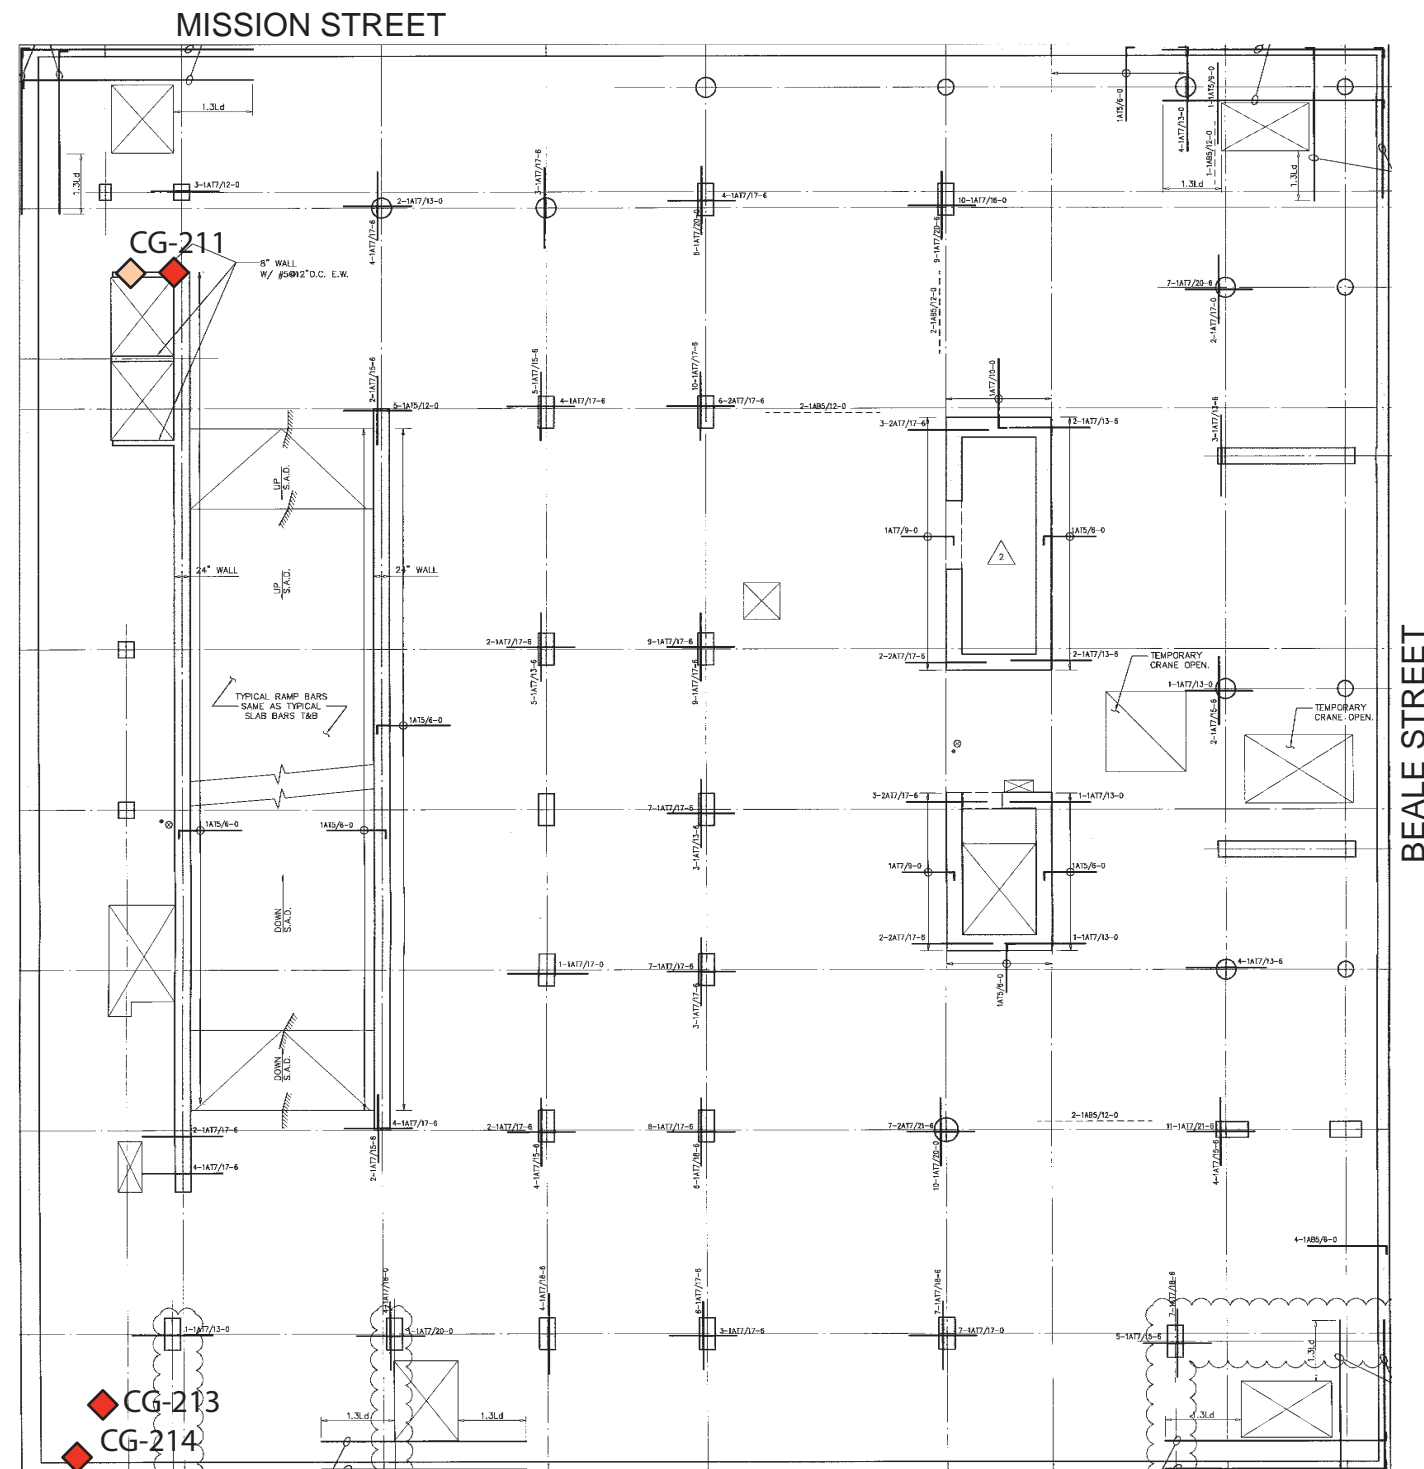
**CRACK GAUGES SHOWING MOVEMENT:
301 MISSION STREET BASEMENT LEVEL B-3**

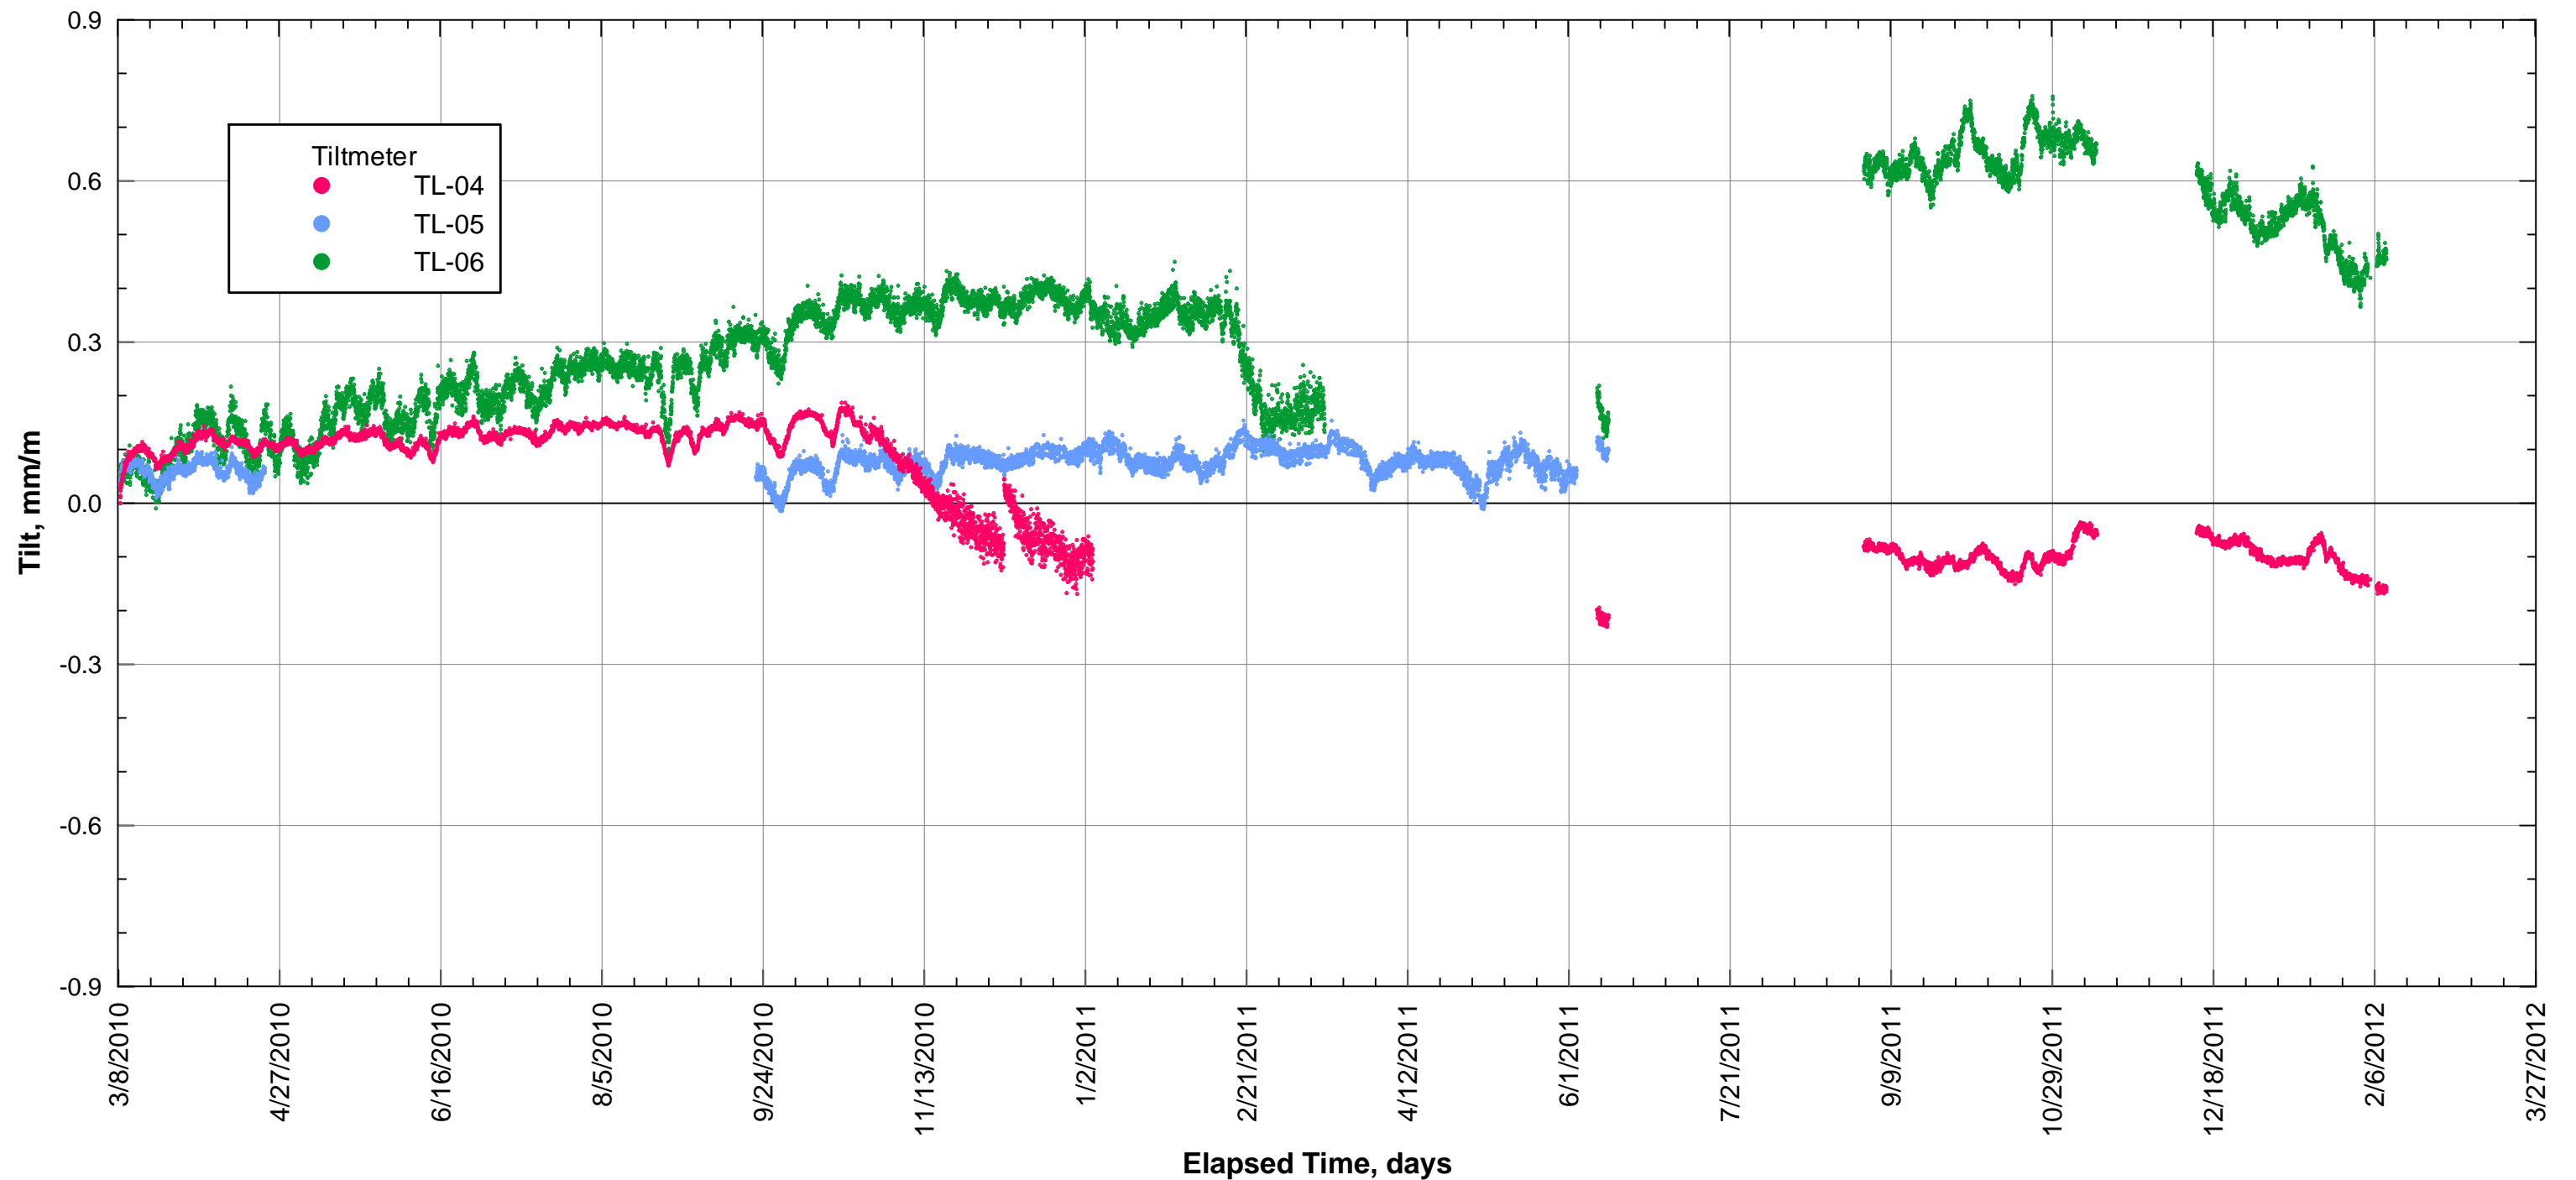
PLATE 3

TILT RECORDED IN TILTMETERS TL-04, TL-05, AND TL-06: BASEMENT LEVEL B-1

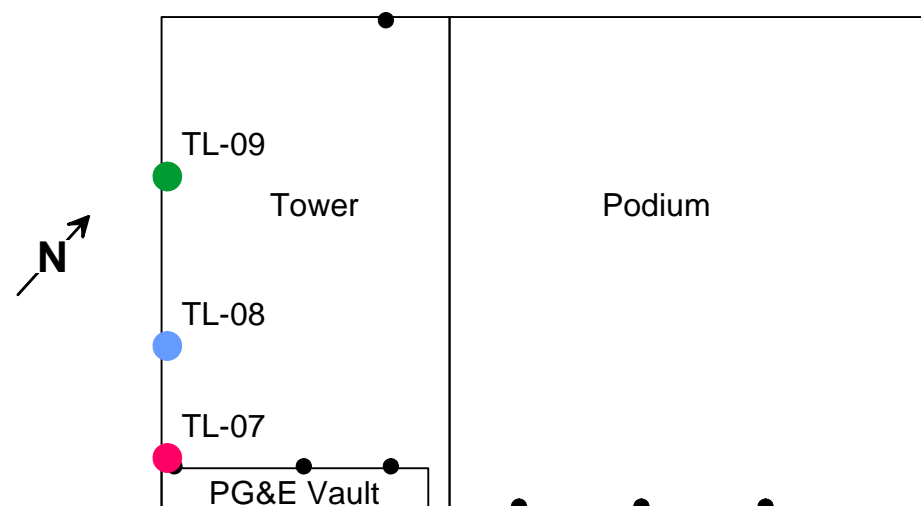
PLATE 4

TILT RECORDED IN TILTMETERS TL-07, TL-08, AND TL-09: BASEMENT LEVEL B-1

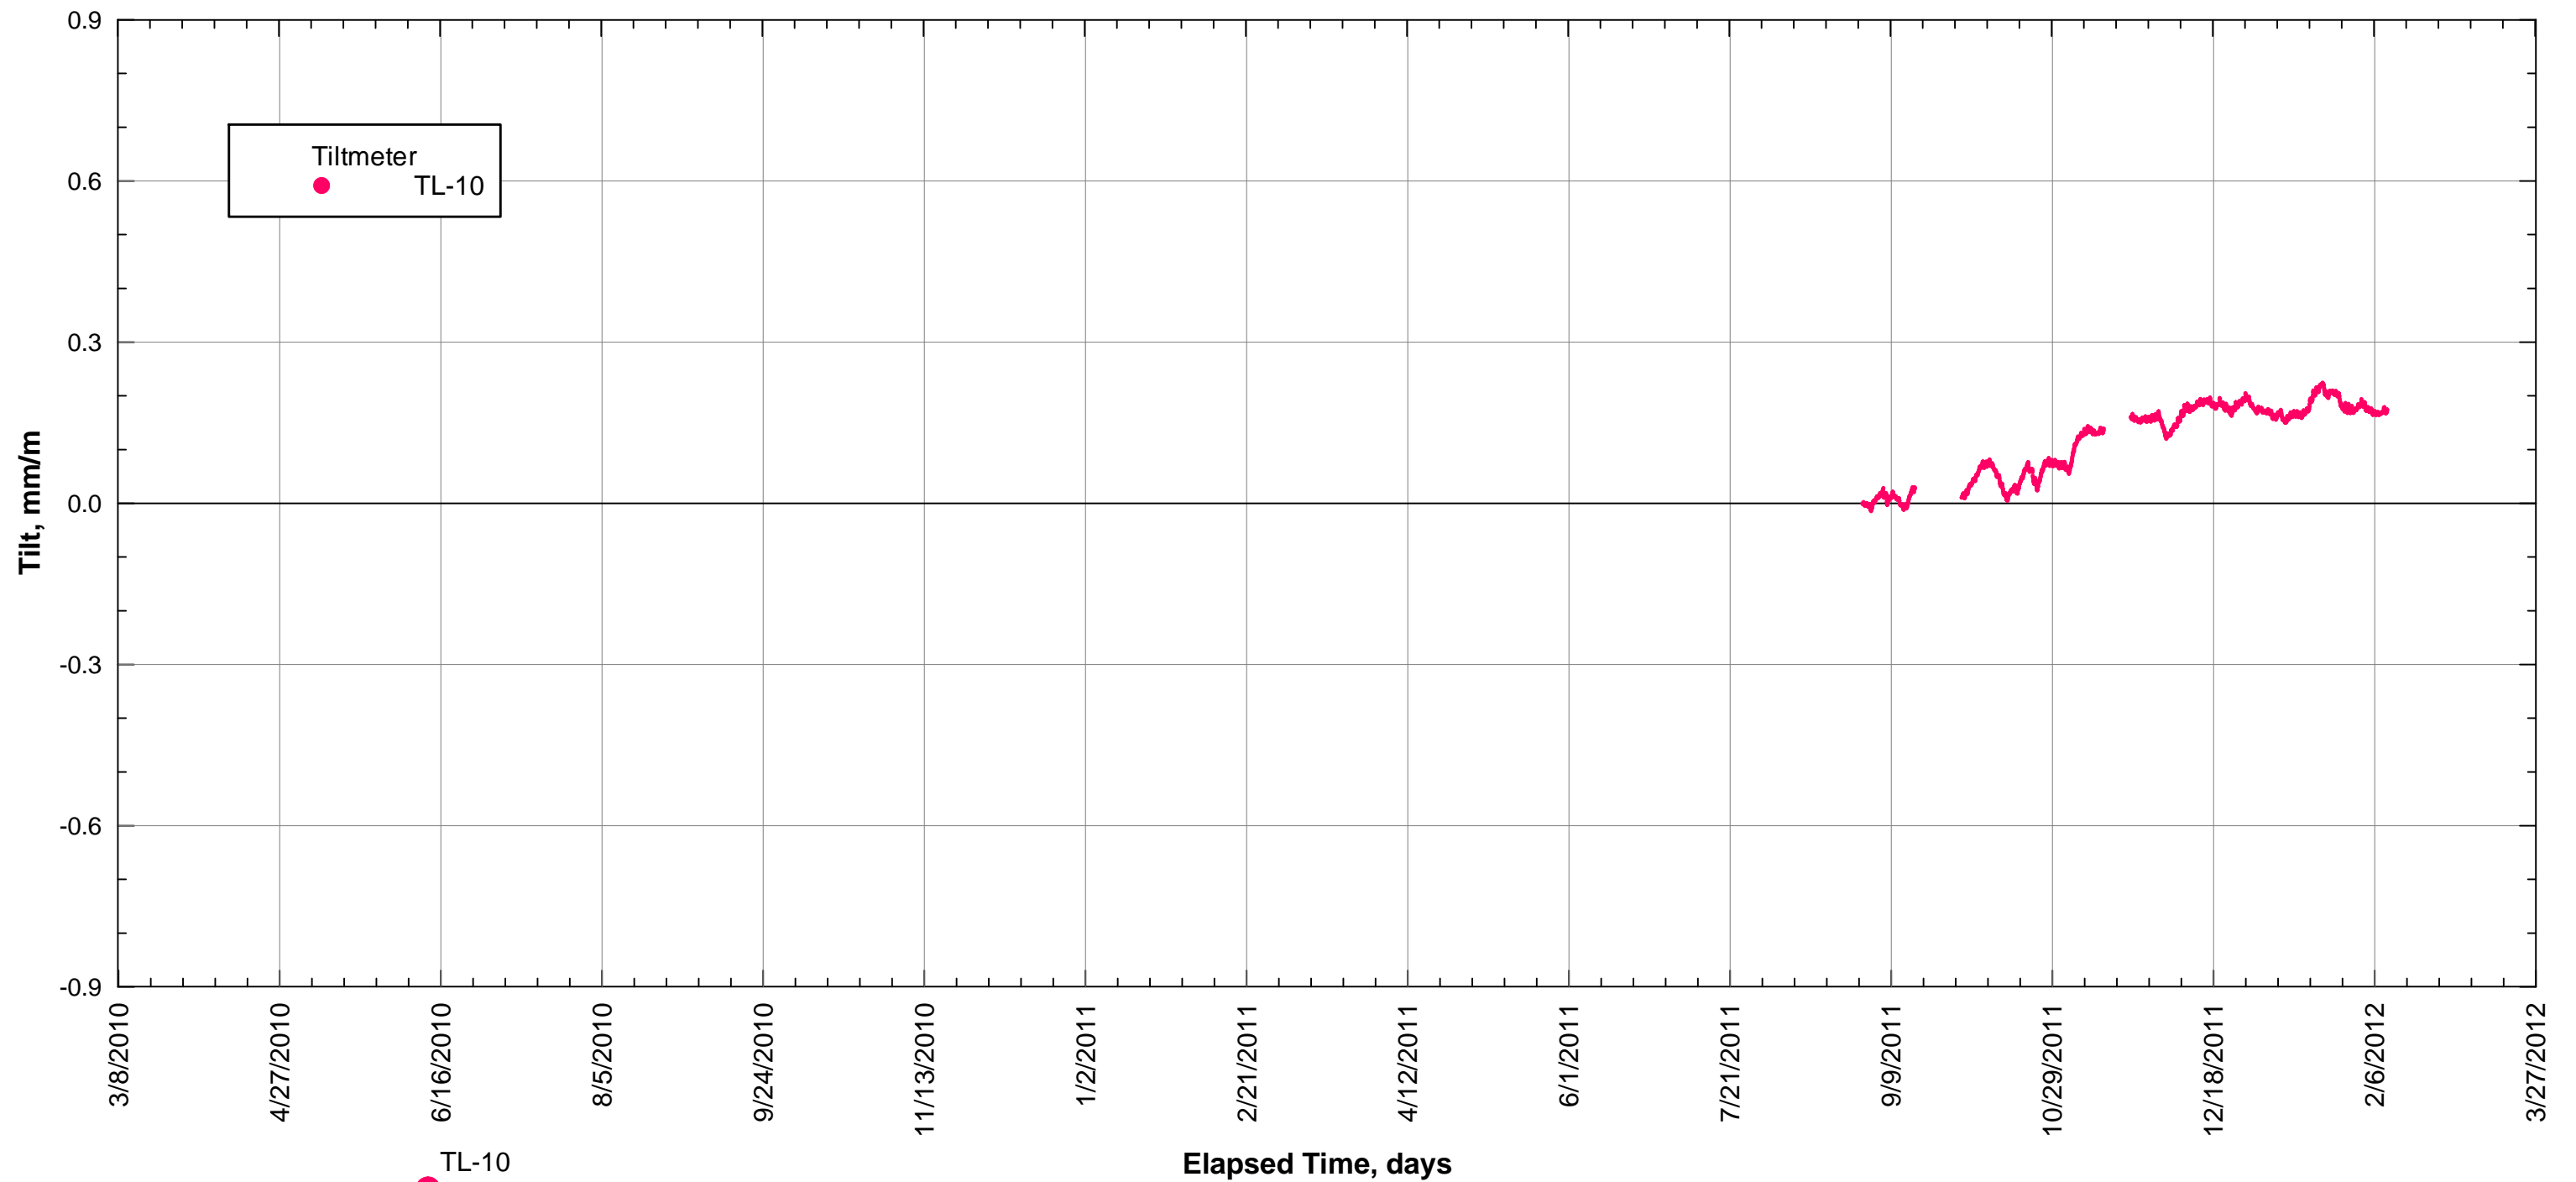
**TILT RECORDED IN TILTMETER TL-10:
BASEMENT LEVEL B-1**

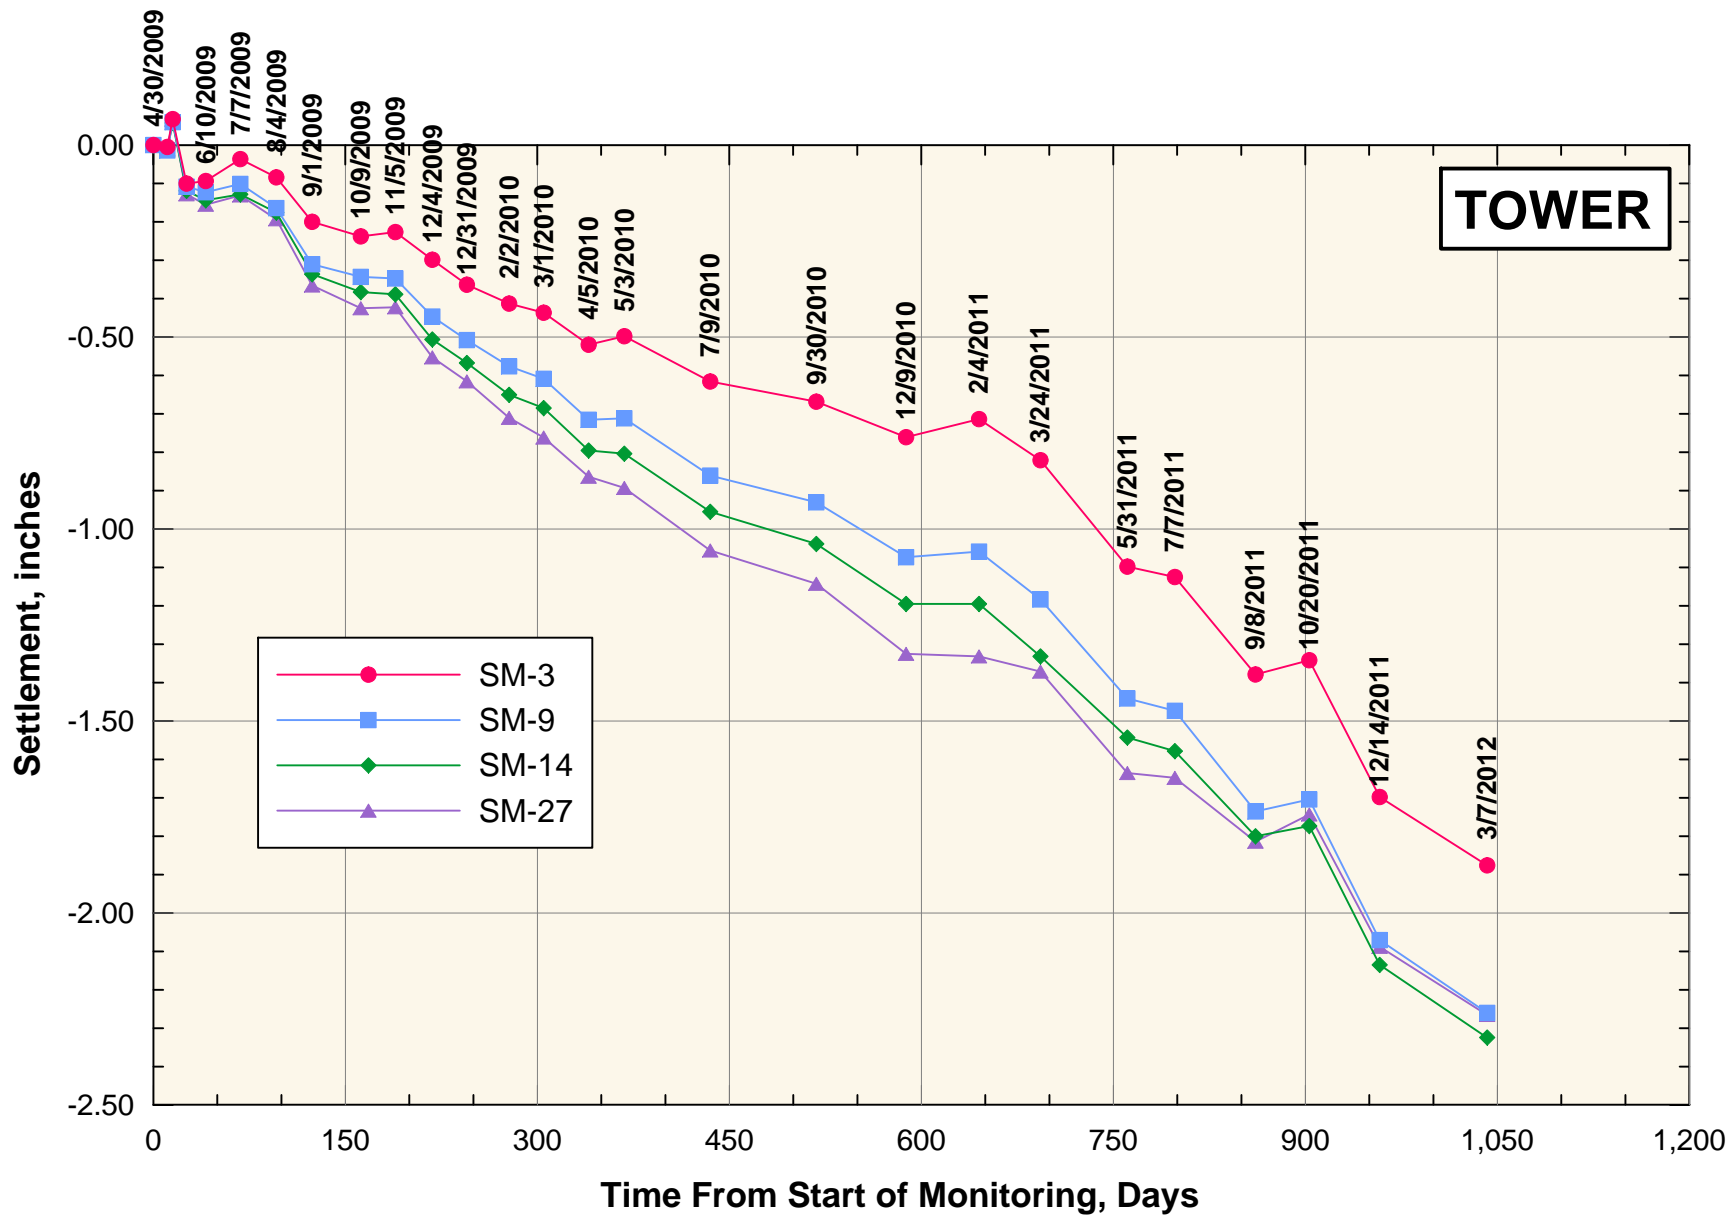
PLATE 4

**SETTLEMENT OVER TIME
FLOOR ELEVATIONS AT LEVEL B-1
OF 301 MISSION PROPERTY- TOWER:
APRIL 30, 2009 THROUGH MARCH 7, 2012**

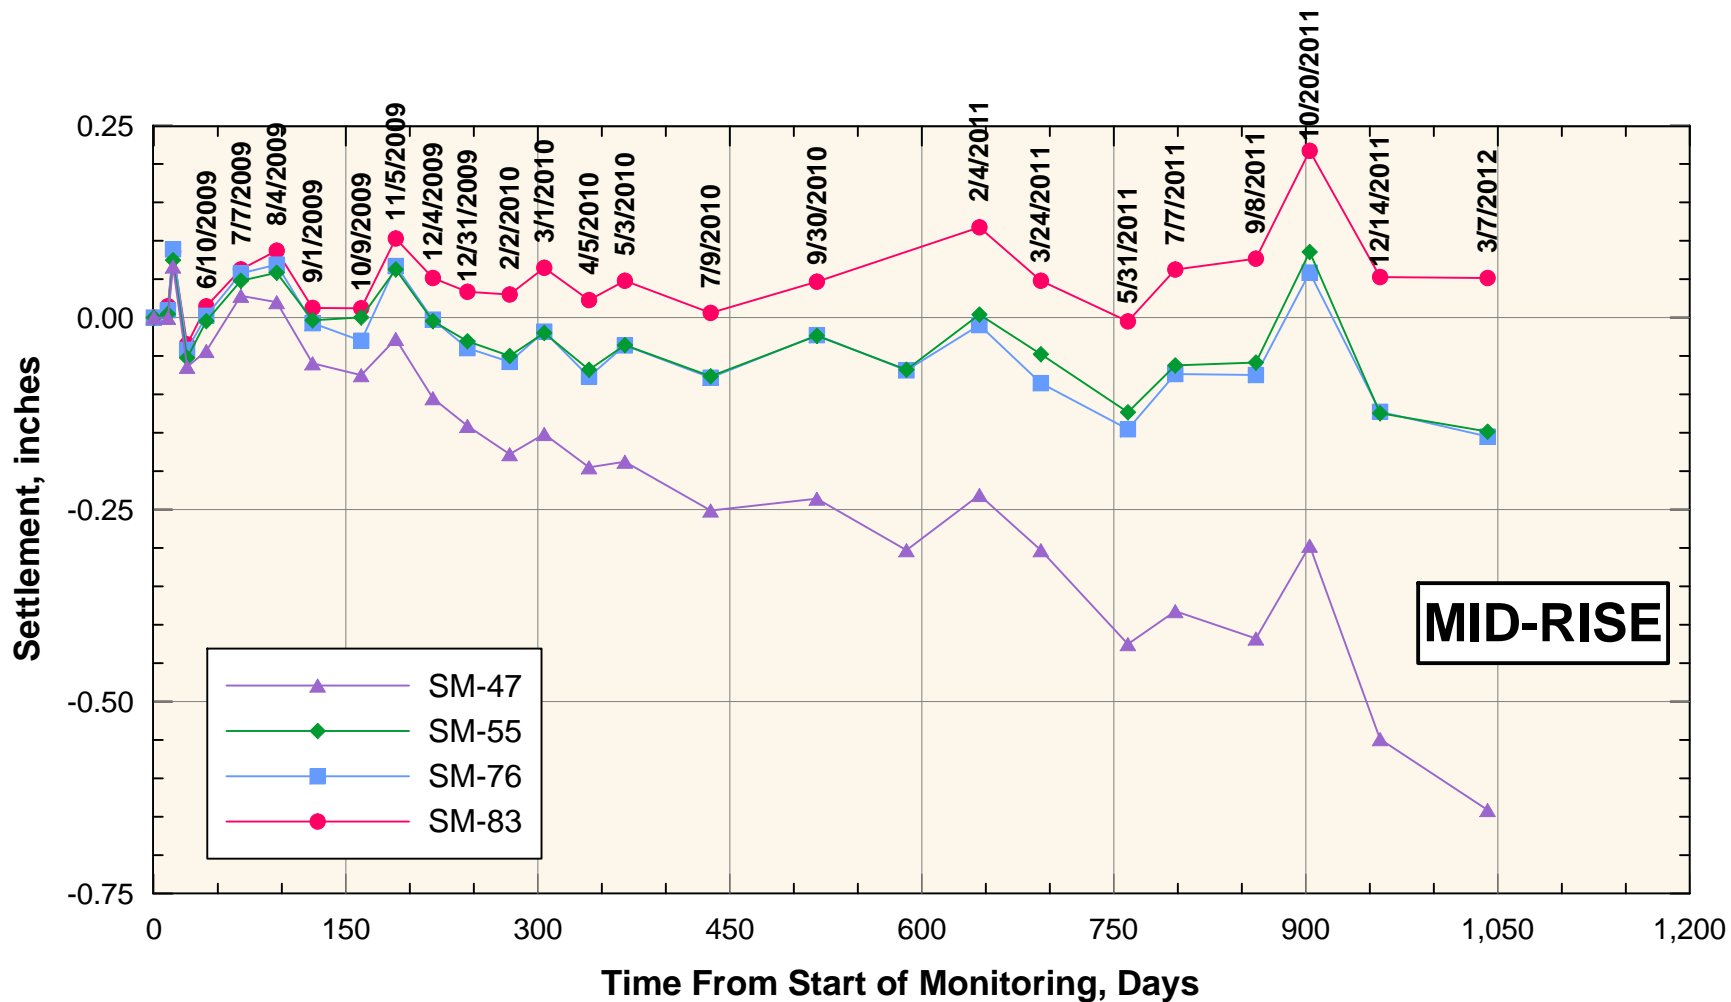
PLATE 5

**SETTLEMENT OVER TIME
FLOOR ELEVATIONS AT LEVEL B-1
OF 301 MISSION PROPERTY- MID-RISE:
APRIL 30, 2009 THROUGH MARCH 7, 2012**
