*Board of Supervisors
City and County of San Francisco*

Government Audit and Oversight Committee

Supplemental Report for Foundation Settlement Investigation

**SUPPLEMENTAL REPORT
FOUNDATION SETTLEMENT INVESTIGATION
301 MISSION STREET
SAN FRANCISCO, CALIFORNIA**

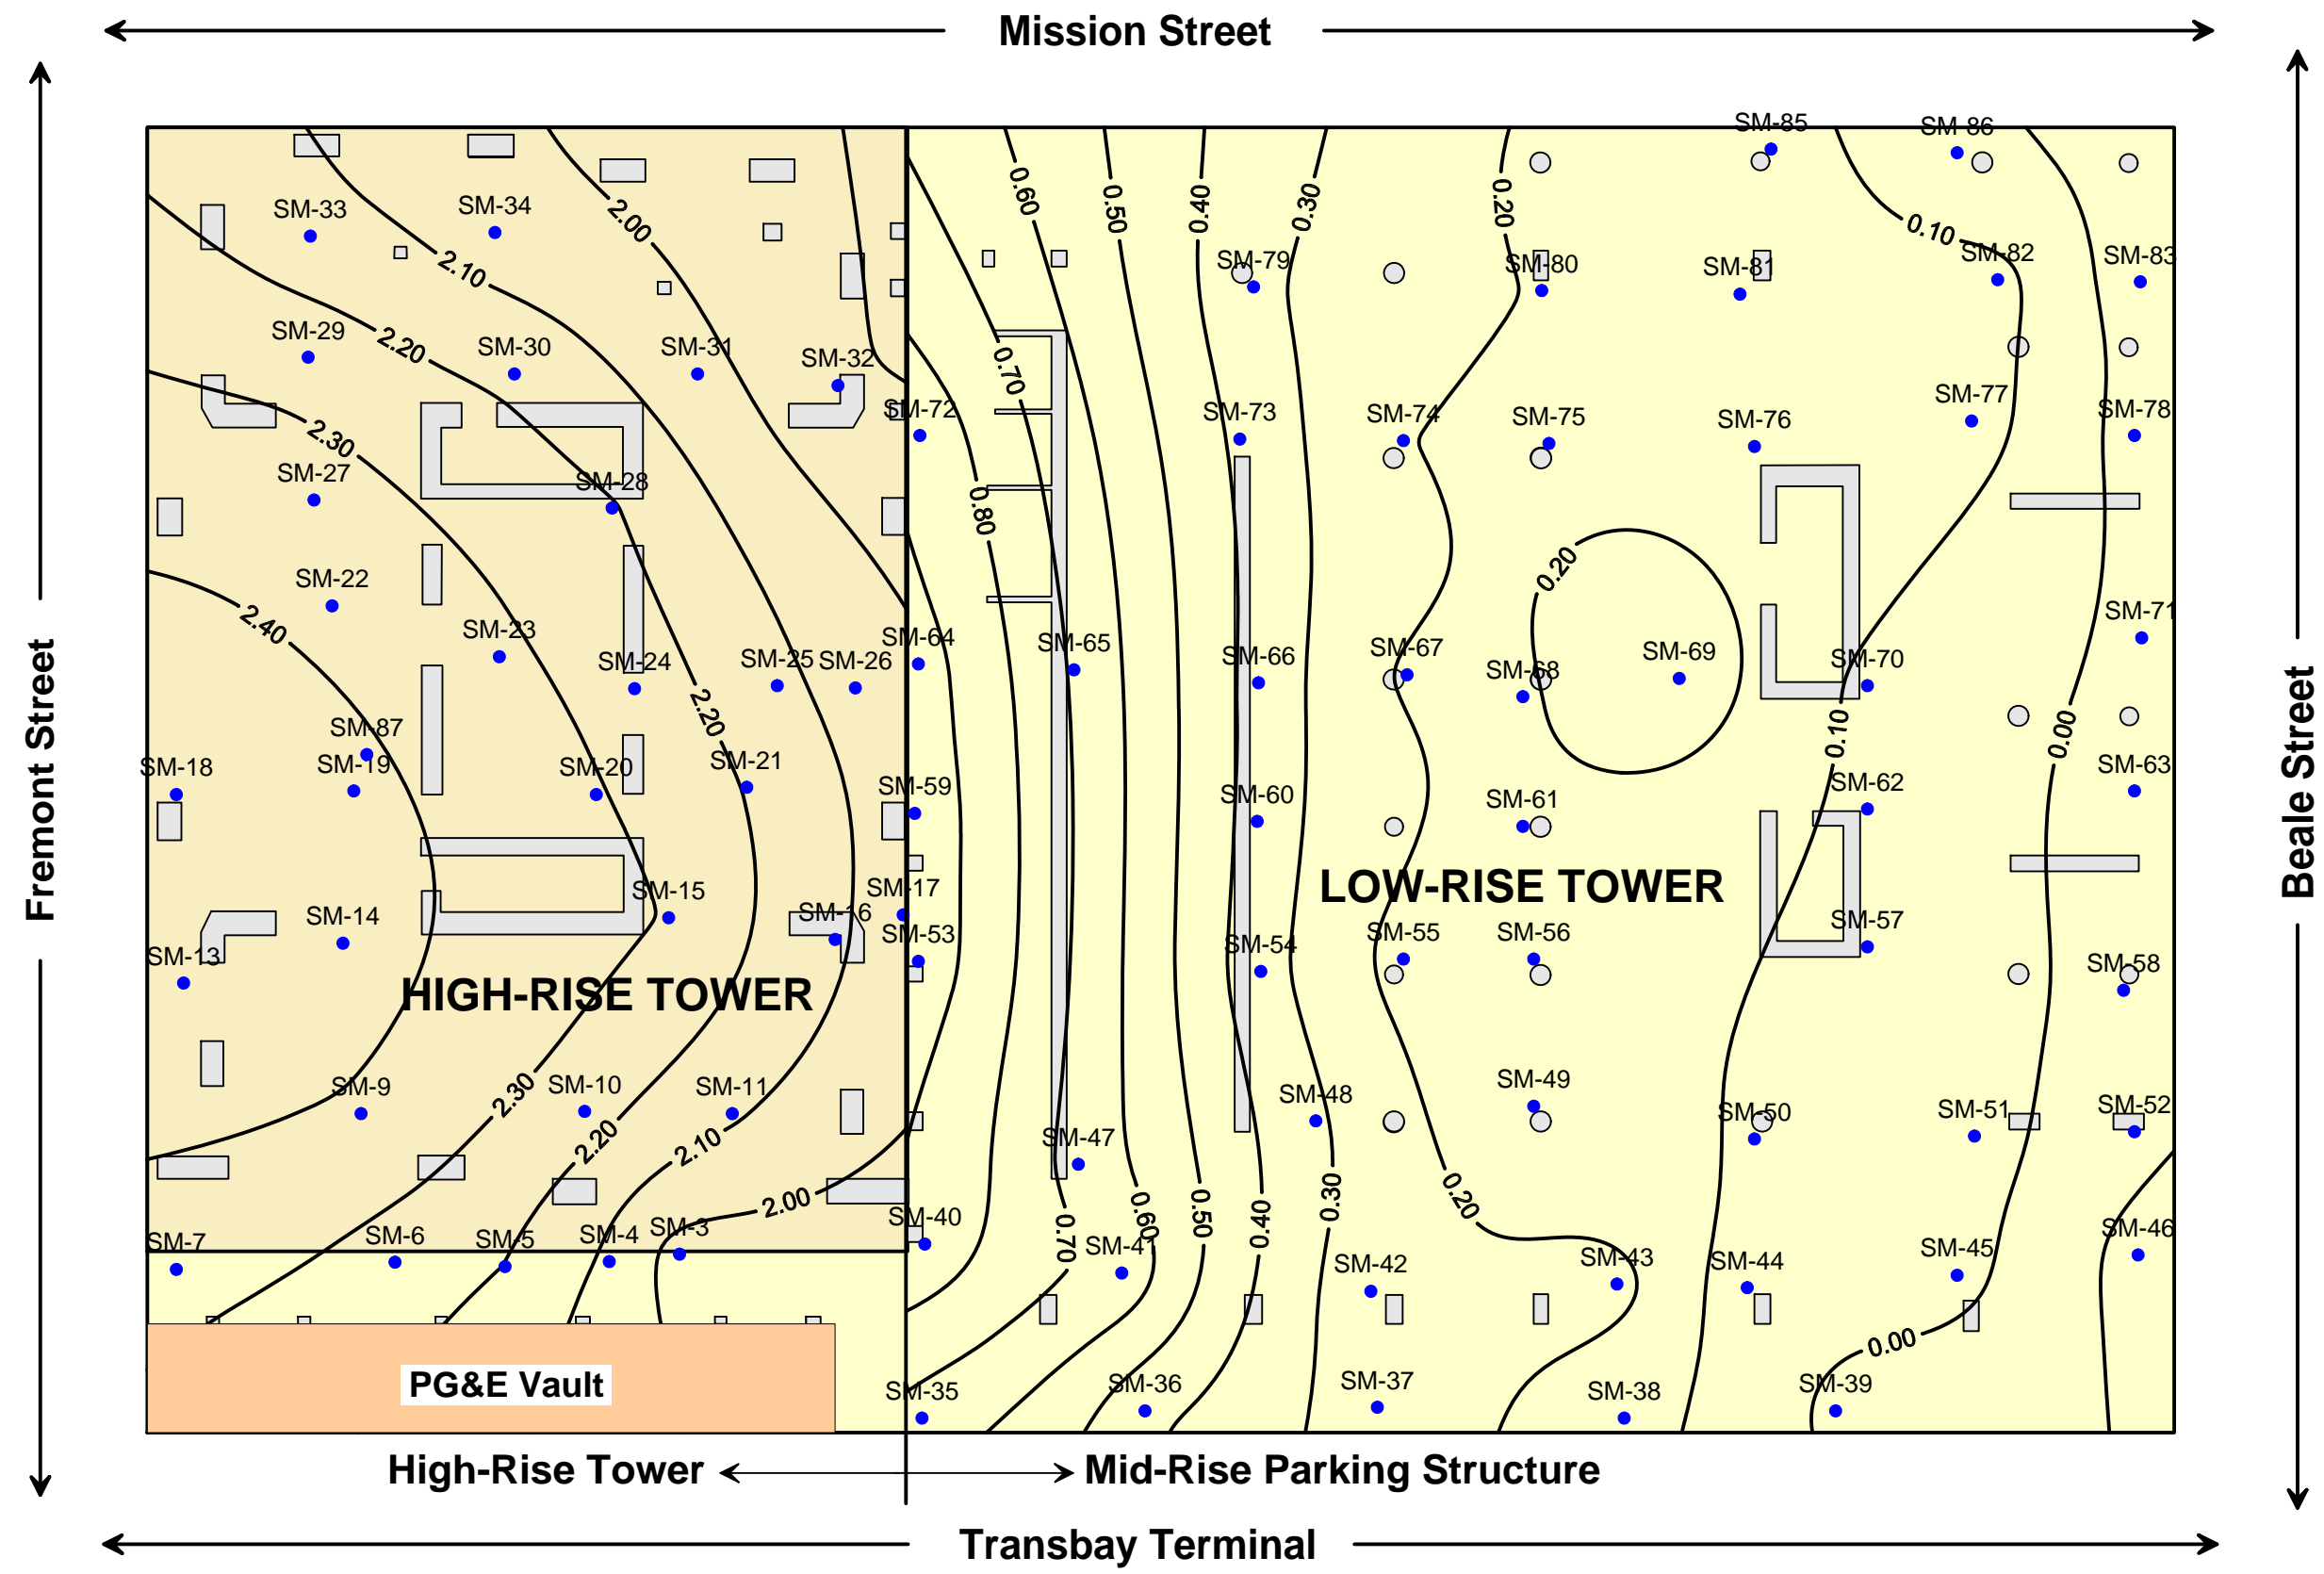
Notes:
Contours represent elevation change, in inches, between Baseline survey (April 30, 2009) and readings taken on April 18, 2012.
Level B-1 at Mid-Rise Parking portion of survey site is approximately 4 inches higher than Level B-1 at High-Rise Tower portion.
The PG&E vault is inaccessible for monitoring.
Negative values of settlement (within Low-rise Tower) indicate uplift.

CONTOURS OF SETTLEMENTS MEASURED AT THE FIRST LEVEL BASEMENT OF THE 301 MISSION STREET STRUCTURE BETWEEN APRIL 30, 2009 AND APRIL 18, 2012
Transbay Transit Center
301 Mission Monitoring
Transbay Joint Powers Authority
San Francisco, California
April 2012

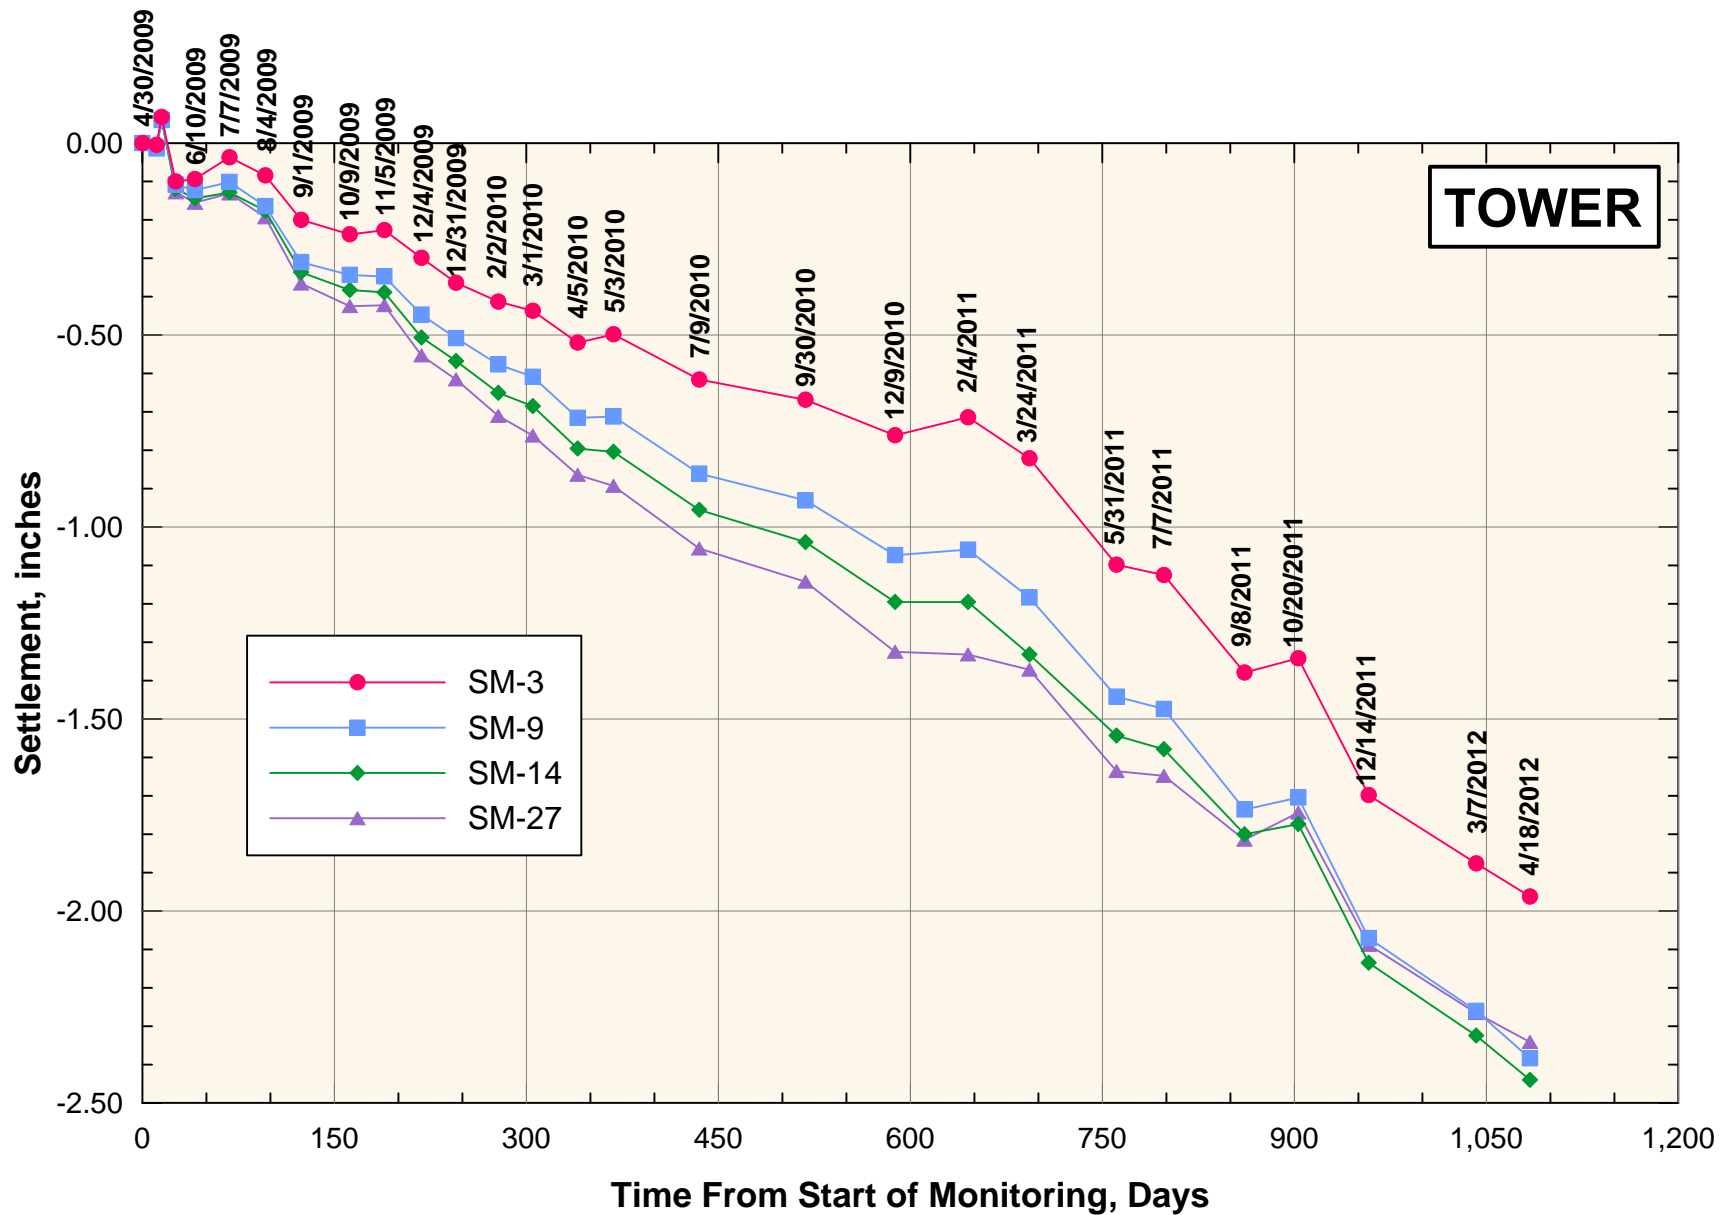
PLATE 4

**SETTLEMENT OVER TIME
FLOOR ELEVATIONS AT LEVEL B-1
OF 301 MISSION PROPERTY- TOWER:
APRIL 30, 2009 THROUGH APRIL 18, 2012**

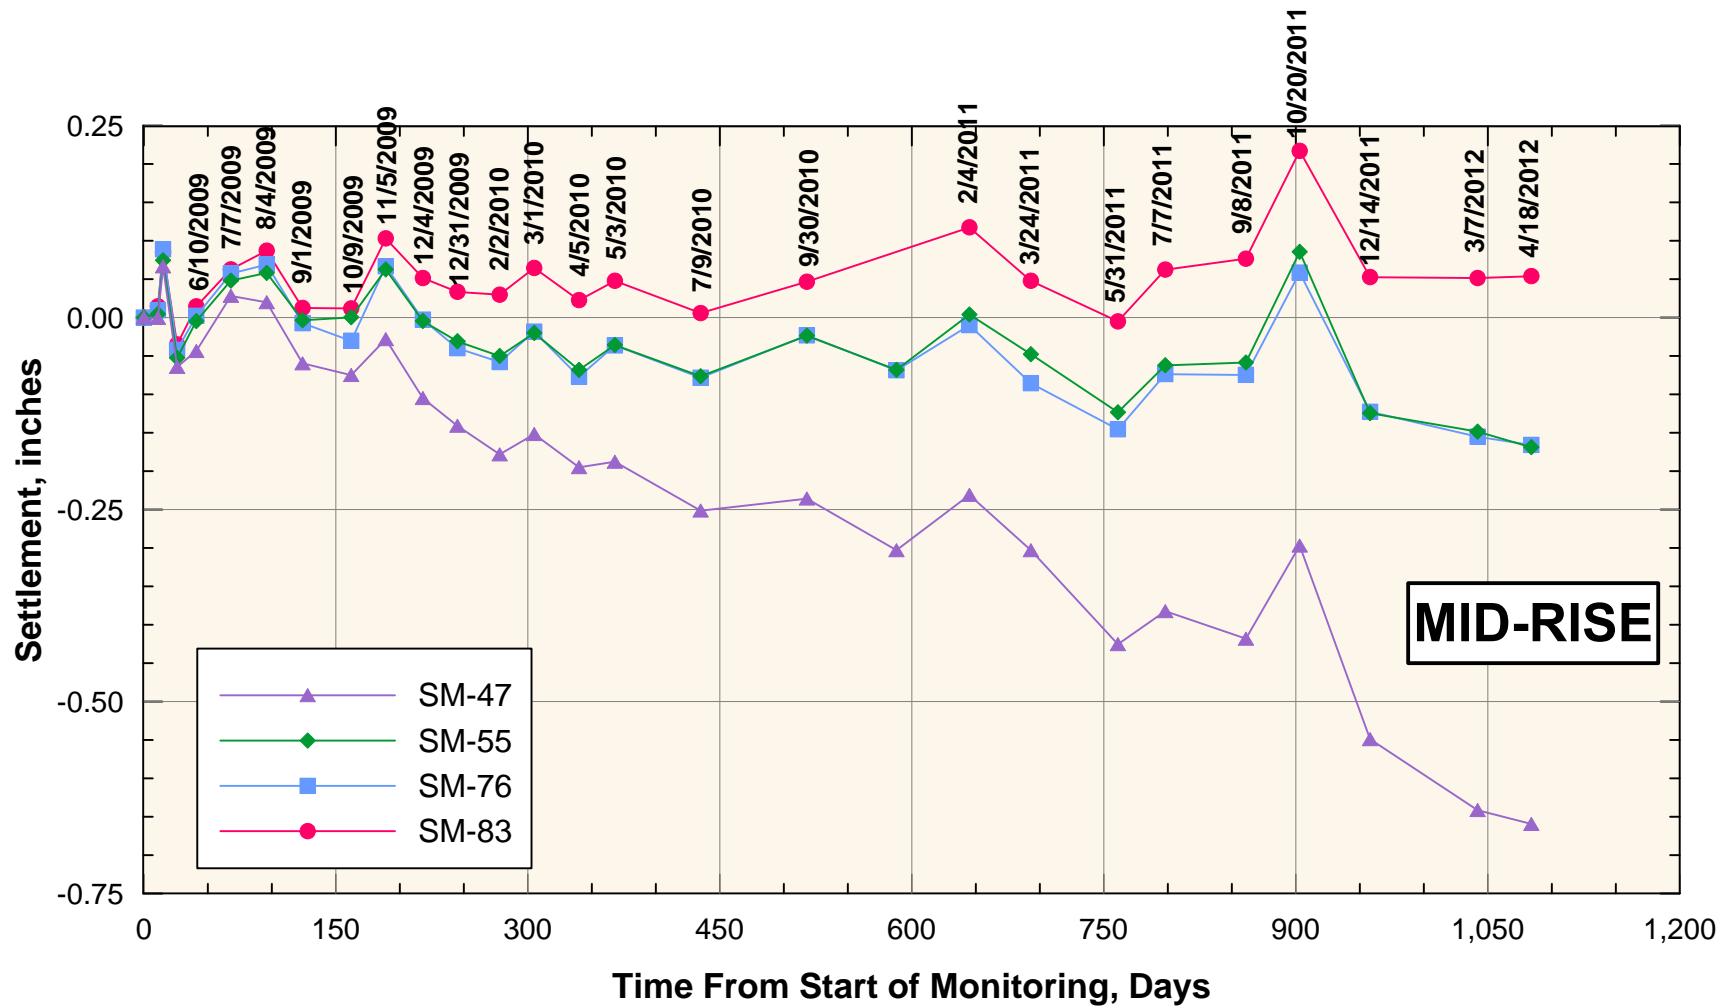
**SETTLEMENT OVER TIME
FLOOR ELEVATIONS AT LEVEL B-1
OF 301 MISSION PROPERTY- MID-RISE:
APRIL 30, 2009 THROUGH APRIL 18, 2012**

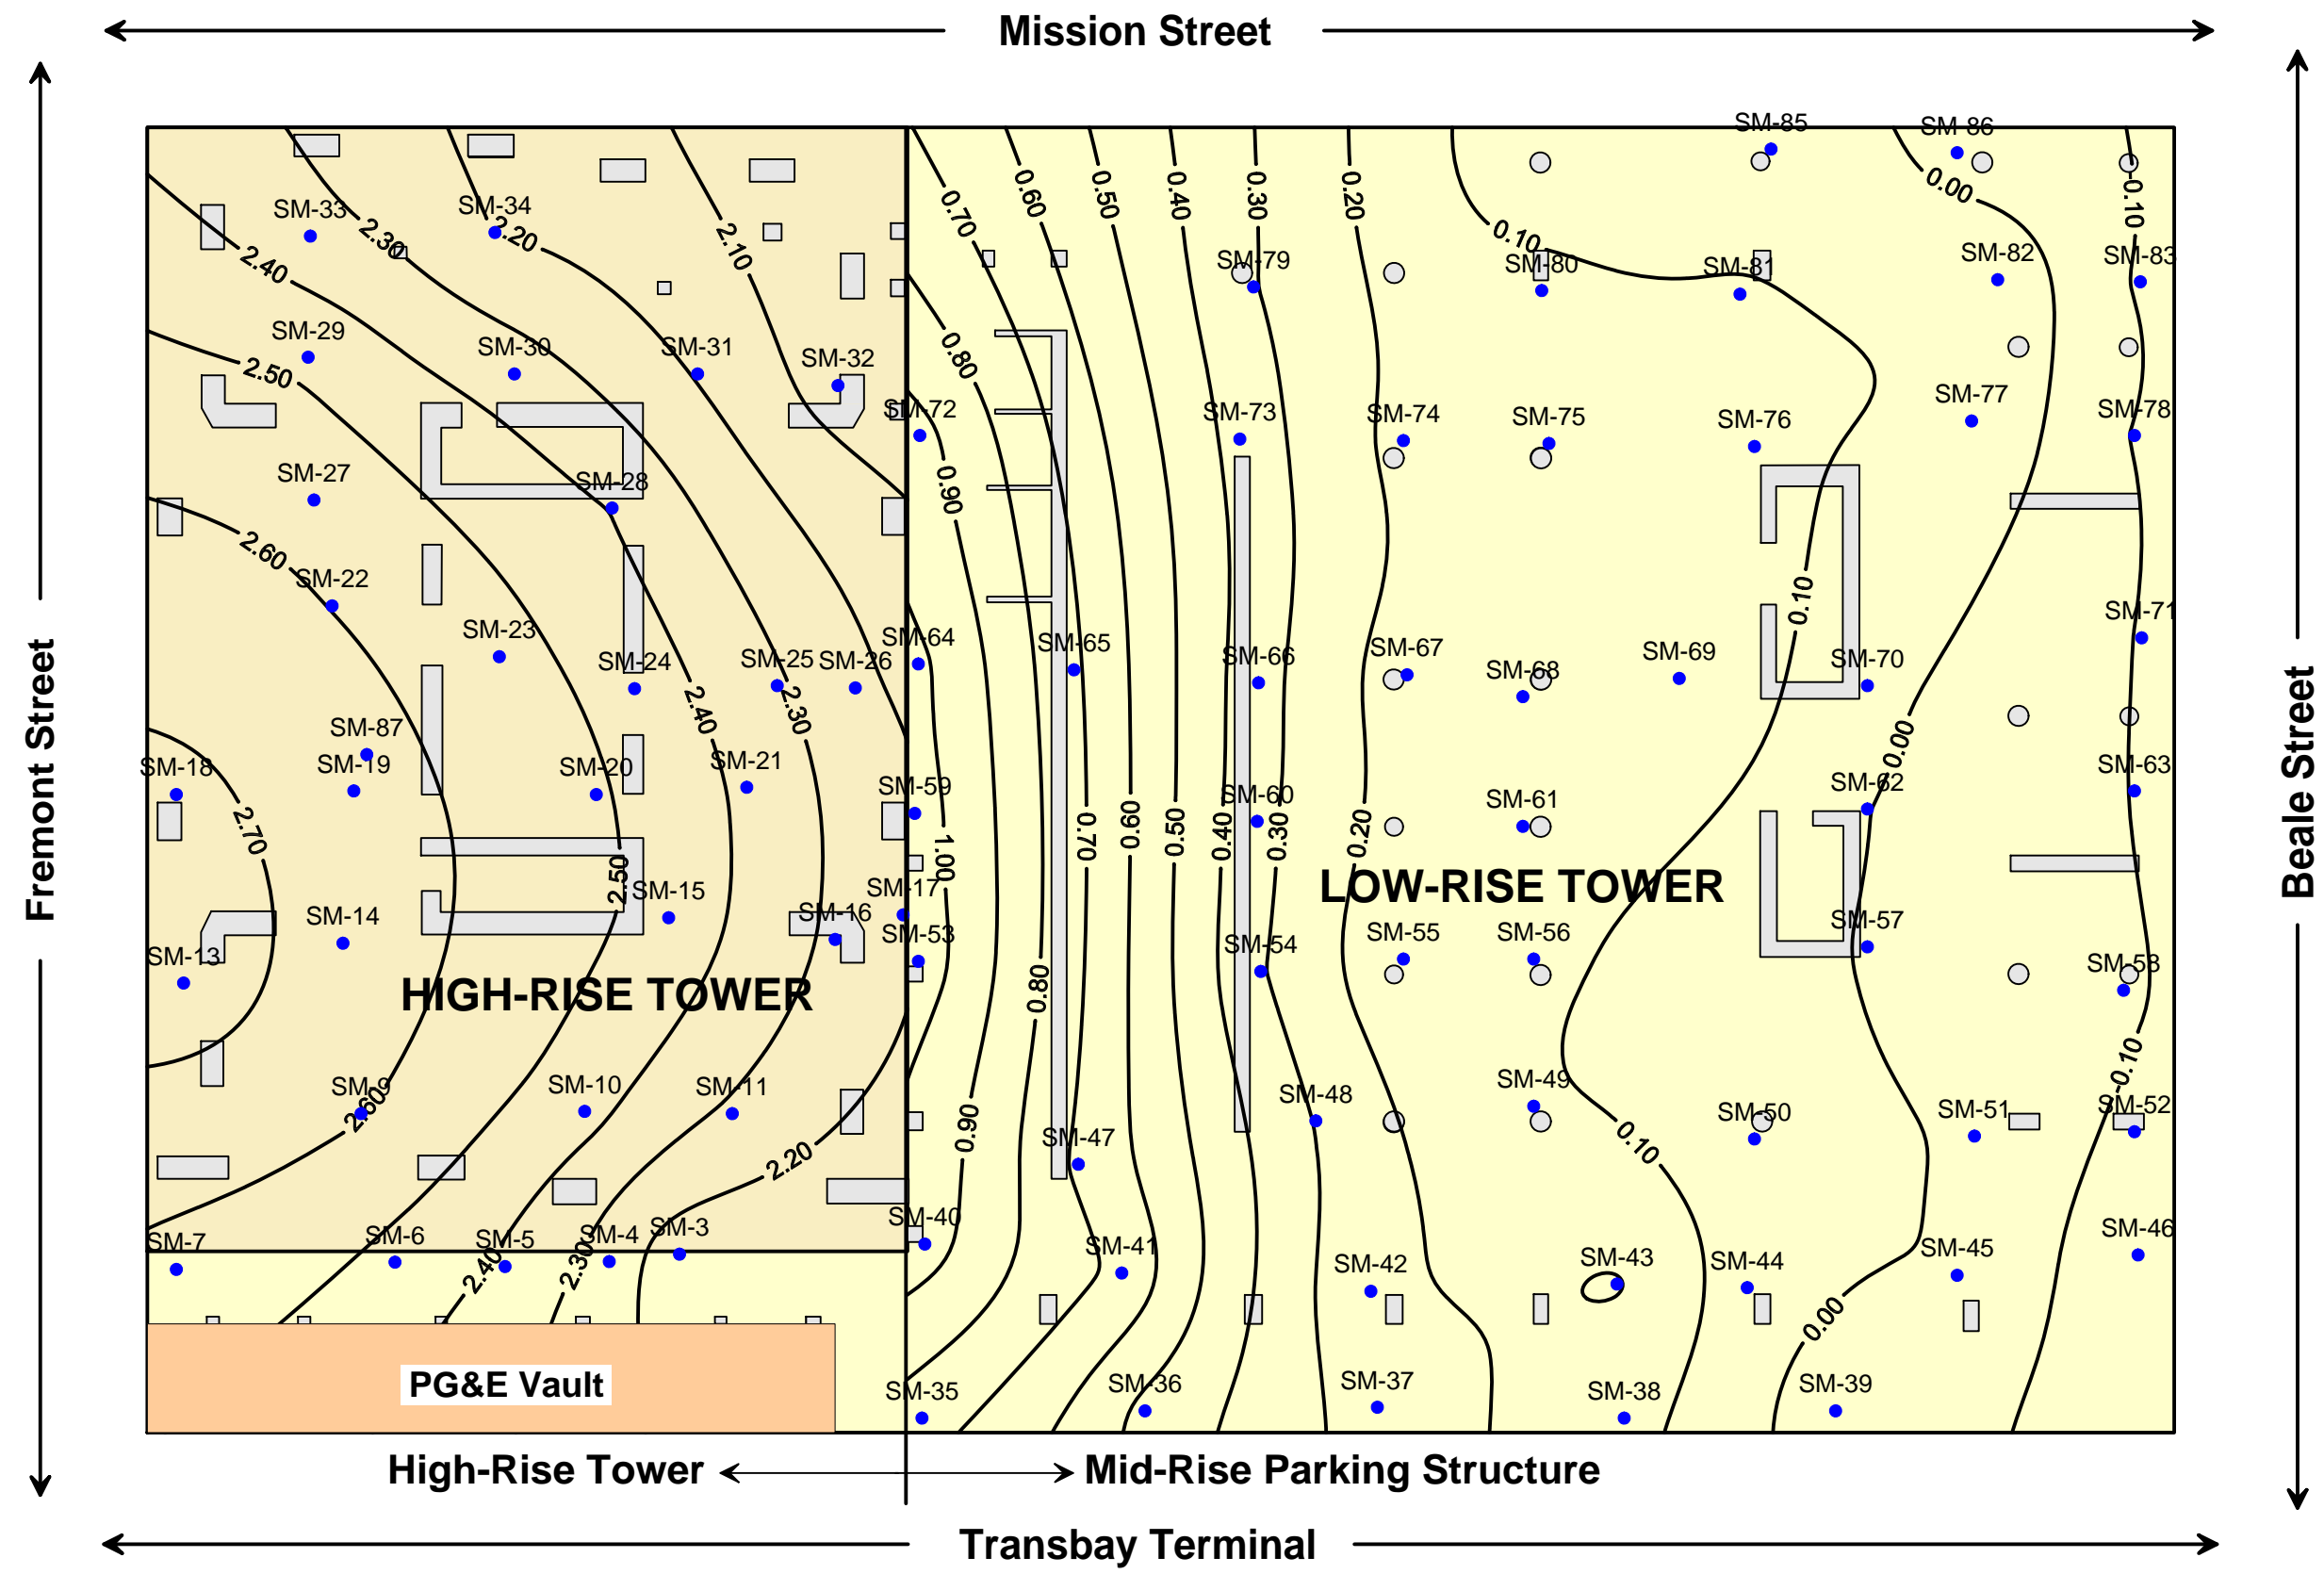
Notes:
Contours represent elevation change, in inches, between Baseline survey (April 30, 2009) and readings taken on August 13, 2012.
Level B-1 at Mid-Rise Parking portion of survey site is approximately 4 inches higher than Level B-1 at High-Rise Tower portion.
The PG&E vault is inaccessible for monitoring.
Negative values of settlement (within Low-rise Tower) indicate uplift.

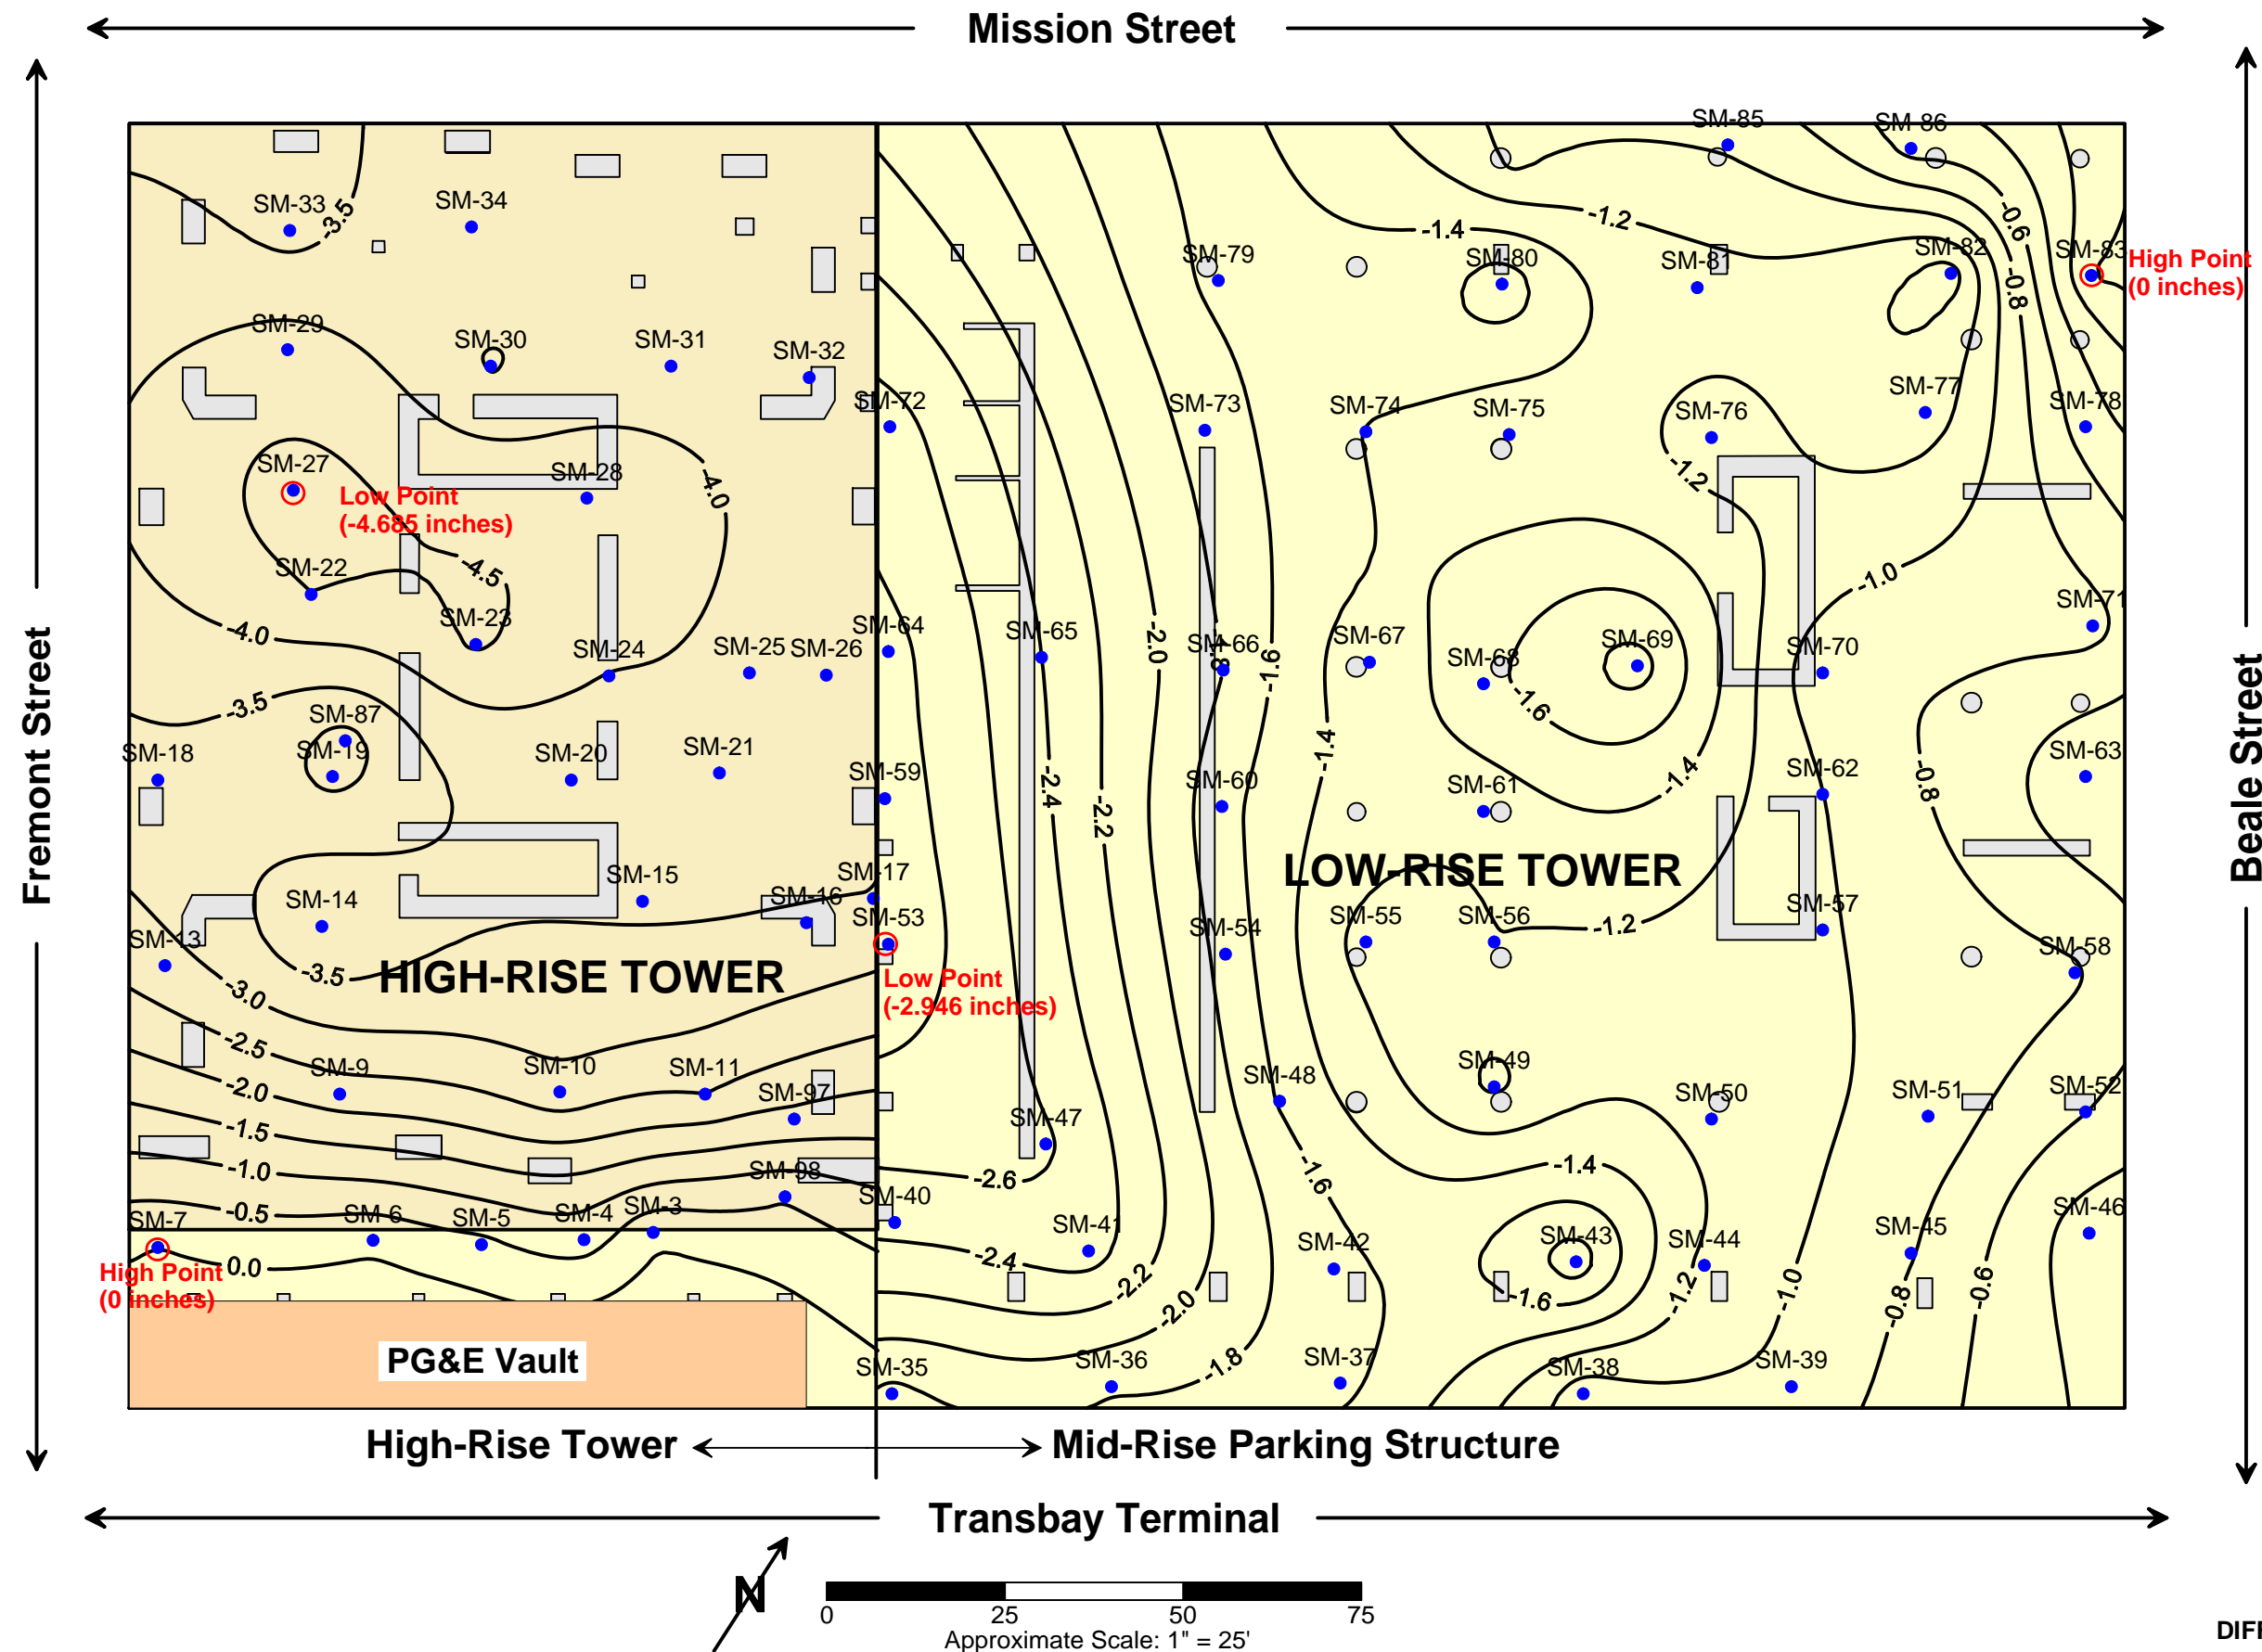
Contours represent differential elevation, in inches, between the highest point and all other points taken on October 12, 2012.
 Level B-1 at Mid-Rise Parking portion of survey site is approximately 4 inches higher than Level B-1 at High-Rise Tower portion.
 The PG&E vault is inaccessible for monitoring.
 Contour intervals are different between the High-Rise Tower and the Low-Rise Tower.

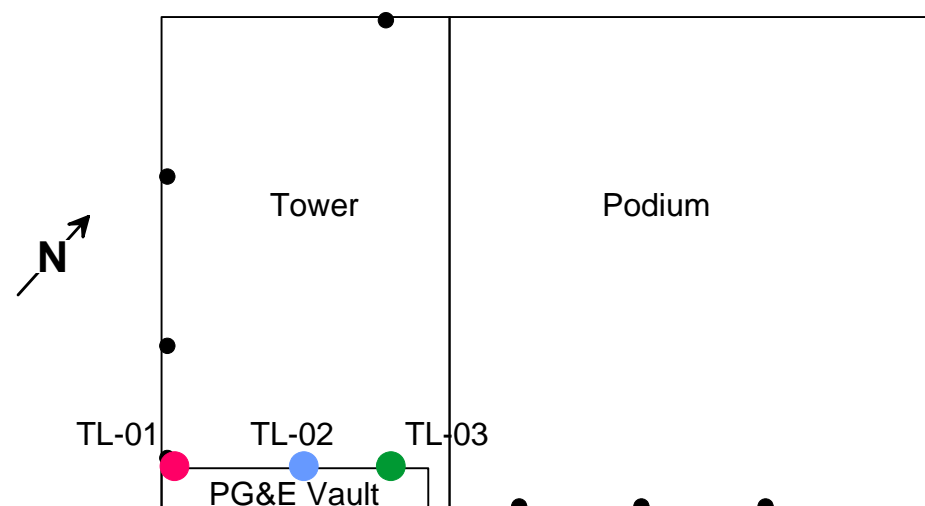
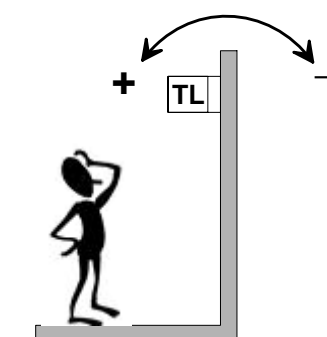
TILT RECORDED IN TILTMETERS TL-01, TL-02, AND TL-03: BASEMENT LEVEL B-1

Positive tilt represents movement of the top of the wall towards the inside of the room.

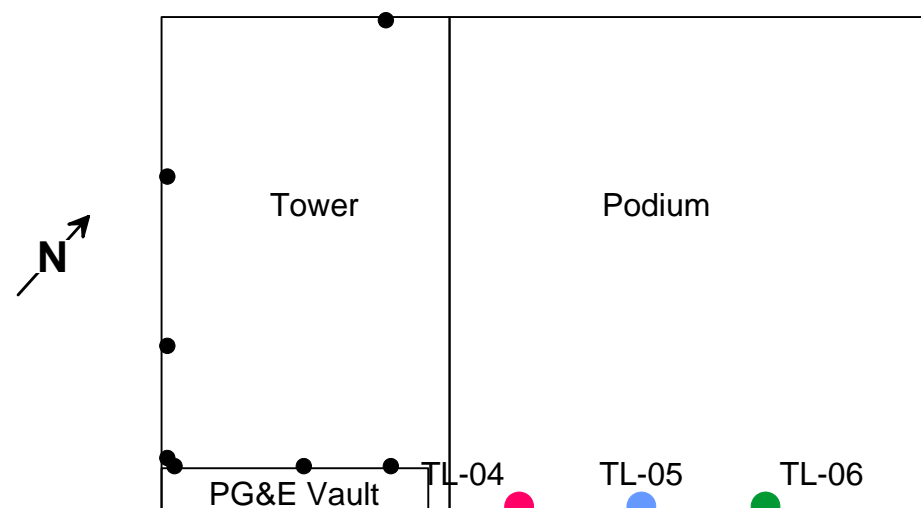
TILT RECORDED IN TILTMETERS TL-04, TL-05, AND TL-06: BASEMENT LEVEL B-1

Positive tilt represents movement of the top of the wall towards the inside of the room.

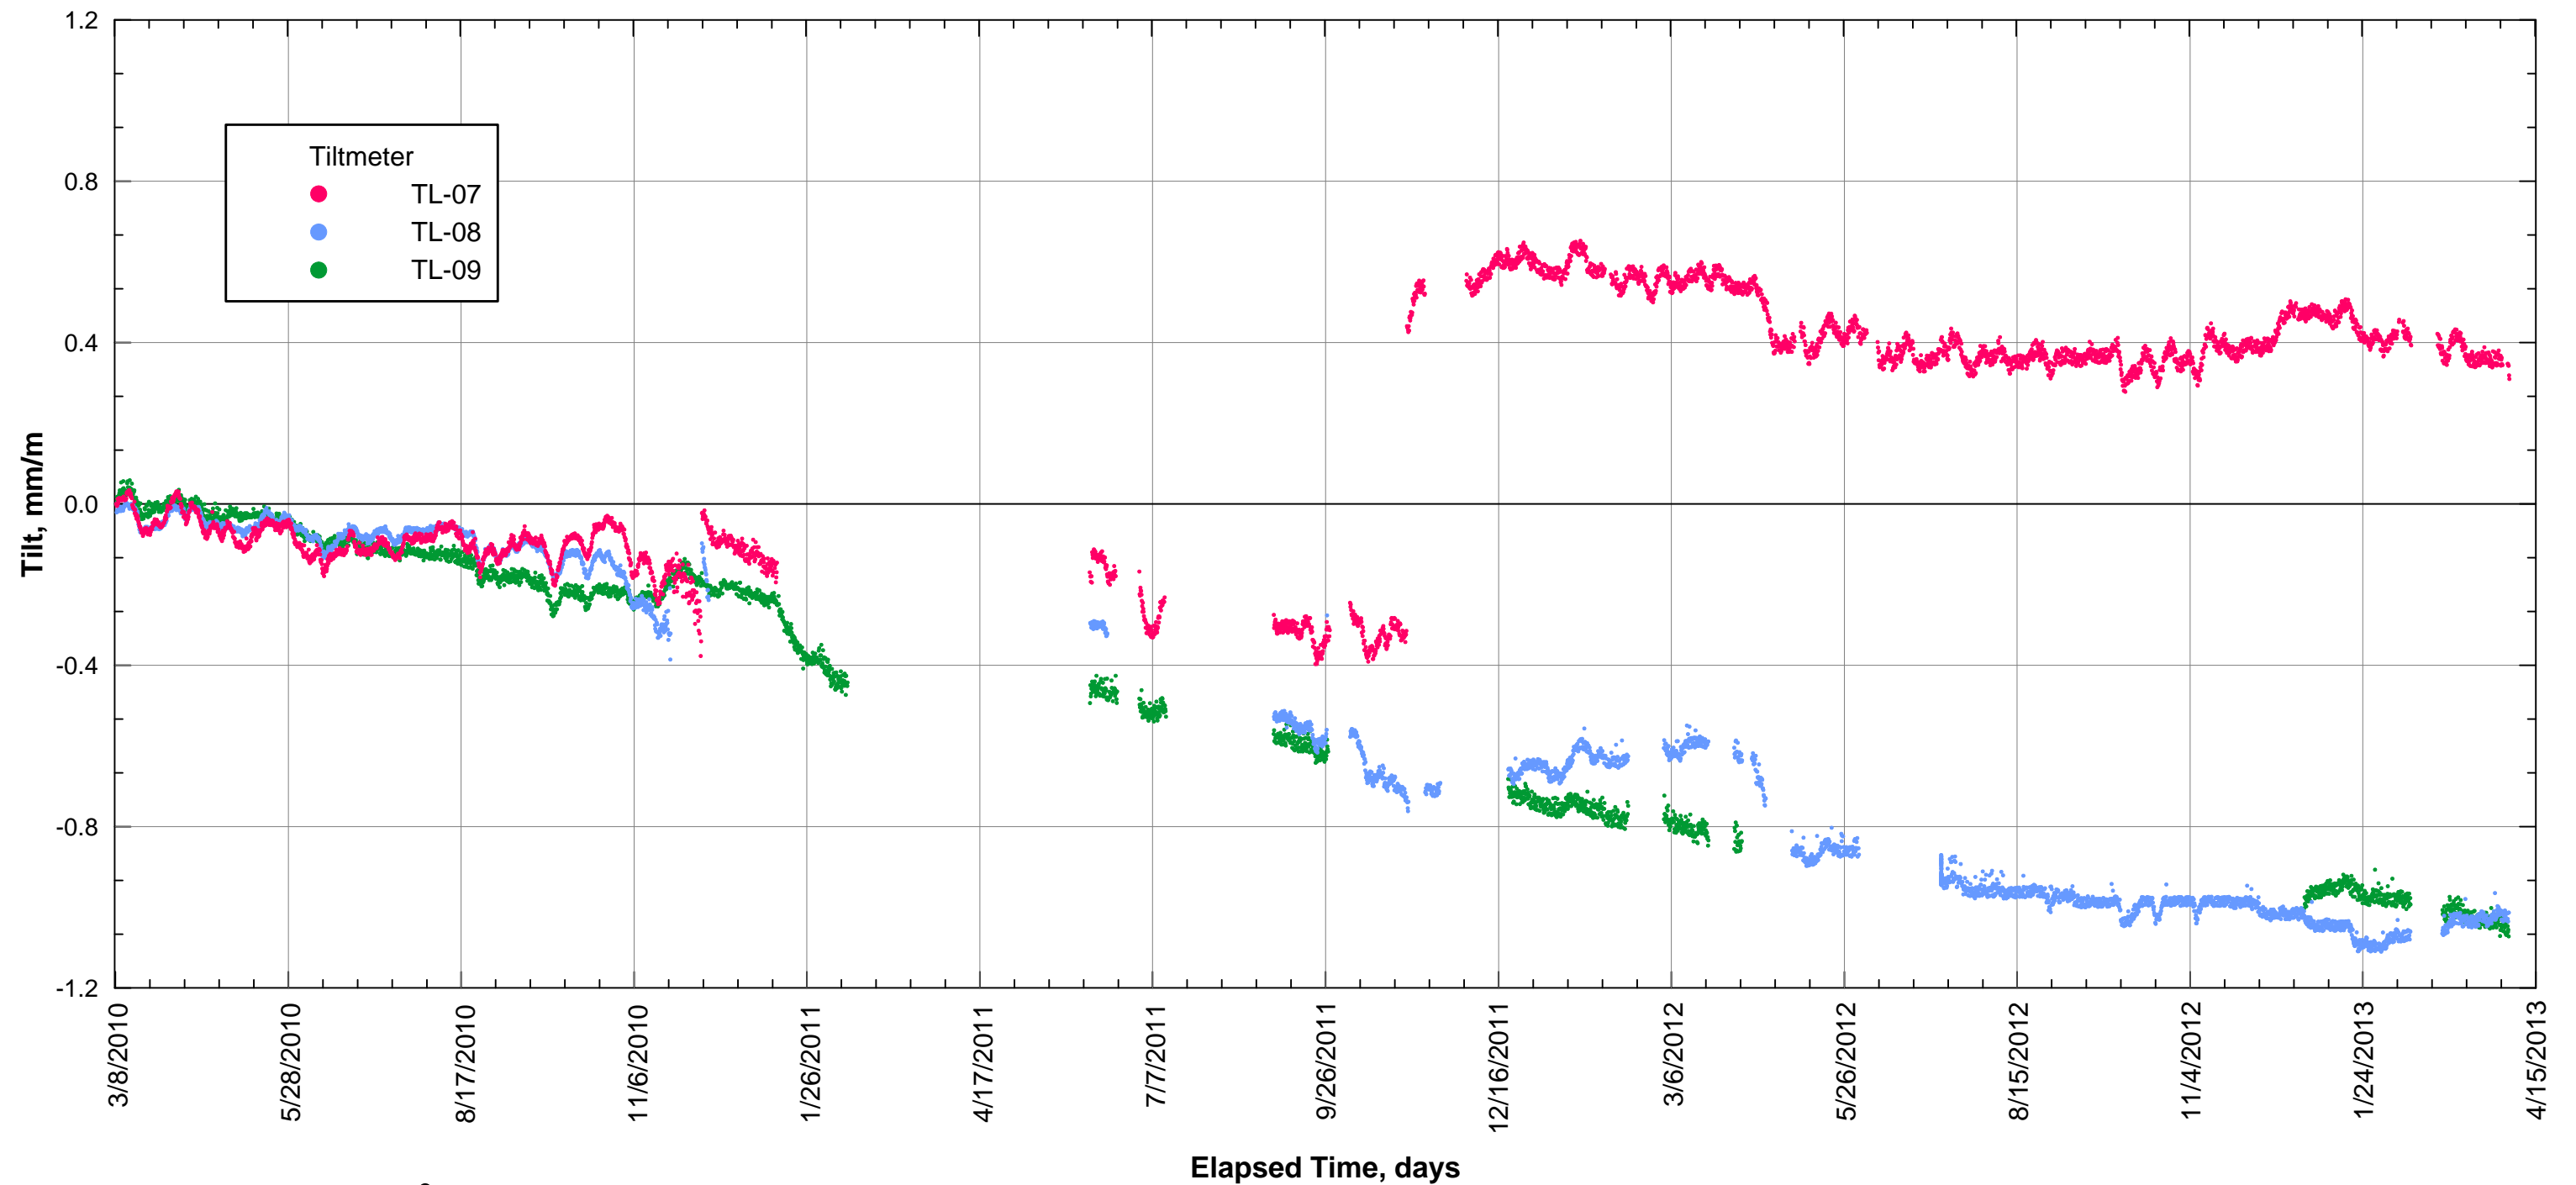
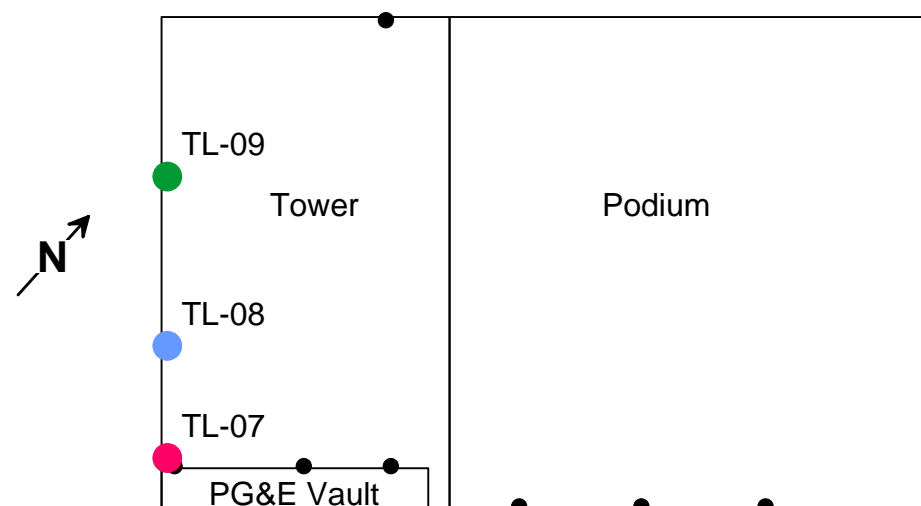
TILT RECORDED IN TILTMETERS TL-07, TL-08, AND TL-09: BASEMENT LEVEL B-1

Positive tilt represents movement of the top of the wall towards the inside of the room.

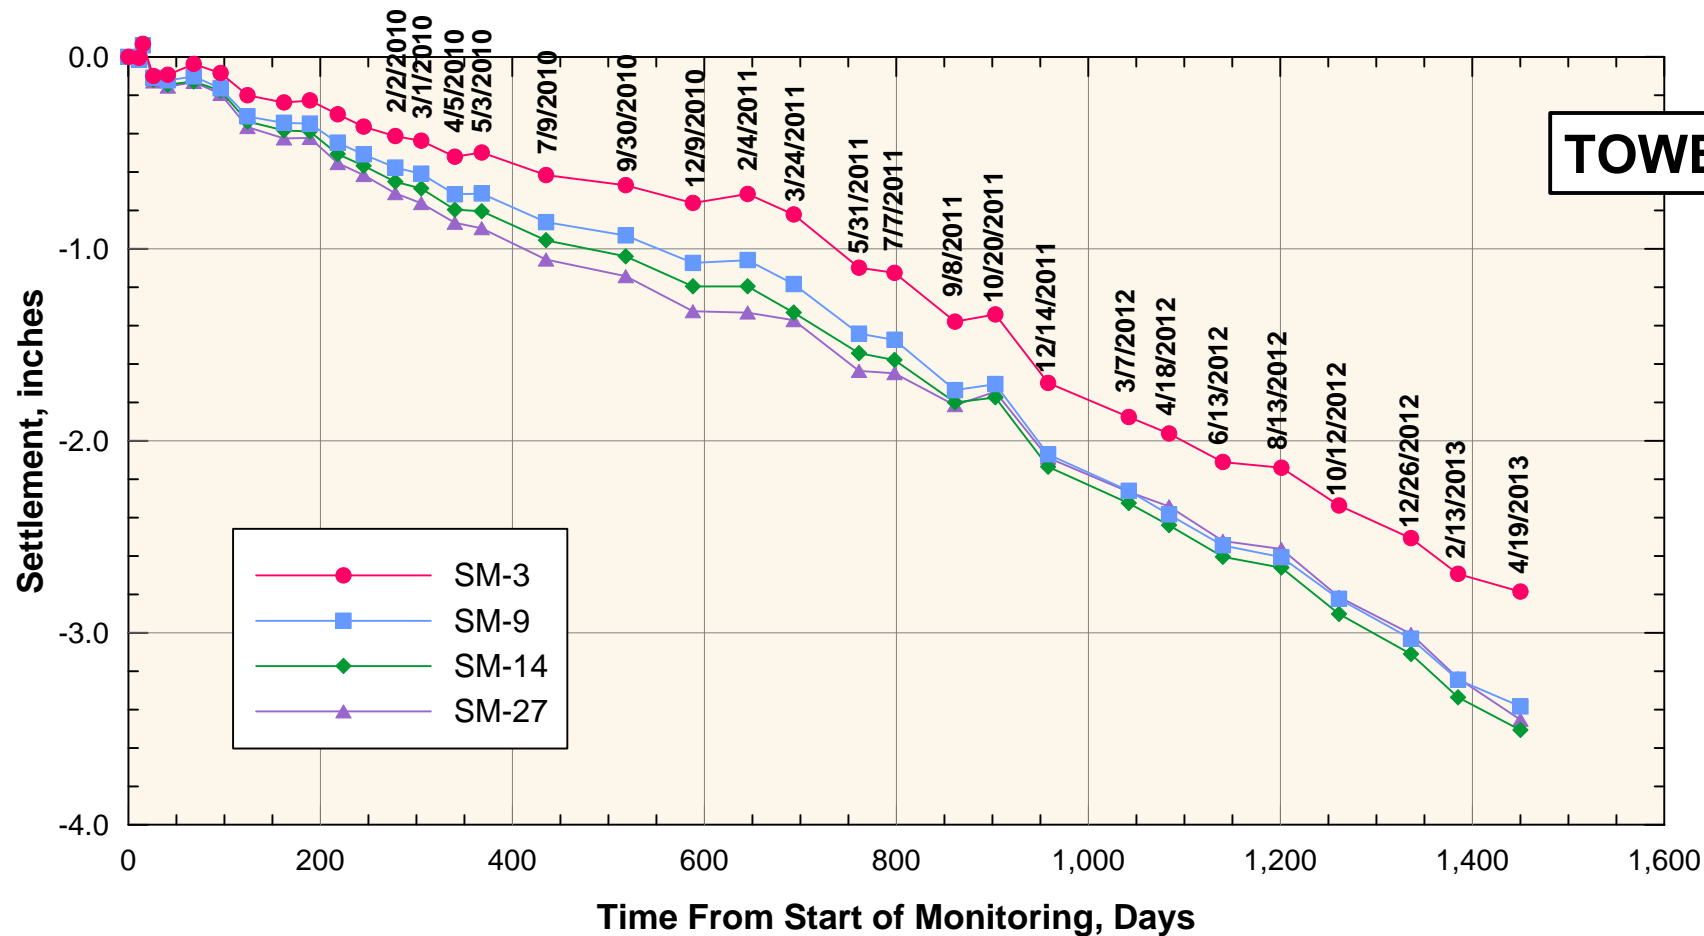
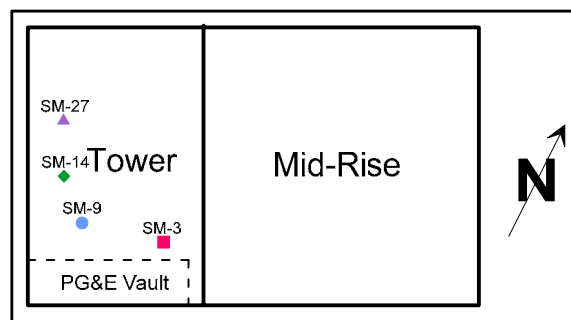
**SETTLEMENT OVER TIME
FLOOR ELEVATIONS AT LEVEL B-1
OF 301 MISSION PROPERTY- TOWER:
APRIL 30, 2009 THROUGH APRIL 19, 2013**

Note:
Initial (Baseline) reading
taken on 04/30/09
