*Board of Supervisors
City and County of San Francisco*

Government Audit and Oversight Committee

Supplemental Report for Foundation Settlement Investigation

**SUPPLEMENTAL REPORT
FOUNDATION SETTLEMENT INVESTIGATION
301 MISSION STREET
SAN FRANCISCO, CALIFORNIA**

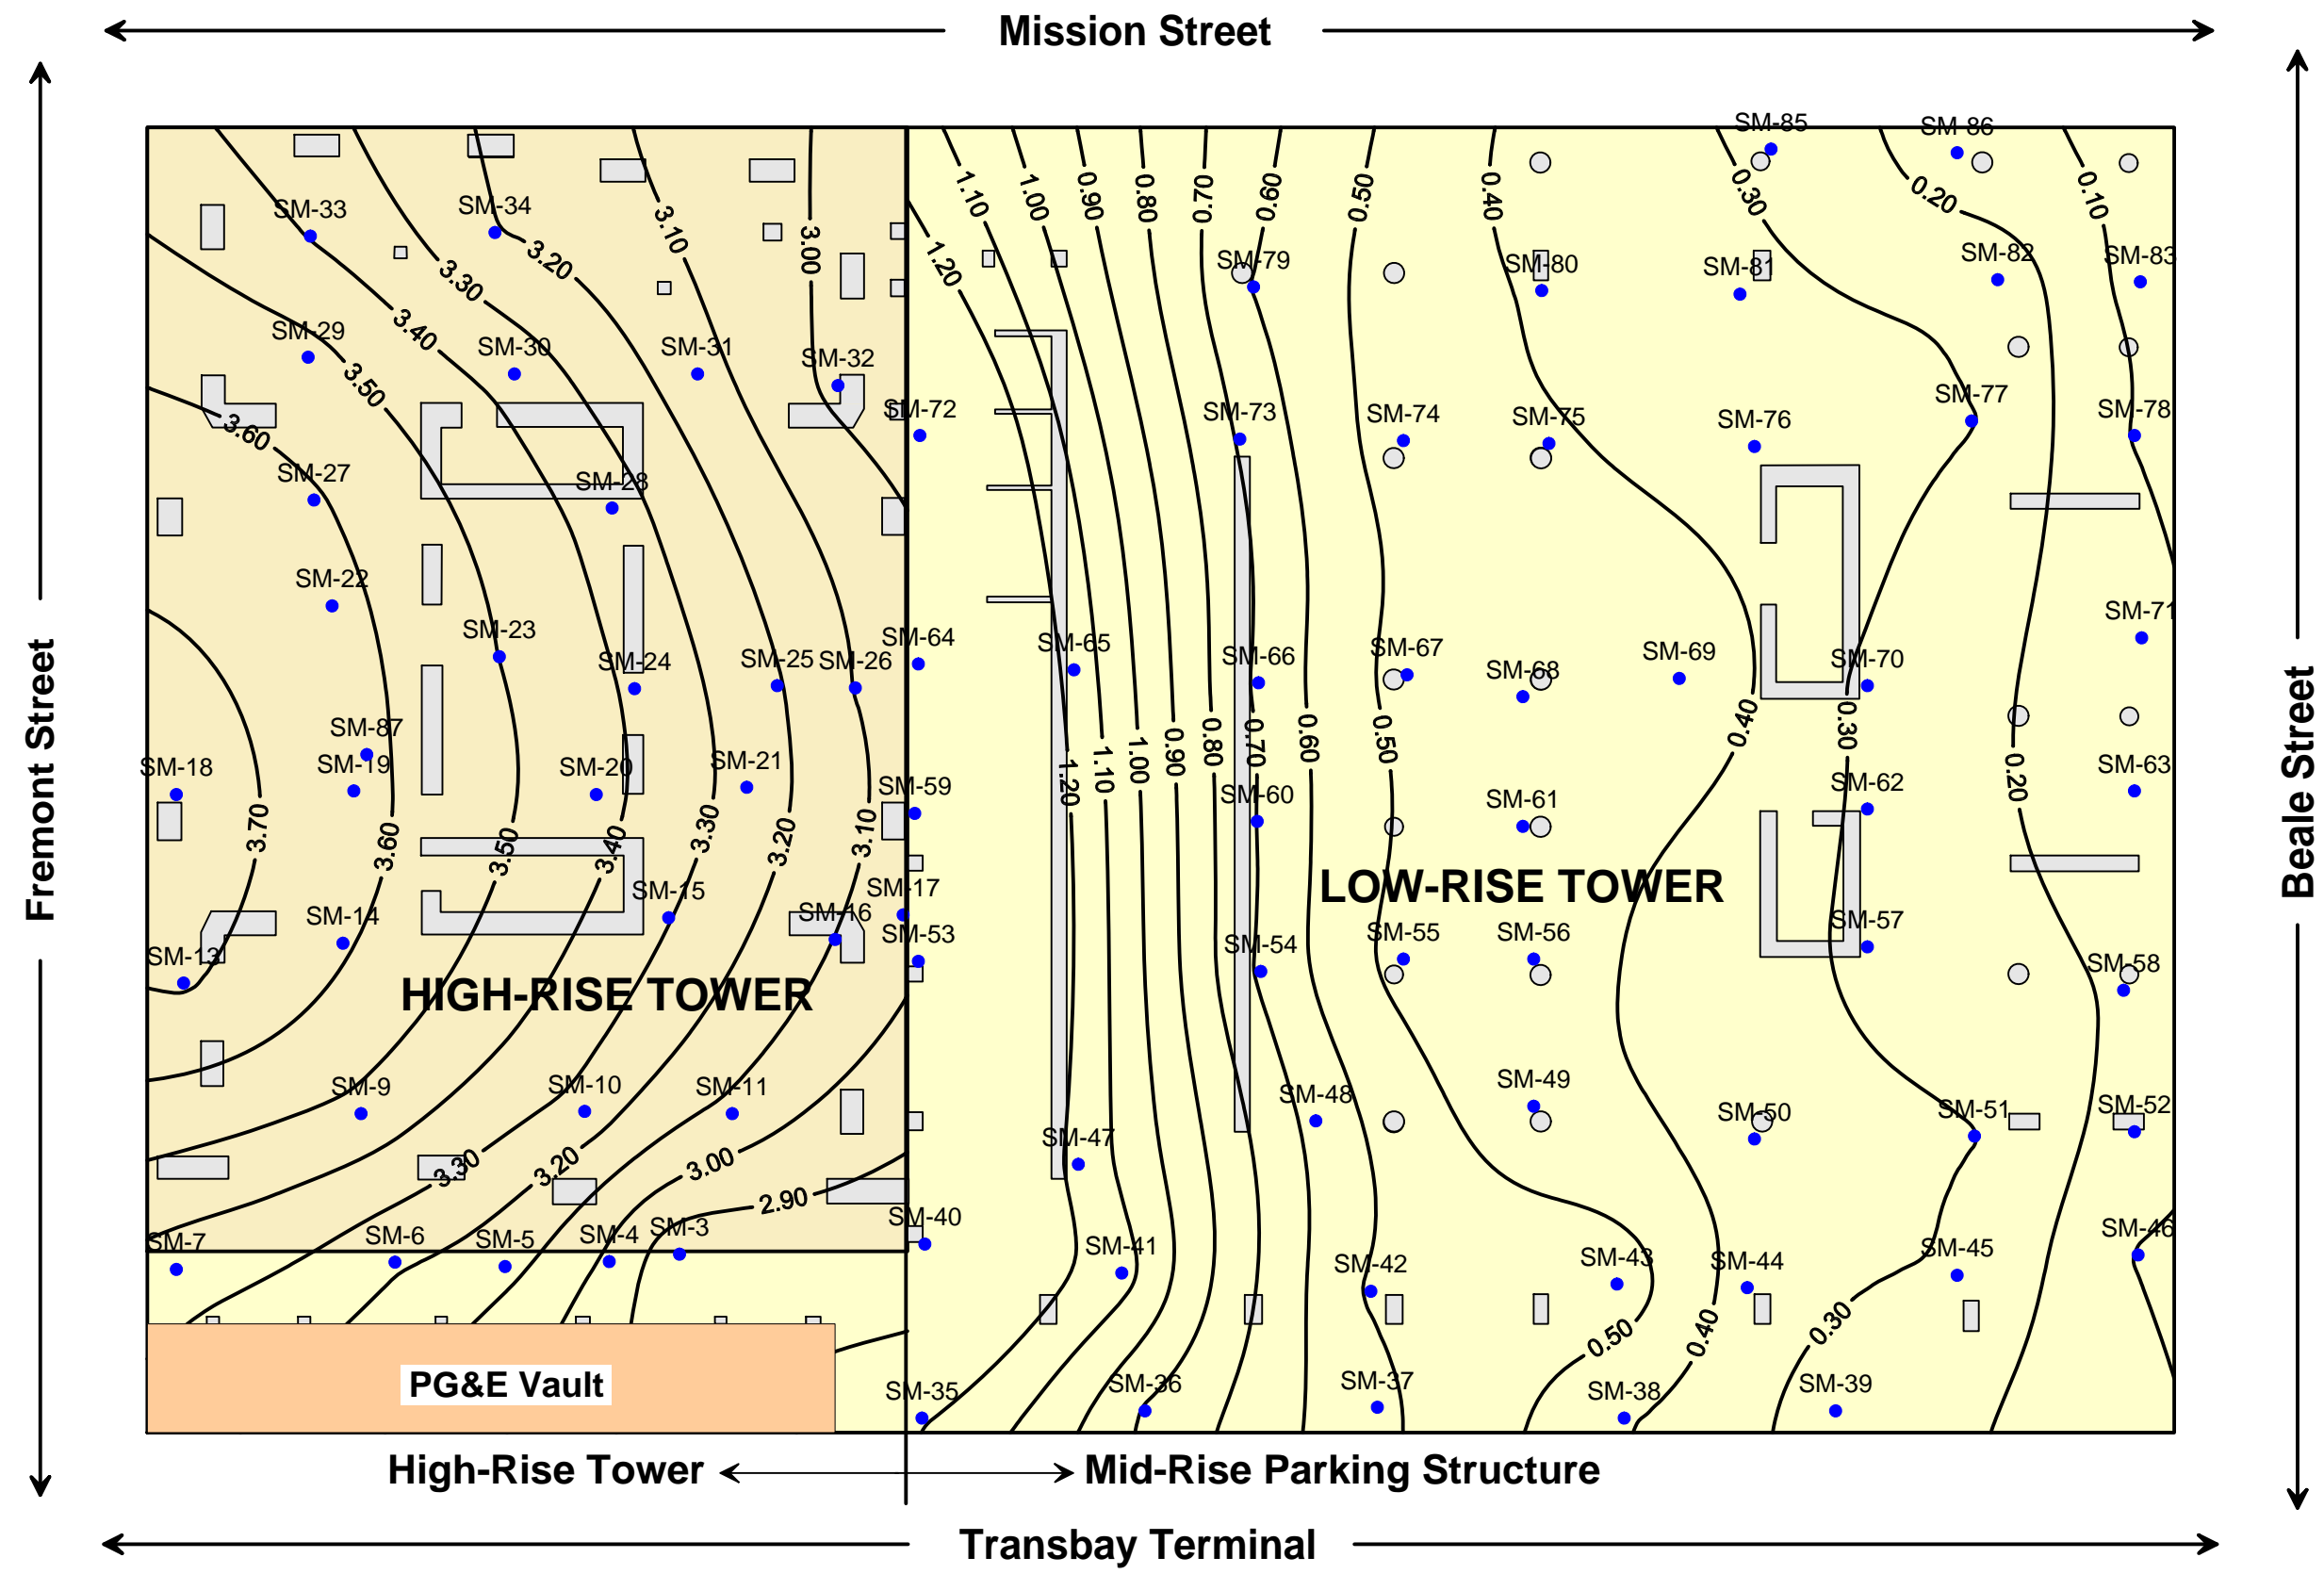
CONTOURS OF SETTLEMENTS MEASURED AT THE 1ST LEVEL BASEMENT OF THE 301 MISSION ST STRUCTURE BETWEEN 04/30/2009 & 06/03/2013
 Transbay Transit Center
 301 Mission Monitoring
 Transbay Joint Powers Authority
 San Francisco, California
 June 2013

Notes:
 Contours represent elevation change, in inches, between Baseline survey (April 30, 2009) and readings taken on June 3, 2013.
 Level B-1 at Mid-Rise Parking portion of survey site is approximately 4 inches higher than Level B-1 at High-Rise Tower portion.
 The PG&E vault is inaccessible for monitoring.
 Negative values of settlement (within Low-rise Tower) indicate uplift.

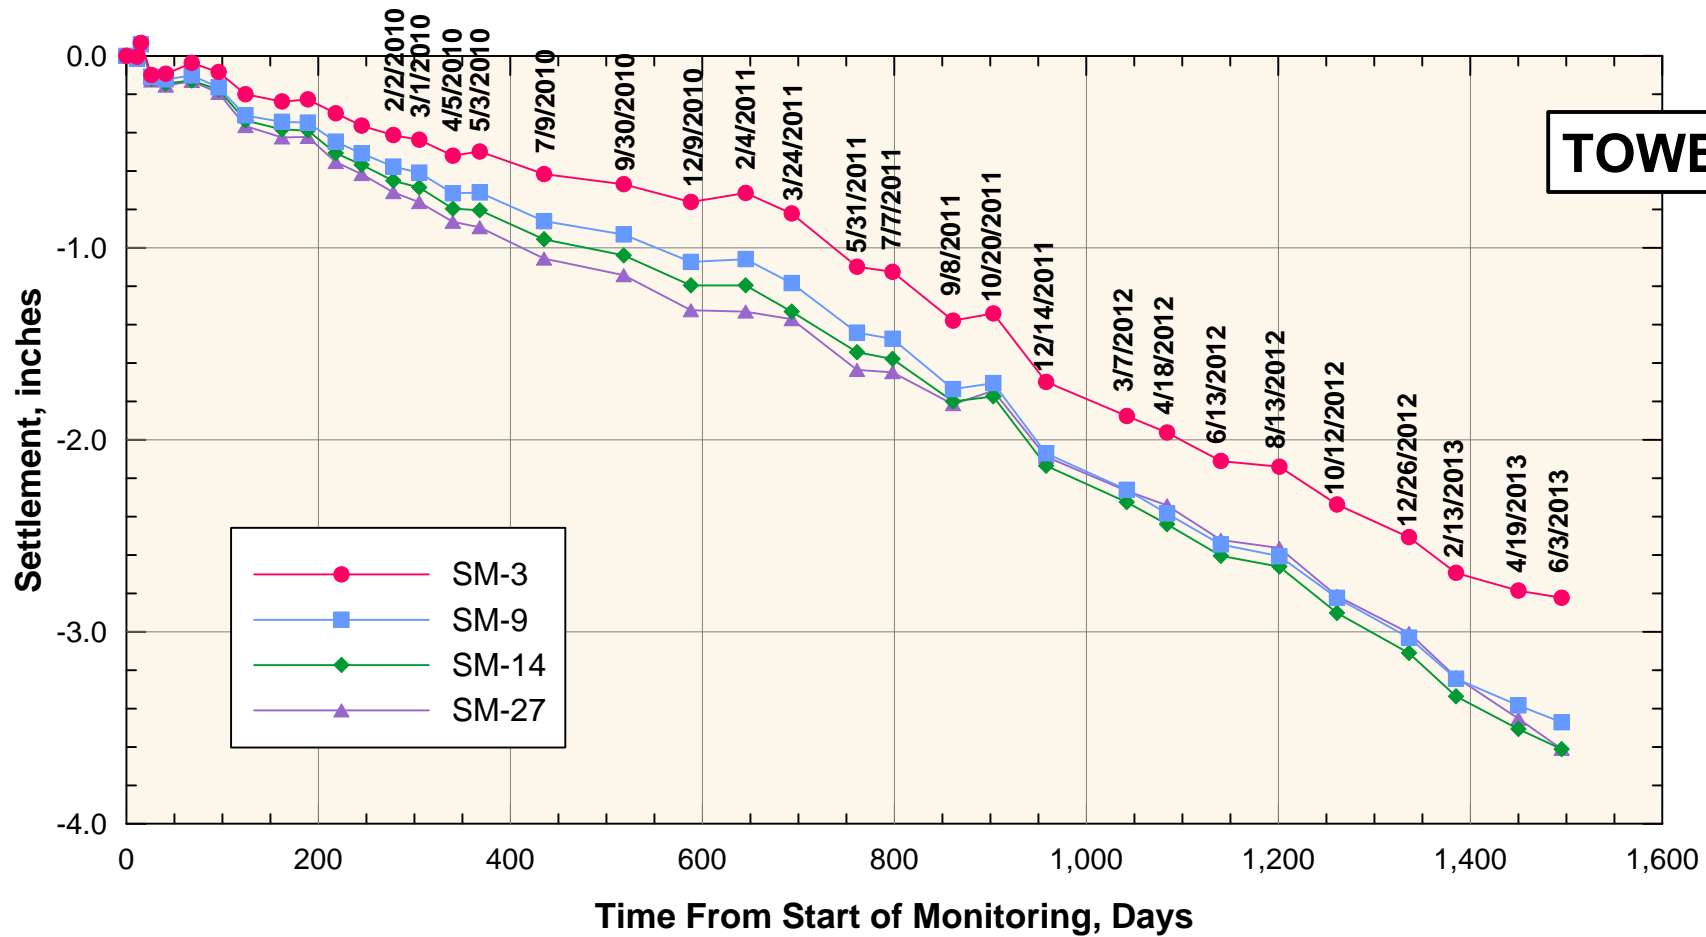
**SETTLEMENT OVER TIME
FLOOR ELEVATIONS AT LEVEL B-1
OF 301 MISSION PROPERTY- TOWER:
APRIL 30, 2009 THROUGH JUNE 03, 2013**

Note:
Initial (Baseline) reading
taken on 04/30/09

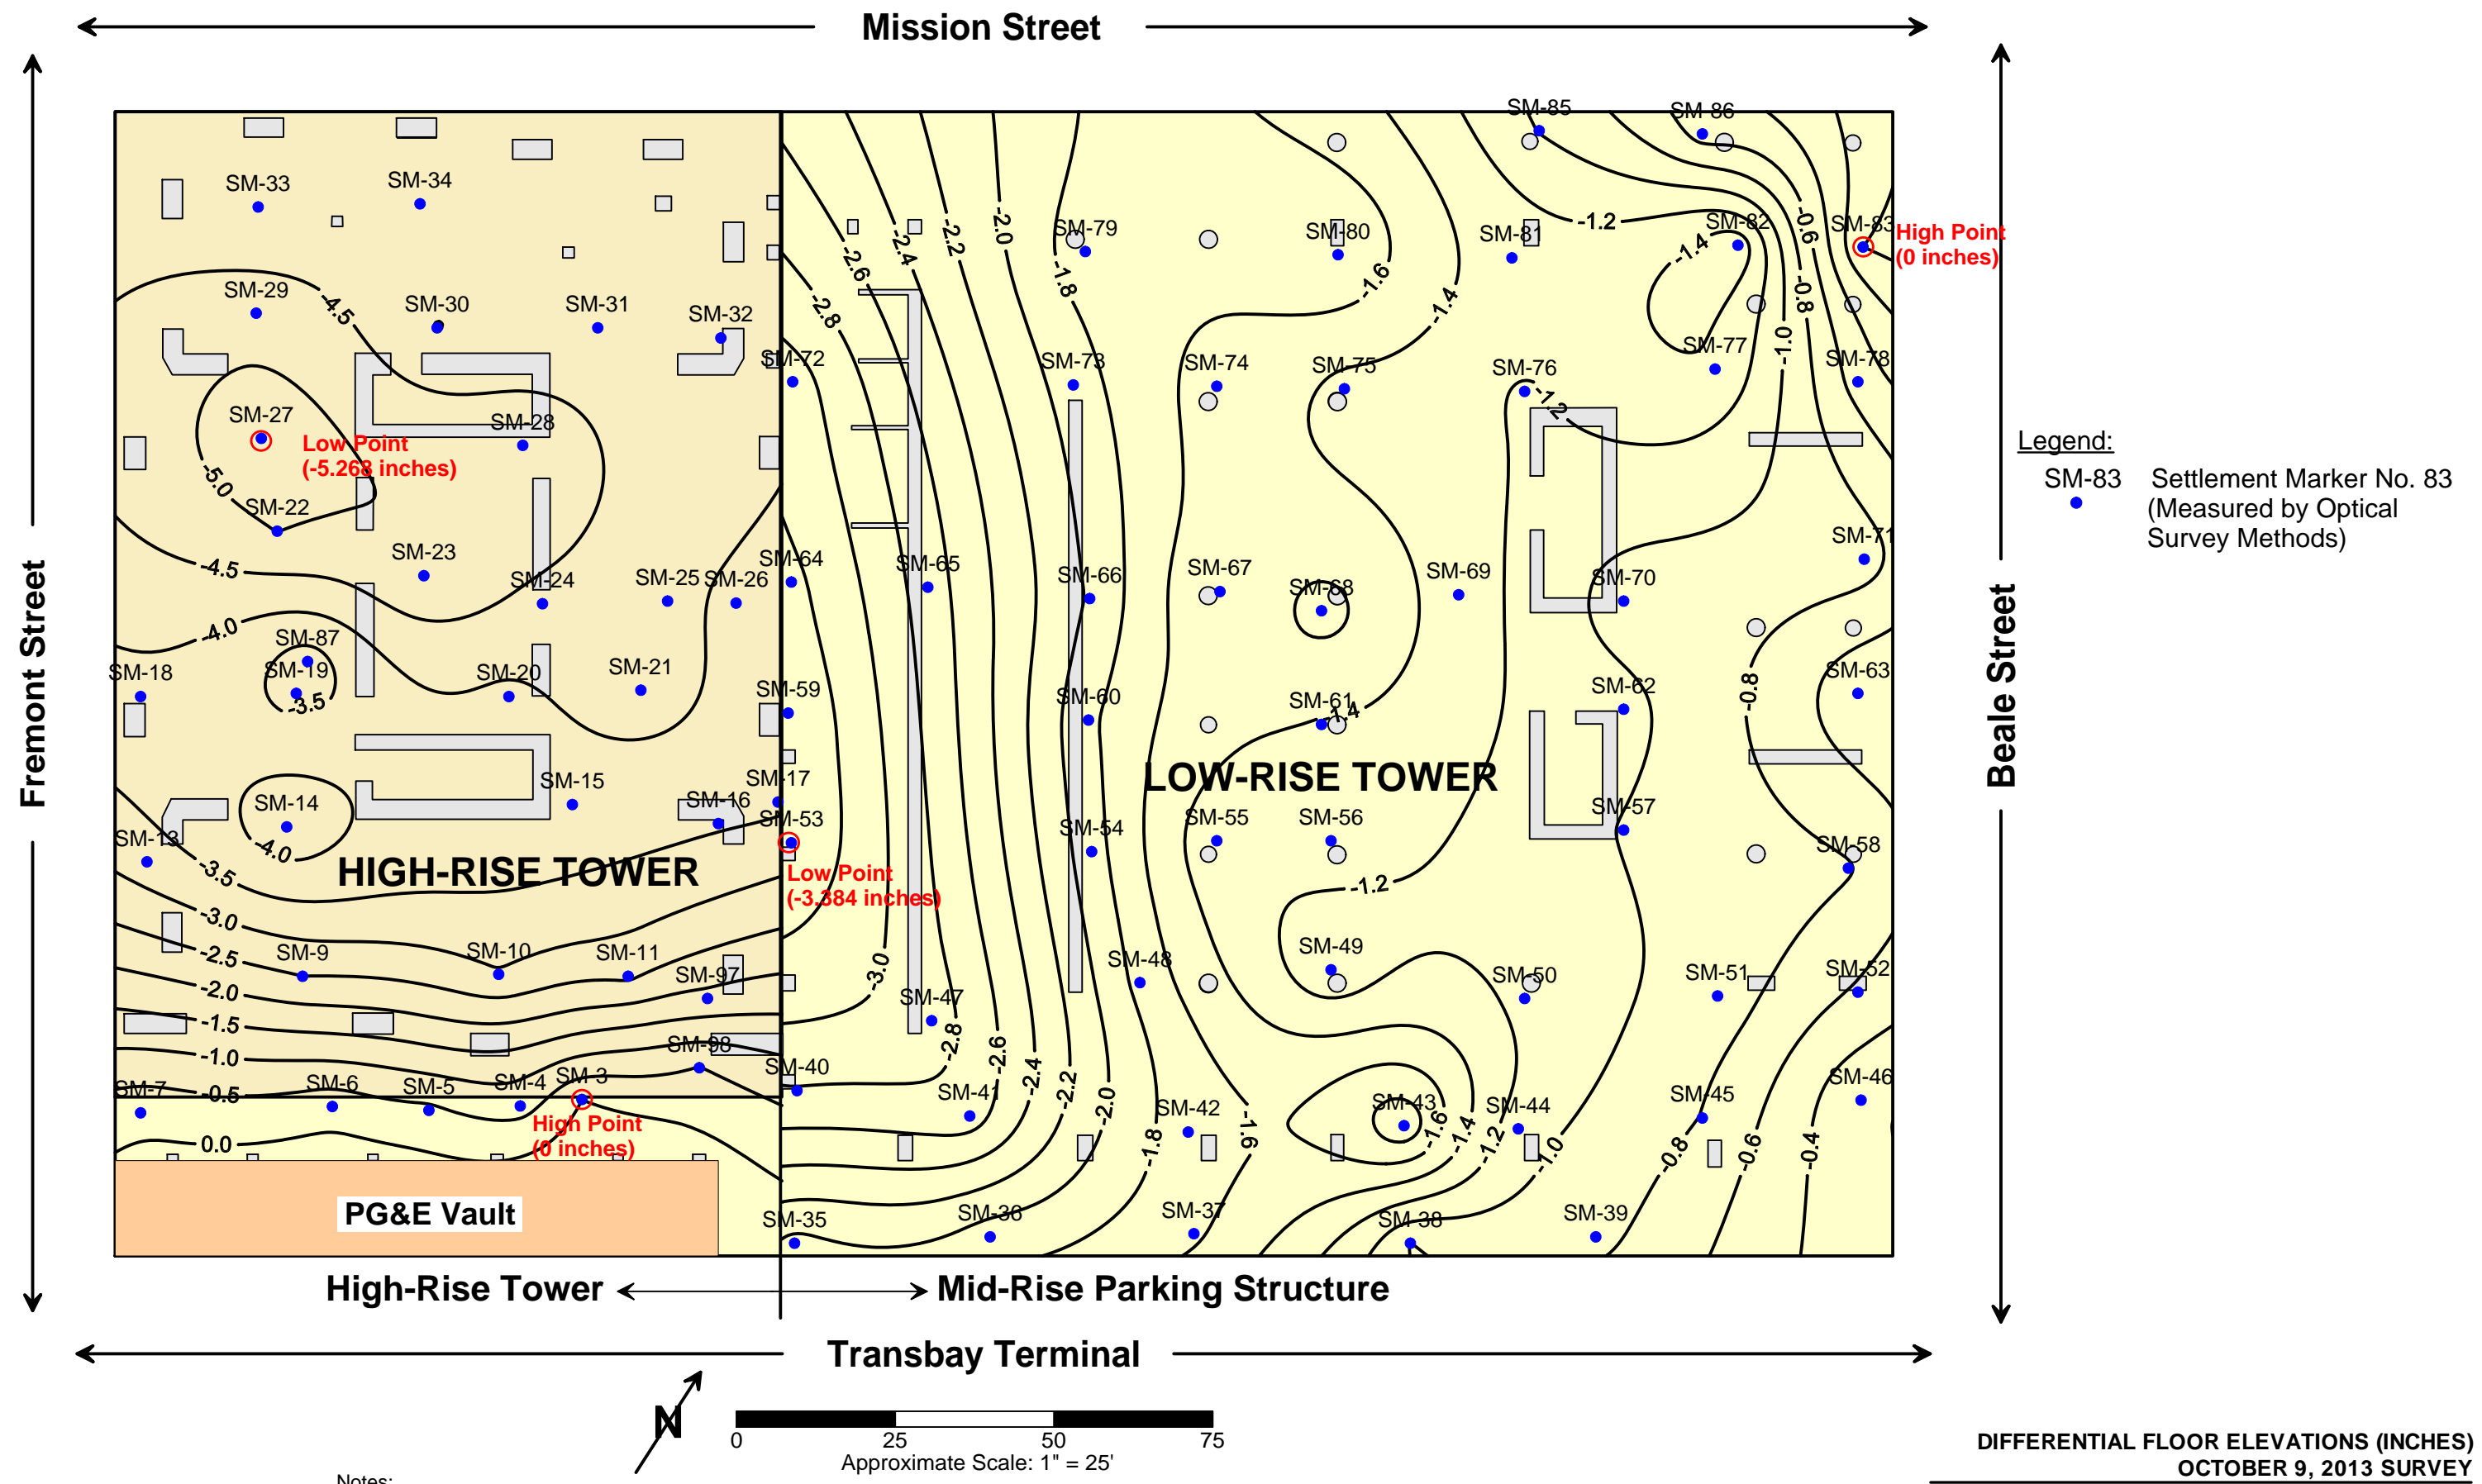
PLATE 1

Contours represent differential elevation, in inches, between the highest point and all other points taken on October 9, 2013.

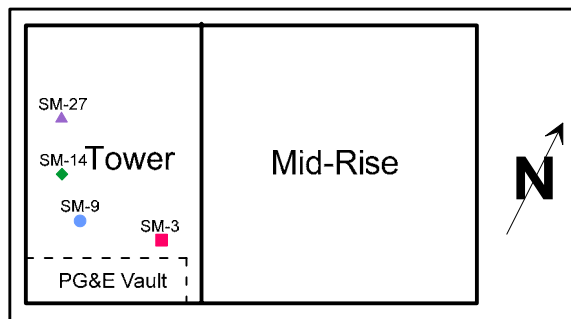
**SETTLEMENT OVER TIME
FLOOR ELEVATIONS AT LEVEL B-1
OF 301 MISSION PROPERTY- TOWER:
APRIL 30, 2009 THROUGH OCTOBER 9, 2013**

Note:
Initial (Baseline) reading
taken on 04/30/09

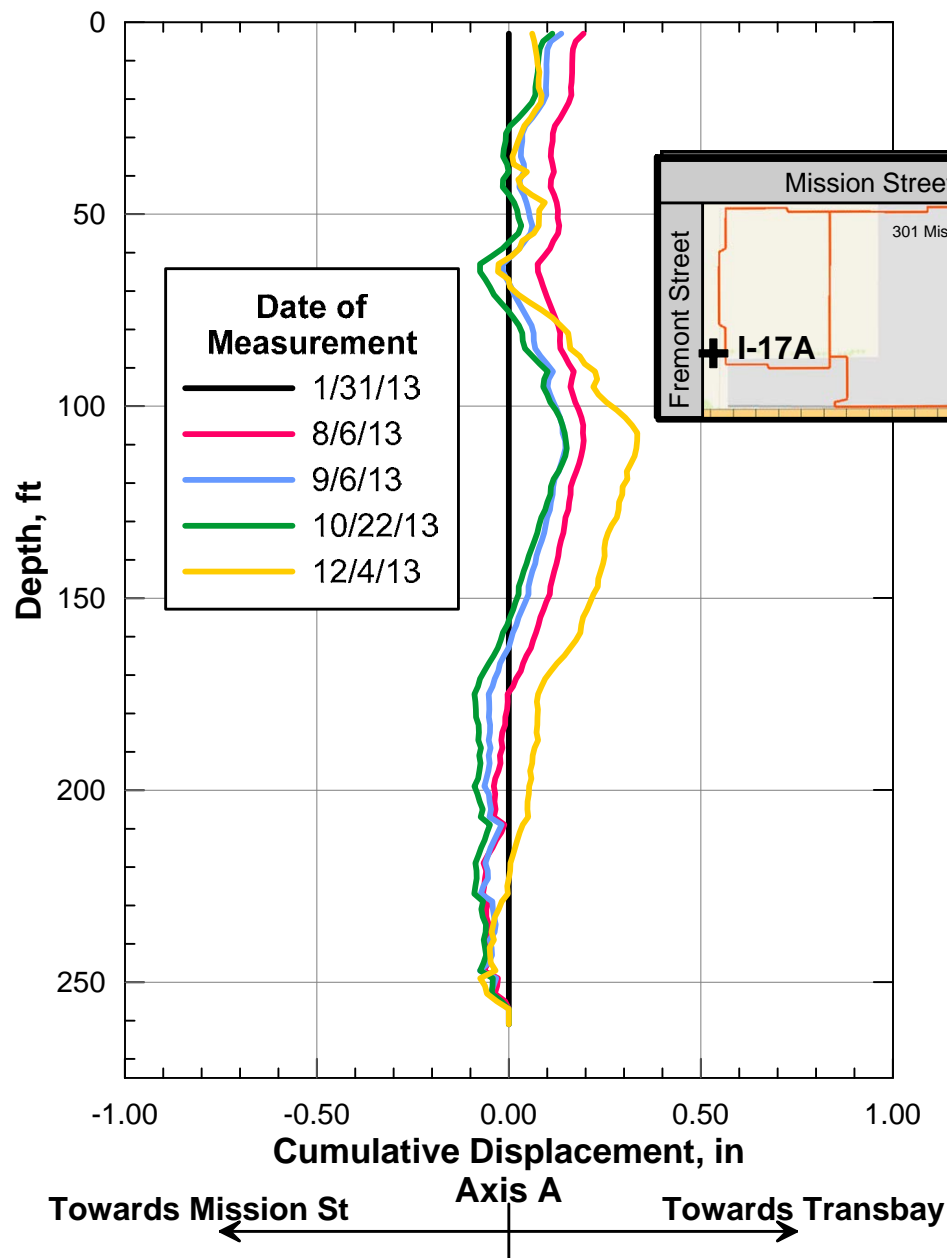
MEASUREMENTS TAKEN AT INCLINOMETER I-17A

Note - The axes were rotated 30 degrees in order to reflect the directions orthogonal to the excavation.

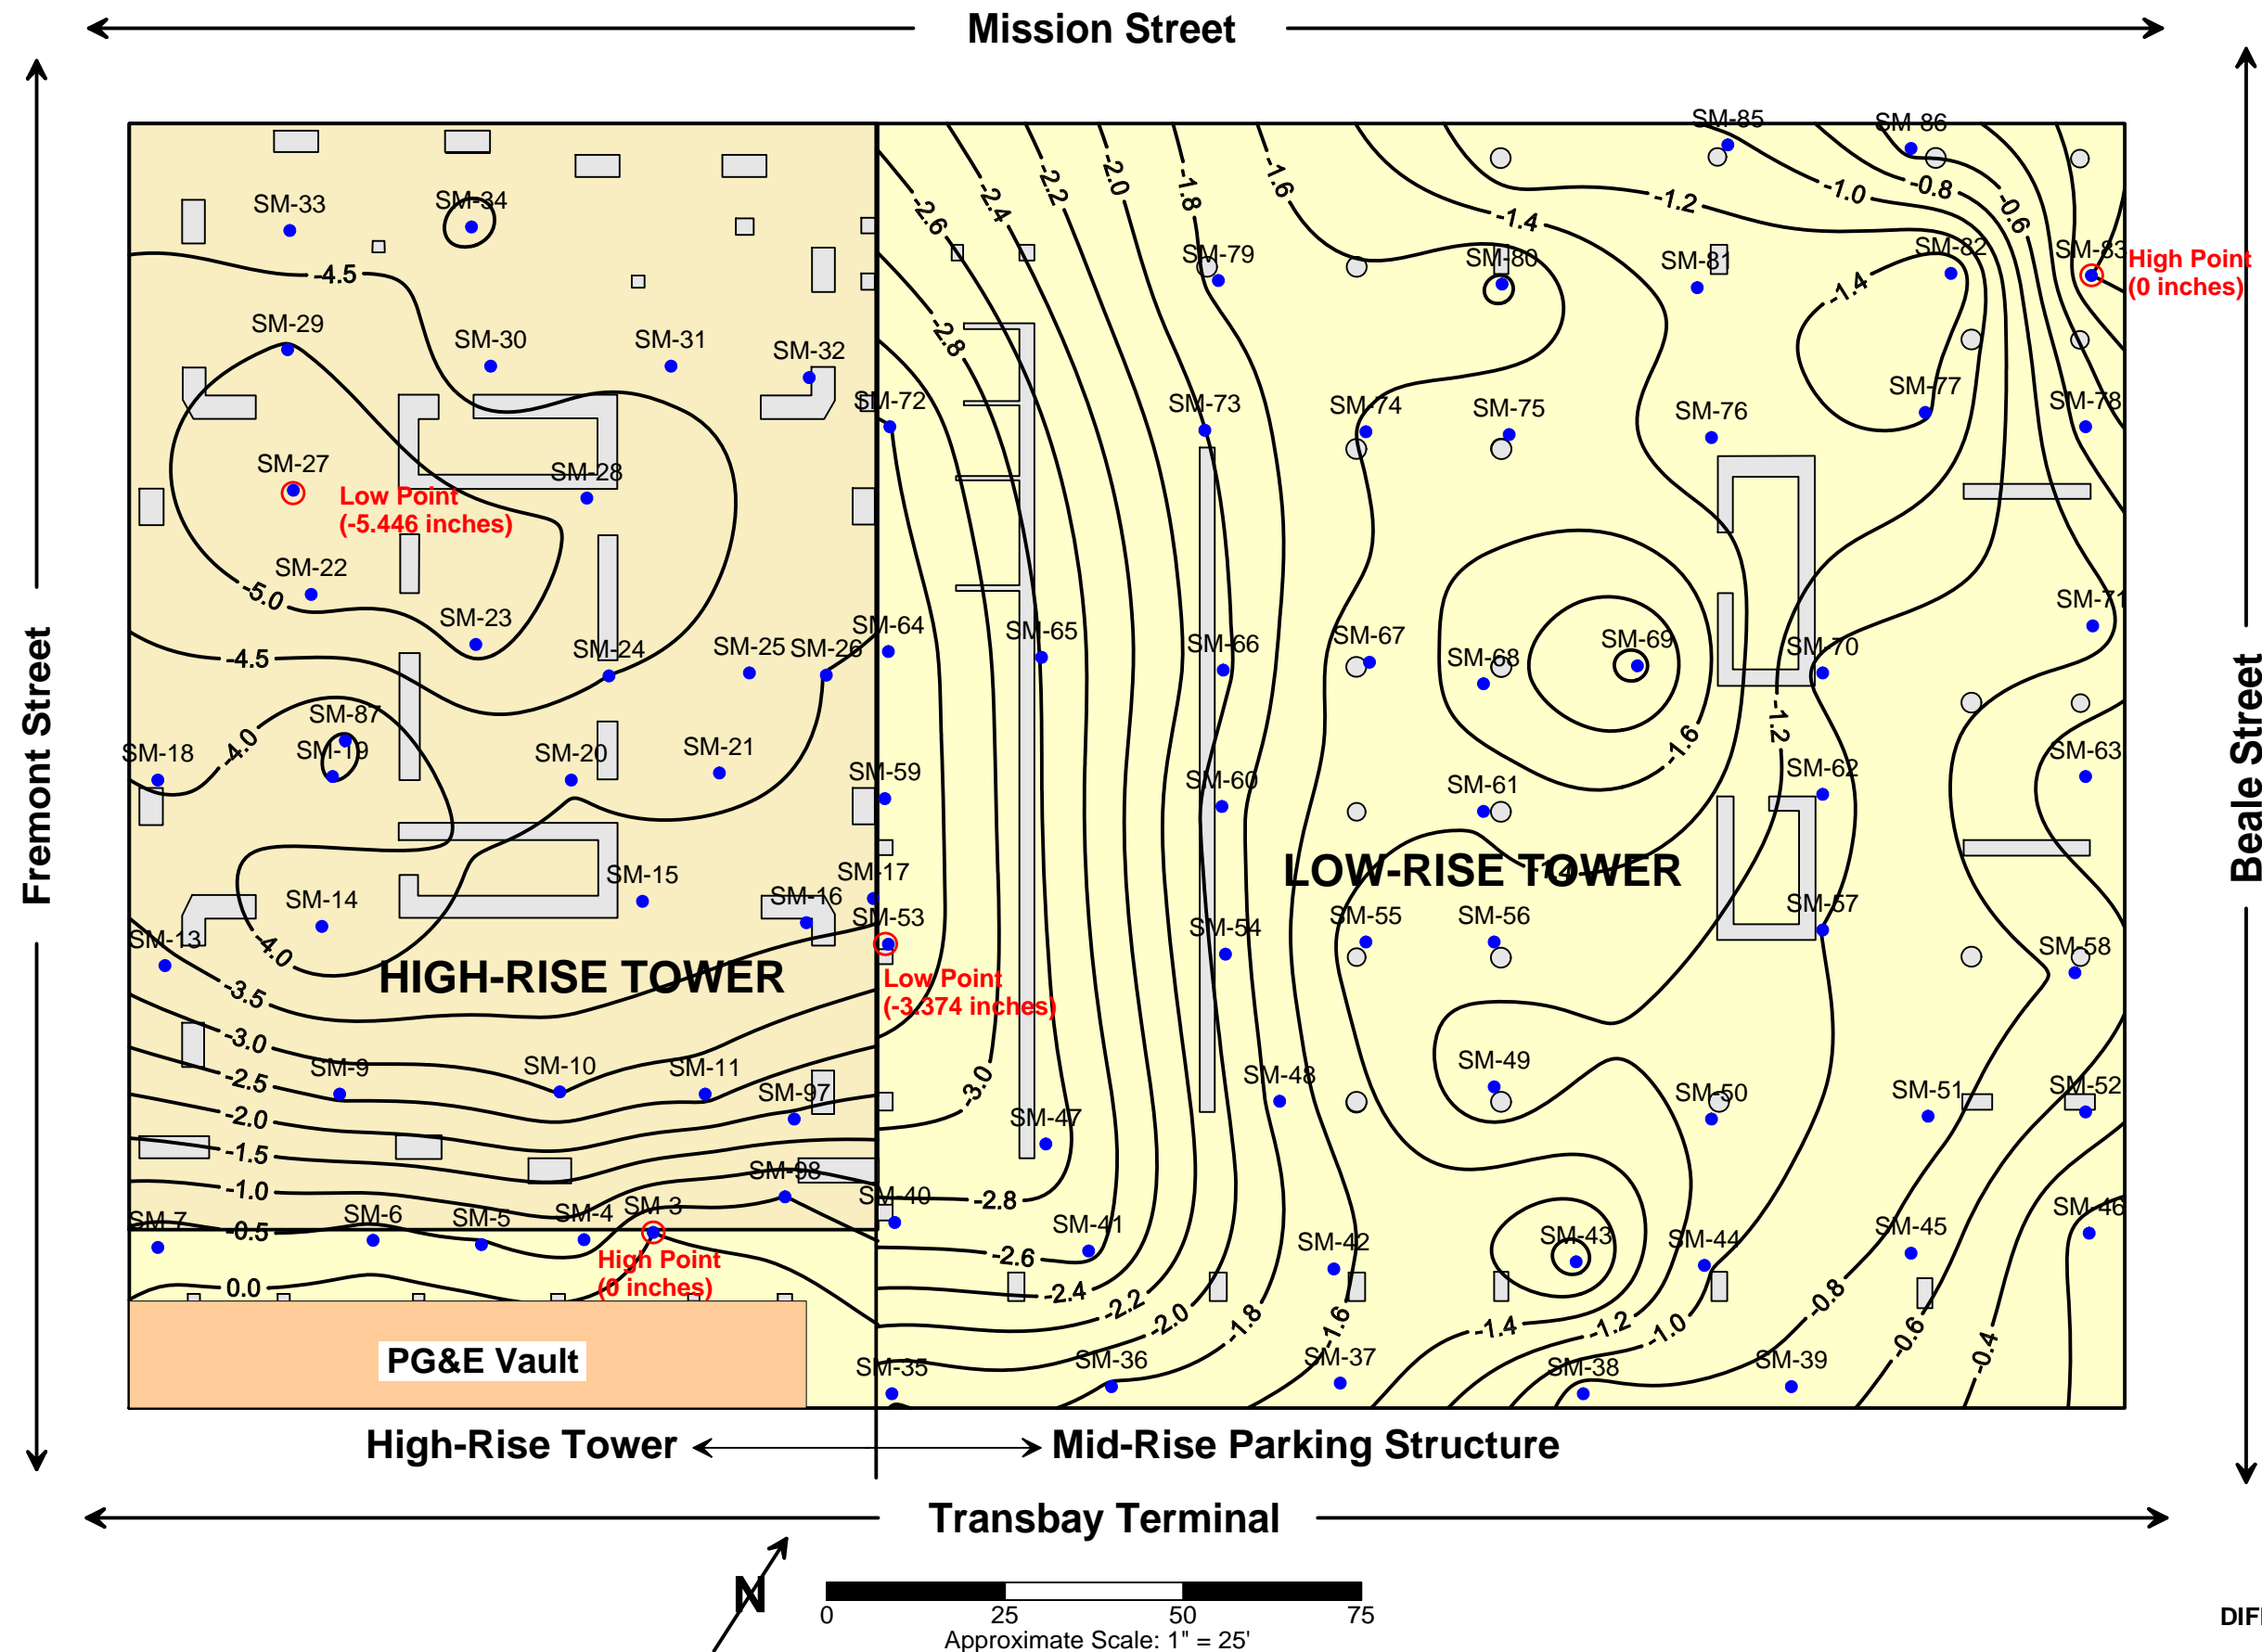
Contours represent differential elevation, in inches, between the highest point and all other points taken on December 17, 2013.
 Level B-1 at Mid-Rise Parking portion of survey site is approximately 4 inches higher than Level B-1 at High-Rise Tower portion.
 The PG&E vault is inaccessible for monitoring.
 Contour intervals are different between the High-Rise Tower and the Low-Rise Tower.

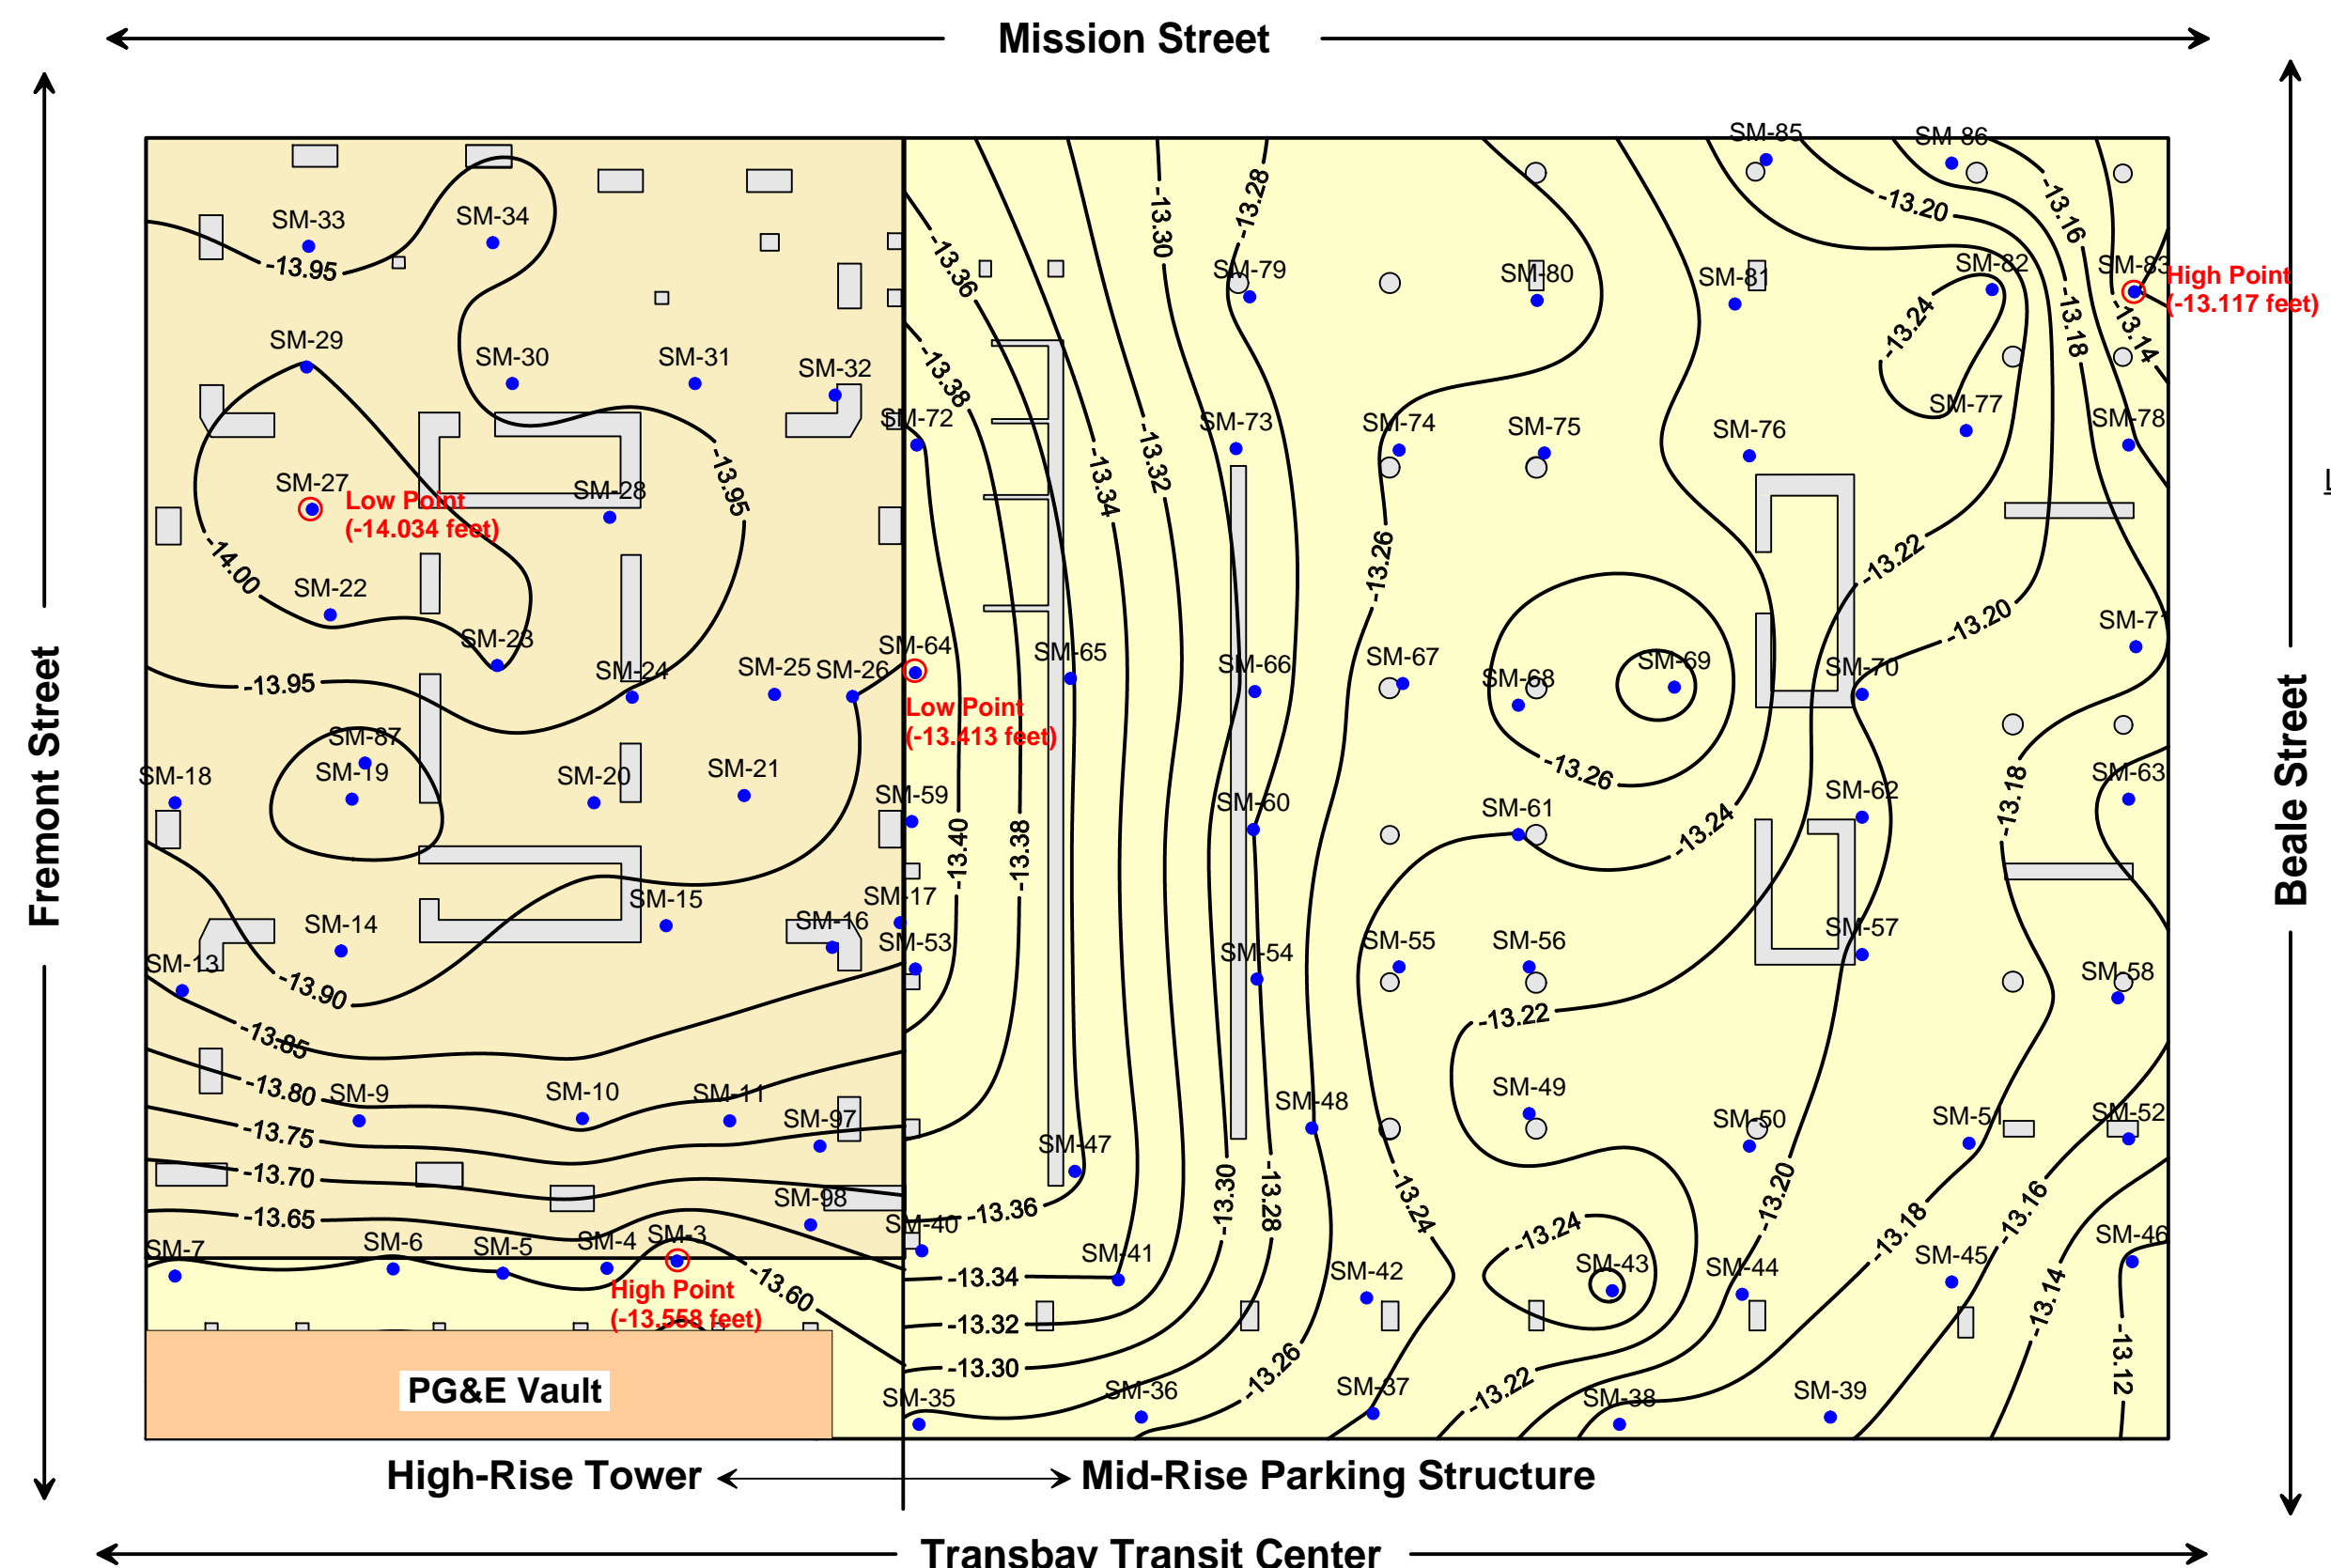
Maximum Differential	
High-Rise Tower	Mid-Rise Parking
0.476 feet (5.714 inches)	0.296 feet (3.552 inches)

Notes:
Contours represent elevation, in feet (CCSF Datum), from survey readings taken on April 11, 2014.
Level B-1 at Mid-Rise Parking portion of survey site is approximately 4 inches higher than Level B-1 at High-Rise Tower portion.
The PG&E vault is inaccessible for monitoring.

FLOOR ELEVATIONS AT LEVEL B-1
OF 301 MISSION PROPERTY:
PERIODIC SURVEY - APRIL 11, 2014

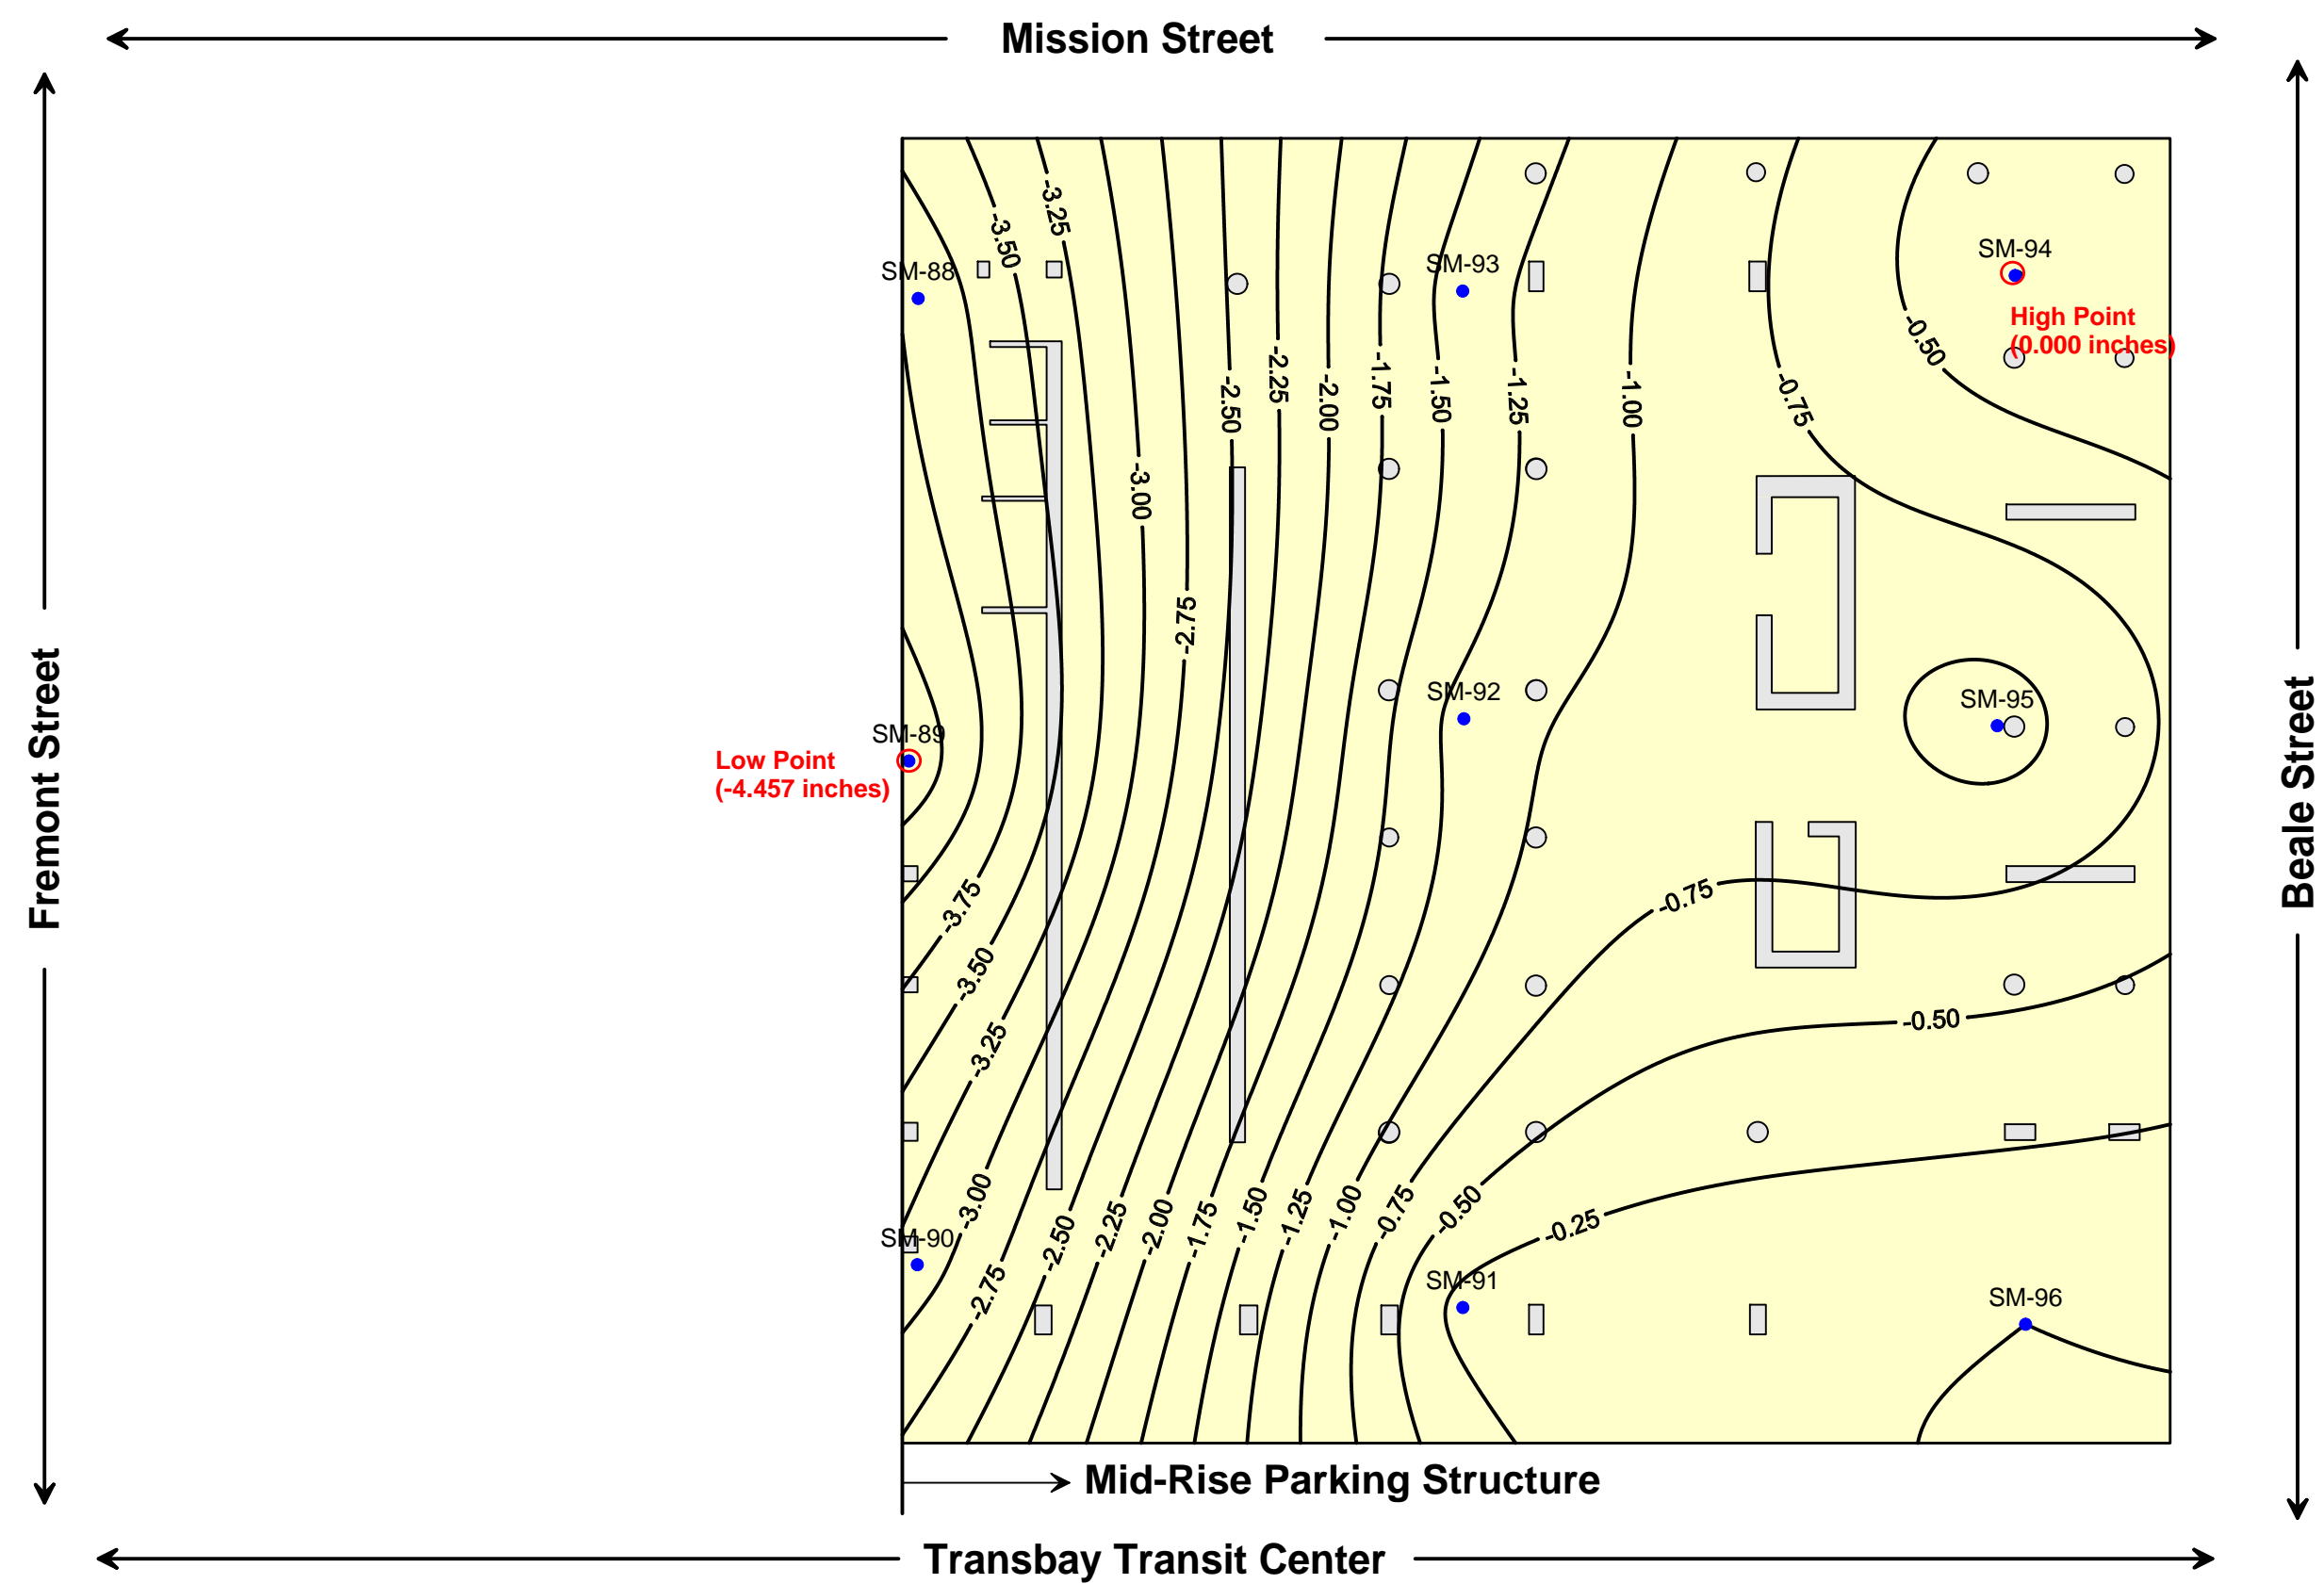
Maximum Differential
B-5 Level Basement
0.371 feet (4.457 inches)

Notes:
Contours represent differential elevation, in inches, between the highest point and all other points taken on June 11, 2014.

DIFFERENTIAL FLOOR ELEVATIONS (INCHES)
AT BASEMENT LEVEL B-5: JUNE 11, 2014 SURVEY
Transbay Transit Center
301 Mission Monitoring
Transbay Joint Powers Authority
San Francisco, California
June 2014
