*Board of Supervisors
City and County of San Francisco*

Government Audit and Oversight Committee

Supplemental Report for Foundation Settlement Investigation

**SUPPLEMENTAL REPORT
FOUNDATION SETTLEMENT INVESTIGATION
301 MISSION STREET
SAN FRANCISCO, CALIFORNIA**

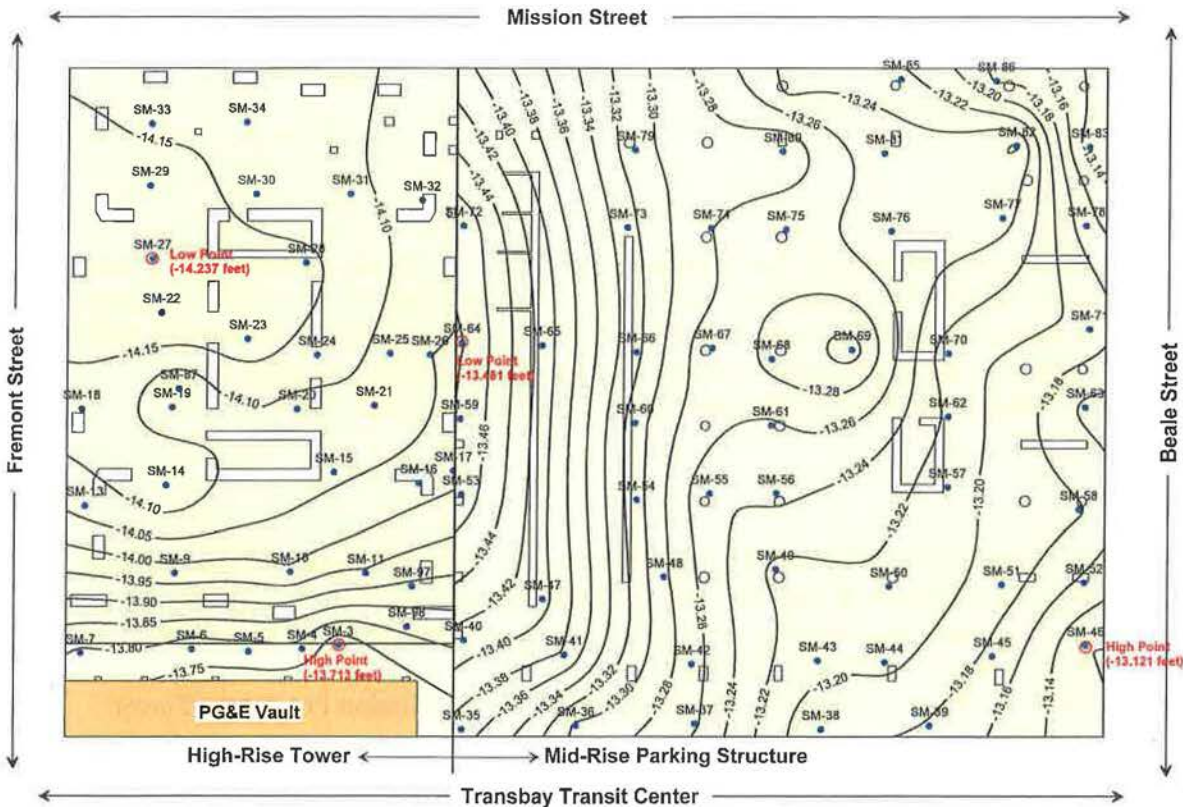
Date of Survey Reading:
June 10, 2016

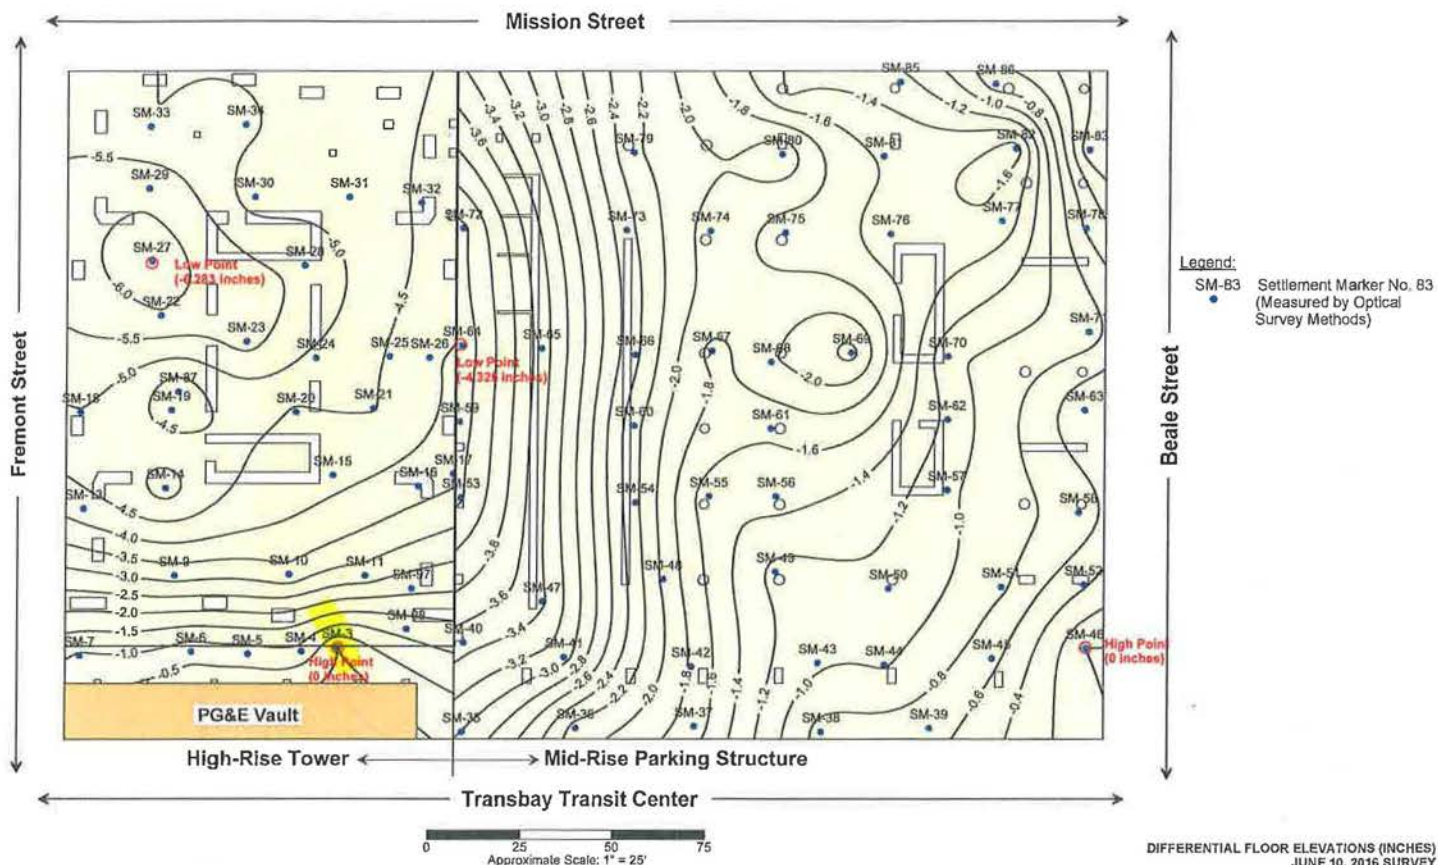
Contours represent differential elevation, in inches, between the highest point and all other points taken on June 10, 2016.
 Level B-1 at Mid-Rise Parking portion of survey site is approximately 4 inches higher than Level B-1 at High-Rise Tower portion.
 The PG&E vault is inaccessible for monitoring.
 Contour intervals are different between the High-Rise Tower and the Low-Rise Tower.

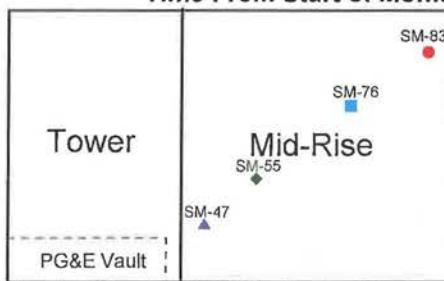
**SETTLEMENT OVER TIME
FLOOR ELEVATIONS AT LEVEL B-1
OF 301 MISSION PROPERTY- MID-RISE:
APRIL 30, 2009 THROUGH JUNE 10, 2016**
