File	No.	160975

Government Audit and Oversight Committee May 16, 2018 ♦ 10:00 a.m.

Supplemental Report for Foundation Settlement Investigation

SUPPLEMENTAL REPORT FOUNDATION SETTLEMENT INVESTIGATION 301 MISSION STREET SAN FRANCISCO, CALIFORNIA

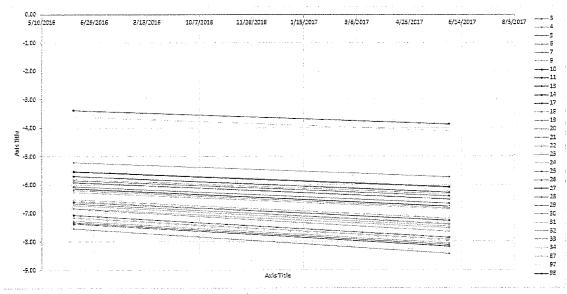
Figure 11. Settlement data, June 2016 through June 2017

Figure 11 of this report compares the settlement of 31 of the 33 measurement points during the period between June 2016 and June 2017. The profiles indicate continued motion of the building as a rigid body without noticeable difference from linear differential settlement across the mat. In this period approximately 1/2 in. additional settlement occurred at the west edge of the mat than at the east edge. Given the 100-foot width of the mat, this amounts to an incremental tilting of the building of 0.04%. This amount is negligible and has not caused any significant impact on stress in the structure.

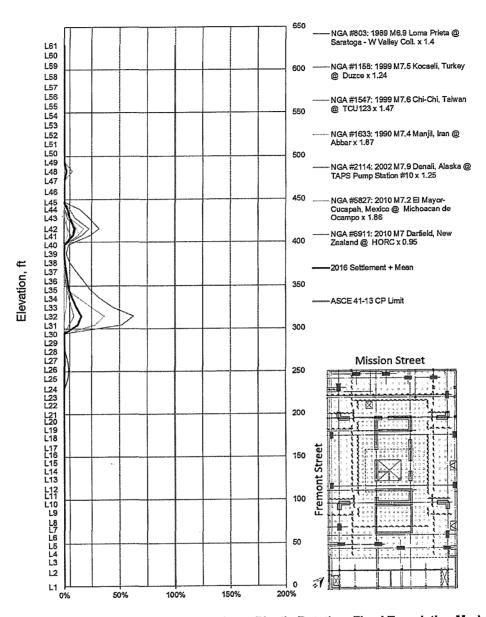
Figure 27. Demand to Capacity Ratios, Column Plastic Rotation, Fixed Translation Model

Figure 27 presents the demand to capacity ratios, in percent, for column plastic rotation. A value of 100% represents the ASCE 41-13 CP limit, which ranges from 0.008 to 0.009 radians for columns in this structure. The figure shows the maximum predicted value for any of the columns at each story, for each ground motion, and also the average peak value for all ground motions.

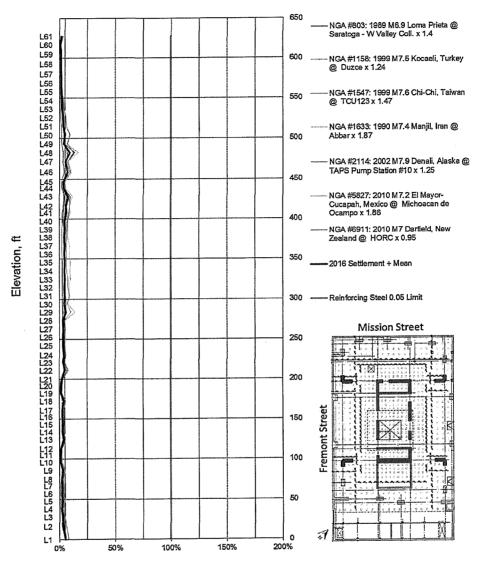
Figure 29. Demand to Capacity Ratio, Core Wall and Outrigger Column Tensile Strain, Fixed Translation Model

Figure 29 presents the demand to capacity ratios, in percent, for concrete core wall and outrigger column reinforcing tensile strains. An acceptable value of 0.05 is used. Demands are substantially below these values at all levels and for all ground motions.

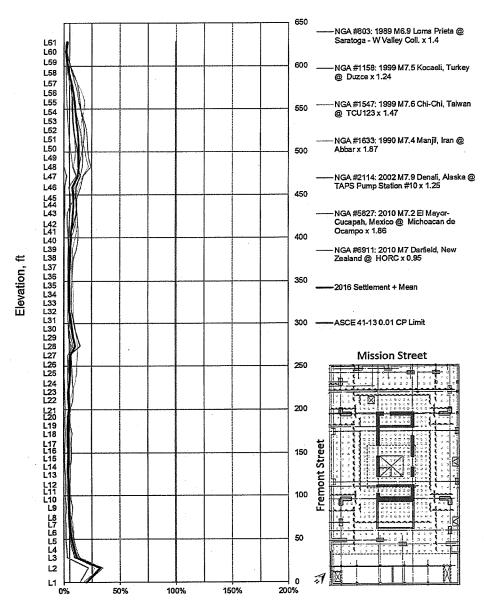
Figure 30. Demand to Capacity Ratio, Core Wall Shear Strain

Figure 30 shows the demand to capacity ratios for core wall shear strain. Strain for all records is substantially less than the 0.01 permitted by ASCE 41.

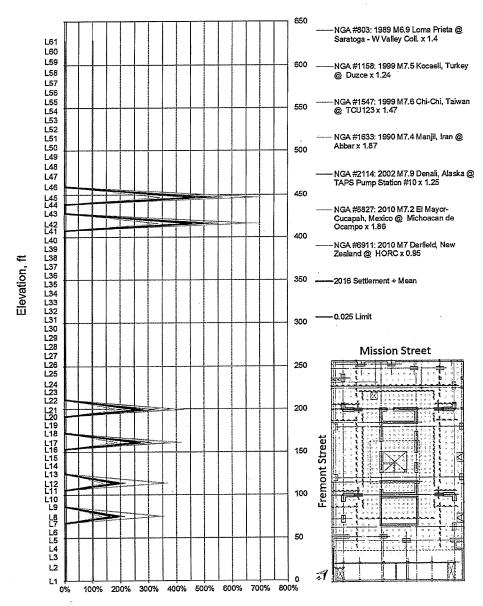
Figure 31. Demand to Capacity Ratios, Outrigger Coupling Beam Rotation, Fixed Translation Model

Figure 31 shows the demand to capacity ratios for coupling beams in outriggers. A value of 100% represents a chord rotation of 0.025 radian and the hysteretic relationship illustrated in Figure 13. All coupling beams degrade in strength without negative impact on other elements or overall stability.

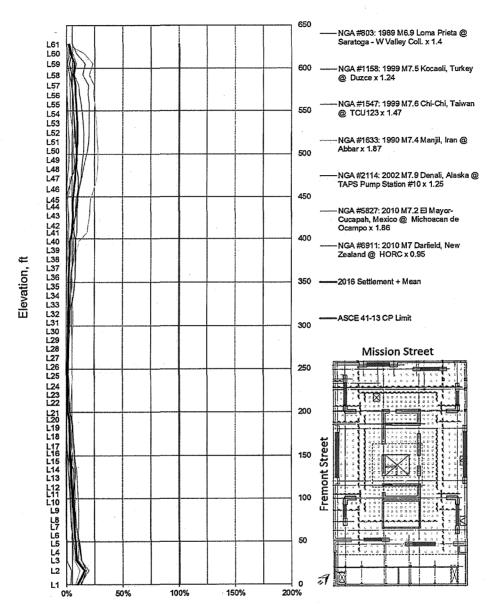
Figure 32. Demand to Capacity Ratios, Concrete Beams, Fixed Translation Model

Figure 32 presents demand to capacity ratios for reinforced concrete beams in moment frames and core walls. Acceptable values range from 0.03 radians to 0.05 radians depending on the

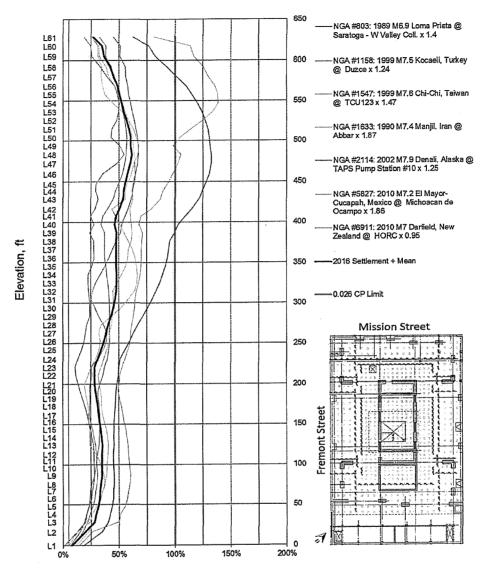
Figure 33. Demand to Capacity Ratios, Steel Coupling Beams, Fixed Translation Model

Figure 33 presents demand to capacity ratios for steel coupling beams. A value of 100% corresponds to a plastic hinge rotation of 0.03 radians. Mean demands are substantially less than this amount although two ground motions do produce locally somewhat higher demands at upper levels. The predicted demands are within the valid modeling range at all levels for all ground motions.

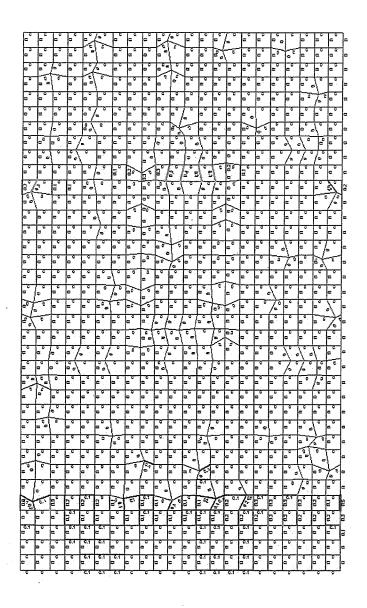
Figure 34. Peak Plastic Hinge Rotations (1999 Chi Chi, TCU3), Mat Grillage, Fixed Translation Model

Figure 34 shows the peak mat grillage beam plastic rotation demands from the 1999 Chi Chi Taiwan, TCU3 record, which of the suite of records evaluated, was the most taxing on the mat. The peak value at any location is 0.003 radians. A value of 0.01 is taken as acceptable. All values are substantially less than this.

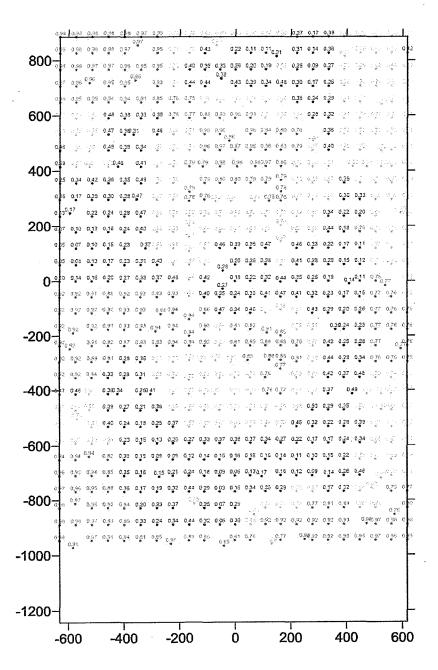
Figure 35. Pile Compressive Demand to Capacity Ratios, Maximum of Seven Ground Motions, Fixed Translation Model

Figure 35 shows the peak compressive demand to capacity ratio for piles. A value of 1.0 indicates that a pile has achieved its estimated geotechnical capacity as indicated in Figure 8 and Figure 9. It is important to note that this plot shows the peak value obtained for all ground motions. Individual ground motions would have lower peak values at most piles. Regardless, no piles exceed a value of 0.98. Also, since pile geotechnical capacity exceeds pile structural capacity, a value of 1.0 would indicate the onset of a yielding mode of behavior, rather than failure.

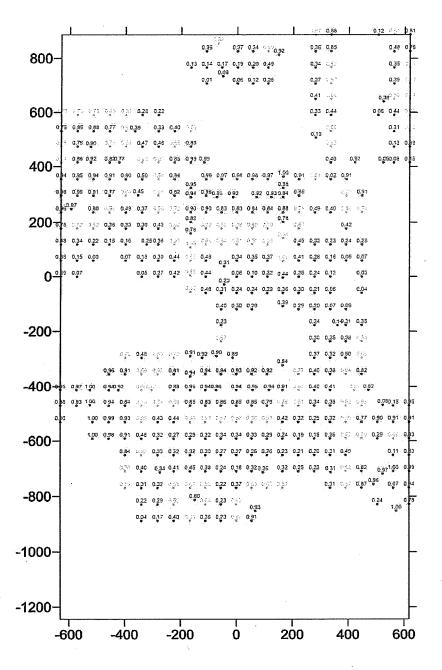
Figure 36. Peak Pile Tensile Demands to Capacity Ratios, Maximum of Seven Ground Motions, Fixed Translation Model

Figure 36 indicates peak pile uplift demand to capacity ratios for all ground motions. As with Figure 35, any one ground motion will produce lower values for most piles. For an individual pile spring, a value of 1.0 represents the lesser of the pile geotechnical seismic capacity, as given by Figure 8 and Figure 9 or the steel yield strength, whichever is less. Several piles are predicted to have a peak demand equal to their capacity. This is suggestive of a benign yielding mode of behavior.

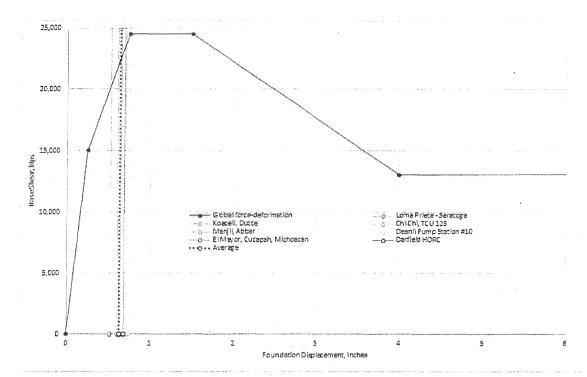
Figure 37. Peak East-West Pile Lateral Displacement Demand from Seven ground motions

Figure 37 and Figure 38 respectively present the peak lateral displacement demands on the pile cap in the east-west and north-south directions, overlain on the global pile nonlinear force-displacement behavior previously shown in Figure 22. Predicted pile lateral displacement is typically less than 1 inch and does not approach the displacement at which foundation strength degradation initiates.

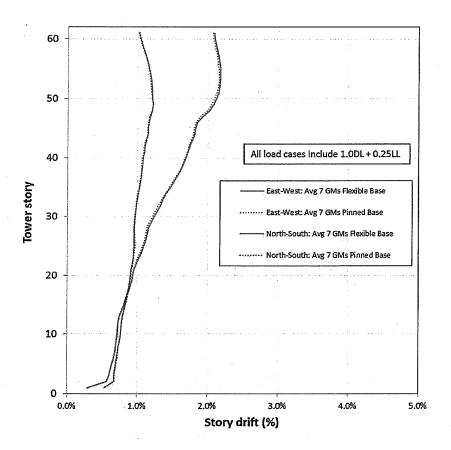
Figure 39. Comparison of Story Drift Ratios for Fixed Translation and Nonlinear Pile Models

Figure 39 compares plots of mean story drift in the east-west and north-south directions for the model fixed against lateral translation at the base and the model with nonlinear lateral translational pile springs. In each of the two directions, the story drift predicted by our analyses is nearly identical for the two models.

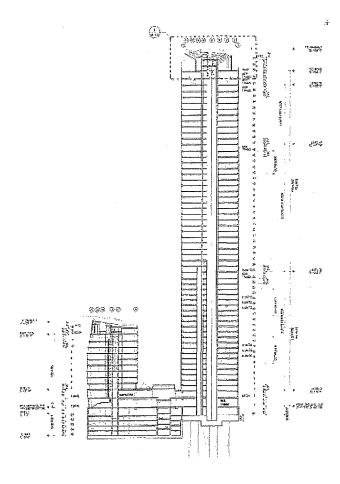
Three borings to bedrock were recently completed. The borings will monitor water level, and movement using piezometers and inclinometers. Monitoring will be real time. There are two borings in Mission Street and one in Fremont Street.

A laser sight was in the process of installation in a Tower elevator shaft for inclination monitoring. The laser will provide real time monitoring.

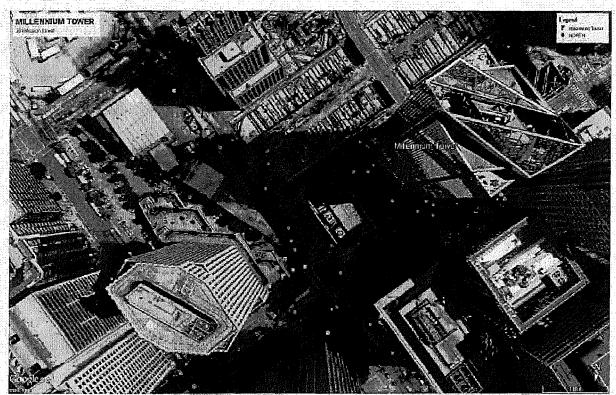
Aerial of Millennium Complex. See below for new construction to East and South.

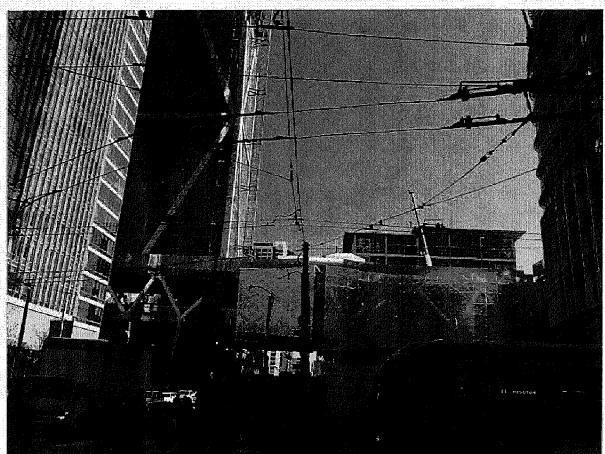
New Buildings to East and South. Light Rail Construction Immediately South

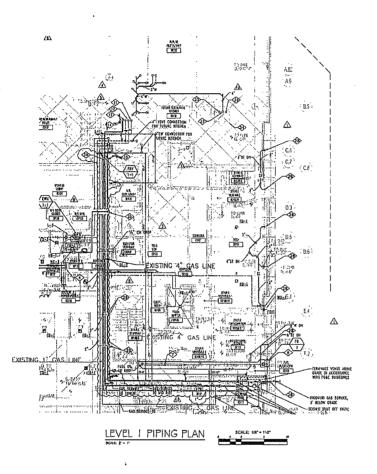
There are three nebral gas mains that enter the building on Level 1 on Beale St. that are hanging from a trapeze. Additional seismic bracing is warranted for the natural gas main piping that supplies the high-rise Adlitentum Tower.

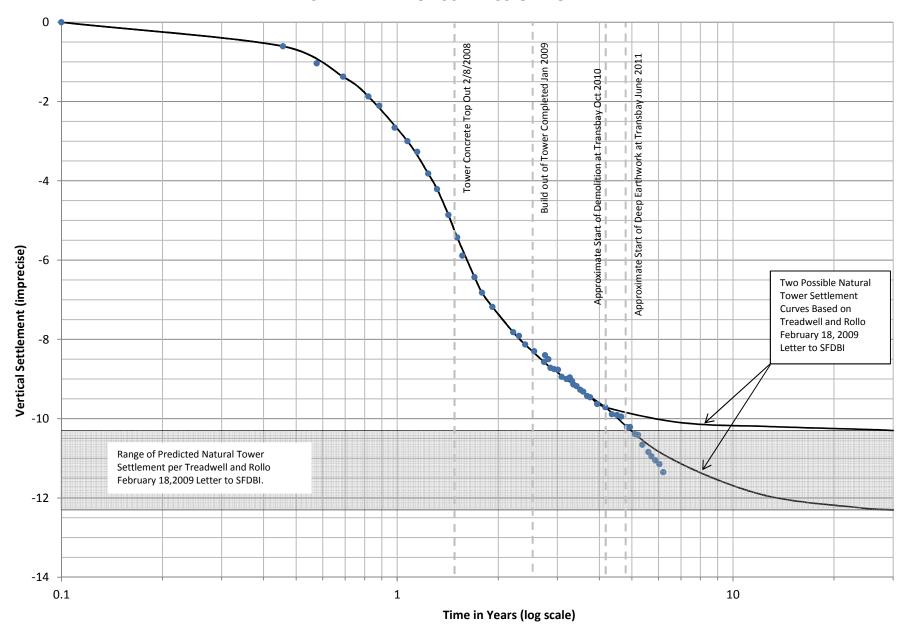
Figure 1

SETTLEMENT OF 301 MISSION TOWER

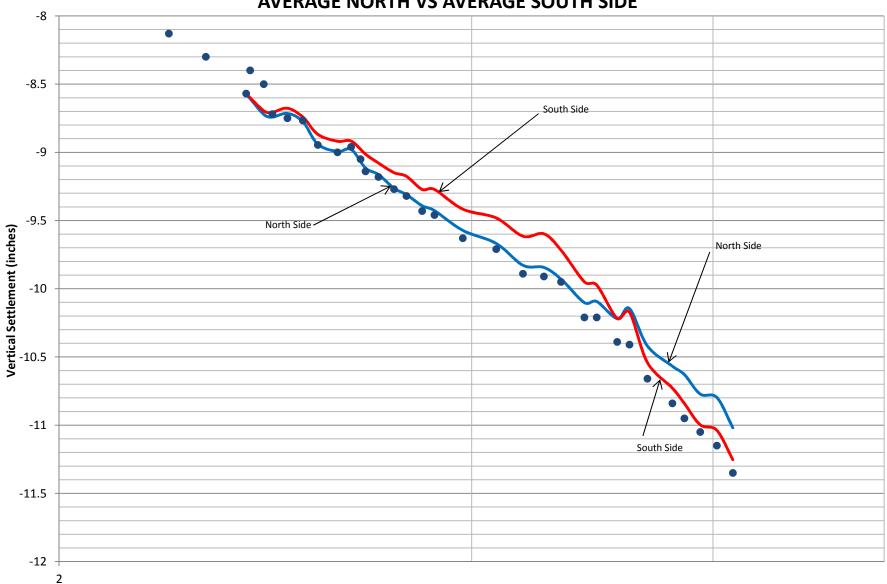
SETTLEMENT OF 301 MISSION TOWER AVERAGE NORTH VS AVERAGE SOUTH SIDE

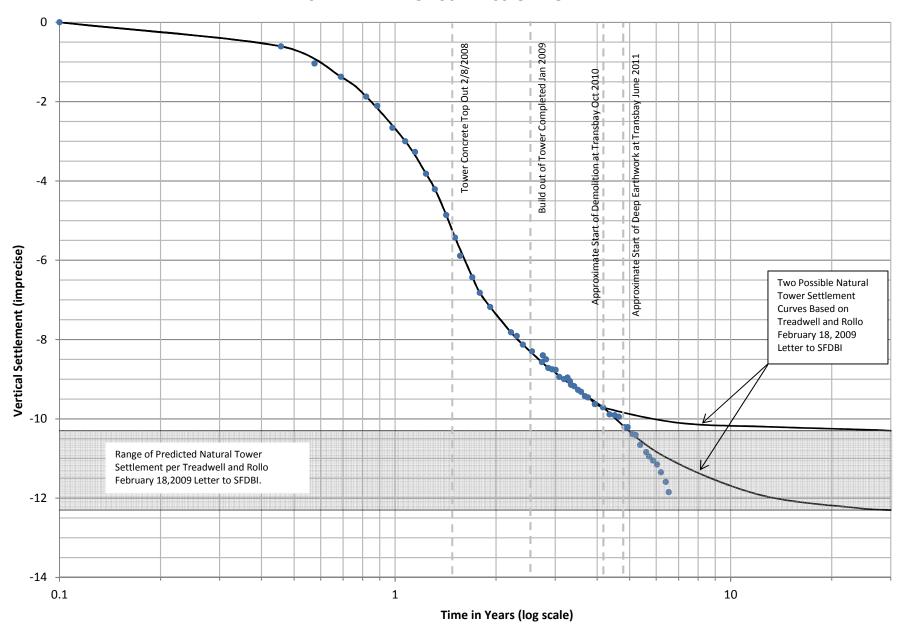
SETTLEMENT OF 301 MISSION TOWER

Analysis of the latest data from the Arup Reports continues to show a varying rate of overall settlement as in preceding settlement reports by Arup. Transbay has now completed the deep foundation activities and are now working at the surface level. It is our understanding that excavation has begun approximately on May 1st, 2013 but was slowed by the deep foundation cut-off effort. However, work on-site continues to coincidentally affect the rate of settlement of the Millennium Tower. Generally, an increased rate of settlement has been observed since the Transbay subsurface construction activities have commenced.

Since Treadwell has predicted a range of total settlement, it is difficult to quantify the amount of settlement in excess of what would have occurred naturally. From a simple reading of the measured displacement versus the predictive curves (Figure 1), the additional settlement due to Transbay activity is between 0.8 to 1.6 inches. Since 0.75 inches is the "Action Trigger Level" for other buildings as specified by Transbay, it is recommended that Millennium obtain a response from Transbay. Further, Transbay changed their specification (Dec 10, 2010) to exclude the 301 Mission Tower from all action trigger levels. It is unclear why they would have changed their specification after construction had begun. This should be considered carefully by ownership.

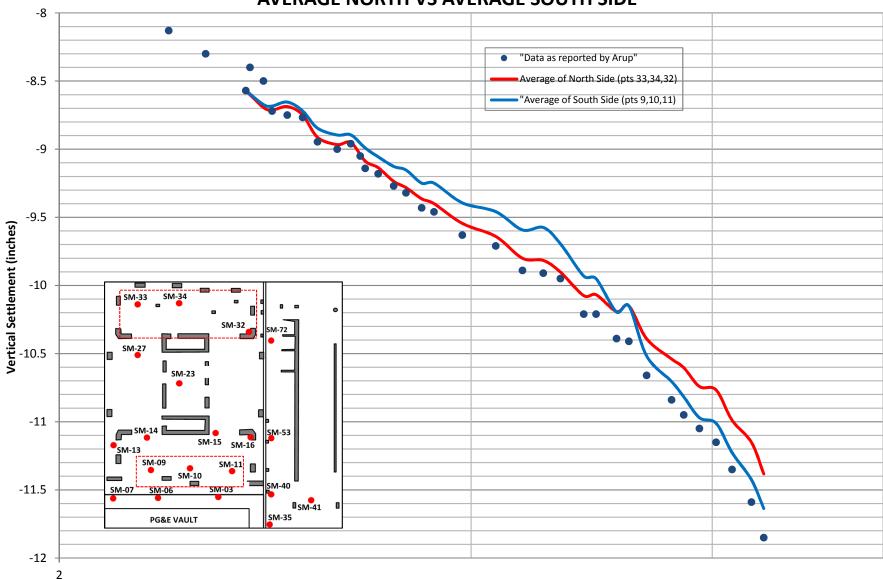
SETTLEMENT OF 301 MISSION TOWER AVERAGE NORTH VS AVERAGE SOUTH SIDE

Figure 2 includes an average of settlement on the north side of the tower and on the south end of the tower. Before construction activities began at Transbay we observe that the north side had settled at a greater rate than the south. After construction activities started, we now observe a greater rate of settlement on the south side. The foundation has rotated slightly towards the Transbay project. Since the south end of the foundation seems now to be moving faster than the north, it follows that the activities at Transbay have caused the additional settlement.

Figure 2 also shows that the overall settlement reported by ARUP (and duplicated in Figure 1) is the worst case settlement anywhere across the foundation (about 11.85") and does not represent the average. Based on this plot, the average overall settlement on the site is currently about 11.5 overall inches.

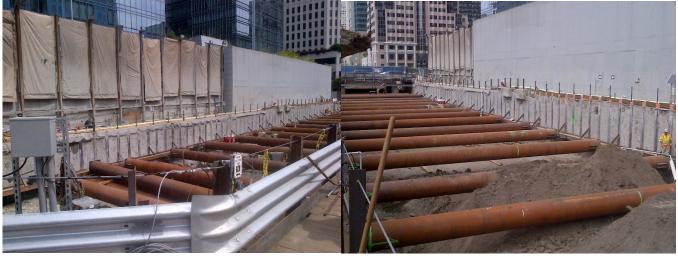
A major Transbay construction milestone has recently occurred. Excavation has begun as of May 2013. The excavation is approximately 15 feet below grade at the current time, immediately below the elevation of the first set of cross lot bracing. The cross-lot bracing has begun to be installed but has not yet been connected to the far side.

Construction progress immediately adjacent to 301 Mission Street. Photos taken July 22, 2013.

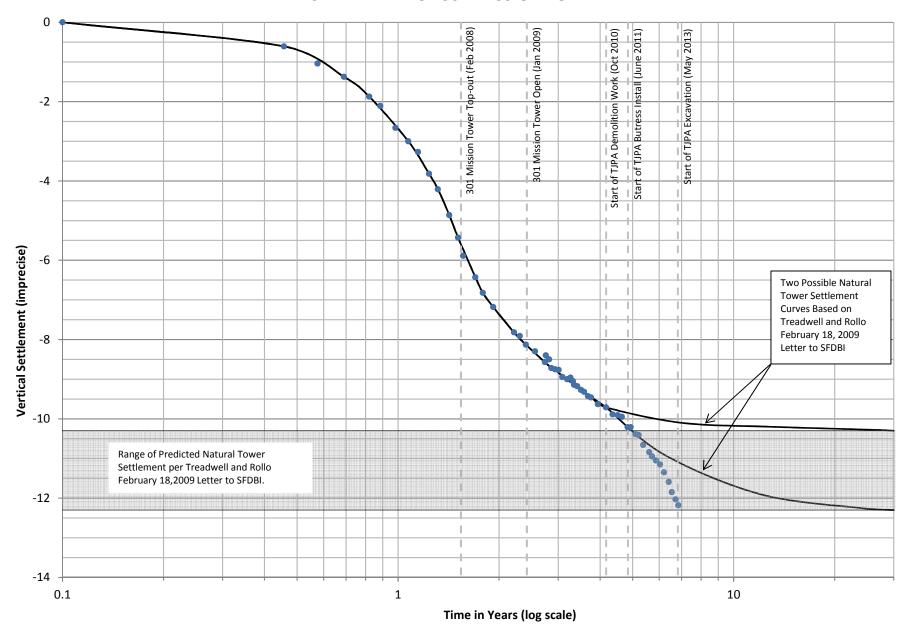
SETTLEMENT OF 301 MISSION TOWER

Analysis of the latest data from the Arup Reports (from June 28, 2013) continues to show a varying rate of overall settlement as in preceding settlement reports by Arup. Transbay has now completed the deep foundation activities and have excavated to approximately 15 feet. The excavation begun approximately on May 1st, 2013 but was slowed by the deep foundation cut-off effort. The top-most level of cross-lot bracing has begun to be installed, but is not yet completely installed. Work on-site continues to coincidentally affect the rate of settlement of the Millennium Tower. Generally, an increased rate of settlement has been observed since the Transbay subsurface construction activities have commenced.

Since Treadwell has predicted a range of total settlement, it is difficult to quantify the amount of settlement in excess of what would have occurred naturally. From a simple reading of the measured displacement versus the predictive curves (Figure 1), the additional settlement due to Transbay activity is between 1.0 to 2.1 inches. Since 0.75 inches is the "Action Trigger Level" for other buildings as specified by Transbay, it is recommended that Millennium obtain a response from Transbay. Further, Transbay changed their specification (Dec 10, 2010) to exclude the 301 Mission Tower from all action trigger levels. It is unclear why they would have changed their specification after construction had begun. This should be considered carefully by ownership.

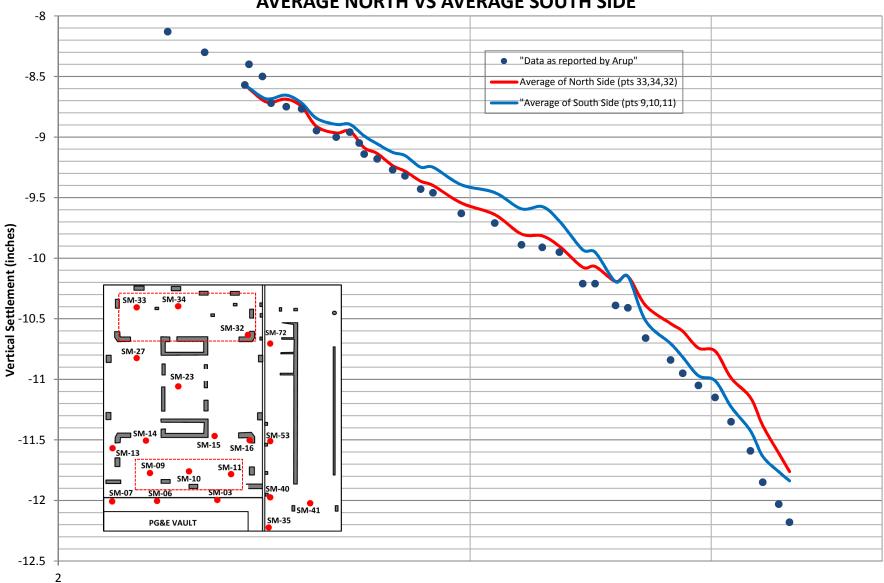
SETTLEMENT OF 301 MISSION TOWER AVERAGE NORTH VS AVERAGE SOUTH SIDE

Figure 2 includes an average of settlement on the north side of the tower and on the south end of the tower. Before construction activities began at Transbay we observe that the north side had settled at a greater rate than the south. After construction activities started, we now observe a greater rate of settlement on the south side. The foundation has rotated slightly towards the Transbay project. Since the south end of the foundation seems now to be moving faster than the north, it follows that the activities at Transbay have caused the additional settlement.

worst case settlement anywhere across the foundation (about 12.2") and does not represent the average. Based on this plot, the average overall settlement on the site is currently about 11.8 overall inches.

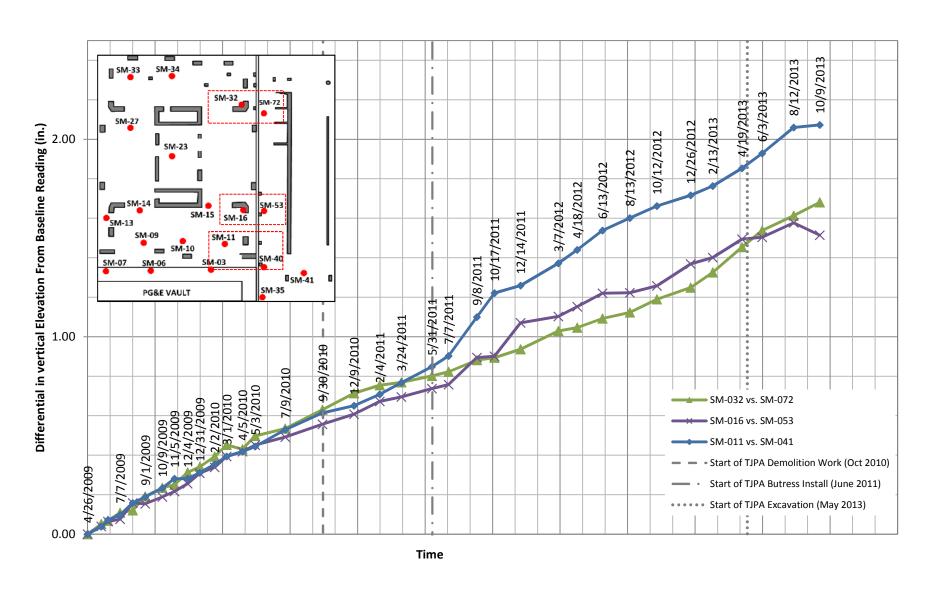
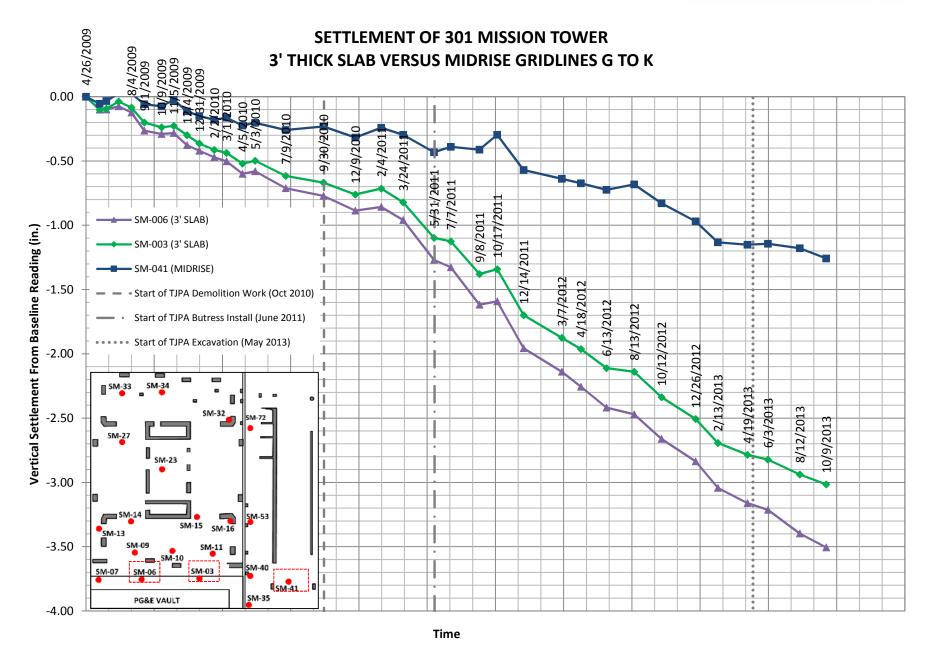
DIFFERENTIAL SETTLEMENT ALONG THE GRIDLINE 12 JOINT BETWEEN TOWER TO MIDRISE

Several settlement markers were reviewed at the building separation joint between the tower and Mid-Rise along gridline 12. It can be clearly observed that since Transbay construction activities have begun, that there is increasing differential across the joint, more than what was naturally occurring prior to the beginning of Transbay construction. The largest impact is near the south side of the building, and little to no impact in natural differential on the north side. It does appear that the joint is performing as expected and allowing free movements between both structures.

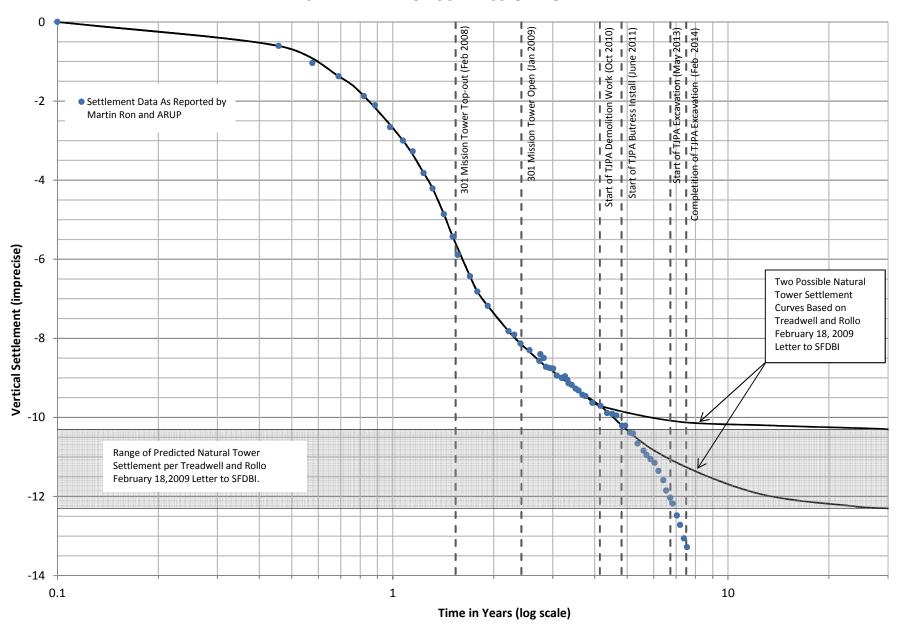
SETTLEMENT OF 301 MISSION TOWER

Analysis of the most recent available settlement data as contained the settlement report by Arup, continues to show a varying rate of overall settlement as compared to the preceding settlement reports by Arup. Generally, an increased rate of settlement has been observed coincidental with the Transbay subsurface construction activities.

If we use Langan Treadwell Rollo's predicted range of total settlement and read the difference between the measured displacement data points and the settlement prediction curves (Figure 1), the additional settlement is between 2.0 to 3.3 inches. Since 0.75 inches is the "Action Trigger Level" for "other buildings" as described in the Transbay Specification, it is recommended, as we had recommended in earlier reports, that Millennium Partners (Millennium) obtain a response from Transbay regarding this discrepancy in predicted settlement. Furthermore, Transbay revised their specification (the Dec 10, 2010 version) to exclude the 301 Mission Tower from all action trigger levels. It is unclear why Transbay would have changed their specification after construction had begun and why no action trigger limit for this site has since been published by TJPA.

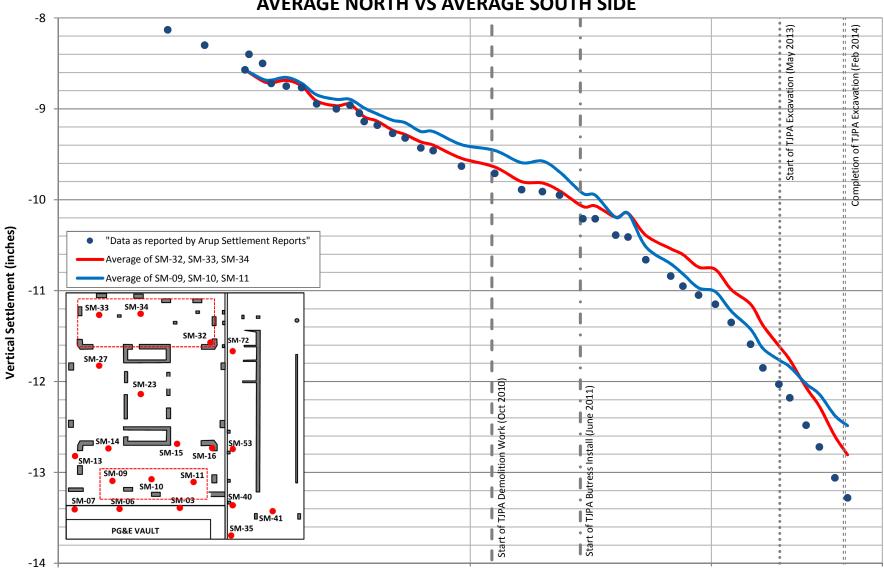
SETTLEMENT OF 301 MISSION TOWER AVERAGE NORTH VS AVERAGE SOUTH SIDE

Settlement of the North vs. South Side of the Foundation - Logarithmic Scale (Figure 2)

Figure 2 presents an average of settlement on the north side of the tower versus the south end of the tower, as measured in logarithmic scale. Before construction activities began at Transbay we observed that the north side had settled at a greater rate than the south. After buttress installation activities started, we observed a greater rate of settlement on the south side. After June 2013, the north side again shows a higher rate of settlement than the south side. The foundation has rotated slightly away from the south side.

Figure 2 also shows that the overall settlement reported by ARUP (duplicated in Figure 1) is the worst case settlement anywhere across the foundation (13.1 inches) and does not accurately represent the average. The average overall settlement for the north side currently shows about 12.8 inches. The average overall settlement for the south side currently shows about 12.5 inches.

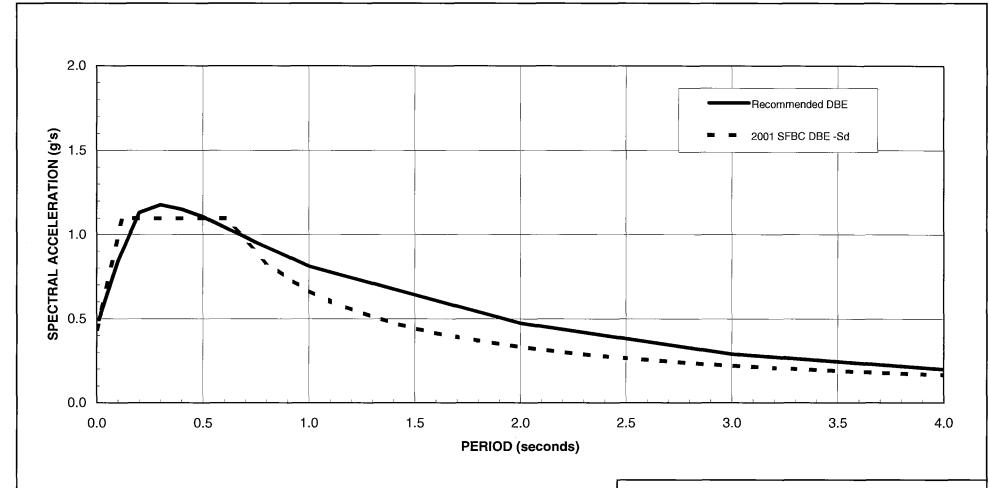
The results of the PSHA for the DBE hazard level is shown on Figure D-1. The average of the attenuation relationships is also shown on the figure. Figure D-2 presents a comparison of the recommended surface spectra (DBE) with the corresponding 2001 SFBC soil profile type S_D spectra.

COMPARISON OF RECOMMENDED DBE SURFACE AND 2001 SFBC SPECTRA

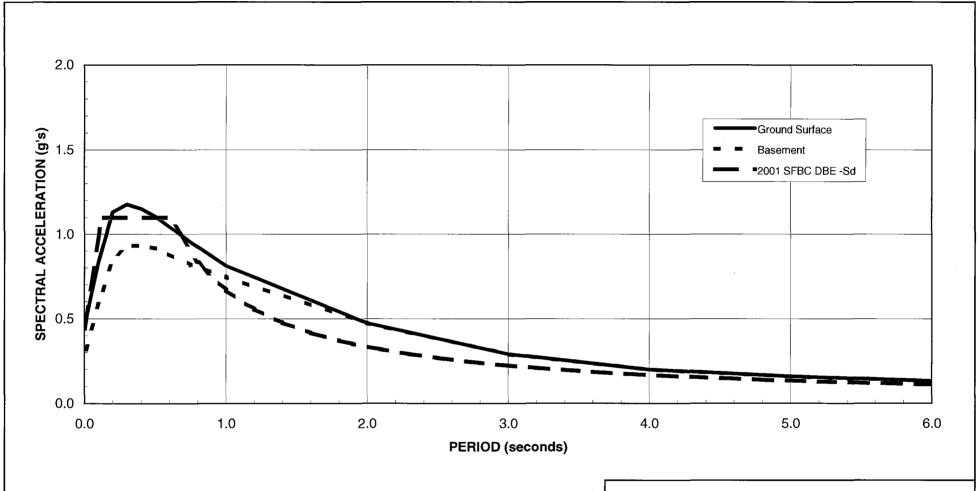
Golesorkhi and Gouchon (2000) developed recommended ratios between spectra at depth to surface spectra that can be used to modify surface spectra for basement/depth effects. Figure D-3 shows this ratio and also provides a comparison with recorded data. These ratios are based

RECOMMENDED SPECTRA

on analytical studies and data by Seed (1986), Tsai (1990), Ostadan (1992), Sykora and Bastani (1998), and most recently Stewart (1999) and were used to modify the surface spectra and develop the basement level spectra. Furthermore, FEMA 440 Appendix 8, discusses effects of reduction of surface (free field) spectrum as a function depth of embedment of the foundation. The reductions presented in the FEMA document are within the same range as recommended by Golesorkhi and Gouchon (2000). Therefore, it is our opinion that the basement reduction is justified and appropriate. The recommended horizontal surface and basement level spectra are presented on Figure D-4. We recommend the use of the basement level spectra at the foundation level for design.

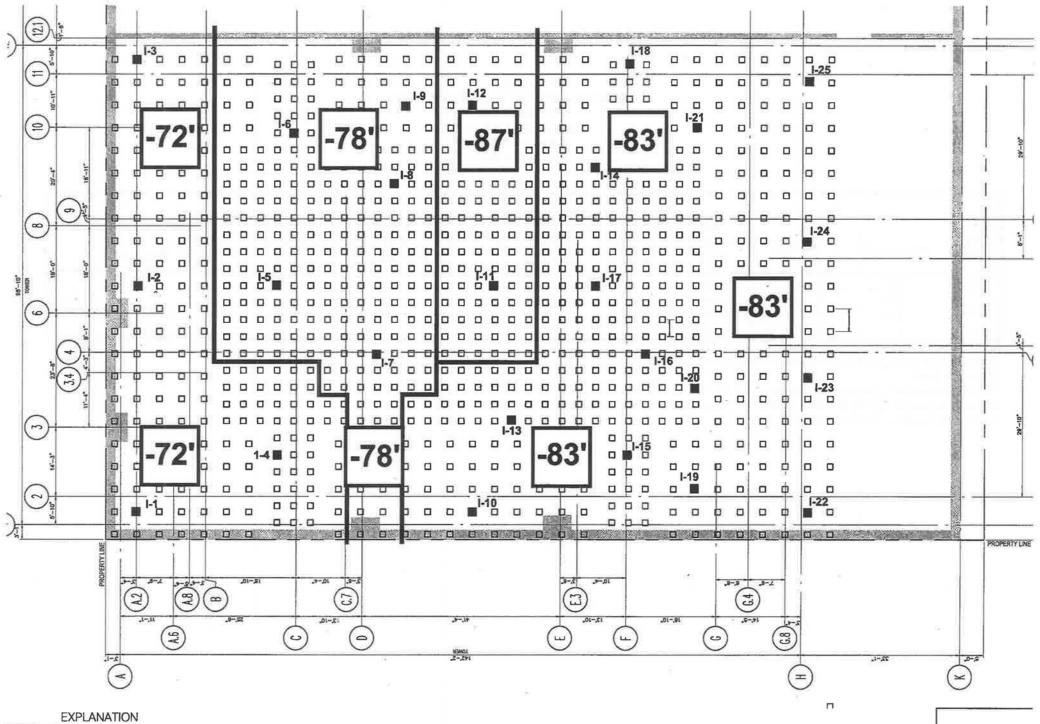
Figure 1 – Site Recommended Production Pile Tip Elevations

Recommended pile tip elevation in feet, San Francisco city datum (SFCD)

On the basis of our previous analyses, our observations of indicator pile driving and our knowledge of subsurface conditions, we conclude that production piles driven to the refusal criteria outlined in the 23 November 2005 letter using the attached revised Figure 1 are acceptable to support the allowable design compression (dead plus live) load of 260 kips.

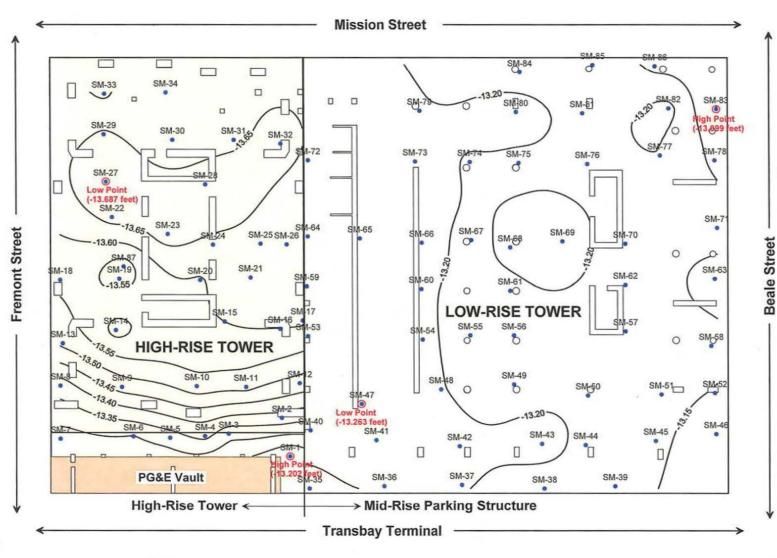
Plate 1 Floor Elevations at Level B-1 of 301 Mission Property: Periodic Survey – March 1, 2010
Plate 2 Differential Floor Elevation (Inches) – March 1, 2010 Survey
Plate 3 Contours of Settlements Measured at the First Level Basement of the 301 Mission Street Structure
Between April 30, 2009 and March 1, 2010
Plate 4 Settlement Over Time Floor Elevations at Level B-1 of 301 Mission Property – Tower: April 30,
2009 through March 1, 2010.
Plate 5 Settlement Over Time Floor Elevations at Level B-1 of 301 Mission Property – Midrise: April 30,
2009 through March 1, 2010
Plate 6 Settlements of the 301 Mission Tower Including Monitoring During Construction

Date of Survey Reading: March 01, 2010

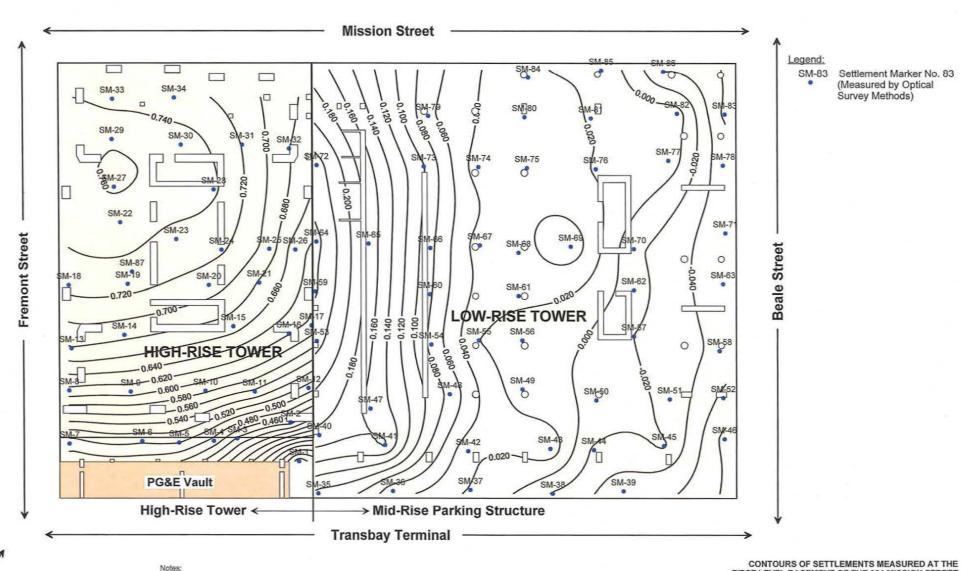
Contours represent elevation change, in inches, between Baseline survey (April 30, 2009) and readings taken on March 1, 2010.

Level B-1 at Mid-Rise Parking portion of survey site is approximately 4 inches higher than Level B-1 at High-Rise Tower portion.

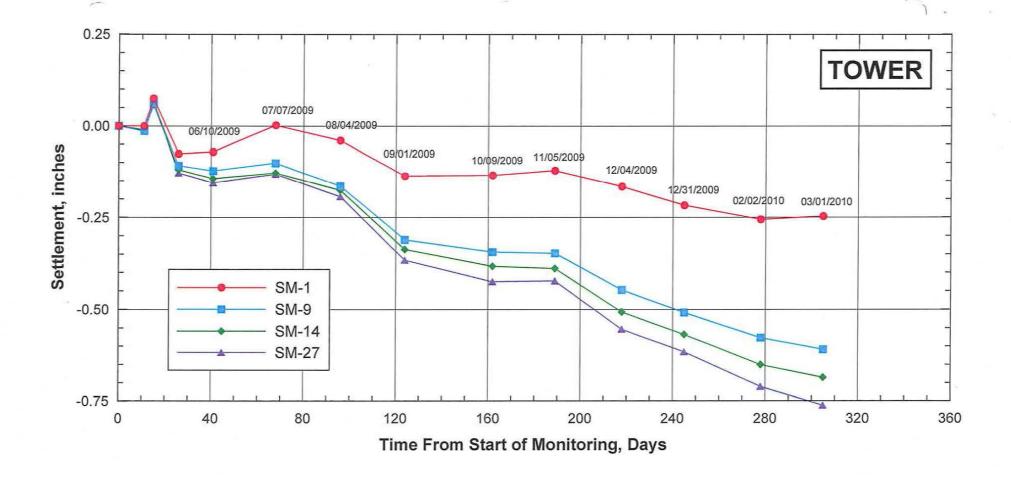
SETTLEMENT OVER TIME FLOOR ELEVATIONS AT LEVEL B-1 OF 301 MISSION PROPERTY- TOWER: APRIL 30, 2009 THROUGH MARCH 1, 2010

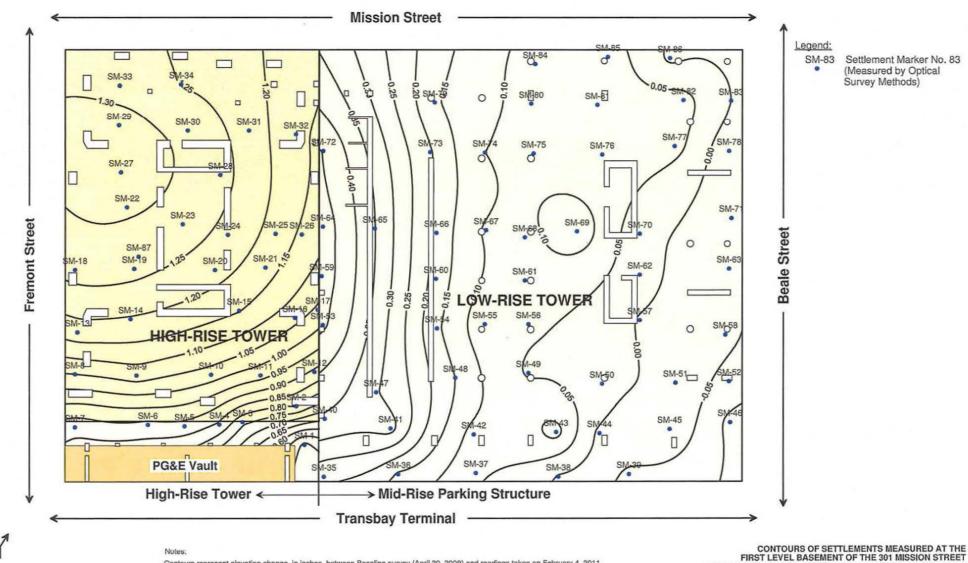
Contours represent elevation change, in inches, between Baseline survey (April 30, 2009) and readings taken on February 4, 2011. Level B-1 at Mid-Rise Parking portion of survey site is approximately 4 inches higher than Level B-1 at High-Rise Tower portion.

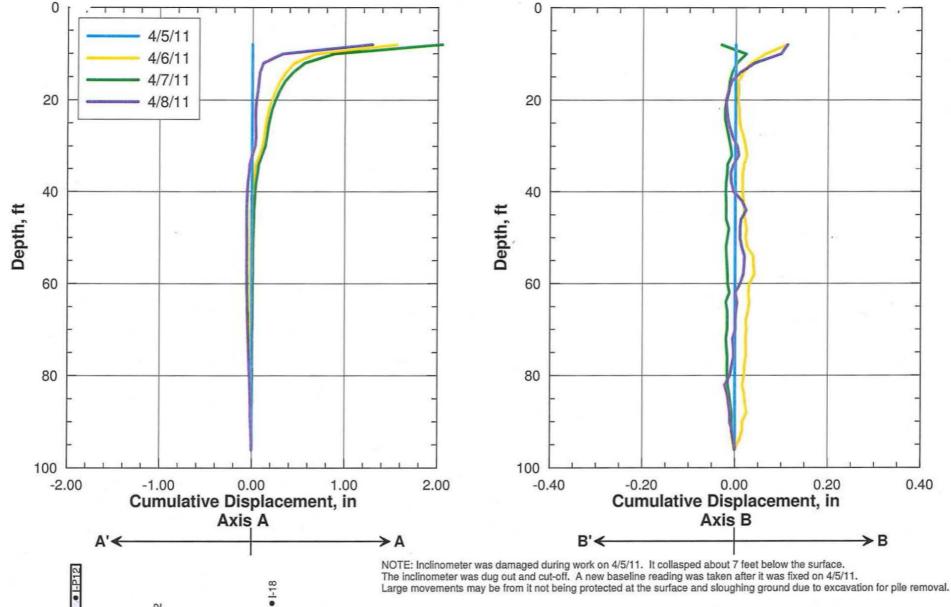
**I-P11 was damaged due to the excavation for the pile removal on 4/4/2011.

INCLINOMETER DATA FOR PILE EXTRACTION **TEST SITE INCLINOMETER READING I-P11**

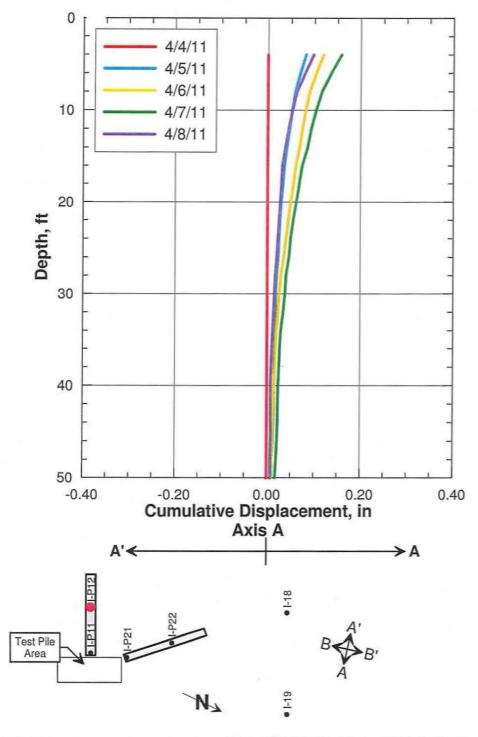
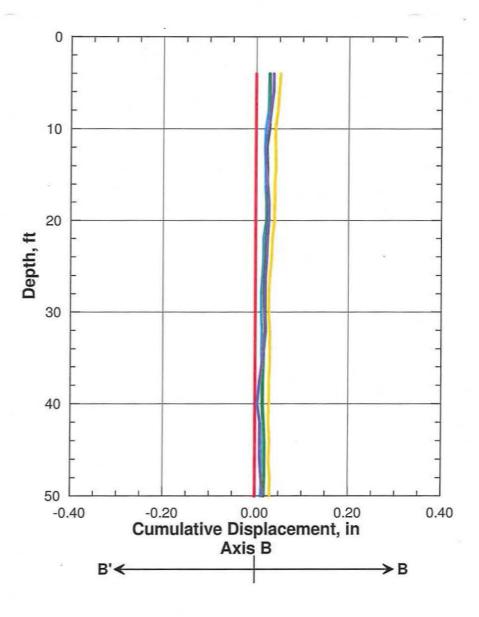
INCLINOMETER DATA FOR PILE EXTRACTION TEST SITE INCLINOMETER READING I-P12: TOP 50 FEET OF THE INCLINOMETER ONLY

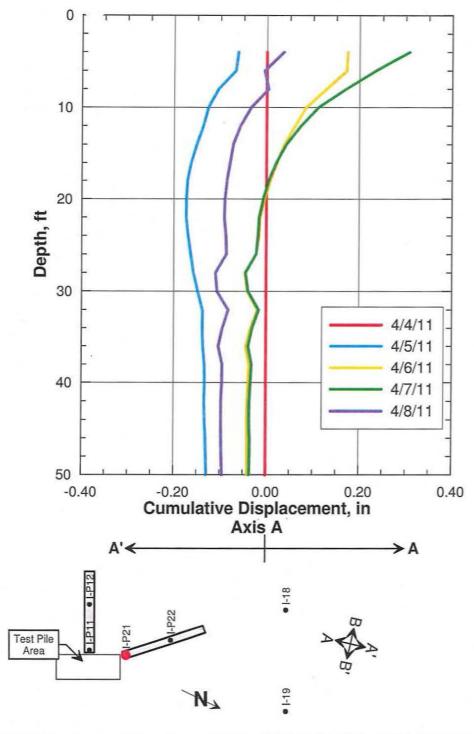
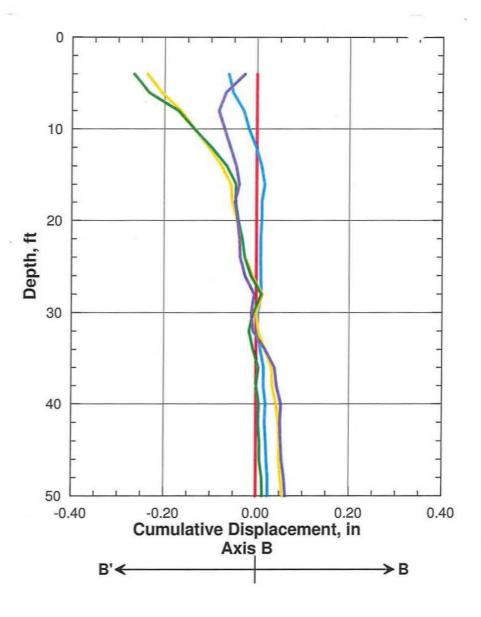
INCLINOMETER DATA FOR PILE EXTRACTION TEST SITE INCLINOMETER READING I-P21: TOP 50 FEET OF THE INCLINOMETER ONLY

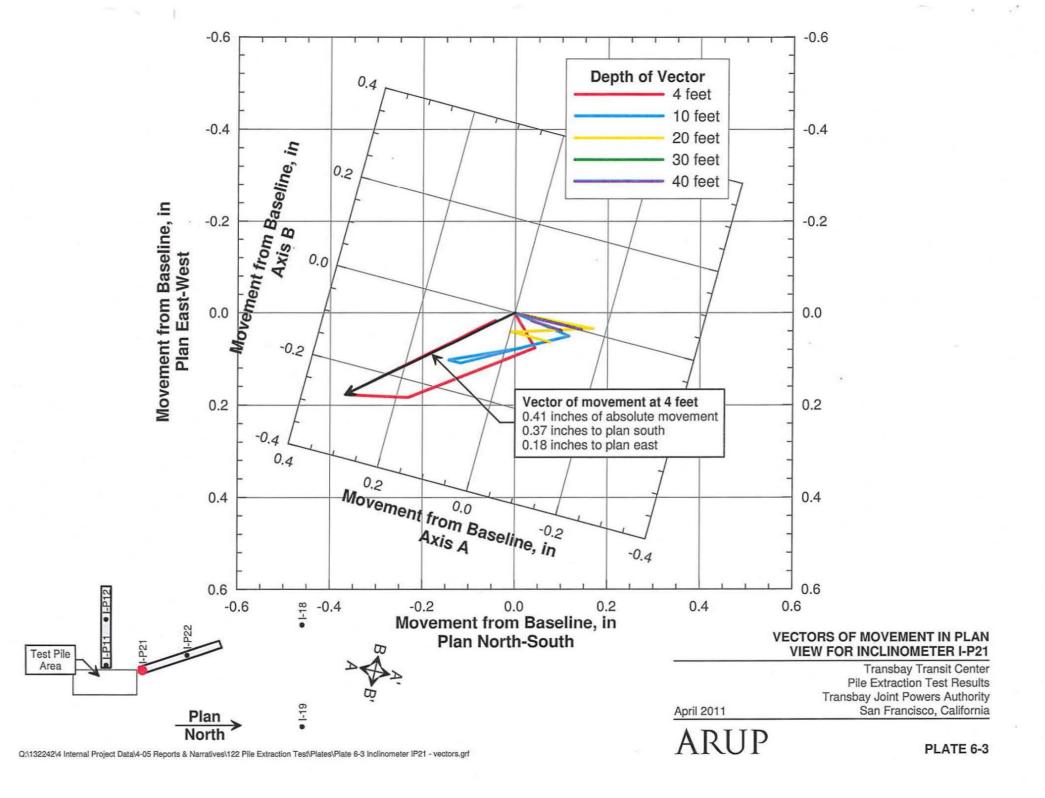
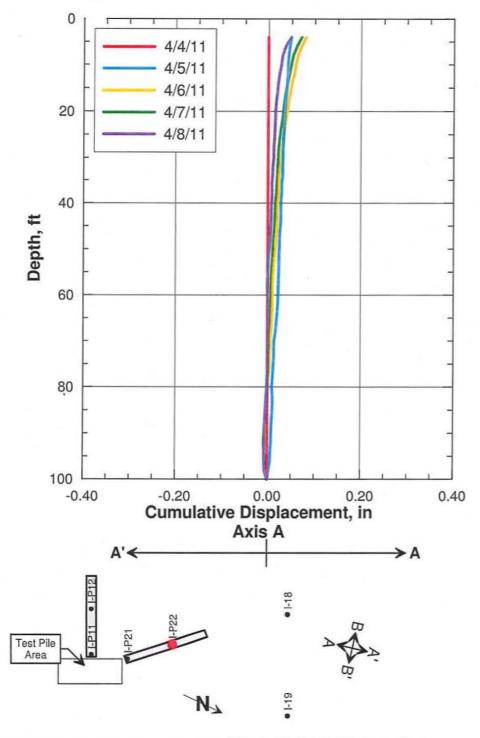
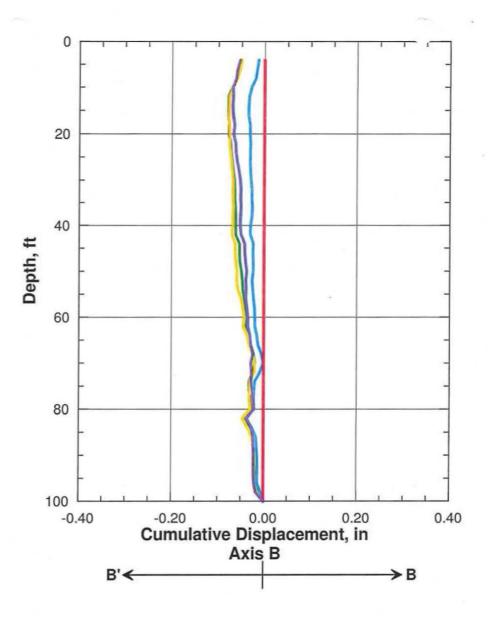
INCLINOMETER DATA FOR PILE EXTRACTION TEST SITE INCLINOMETER READING I-P22

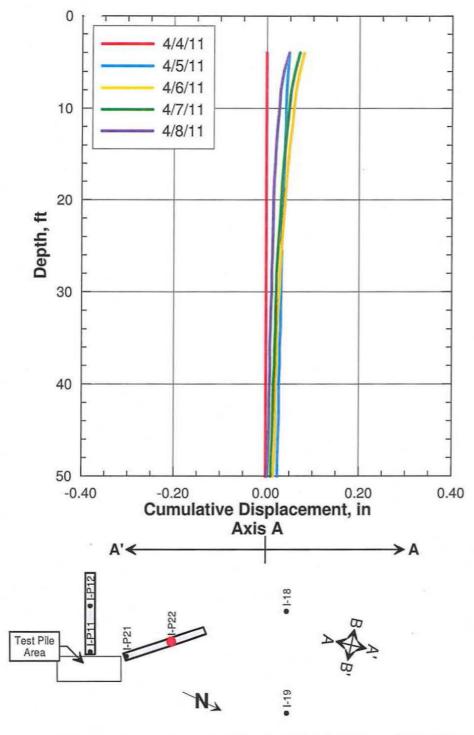
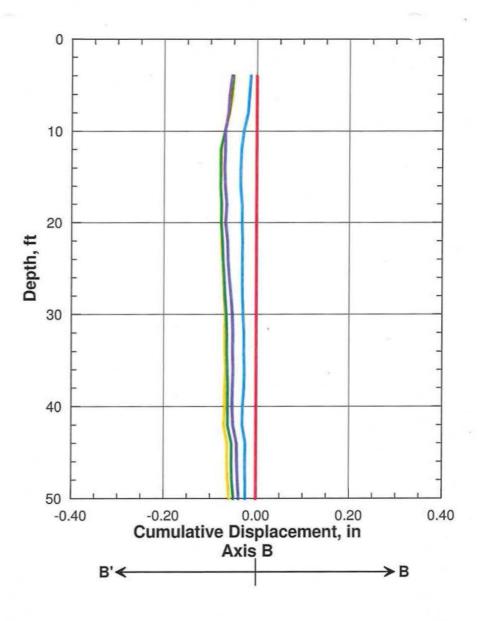
INCLINOMETER DATA FOR PILE EXTRACTION TEST SITE INCLINOMETER READING I-P22: TOP 50 FEET OF THE INCLINOMETER ONLY
