File	No.	160975

Government Audit and Oversight Committee May 16, 2018 ♦ 10:00 a.m.

Supplemental Report for Foundation Settlement Investigation

SUPPLEMENTAL REPORT FOUNDATION SETTLEMENT INVESTIGATION 301 MISSION STREET SAN FRANCISCO, CALIFORNIA

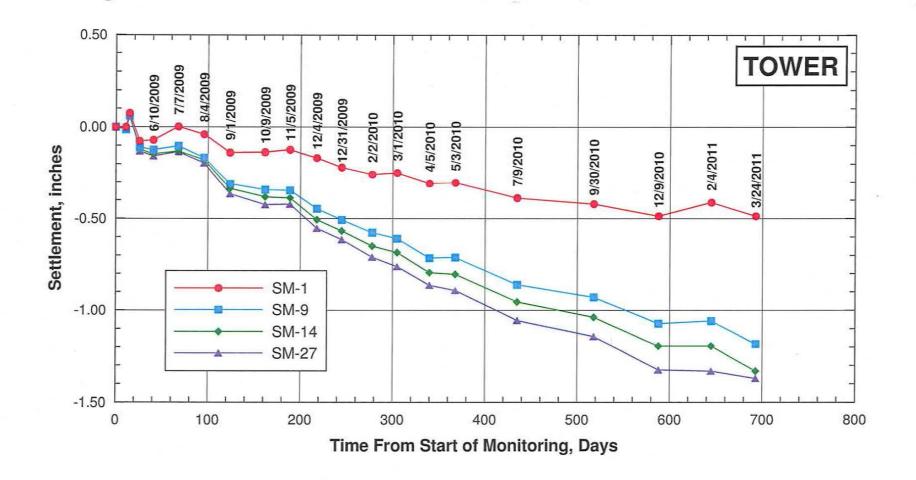
SETTLEMENT OVER TIME FLOOR ELEVATIONS AT LEVEL B-1 OF 301 MISSION PROPERTY- TOWER: APRIL 30, 2009 THROUGH MARCH 24, 2011

Negative values of settlement (within Low-rise Tower) indicate uplift.

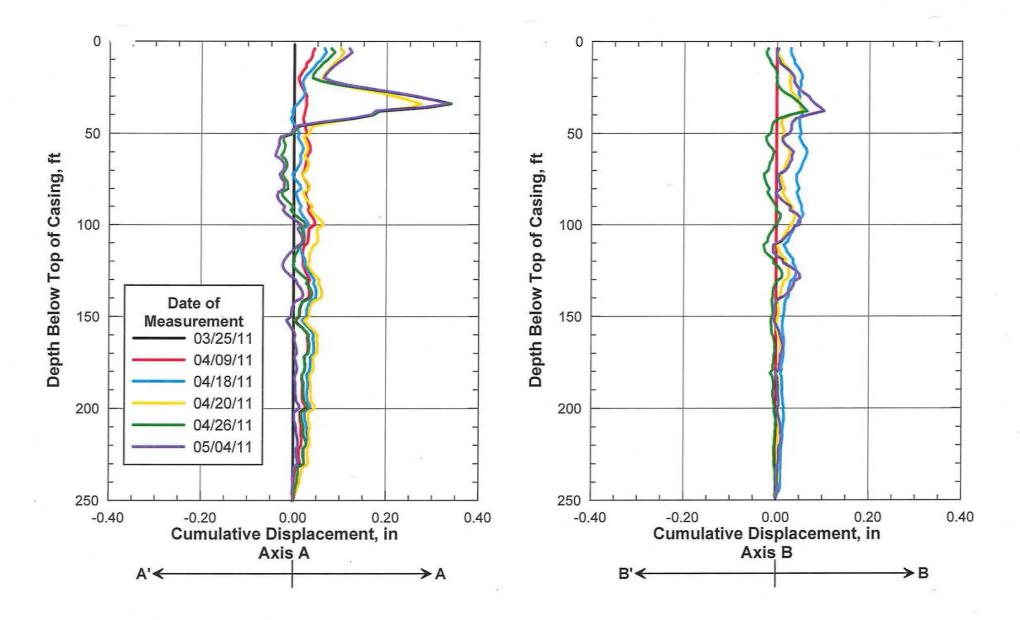
INCLINOMETER DATA FOR PILE EXTRACTION TEST SITE INCLINOMETER READING I-18

Overall, the lateral movements recorded to date are within the tolerances prescribed in the Specification.

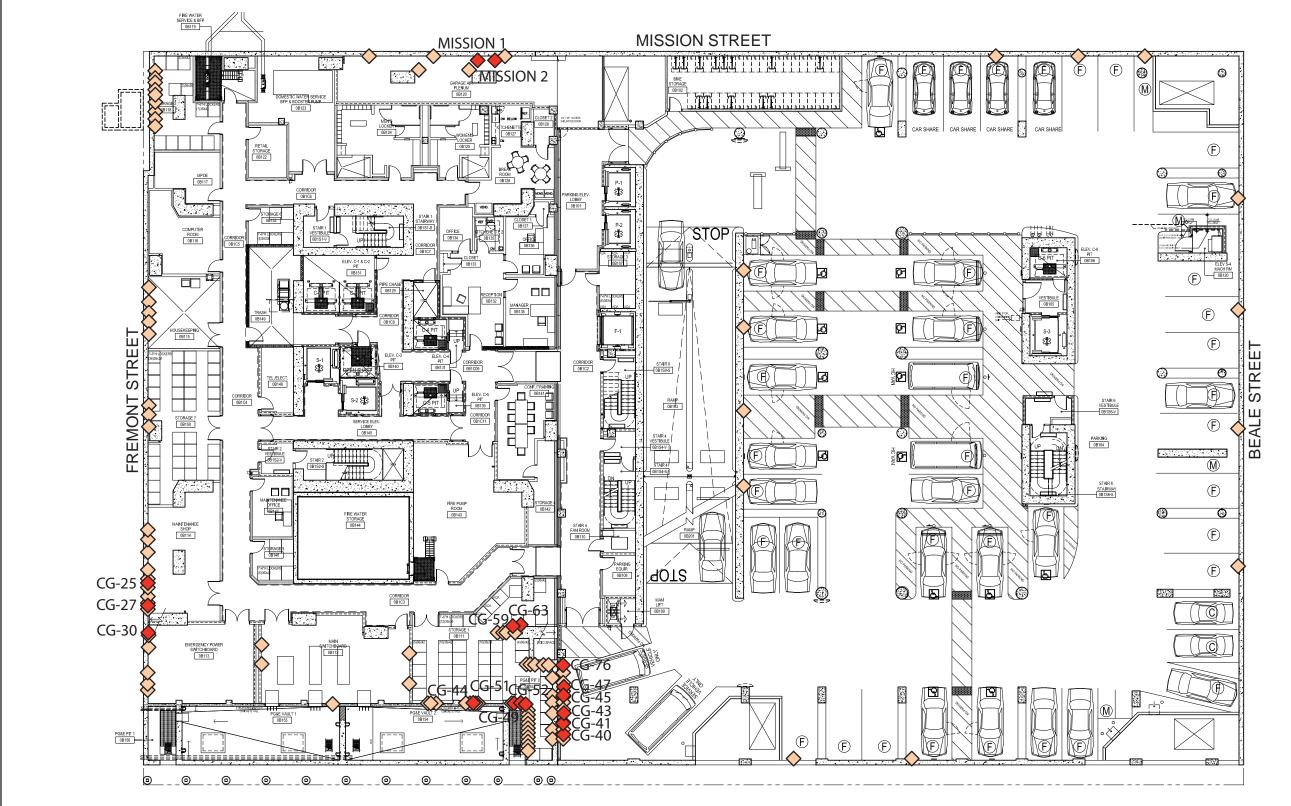
CRACK GAUGES SOWING MOVEMENT: 301 MISSION STREET BASEMENT LEVEL B-1

Crack gauge Nos. 94 through 102, located on level B1, may possibly be cemented together. This is likely from the wall re-surfacing which was performed in the area of these gauges. Additionally, crack gauge Nos. 2, 8, 13, 16 and 18 are covered in water-proofing epoxy.

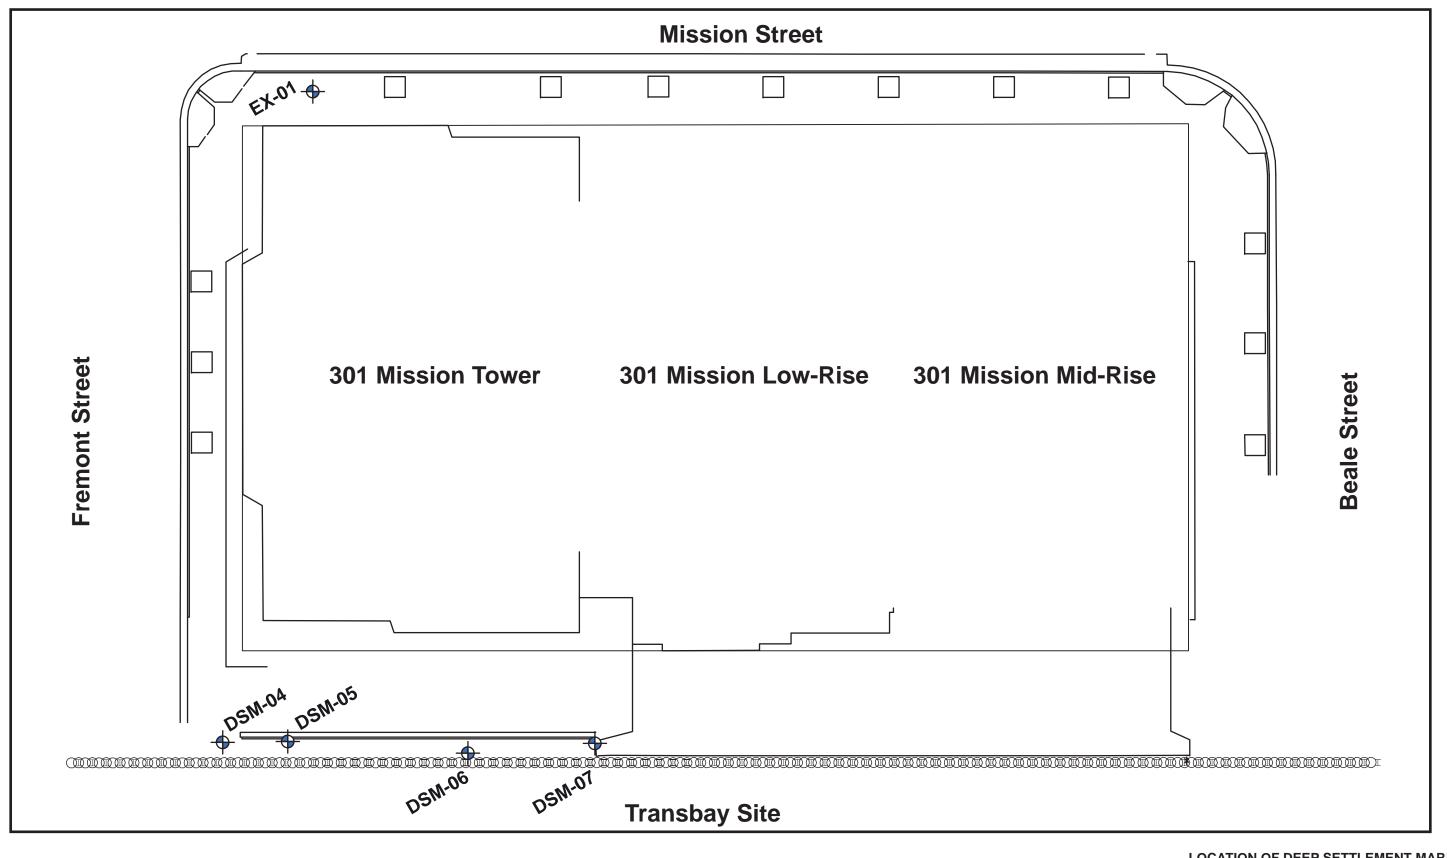
LOCATION OF DEEP SETTLEMENT MARKERS AND EXTENSOMETER IN THE VICNITY OF 301 MISSION

The deep settlement markers and the extensometer have been installed to allow digital data acquisition. These instruments are currently not reporting data. Deep settlement marker DSM-07 has already been damaged and is likely not able to collect data. It is not feasible to reinstall this instrument at this time.

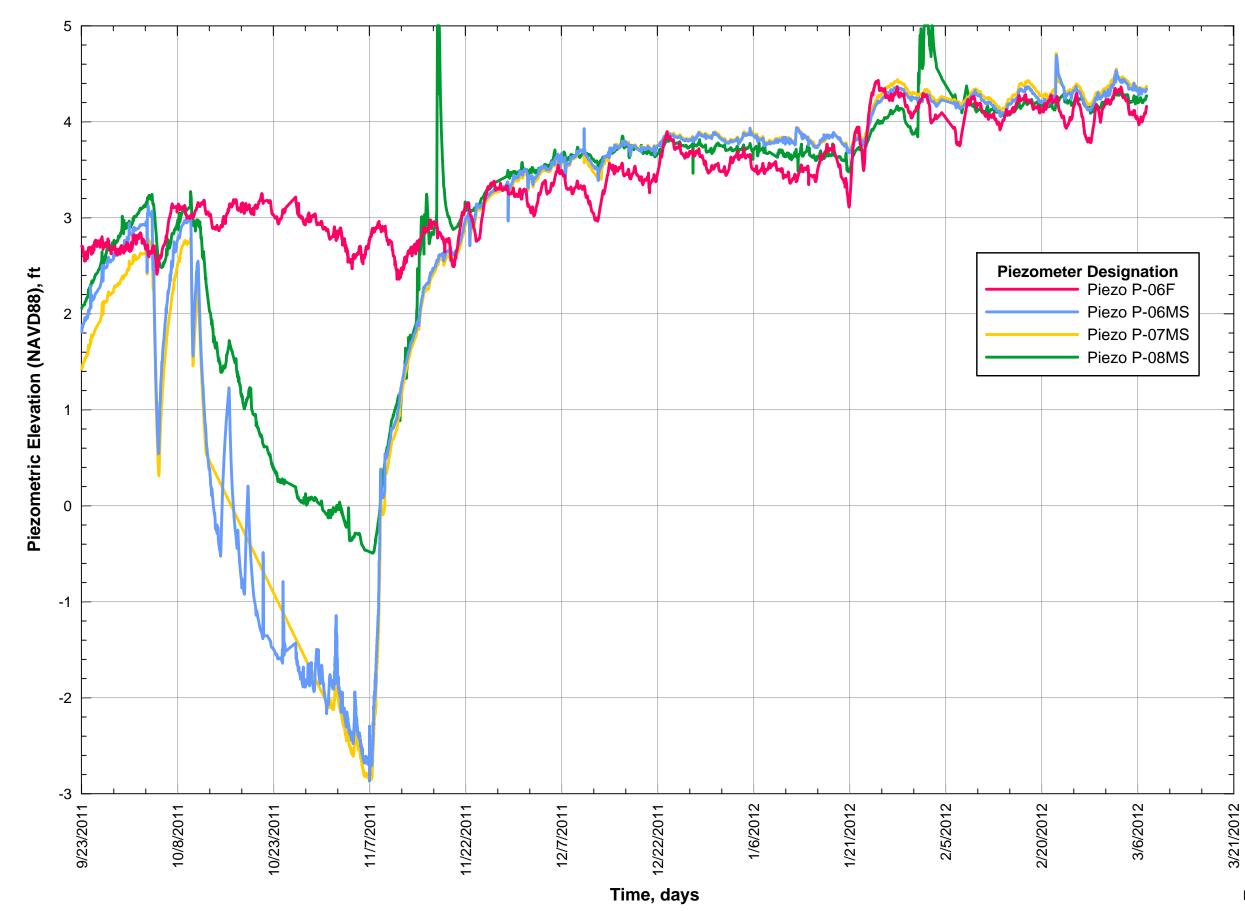
PIEZOMETER READINGS ADJACENT TO 301 MISSION

NOTE: Ground surface is approximately +14.0 ft NAVD88 in the vicinity of the 301 Mission/Transbay interface.

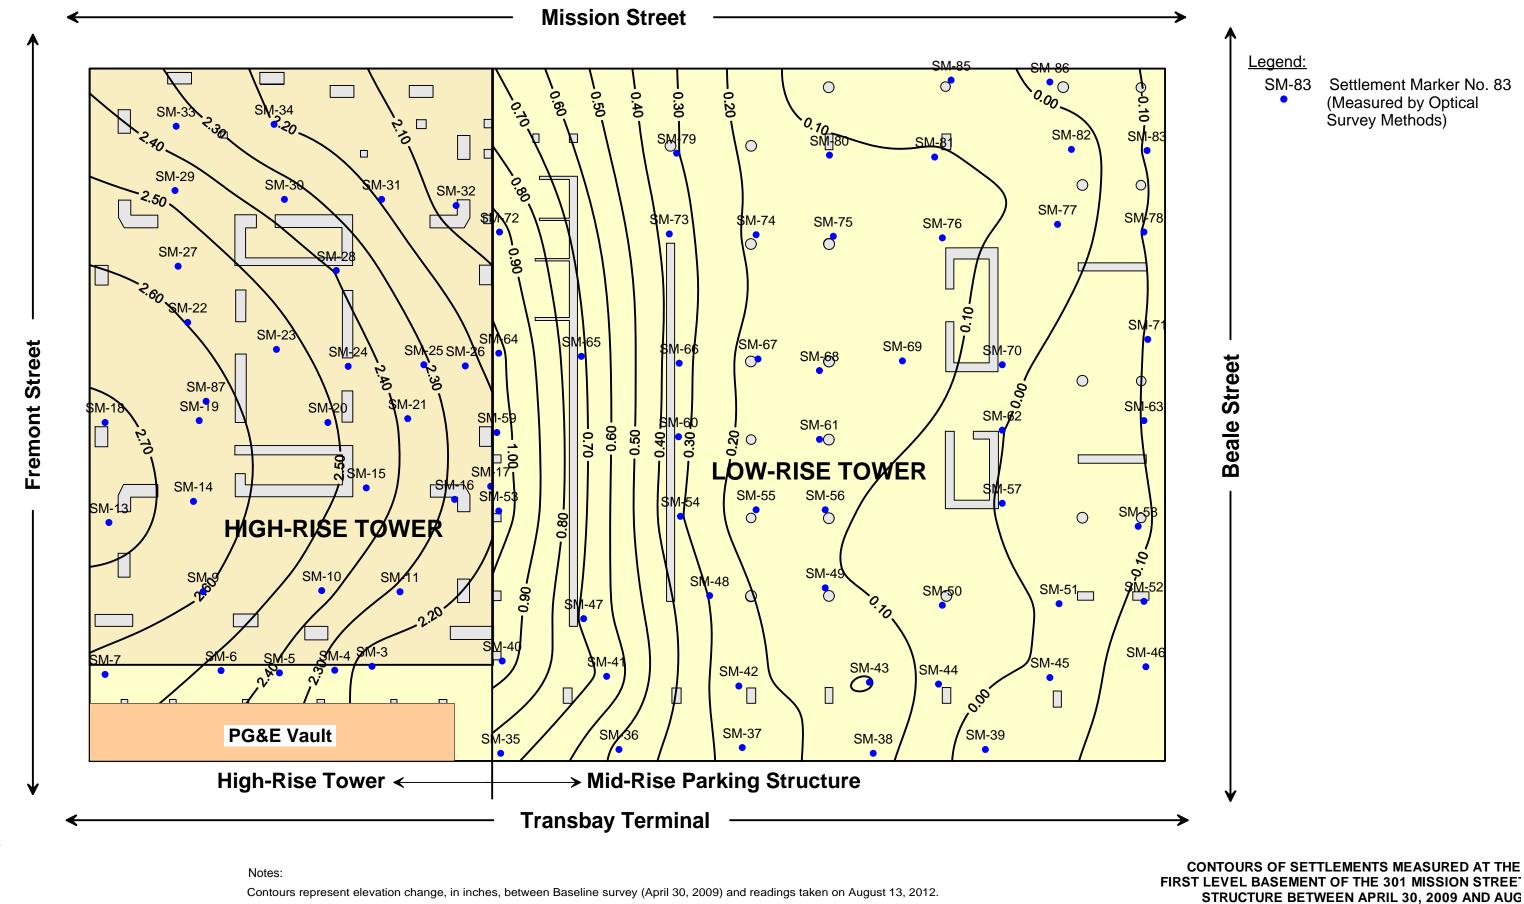
Level B-1 at Mid-Rise Parking portion of survey site is approximately 4 inches higher than Level B-1 at High-Rise Tower portion.

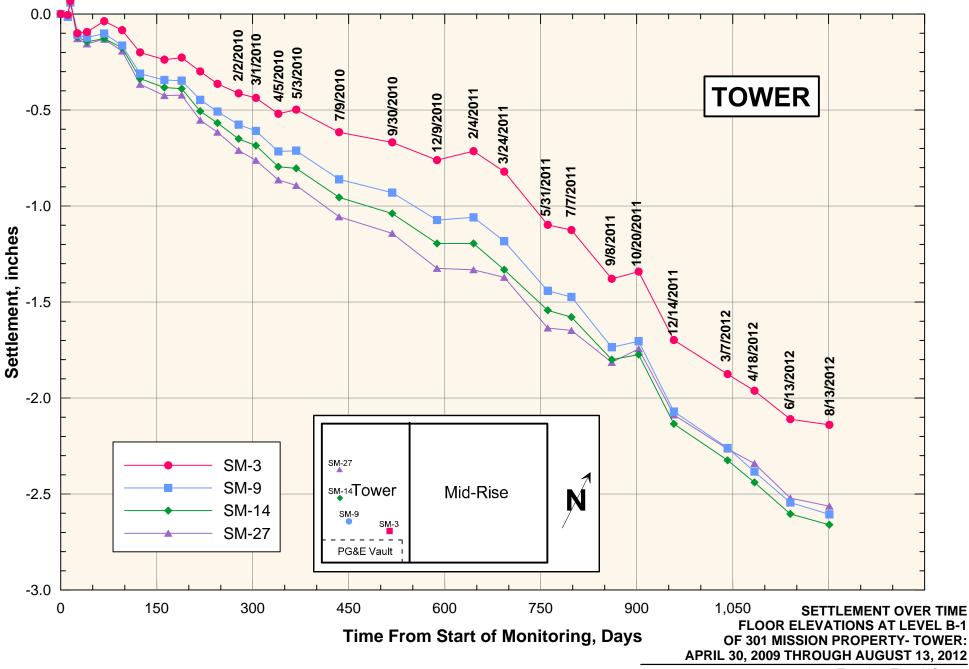
The PG&E vault is inaccessible for monitoring.

Negative values of settlement (within Low-rise Tower) indicate uplift.

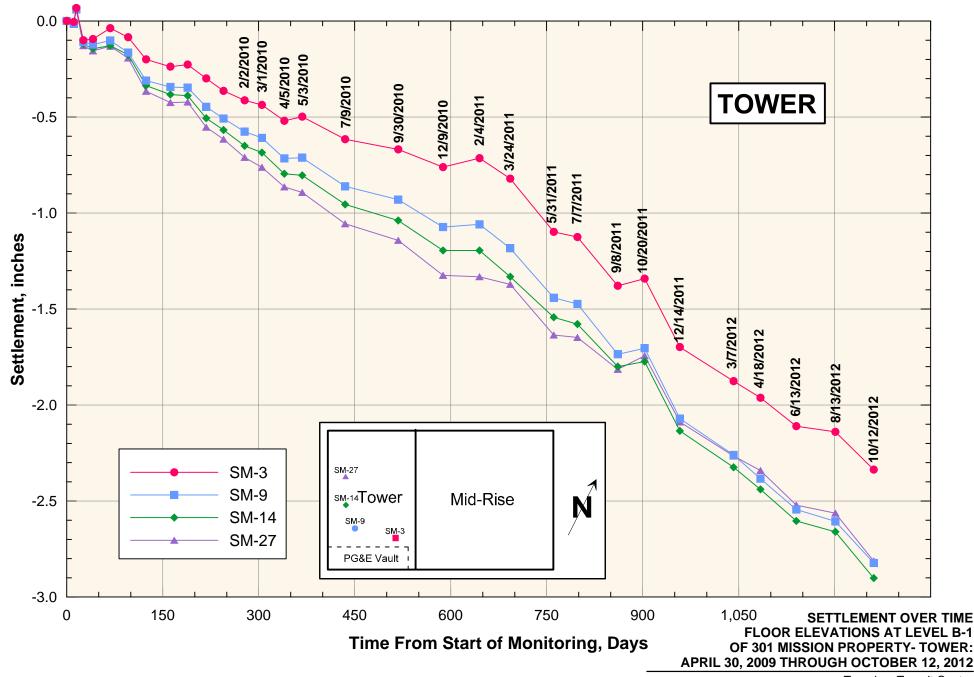
The PG&E vault is inaccessible for monitoring.

Negative values of settlement (within Low-rise Tower) indicate uplift.

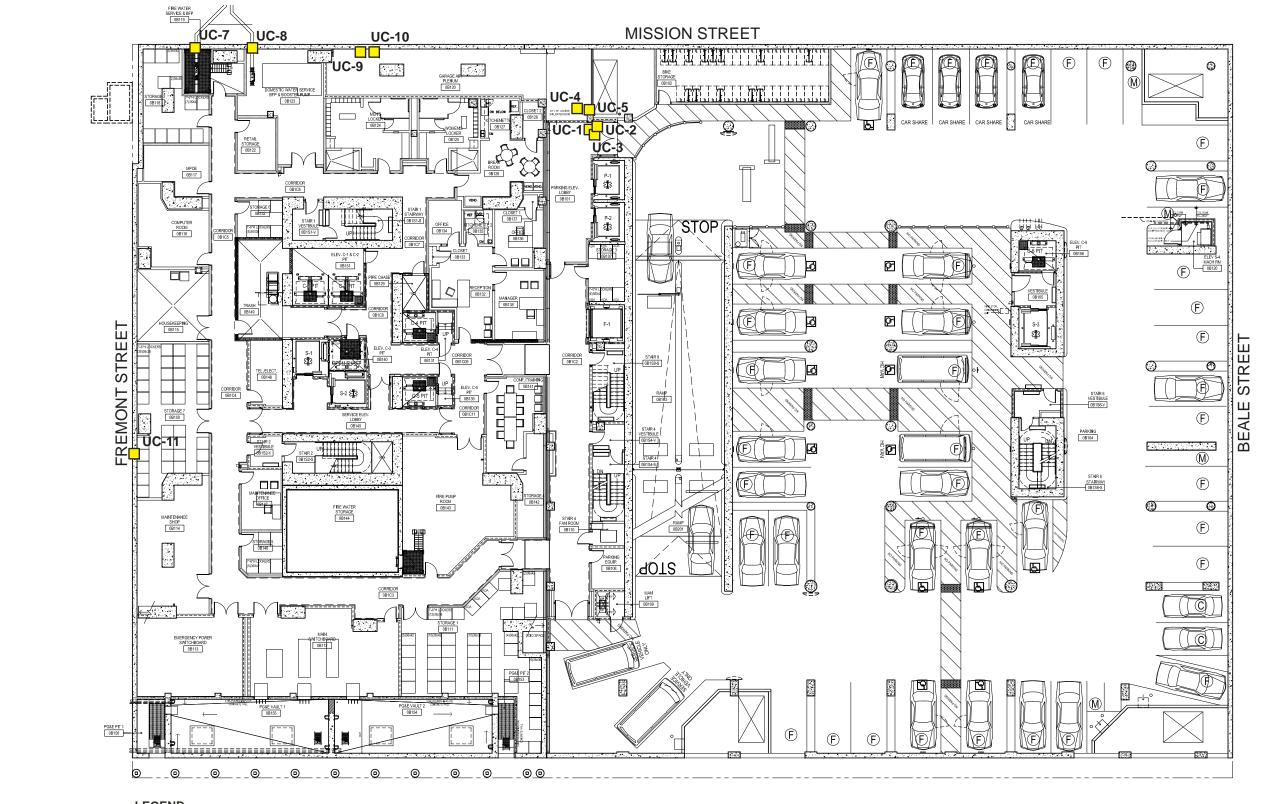
LOCATION OF UTILITY CROSSING MONITORING: 301 MISSION STREET BASEMENT LEVEL B-1

^{*} UC-11 was damaged during utility maintenance and is not included in this memo

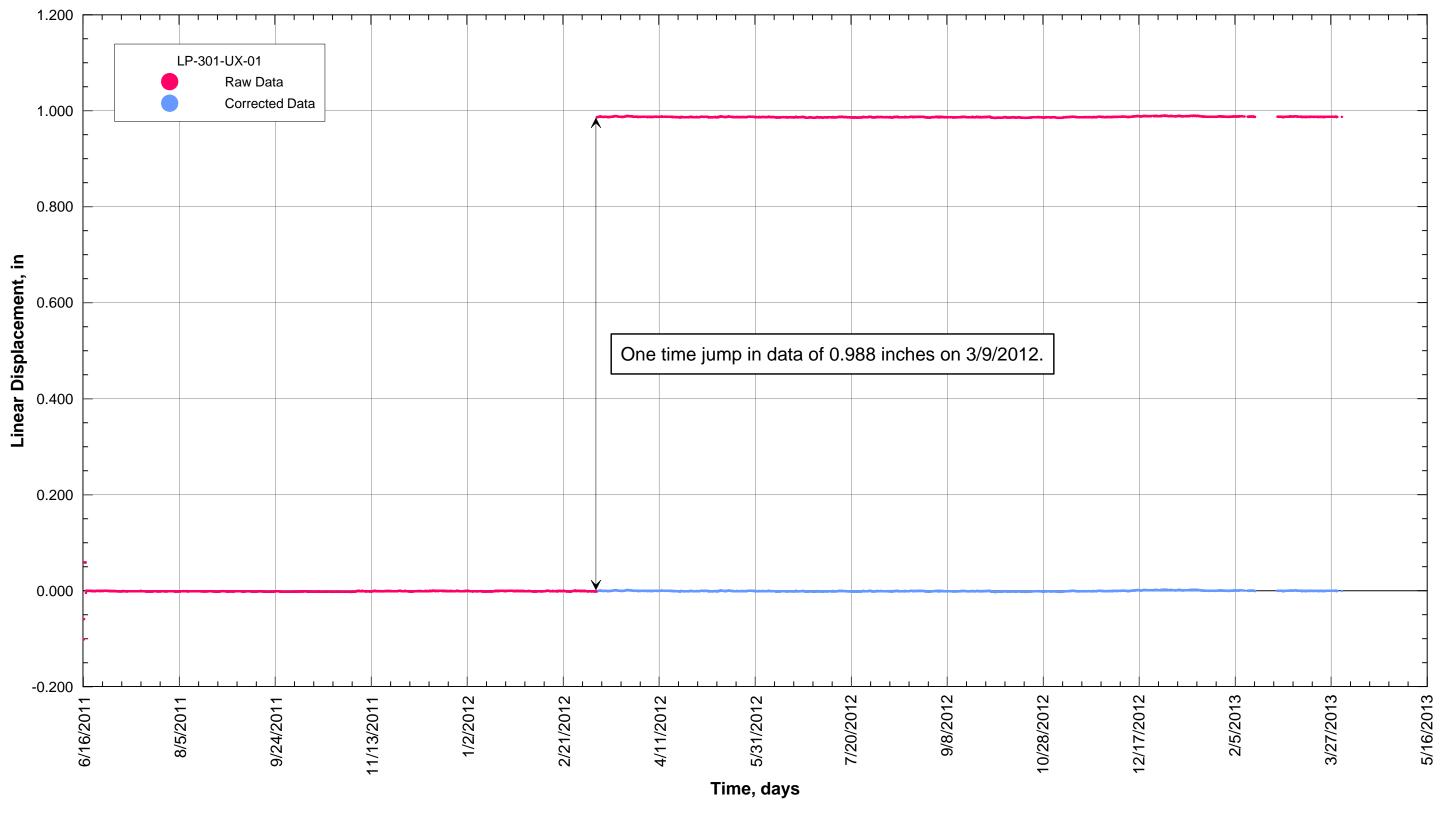
BASELINE CORRECTION EXAMPLE: UC-01

original baseline. An example of the baseline correction for UC-01 is presented on Plate 13 which displays the raw and corrected data as well as the magnitude of the jump. The jump on UC-01 and UC-03 occurred on the same day and was likely caused by the same event given their proximity. The jump on UC-07 occurred during the manual gauge length measurements on 3/19/2013 and was likely inadvertently bumped while the measurement was taken.

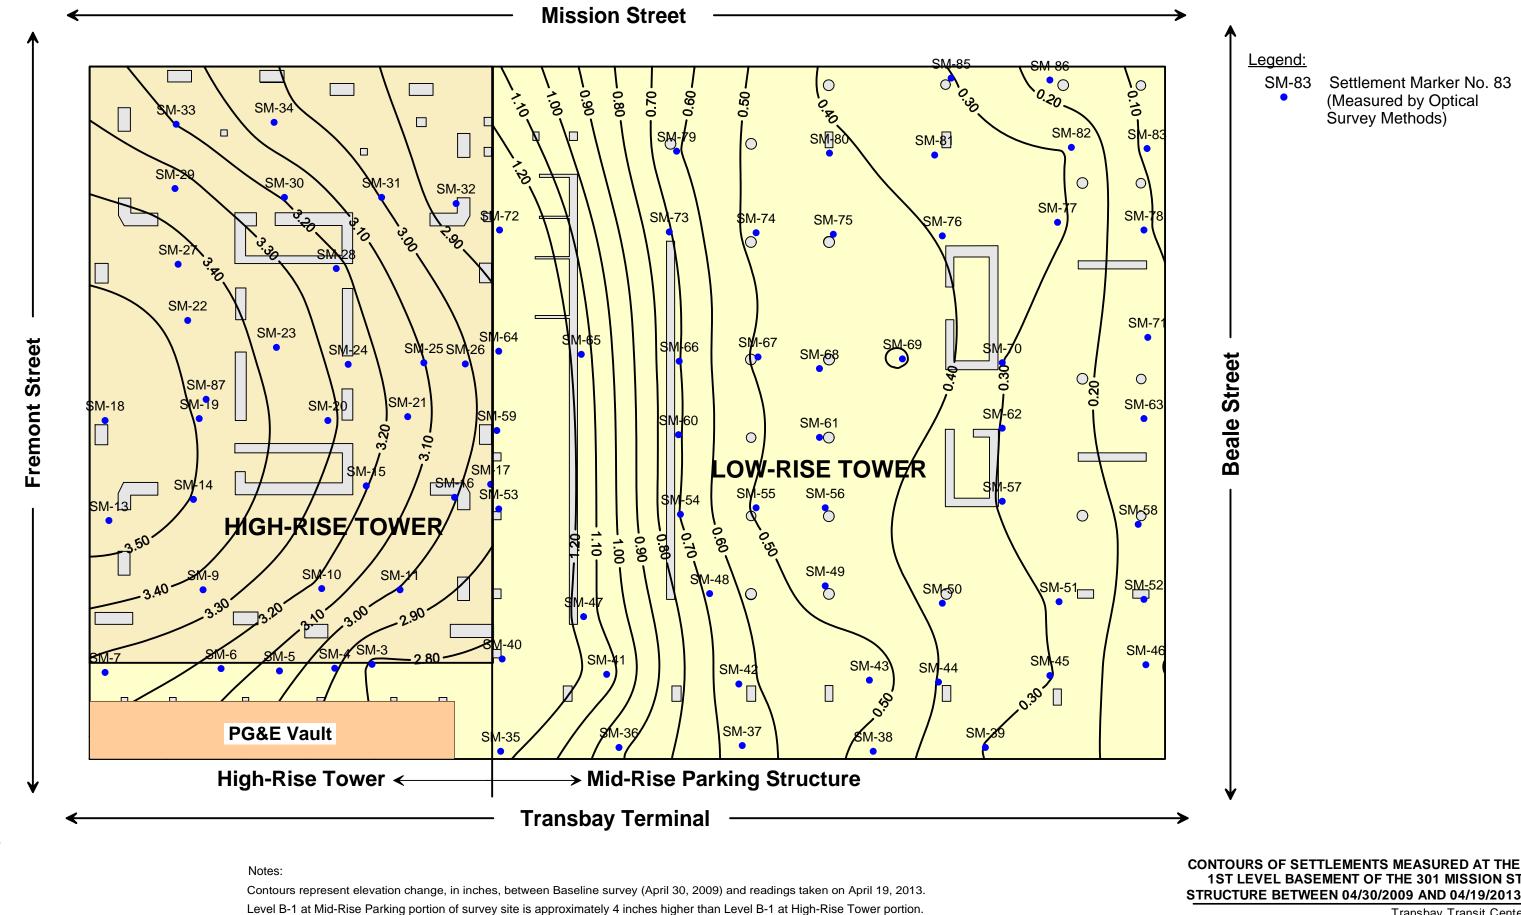
1ST LEVEL BASEMENT OF THE 301 MISSION ST STRUCTURE BETWEEN 04/30/2009 AND 04/19/2013

Negative values of settlement (within Low-rise Tower) indicate uplift.

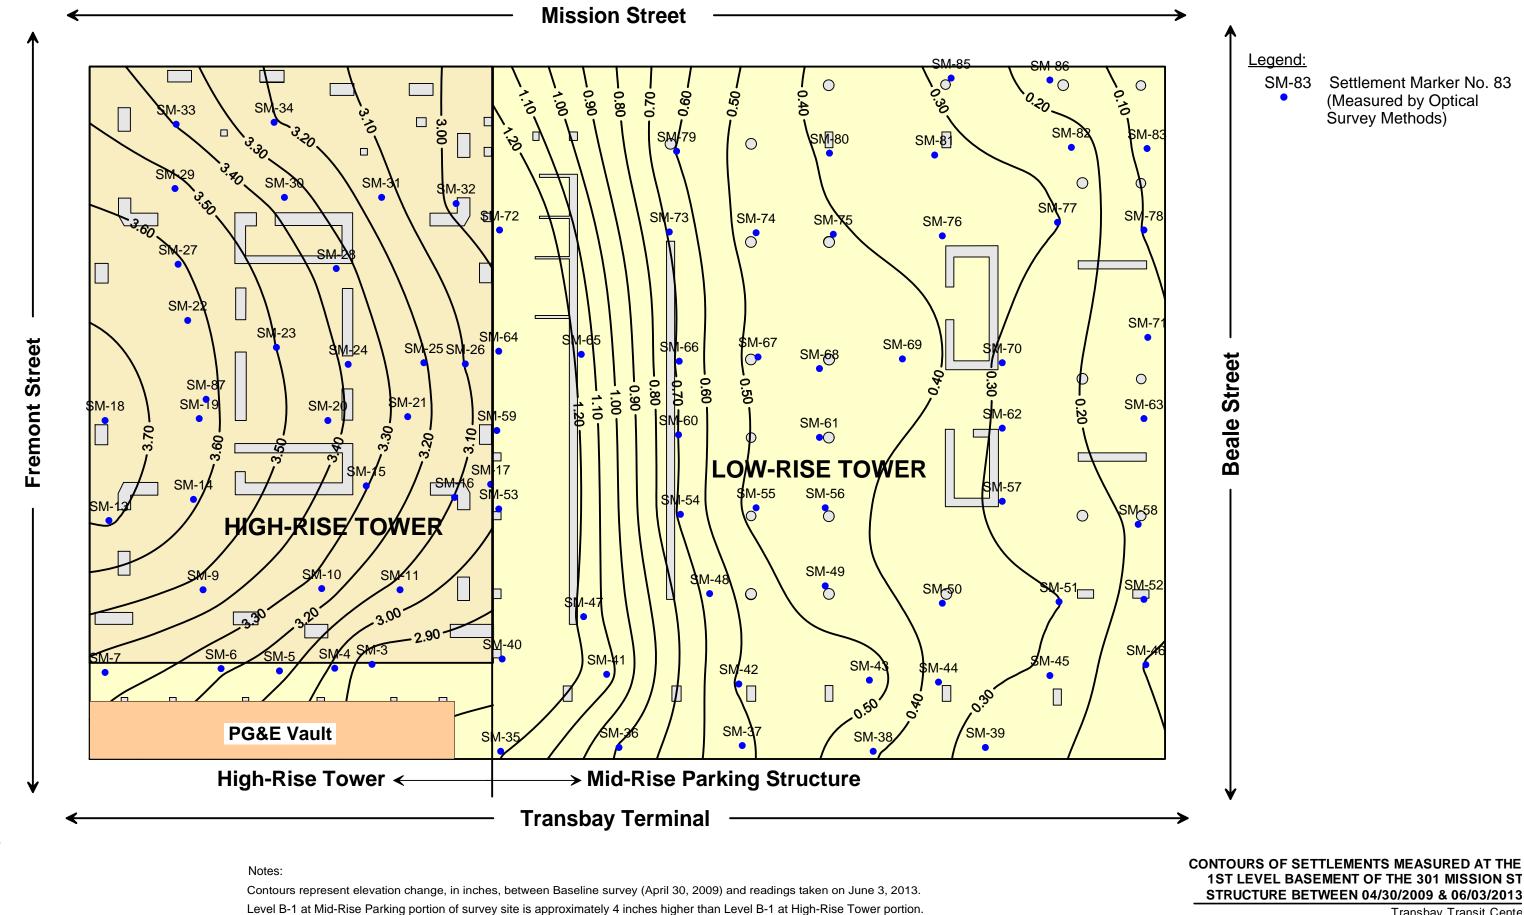
1ST LEVEL BASEMENT OF THE 301 MISSION ST STRUCTURE BETWEEN 04/30/2009 & 06/03/2013

Negative values of settlement (within Low-rise Tower) indicate uplift.

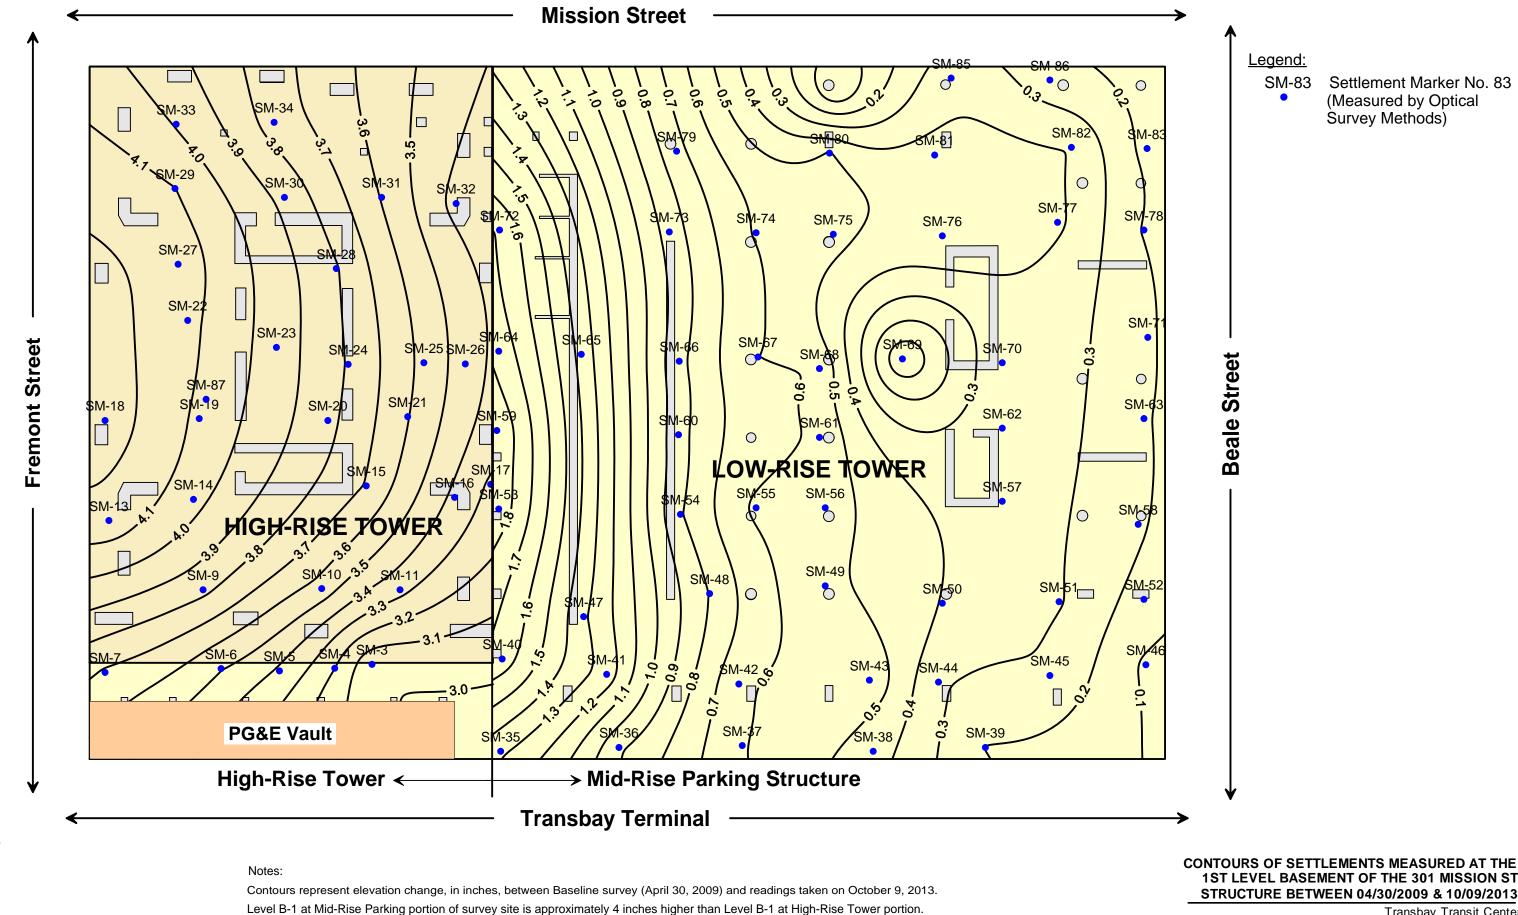
1ST LEVEL BASEMENT OF THE 301 MISSION ST STRUCTURE BETWEEN 04/30/2009 & 10/09/2013

Negative values of settlement (within Low-rise Tower) indicate uplift.

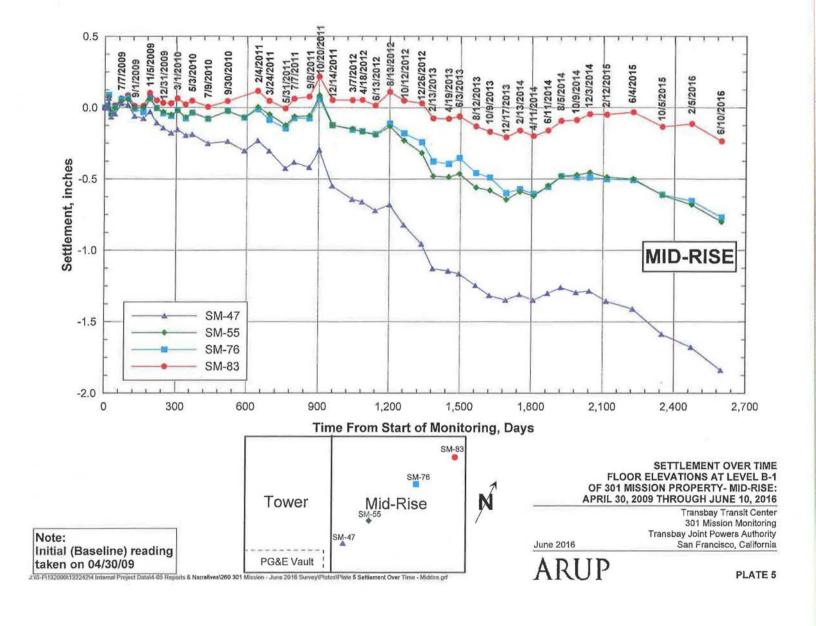
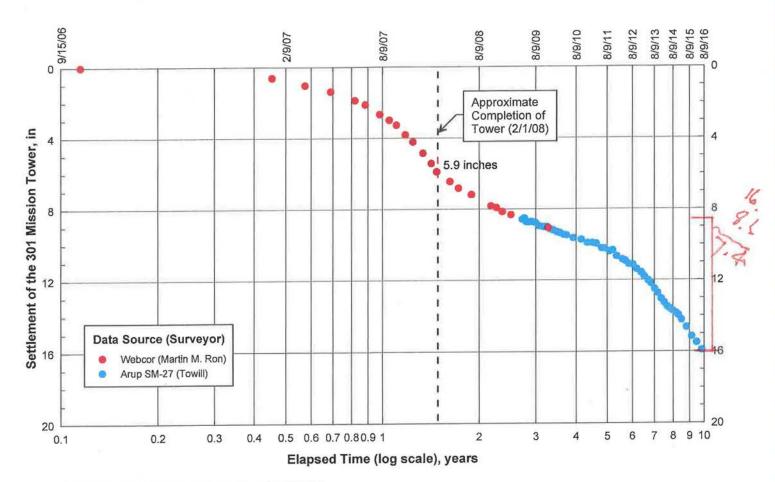
PLATE 6

Begining of Tower Construction: 8/9/06 End of Tower Construction: 2/1/08 Construction Duration: 542 days (1.5 years)

SETTLEMENTS OF THE 301 MISSION TOWER INCLUDING MONITORING DURING CONSTRUCTION

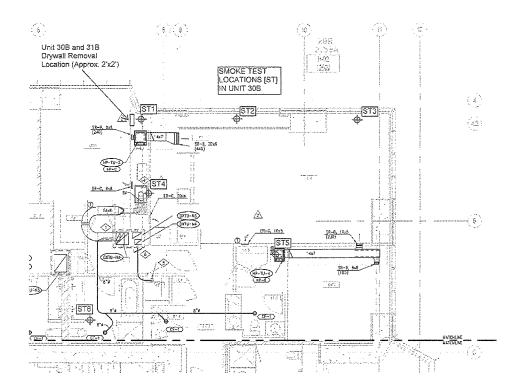
- (1) smoke emitter cartridge was setoff in Unit 30B at ST4
 - Odor detected in Unit 31B kitchen area.
 - Faint smoke haze in same area.
