Planning Department Response to the Appeal of the Categorical Exemption for 26 Hodges Alley

Categorical Exemption Appeal 26 Hodges Alley

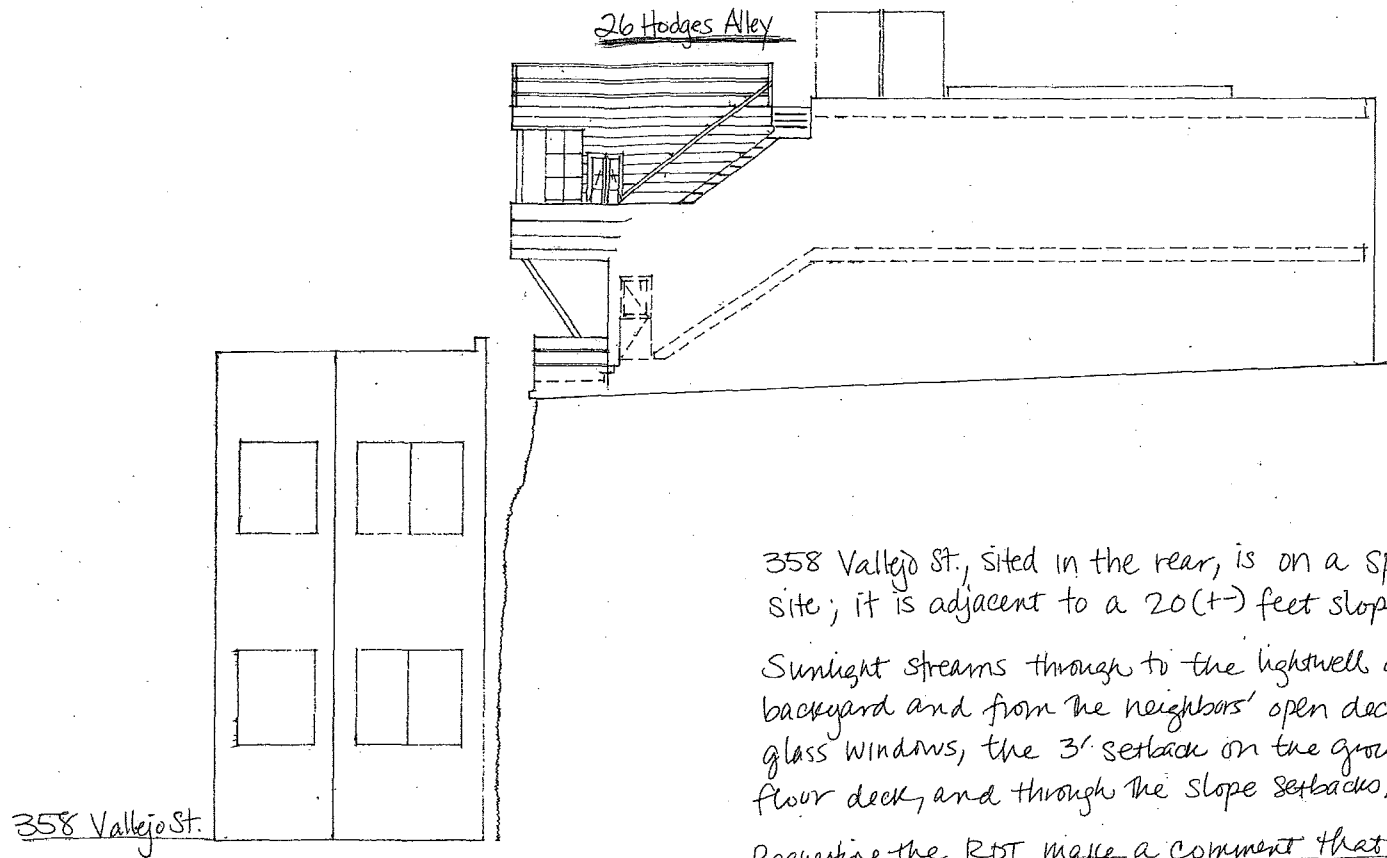
3

358 Vallejo St., sited in the rear, is on a special site; it is adjacent to a 20(+)-feet slope.

Sunlight streams through to the lightwell and backyard and from the neighbors' open deck rails, glass windows, the 3' setback on the ground floor deck, and through the slope setbacks.

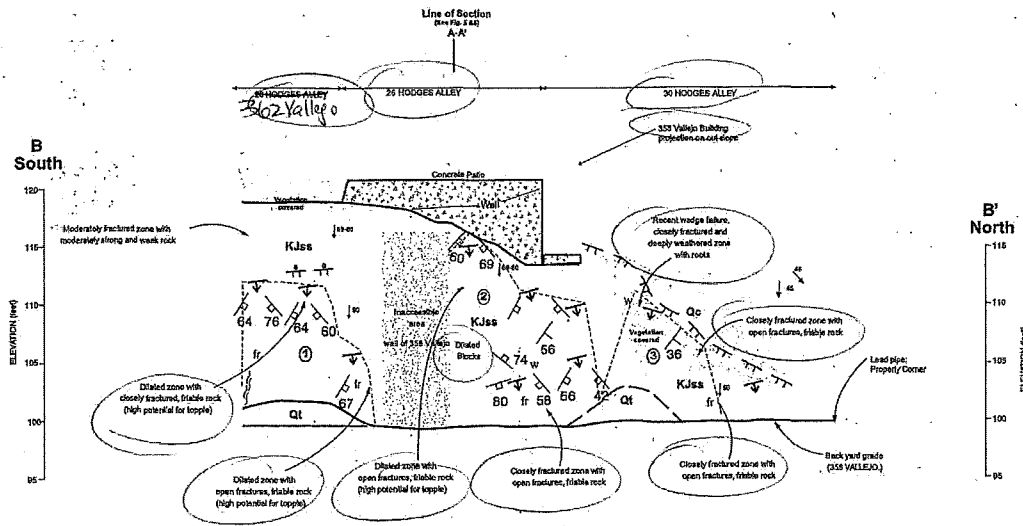
Date: 5/28/03 Figure 5

- Qc Soil or Colluvium with Roots
- Qt Talus Deposit, includes recent rockfall debris
- KJss Sandstone with minor Shale (Franciscan complex)
- fr friable, matrix
- w - deeply weathered
- b - block or block-rich

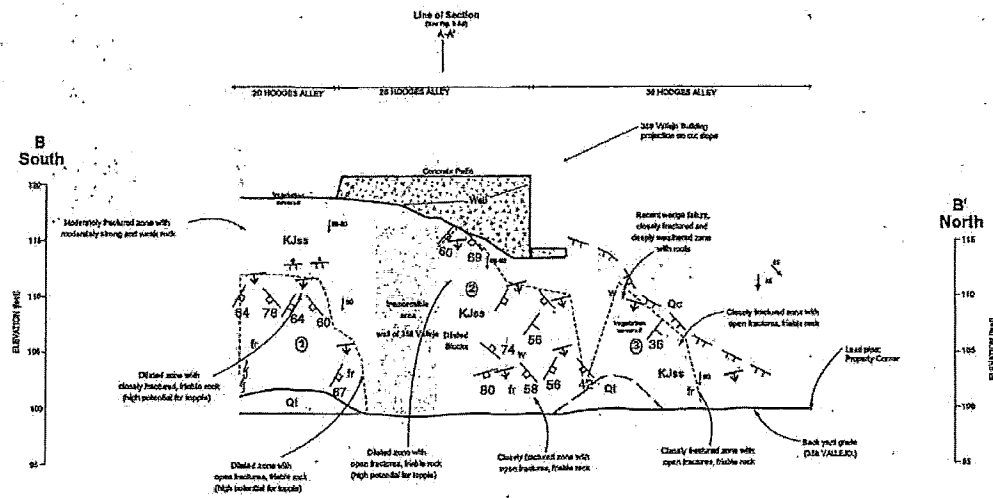
GEOLOGIC CROSS SECTION B-B'		
DEWILDE RESIDENCE 26 HODGES ALLEY San Francisco, California		
Date: 5/28/13	Project No. 91552.01	Figure 5
Gipin Geosciences, Inc. Earthquake & Engineering Geology Consultants

The results of our observations are presented on Figures 3, 4 and 5. Figure 3 shows a generalized site plan for reference. Because of the steep slope and limited access we have mapped our observation on cross sections perpendicular and parallel to the cut slope; these are shown on Figures 4 and 5, respectively. The Cross Section B-B', Figure 5, shows the limits of the parcels at 20, 26, and 30 Hodges Alley.

We mapped three areas of the slope that are susceptible to wedge-type rock failures. Evidence of recent rockfalls include numerous fresh scars, loose blocks, and talus composed of debris and sandstone blocks at the base of the slope, which is the backyard of 358 Vallejo Street residence. Three areas that appear to be rockfall areas susceptible to wedge-type block failures are depicted on Figure 5.

Bedding in the sandstone and shale unit dips generally northeast, oriented out of the slope, at inclinations of 30 to 56 degrees. Jointing was mapped in the sandstone unit as dipping to the southeast at between 42 to 76 degrees and north or northeast at between 36 to 74 degrees. The adverse joints combined with the northeast dipping beds yield wedge-type failure potential along the intersection of these two planes with a preponderance of failures oriented due east and northeast dipping at 16 to 54 degrees out of the slope. (See Figure 5).

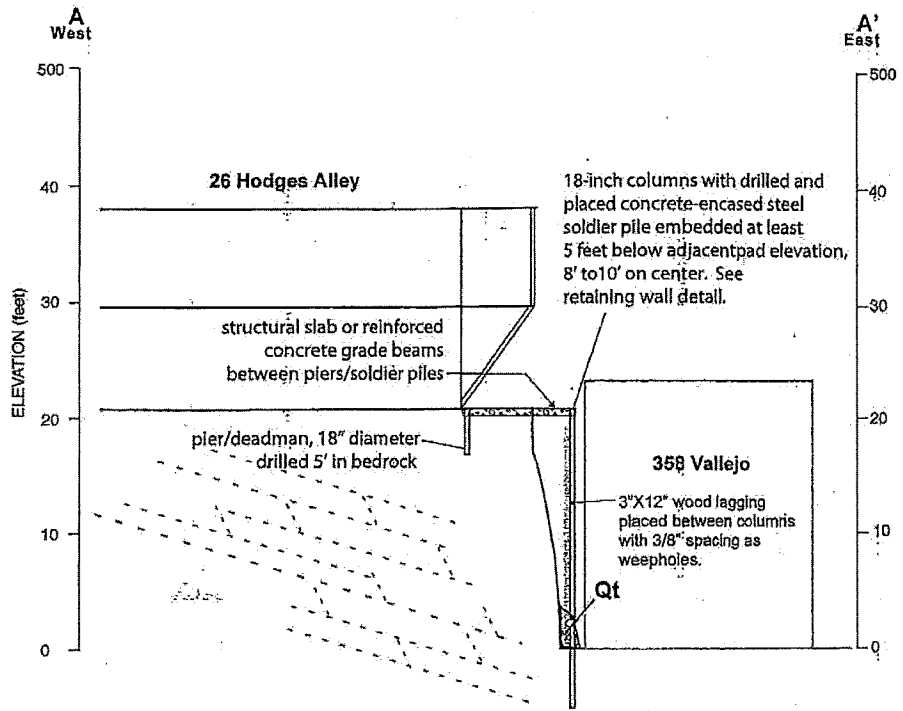
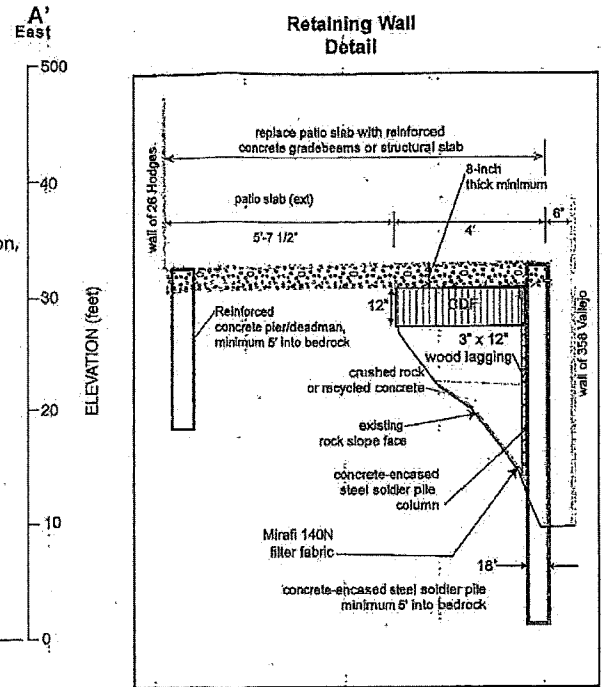
Conceptual Repair Section		
A-A'		
DE WILDÉ RESIDENCE 26 Hodges Alley San Francisco, California		
Date 5/28/13	Project No. 91552.01	Figure 6
Gliplin Geosciences, Inc. Earthquake & Engineering Geology Consultants

The wall should be constructed to support the existing rock cut slope (Figure 6, 7) and should extend approximately 17 lineal feet across the 26 Hodges Alley parcel width. The soldier piles should be connected by a structural slab or reinforced concrete grade beam to piers drilled along the rear of the building for supplemental lateral support. The piers would require drilling at or close to the present building perimeter foundation.

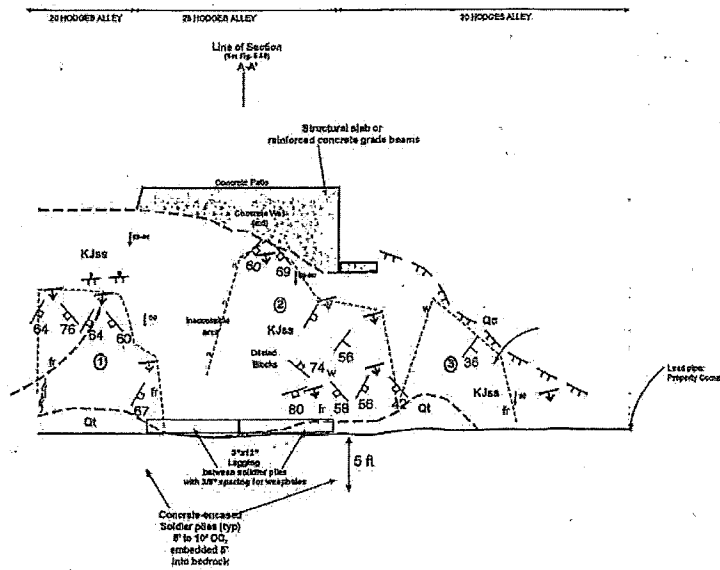
EXPLANATION
(see Figure 5)
