COMMITTEE/BOARD OF SUPERVISORS
AGENDA PACKET CONTENTS LIST

Committee: Land Use and Transportation Committee Date July 20, 2020

This memorandum has been prepared to document the findings of the Page & Turnbull exploratory team who were on site at Toland Hall on February 11-12, 2020 and also on February 27, 2020 and to provide a preliminary approach to relocation to inform a rough order of magnitude cost estimate prepared by tbd Consultants (attached). The purpose of these site visits was three-fold: 1) to evaluate the current condition of the Zakheim "History of Medicine" frescoes against conditions that were documented by Anne Rosenthal in 2011, noting further deterioration or changes; 2) to investigate and determine the original installation and construction techniques of the artwork in order to prepare a forthcoming recommended approach for extraction and relocation; and 3) identify initial preparation for relocation. The findings are summarized below as noted by experts in the field of fine art conservation and moving:

CURRENT CONDITION OF THE FRESCOES

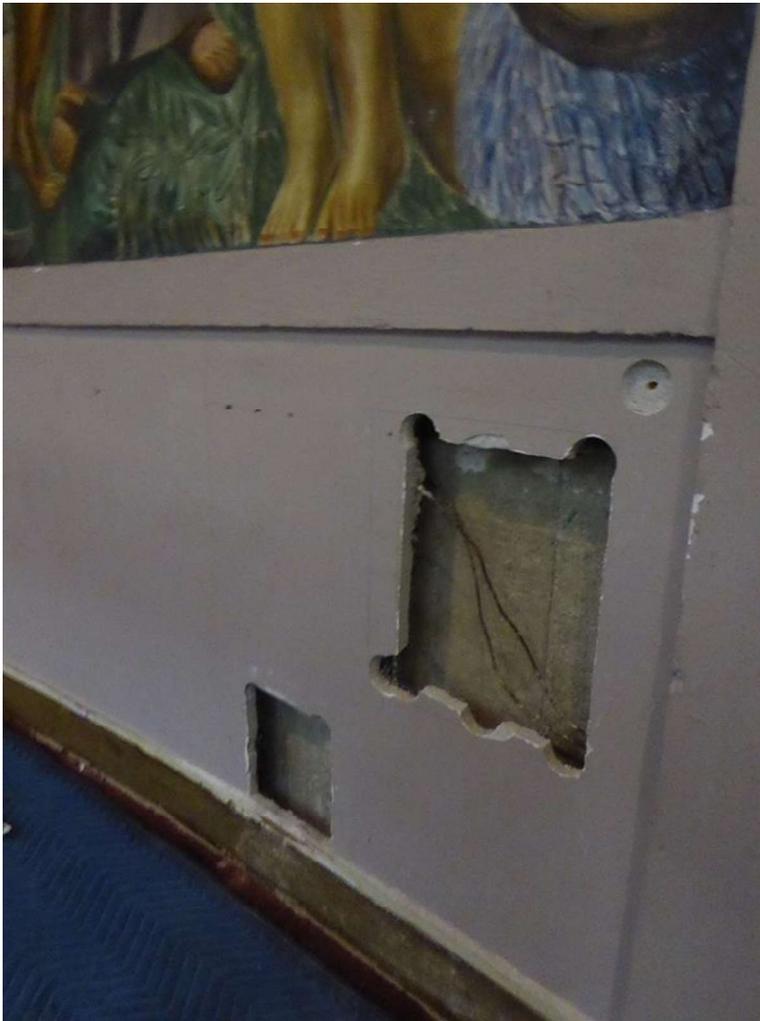
Figure 1: two access panels were removed to investigate construction and attachment of fresco wall

Staff from Atthowe Fine Art Services explored and photographed the plenum space above the fresco which is accessible from the ceiling and allow a limited view of the space behind the fresco(es). Additional view access was created by cutting and removing two (2) panels below one of the curved mural panels to better understand the construction method.

From this investigation Atthowe determined that the soffit ceiling and the wall are made from the same plaster and lathe technique. The fresco wall is constructed using metal vertical supports (furring) with a wooden nailer bound to them by wire clips. It appears that the lathe was nailed to the wooden elements to form the curve of the wall. Atthowe was able to observe the plaster and lathe extending above the image area of the fresco.

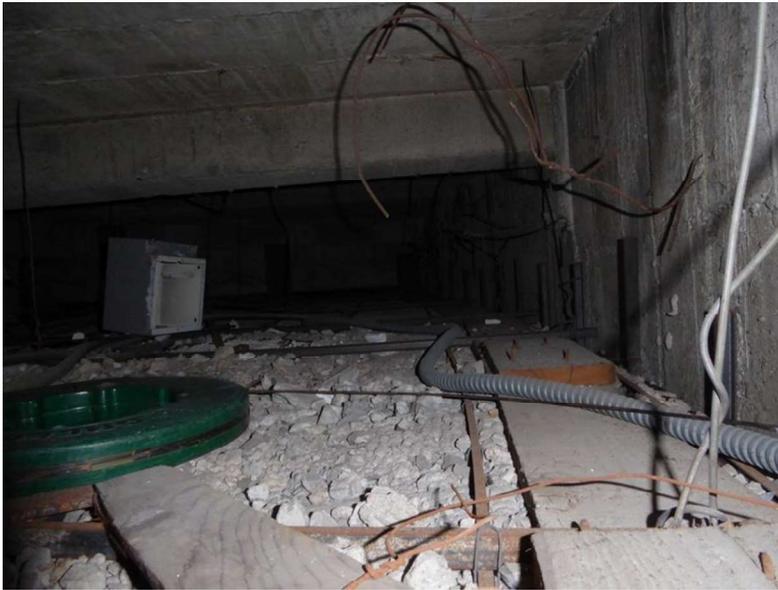
Figure 2: Image looking across plenum space above fresco wall, showing concrete rear wall, ceiling and lathe and plaster soffit.

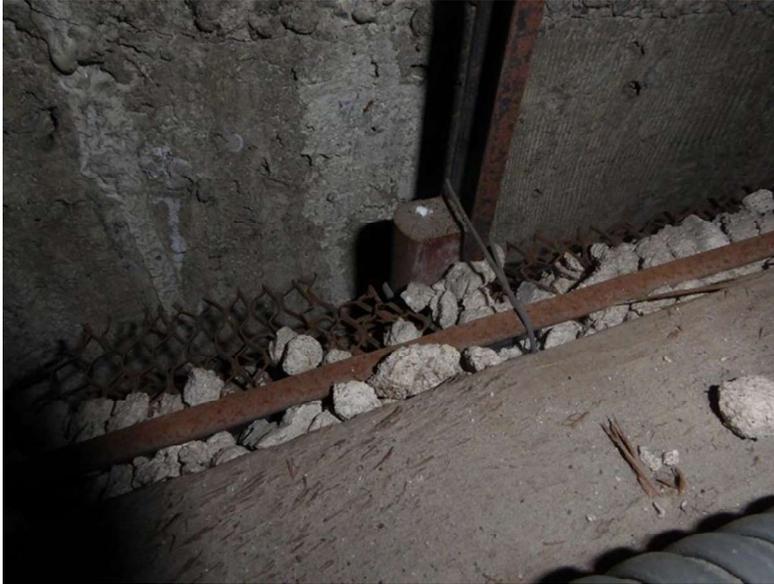
Figure 3: View looking down toward rear of fresco showing metal furring with wood nailer and attachment

The structural support of the frescoes' plaster wall is constructed from metal furring approximately 1 ½" x 1" that extend from floor to ceiling and are approximately 14" on center. These metal furring strips follow a curved concrete curb form at floor and ceiling and seem to only be attached at those points. The upright metal furring strips do not appear to be secured to the concrete structural wall however it is possible that there are some metal ties that would need to be severed once the fresco is secured in place.

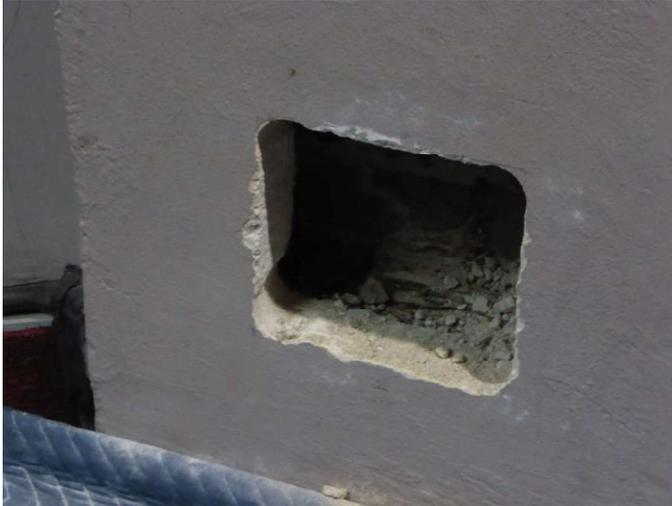
Figure 4: Decorate plaster pilaster

The sides of each fresco are bound by a decorative plaster pilaster, while the base of each fresco panel is framed by a decorative plaster molding strip. The exploration team removed a core sample at the molding strip and a square panel at a pilaster along a flat wall in the front of the auditorium to confirm this construction. The removal of a panel at the pilaster revealed finish paint on the wall below, suggesting that the decorative pilasters may have been installed along with the frescoes in 1936-1938, twenty years after completion of the building. There are two unbound frescoes, one on either side of the flat wall that describe and title the overall work – these would be removed with the same technique as the other flat frescoes.

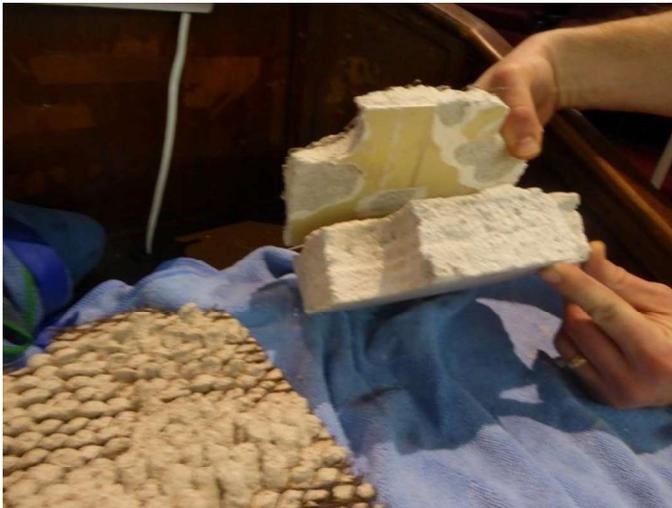
Figure 5: Access panel from pilaster shows finish paint between layers of plaster.

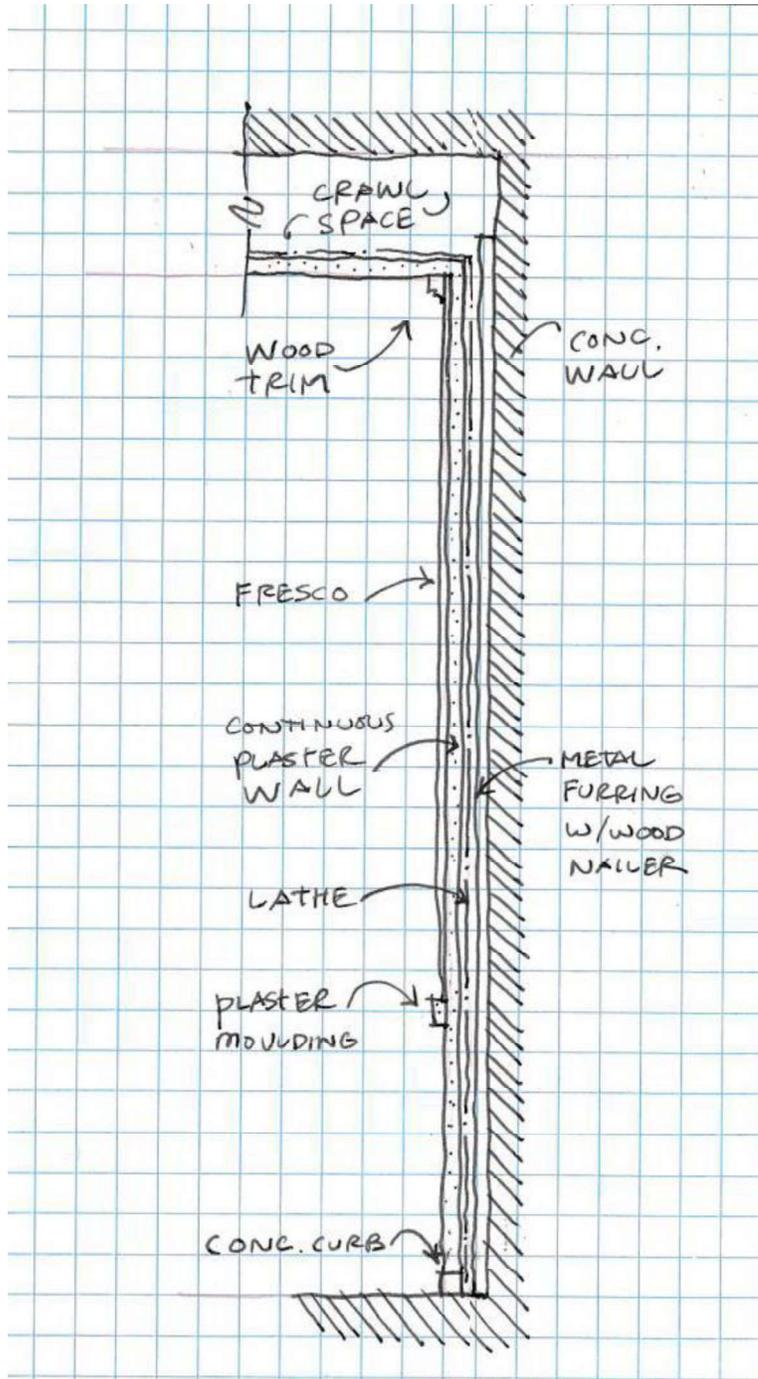
Figure 6: Wall section at typical curved fresco wall

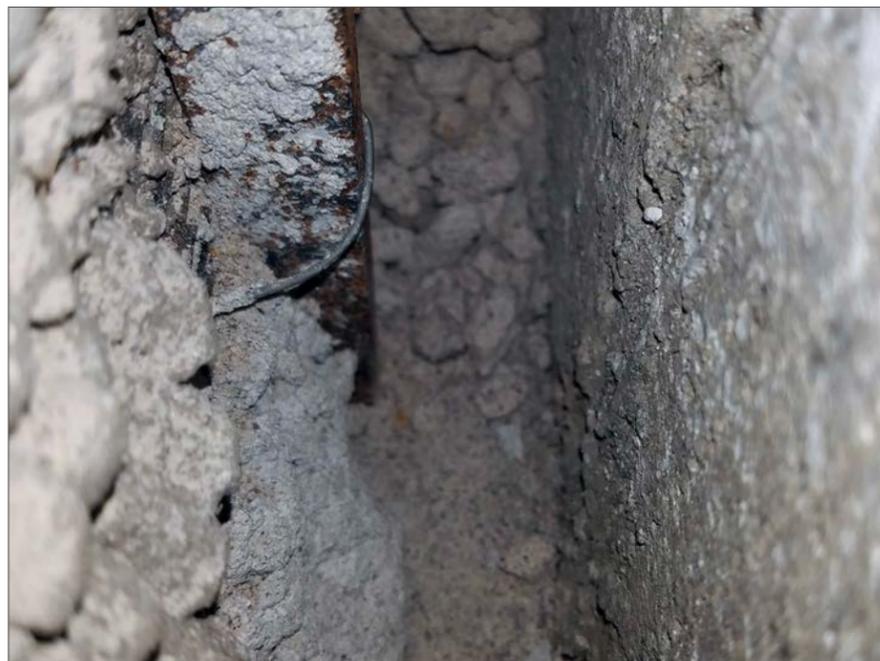
Probe 1, looking down. Note the vertical furring channel with wire tie. The black iron does not appear to be set in the concrete, but sits on top of the concrete. Note the amount of plaster debris in the void space.

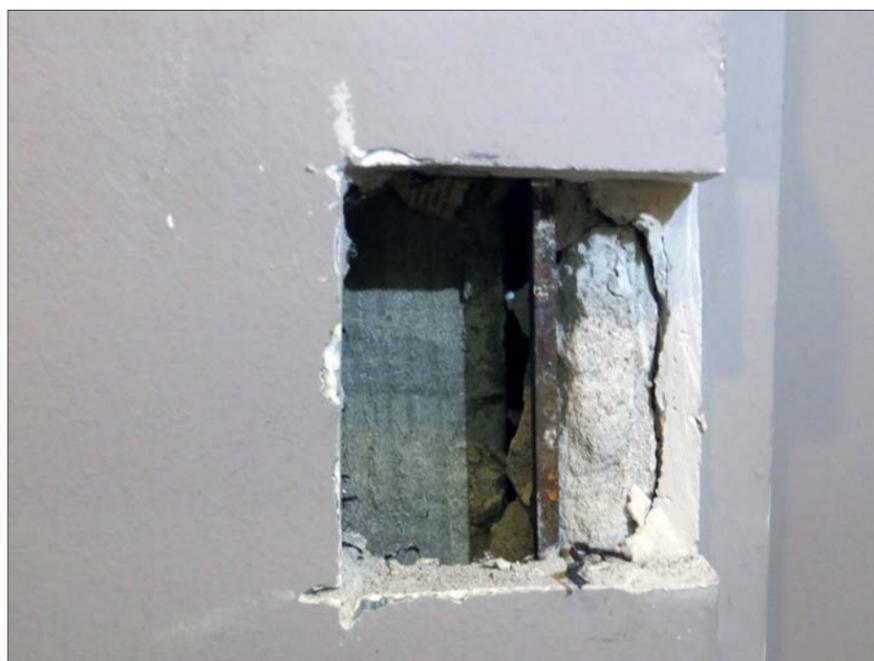
Probe 3. Note the black iron furring channel in the corner. The void space here was not filled with plaster debris, which is consistent with it being an area of repair.

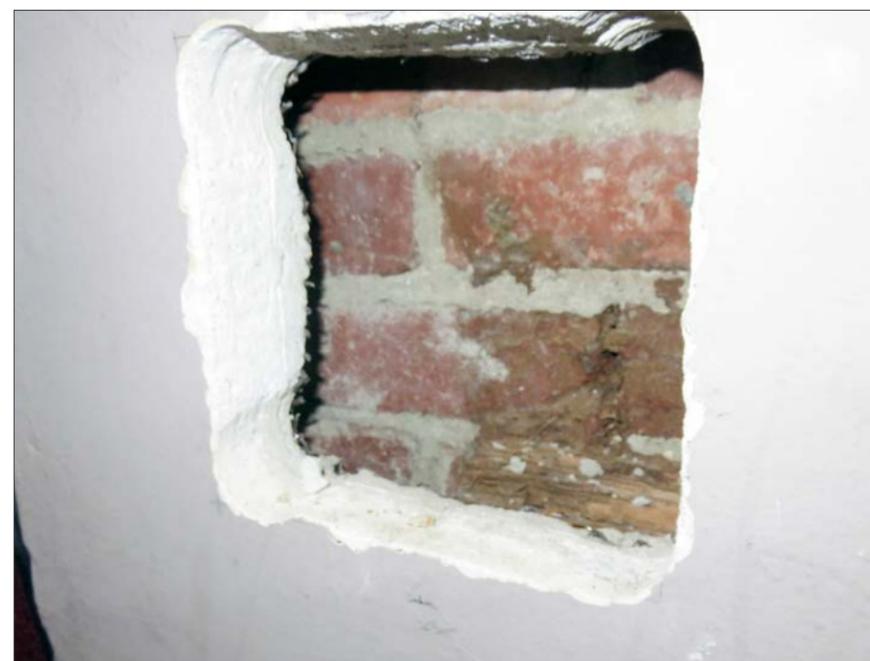
Probe 6. Note the wood block in the lower portion of the opening.

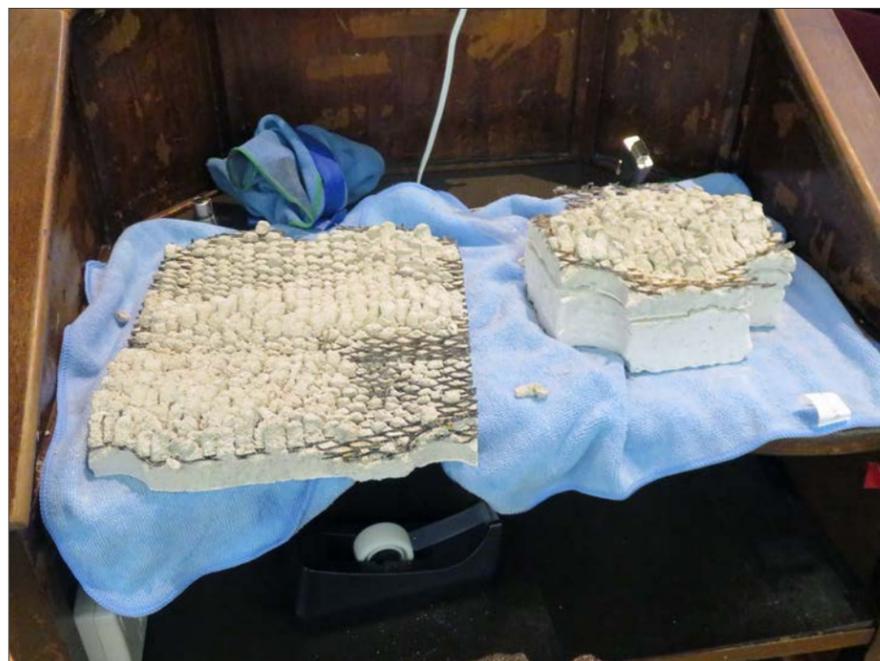
Plaster from Probe 1 and Probe 6. Note the presence of a distinct scratch coat and brown coat.

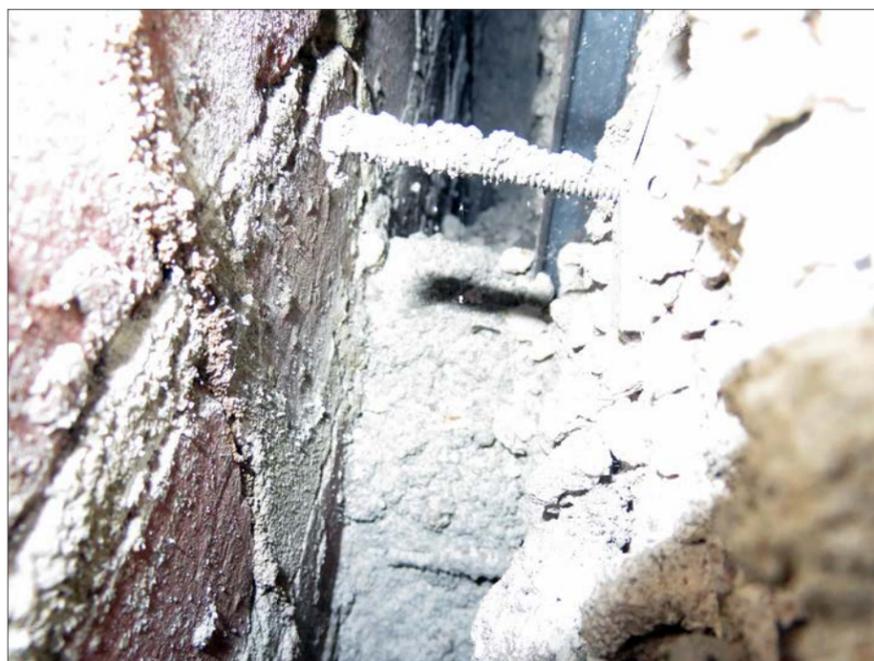
Probe 5, looking to the right and slightly down. Note the wad of mortar in the void at the furring channel. The toggle bolts are part of the handrail installation.

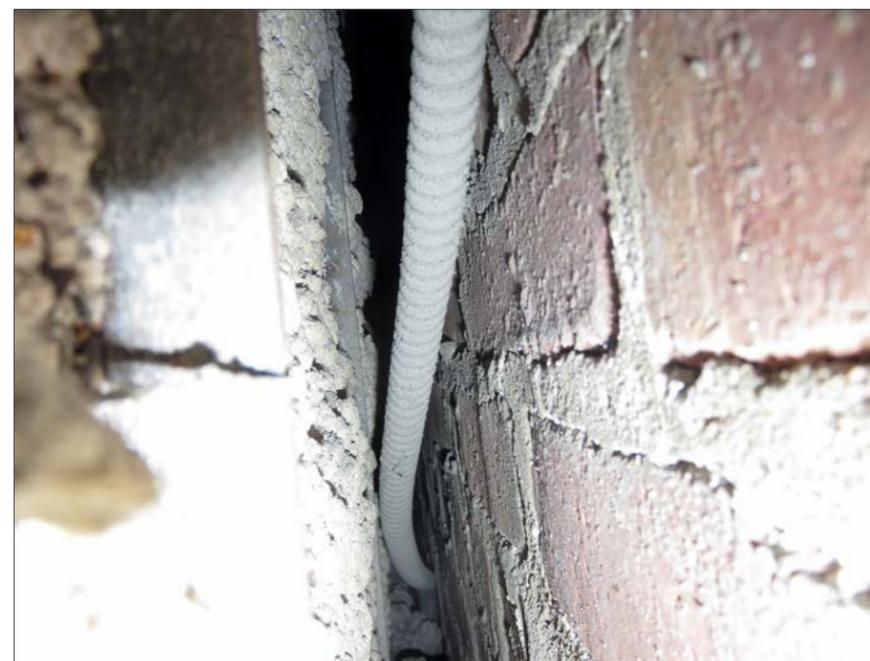
Probe 6 looking up to the left. Note the conduit crossing above the probe opening.

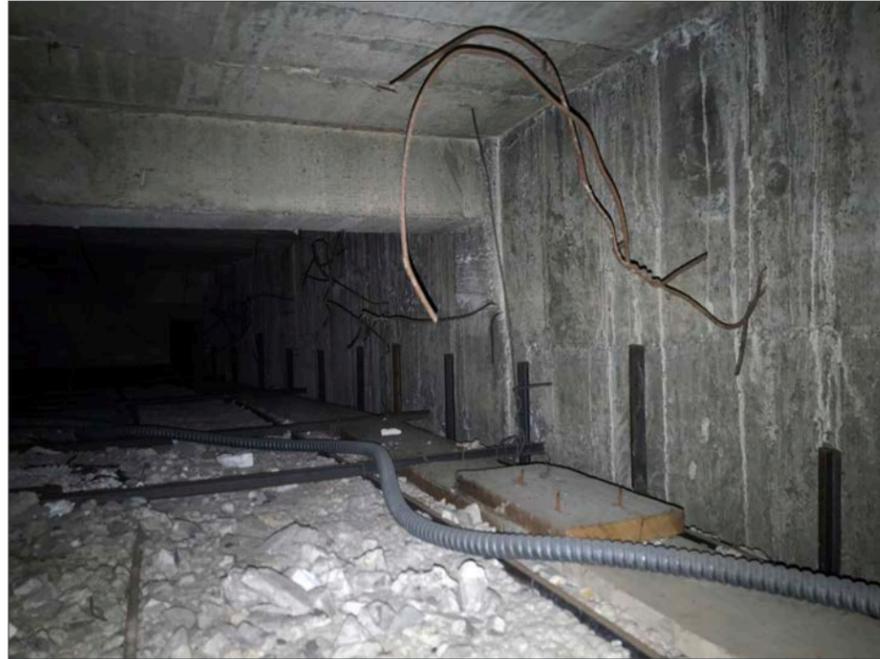
Ceiling above Fresco 3. Note the ceiling framing and the vertical furring channels of the fresco supports. Photo by Tuan and Robinson.

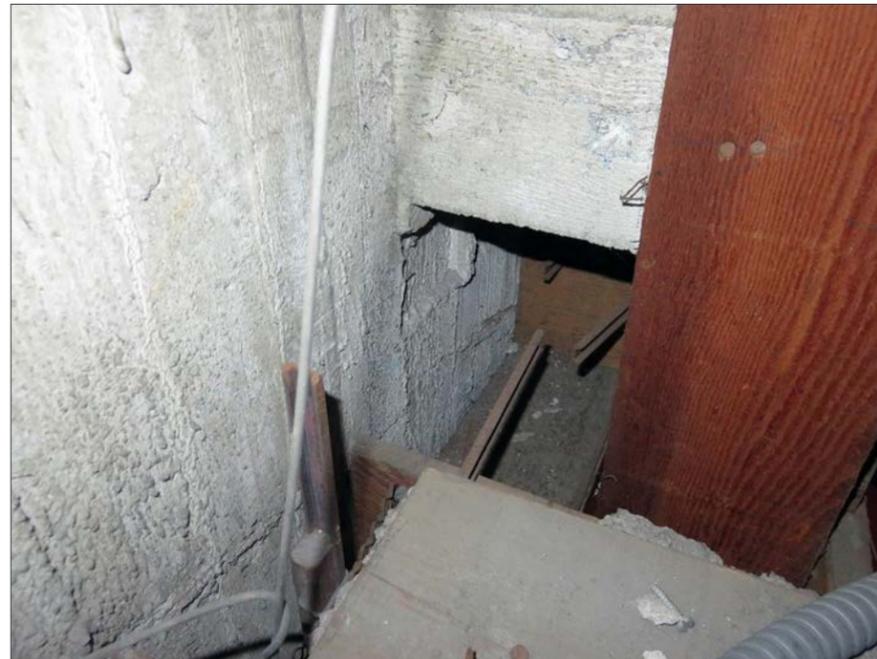
Pilaster between Frescos 3 and 4 from above. Note the board nailed to the concrete and supported furring channels of the ceiling.

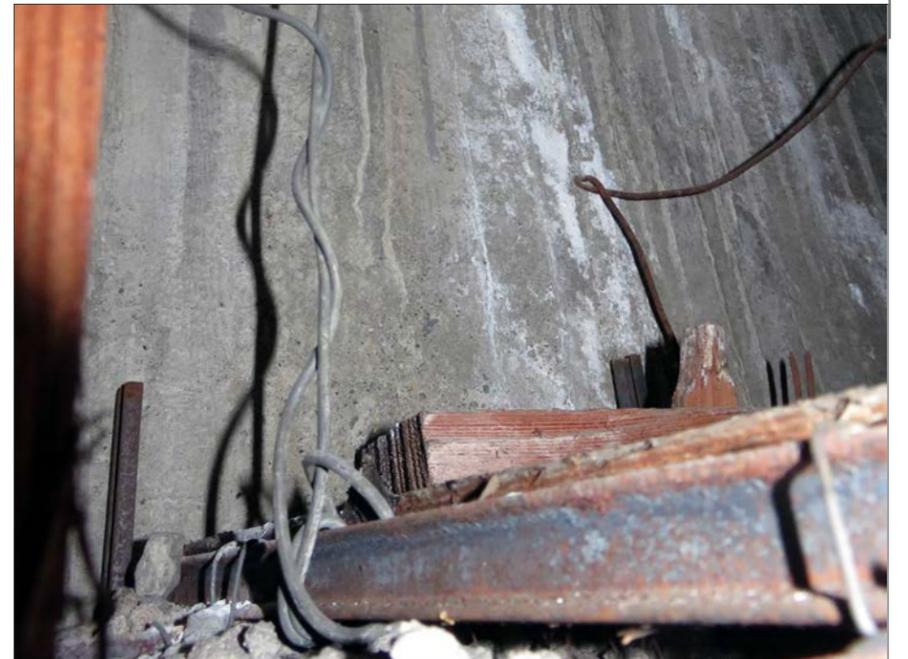
Ceiling above Fresco 7. Note the salts on the concrete from moisture infiltration and the use of the concrete form tie to hang the black iron support of the ceiling.

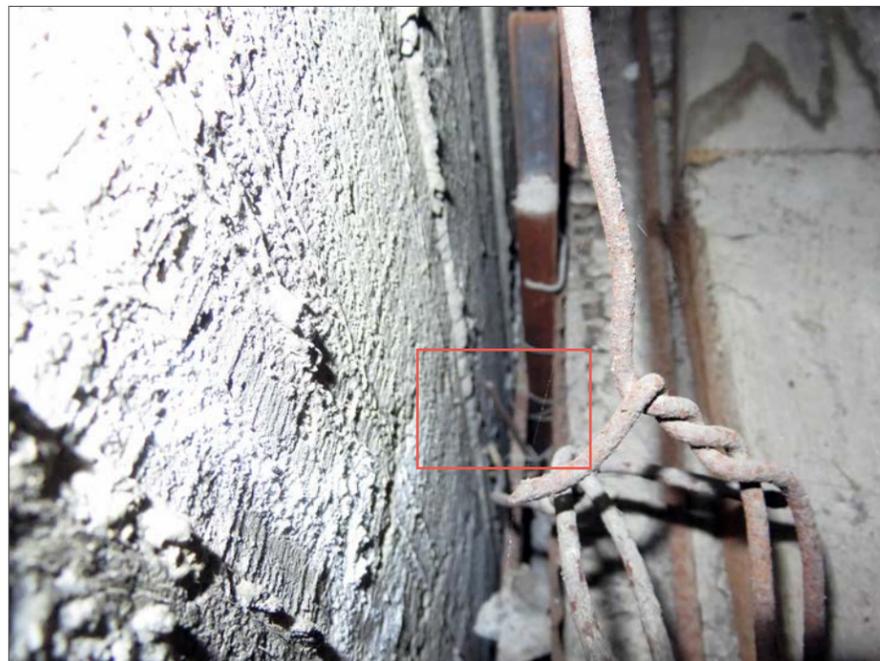
View behind Fresco 3 from above. Note the form tie used to attach the vertical support to the wall.

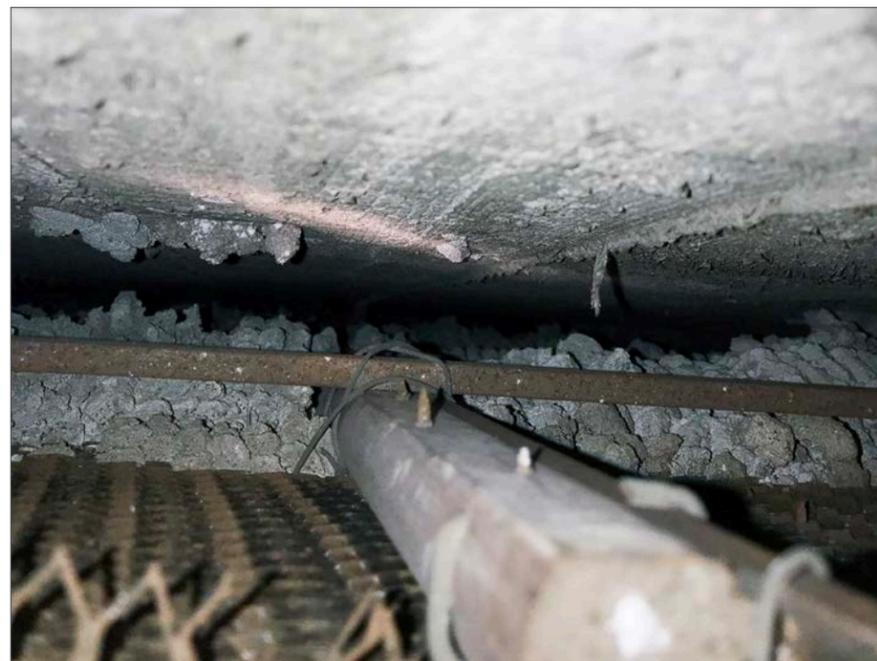
View behind Fresco 3 from above. Note the small void space and horizontal channel wire tied to the vertical furring channel. Photo by Tuan and Robinson.

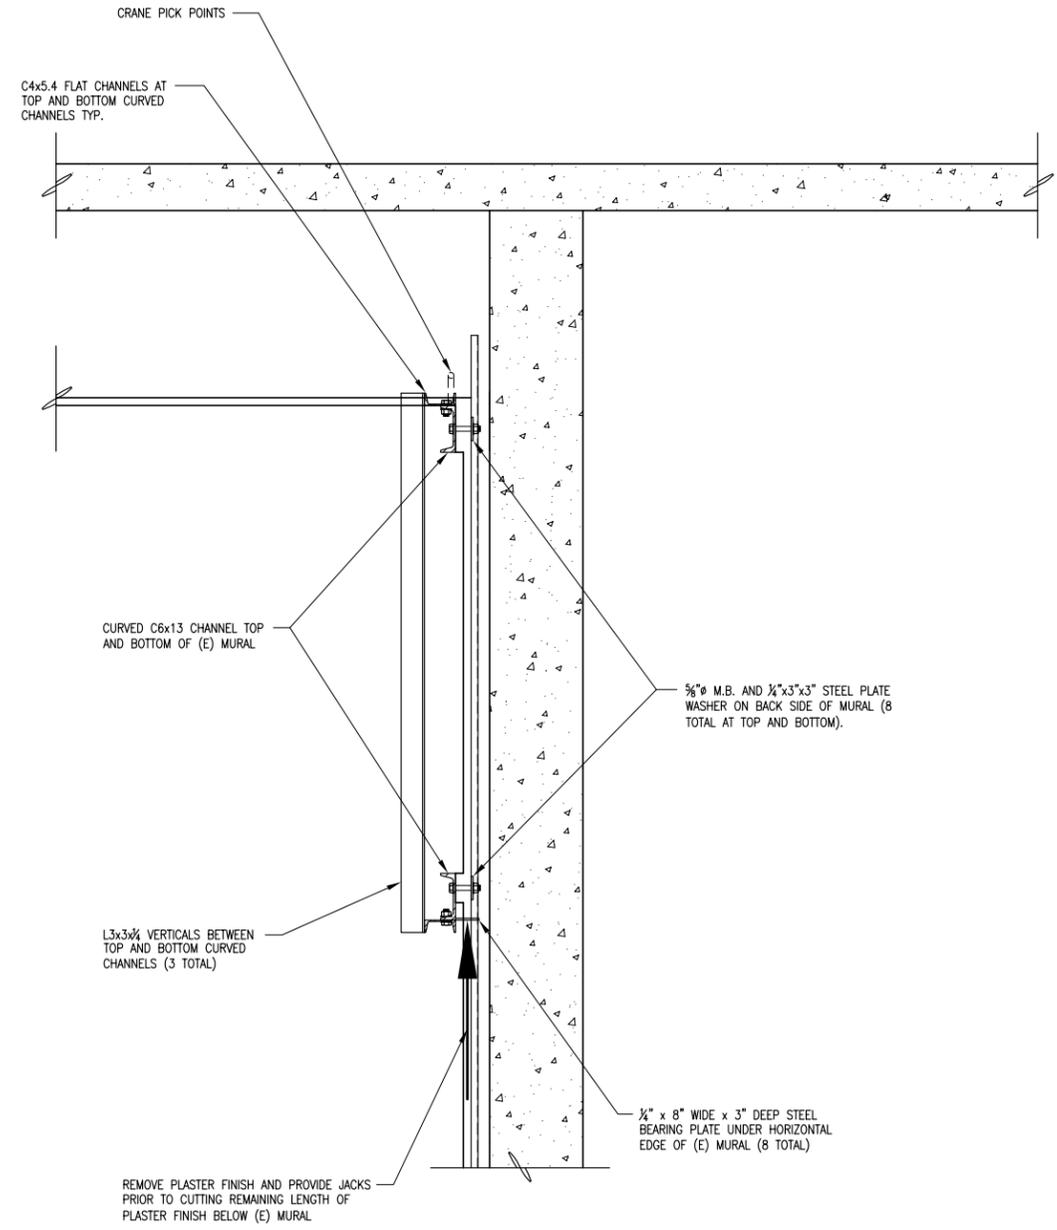
3 MURAL SECTION 1" = 1'-0"

5. PLACE THE UPPER CURVED STEEL CHANNEL ABOVE THE MURAL AND REMOVE THE PLASTER CEILING TO PLACE THE STEEL PLATE WASHERS BEHIND THE MURAL AND ATTACH TO THE CURVED STEEL CHANNEL WITH THROUGH BOLTS.

6. BOLT THE FLAT CHANNELS WITH THE VERTICAL ANGLES TO THE TOP OF THE UPPER CURVED CHANNEL AND BELOW THE LOWER CURVED CHANNEL.
7. REMOVE THE REMAINING WALL AND CEILING PLASTER AROUND THE MURAL TO REMOVE THE MURAL. KEEP MURAL RELATIVELY VERTICAL AND AGAINST THE STEEL FRAMING AND PLACE IN A GANTRY.
