Re: **Transmittal of Planning Department Case Numbers 2025-005918DES & 2025-005930DES**  
**Alert Alley Early Residential District Landmark District Designation**  
**Chula-Abbey Early Residential District Landmark District Designation**  
BOS File No. TBD & 250297 & 250298

**Landmark Designation Report**

**Chula-Abbey Early Residential Historic District**

## CHULA-ABBEE EARLY RESIDENTIAL DISTRICT

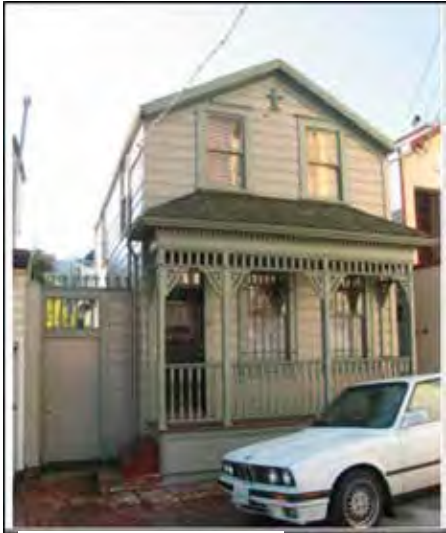
**67 Chula Lane**

**Single-Family Early Residential:** Properties dating from the “Early Neighborhood Development (1864-1906)” period are unified by their common forms, massing, and materiality representative of the early residential and agricultural development of the Mission Dolores neighborhood. Character-defining features of the properties within the district dating from this period include:

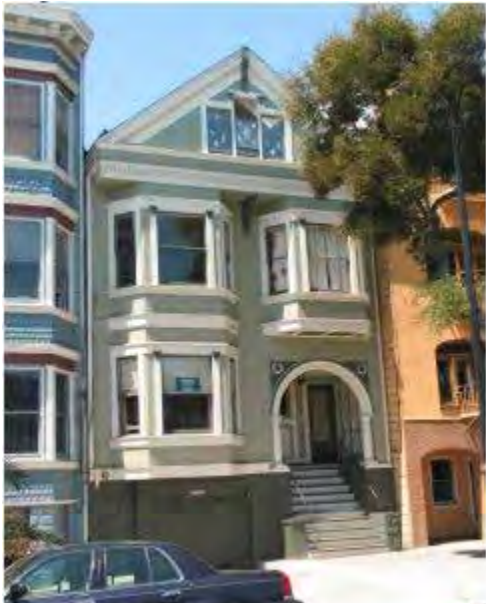
**368-370 Dolores Street**

**Multi-Family Reconstruction Residential:** Properties dating from the “Earthquake and Reconstruction (1906-1915)” period are unified by their larger scale, form, and massing to meet housing needs of the growing population of the Mission Dolores neighborhood. Character-defining features of the residential flats or apartment buildings within the district dating from this period include:

- Two or three-story over-integrated garage or three-story massing
- Horizontal painted wood siding
- Front-facing gable roof or projecting cornice
- Wood double-hung windows with ogee lugs
- Single or paired projecting bay(s) at front facade
- Front setback/location on lot in reference to street
- Offset entrance with recessed, straight-run original stair configuration
