**[Planning Code - Landmark District Designation - Alert Alley Early Residential Historic District]**

**ALERT ALLEY EARLY RESIDENTIAL DISTRICT (FILE NO. 251101)**

**Landmark Designation Report**  
**Alert Alley Early Residential District**

### Alert Alley Early Residential Historic District

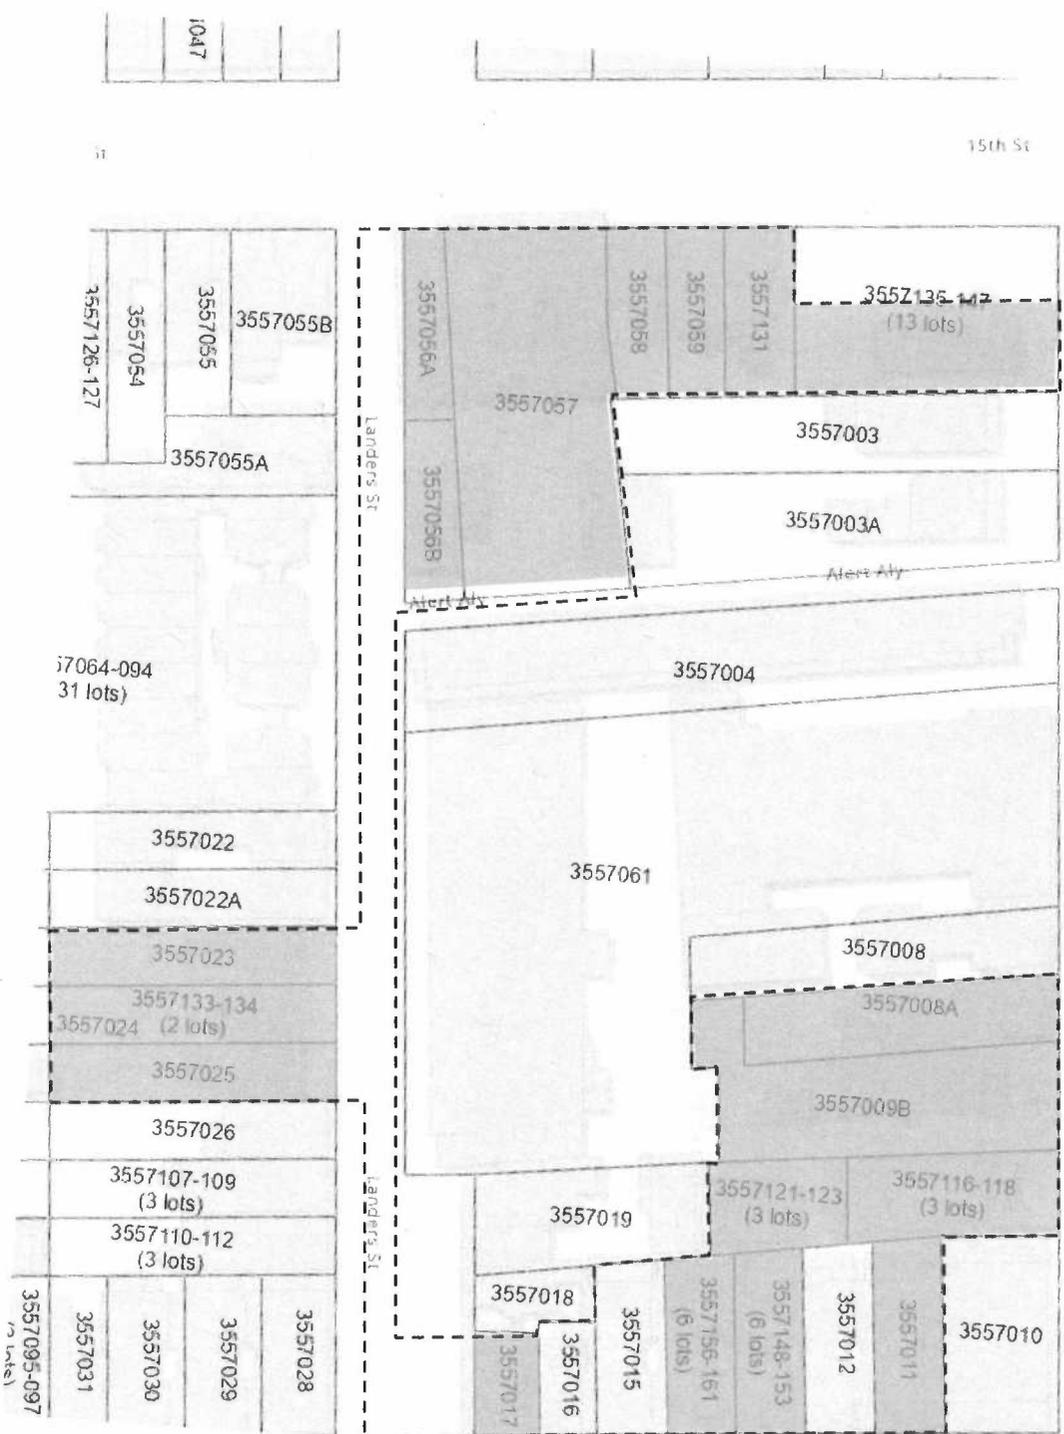
--- District Boundary  
 ■ District Contributor

# ALERT ALLEY EARLY RESIDENTIAL DISTRICT

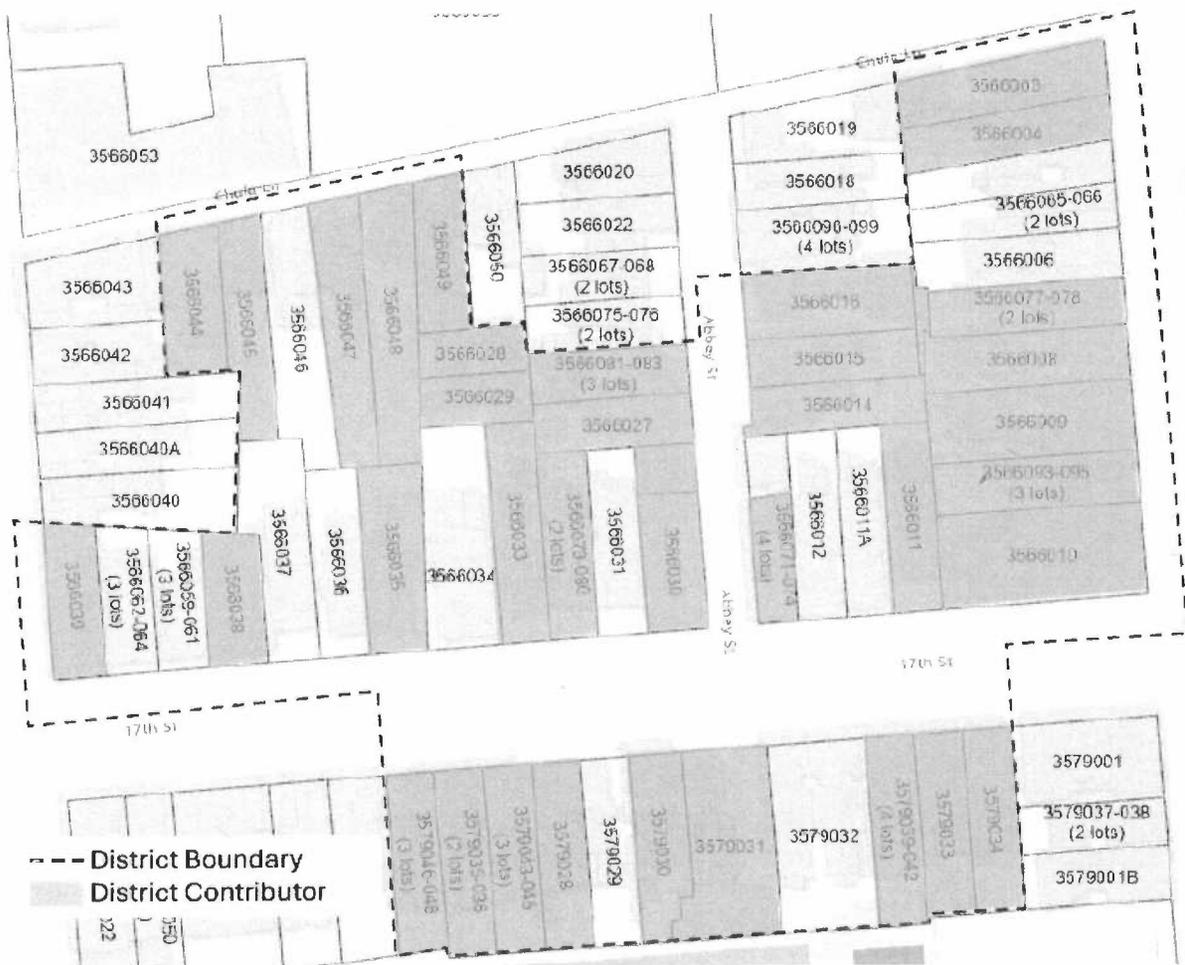
## CHULA-ABBEY EARLY RESIDENTIAL DISTRICT

Centered on Chula Lane, Abbey Street, and 17<sup>th</sup> Streets, the district is a representative collection of pre- and post-earthquake residential buildings, plus two mixed-use buildings, built in the Folk Victorian, Italianate, Classical Revival, and Queen Anne architectural styles.

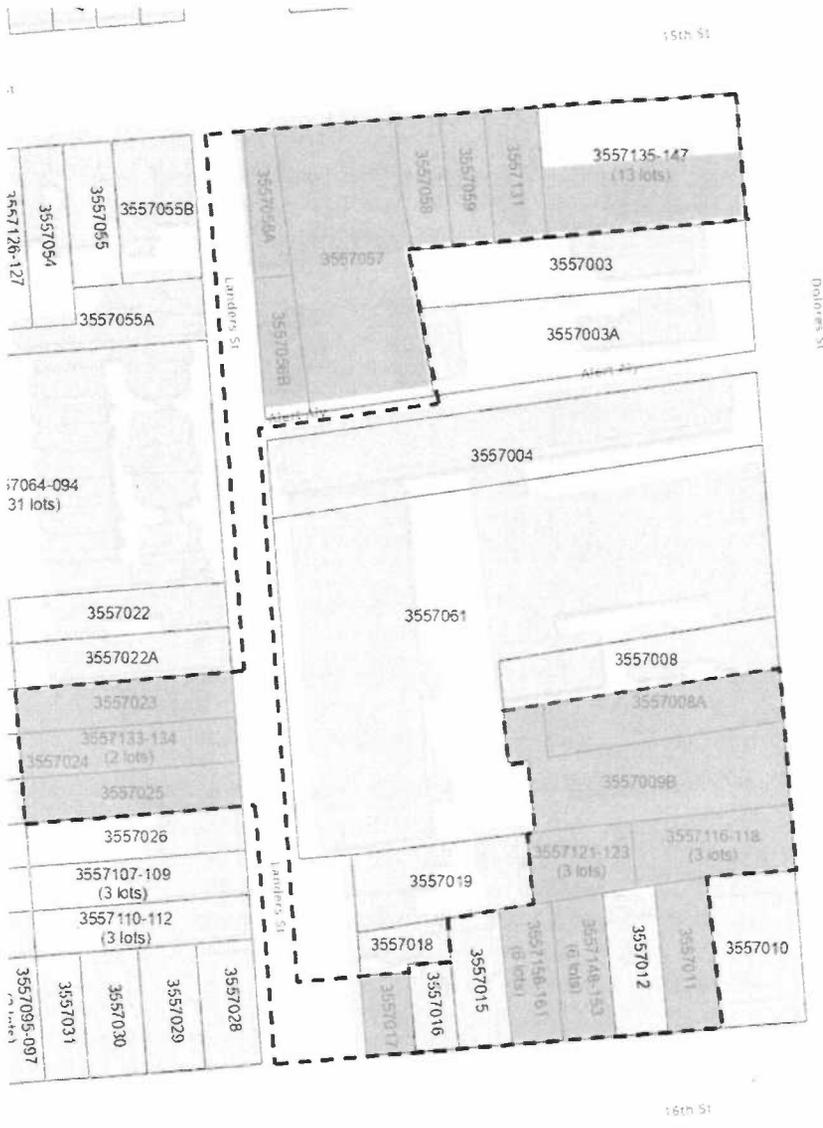
The boundaries of Alert Alley Early Residential District are outlined.

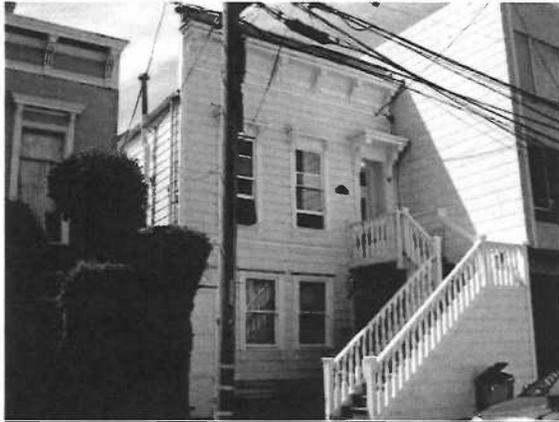
156 Landers Street

- Small, one-story over- integrated garage or two-story massing
- Horizontal painted wood siding
- Flat front with front facing gable roof or Italianate style parapet roof form
- Original wood double-hung windows with ogee lugs

- Architectural ornament including brackets, applied columns, window and/or door hoods, and other façade ornamentation indicative of the Italianate style
- Front setback or location on lot in reference to street
- Central or offset primary entrance stair

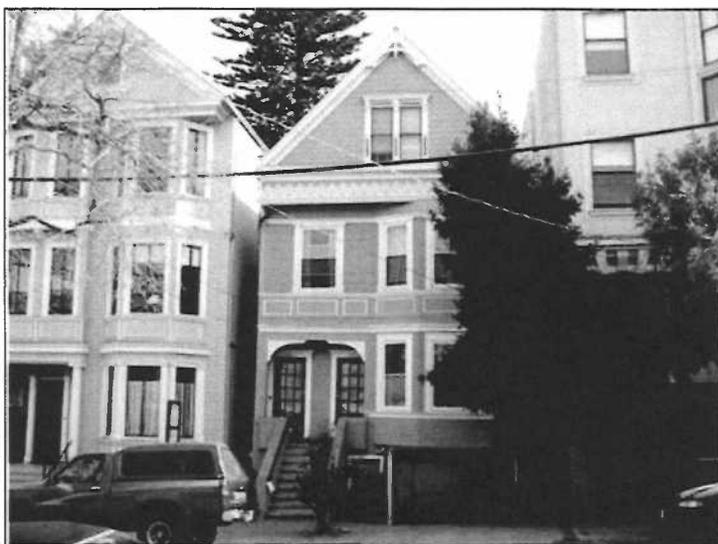
1919-1923 (left) and 1931-1933 15<sup>th</sup> Street (center)

The district's larger flats buildings, facing onto the wider, primary streets, are typically Classical Revival style, including all the district's Romeo Flats buildings. Buildings in the district in this style feature wide angled or round bay windows, flat roofs, bulky projecting cornices with modillions or dentils, raised panel spandrels, scroll keystones, broken entablatures, and pedimented and columned porch or portico entries.

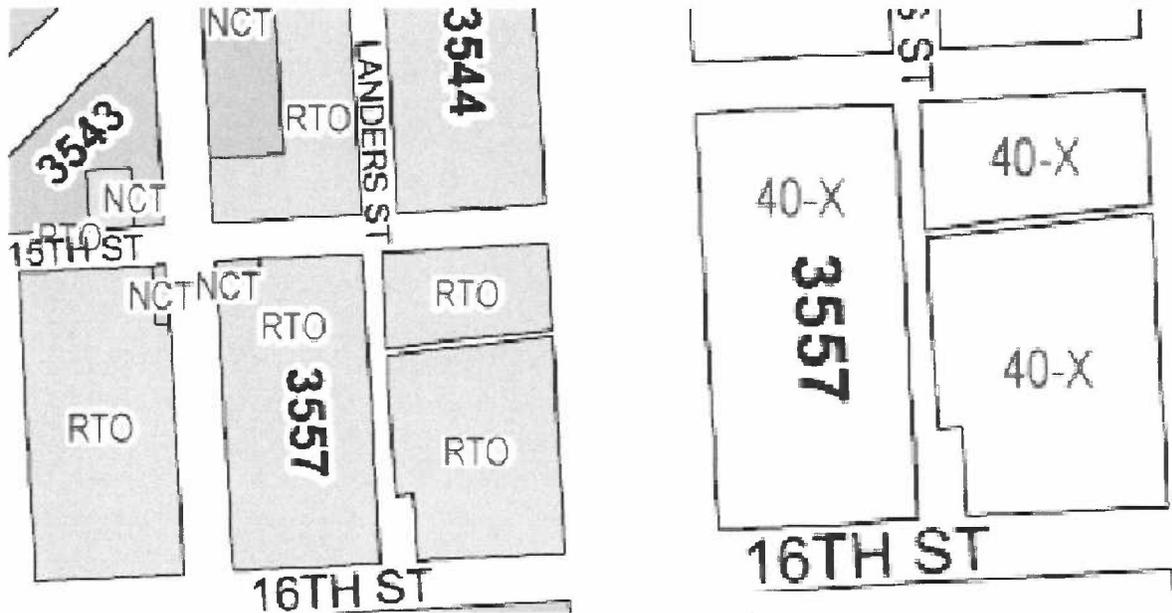
**Zoning:** Properties in the Alert Alley Early Residential District are in an RTO – Residential Transit Oriented District, 40-X Height and Bulk District, and American Indian Cultural District.

In the proposed Family Zoning Plan, properties in the Alert Alley Early Residential District are in an RTO-1 – Residential Transit Oriented District, 40' Base Height Limit, 55' Local Program Height, and American Indian Cultural District. The base height limit represents the maximum height available for projects not using the Local Program for housing development projects. Projects that opt into the Local Program for housing development would have a 55' height limit. Local Program heights are generally equivalent to heights projects may receive if using the State Density Bonus or other state bonus program.

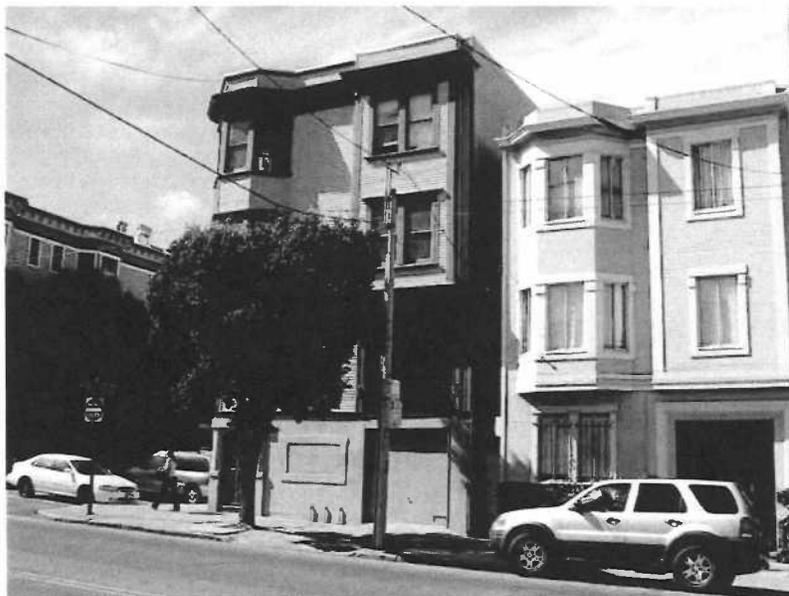
16<sup>th</sup> Street (south) elevation

window in the left bay. The right bay windows have pilasters with floral drops and dentil cornices. The Landers Street elevation has four garage entries on the ground floor. The upper stories have paired and single windows with pilaster surrounds and dentil cornices. The right bay of the second and third stories has a semi-hexagonal bay window. All windows have undivided, double-hung wood sash. Both elevations terminate in a deeply projecting cornice with dentils and a plain parapet. The rear elevation has wood egress porches. The building appears to have been lifted to allow for the insertion of garages underneath. The building appears to be in good condition.
