Re: 3637-3657 Sacramento St- Case 2007.1347E

We are the proposed contractors for the demolition, shoring and excavation of the above project. This is a typical infill project in San Francisco. We have completed hundreds of very similar projects.

Small Selection of 2017 and 2018 projects

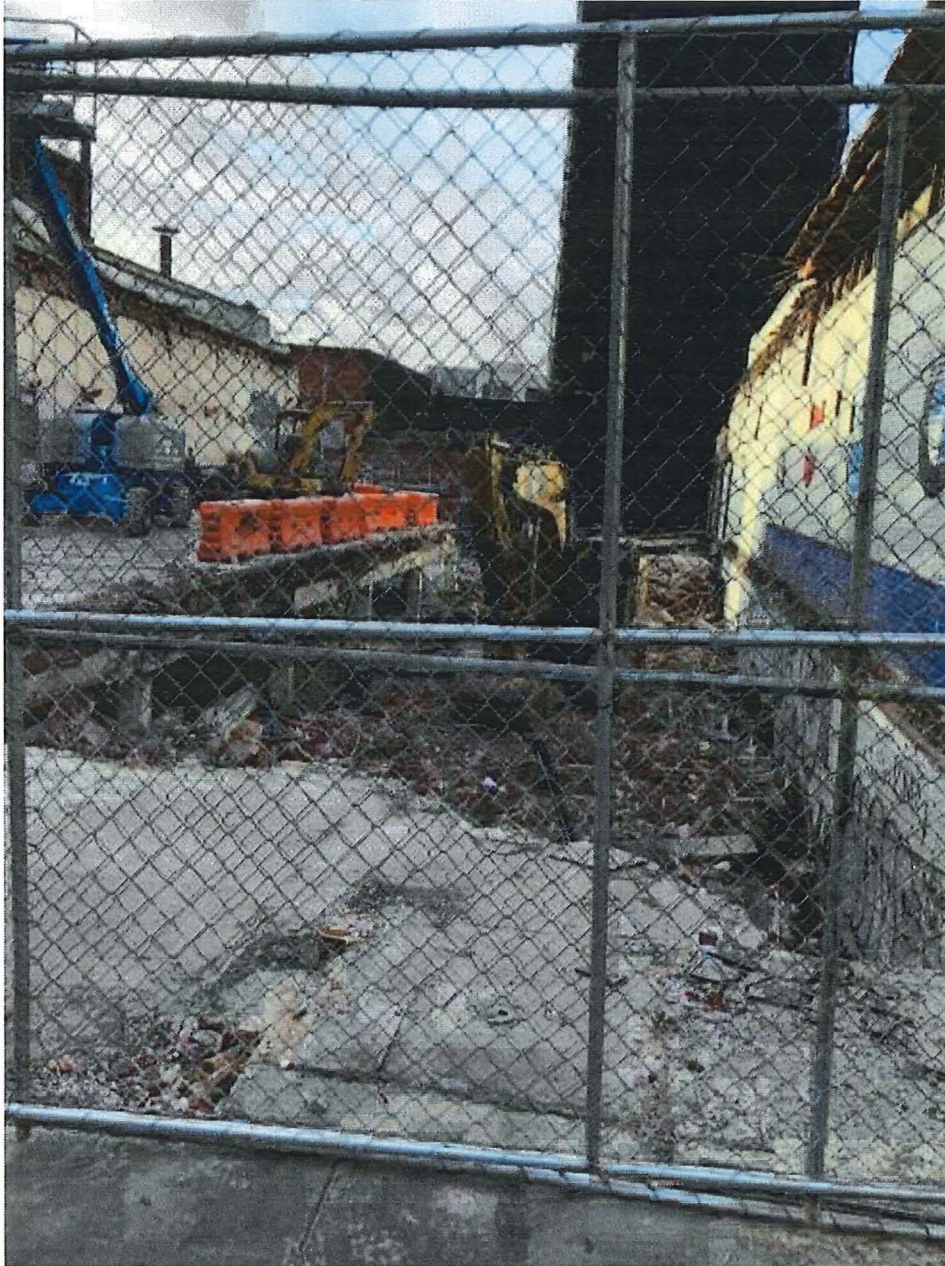
Figure 6 1433 Bush Street Demolition, Excavation and shoring 6,000 CY

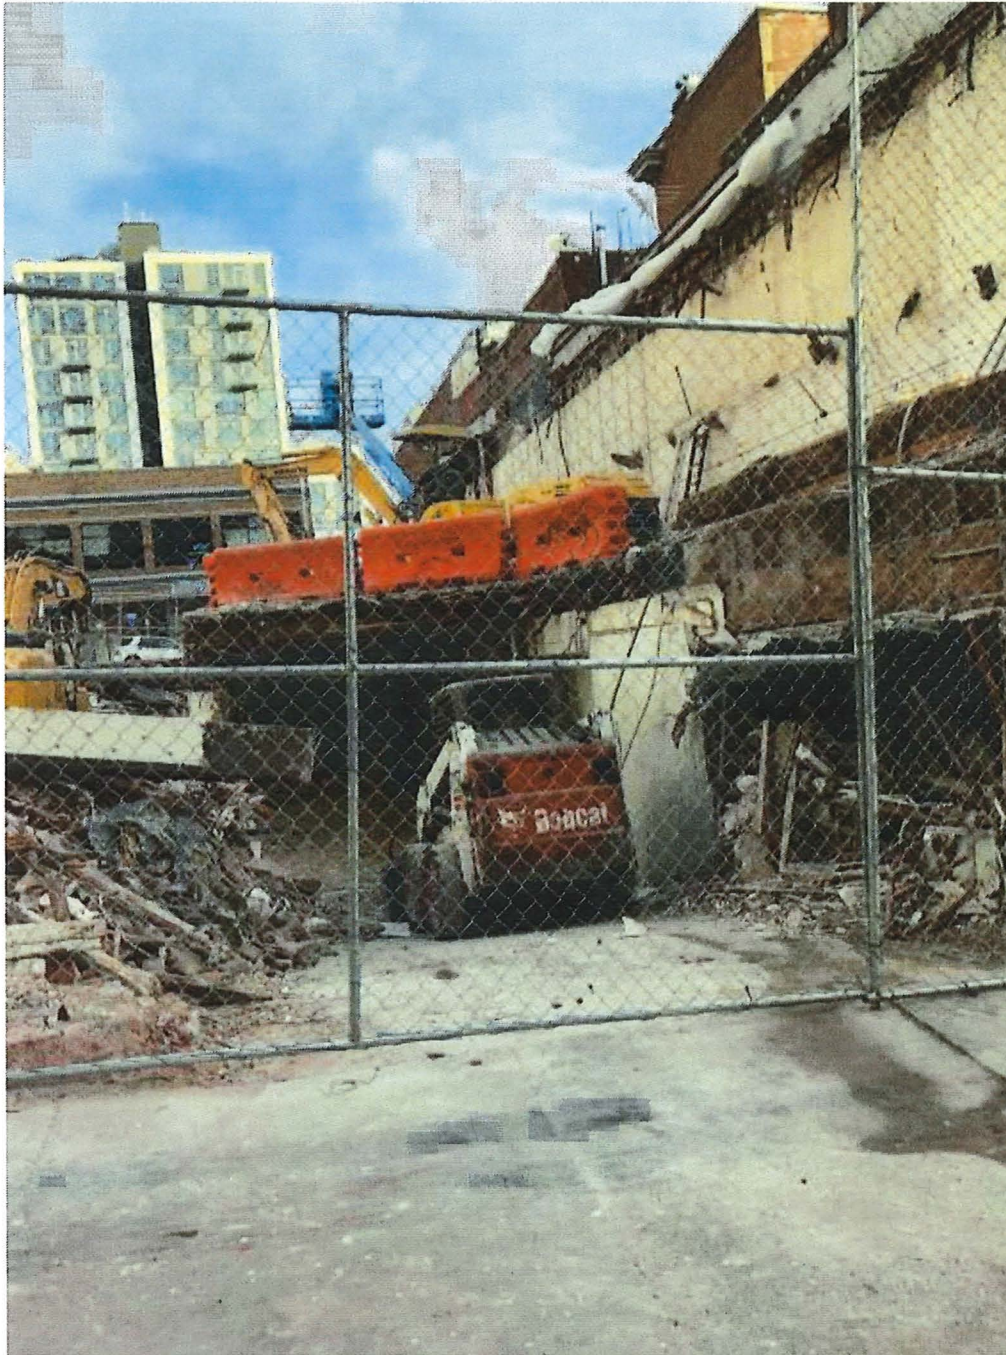
Figure 7 1433 Bush Street Demolition using small tools

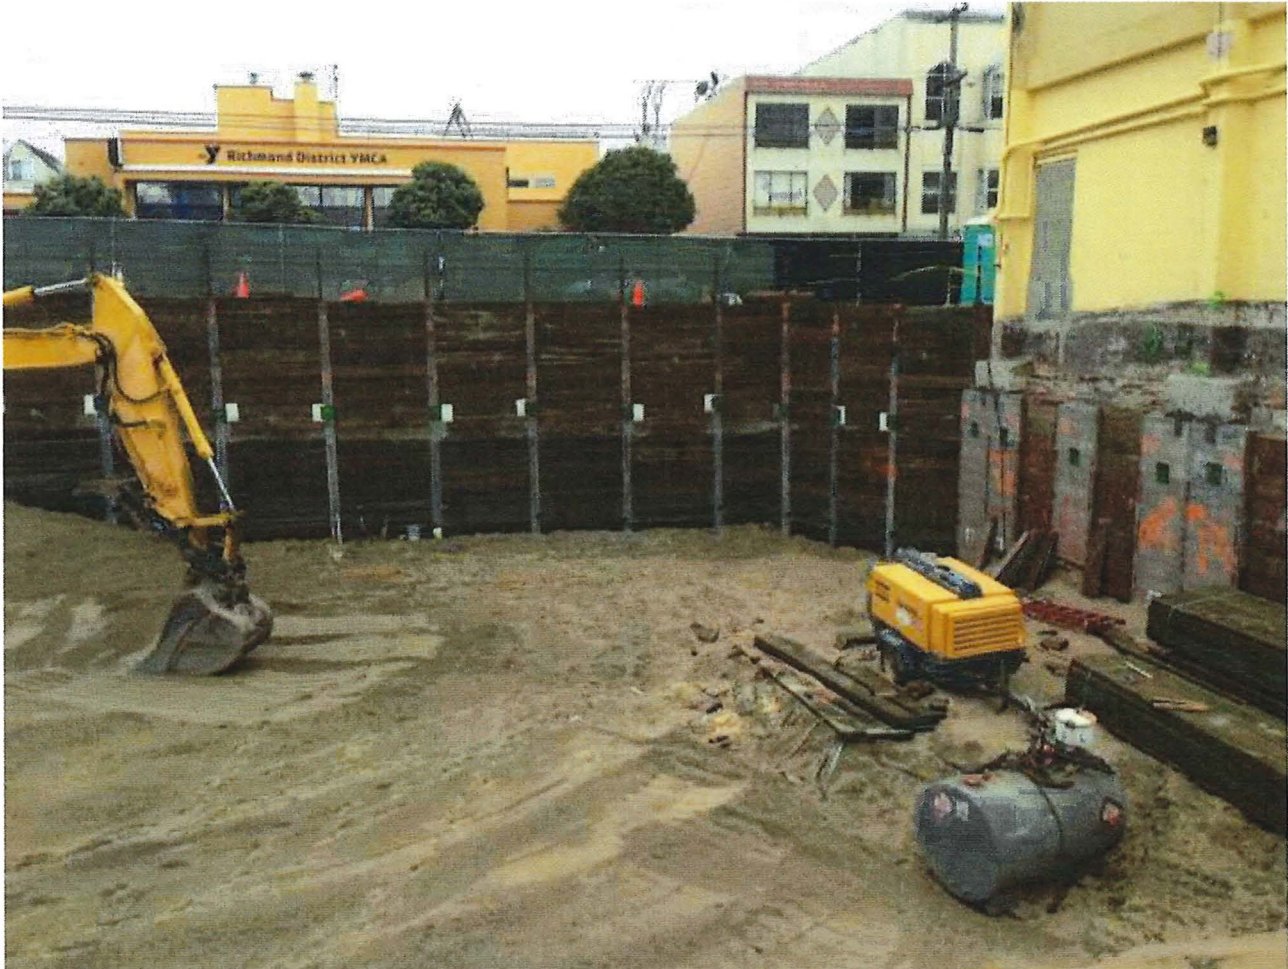
Figure 8 1810 8th Ave - 30,000 CY of sand. All compaction done with water and excavator. No vibratory rollers. Note hand dug pits.

Shoring and underpinning is done with a small drill rig and the underpinning pits are hand dug under adjacent foundations. Rebar and concrete are placed in the pits. All of this work is observed on a daily basis by the design engineers, inspected by the SF Department of Building Inspection, the original soil engineer, a testing laboratory for the concrete and the surveyor monitors property lines, settlement lines, etc.
