SAN FRANCISCO PLANNING DEPARTMENT

Mills Act Contracts Case Report

Hearing Date: October 7, 2015

761 Post Street San Francisco, CA Historic Structure Report

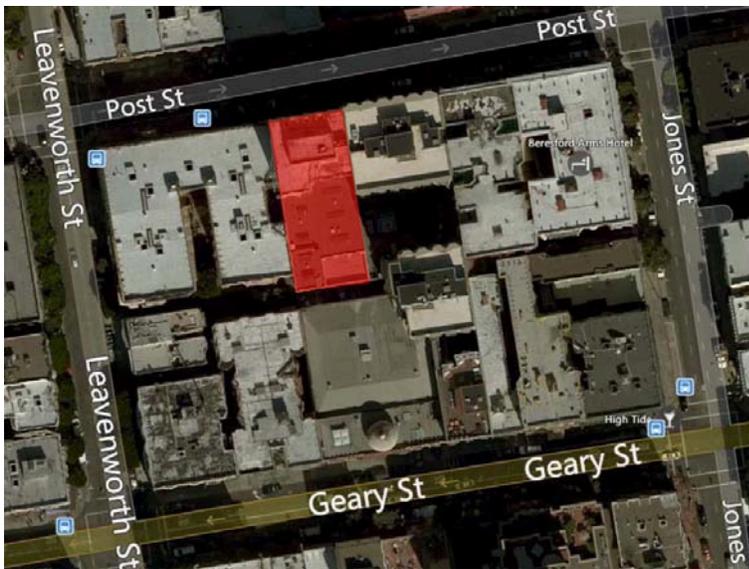
Figure 1. Aerial view of 761 Post Street, with subject property highlighted. (Map generated by Google Earth, amended by author.)

The subject property (APN Number 0304-015) is located along the south side of Post Street, between Jones and Leavenworth Streets (see Figures 1 through 3).

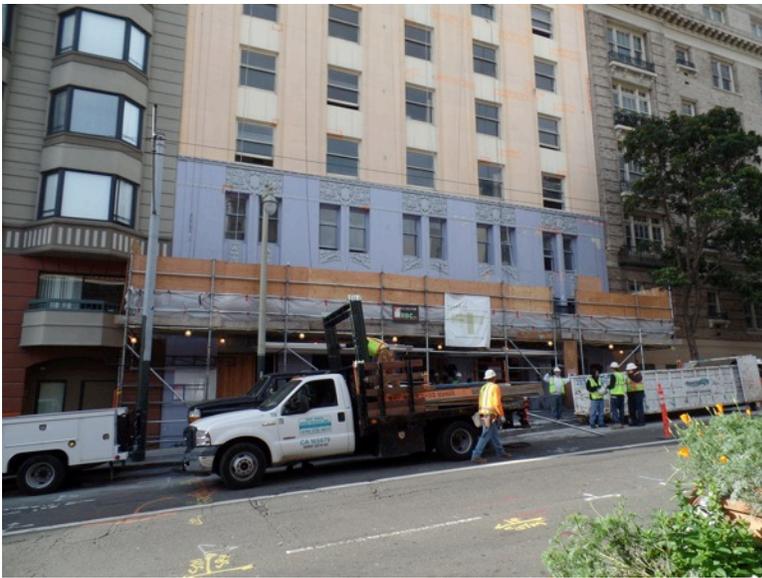
The building is eighteen stories tall, including basement. It is a reinforced concrete structure, topped with cementitious coating, which has been coated multiple times. The design is a modified Art Deco design. It has a streamlined, vertical appearance with piers, but historicist panels above windows and doors (see Figures 8 through 9).

Figure 8. Overview of north (Post Street) elevation, showing first two floors of building. (Photograph by Garavaglia Architecture, Inc., April 2015.)

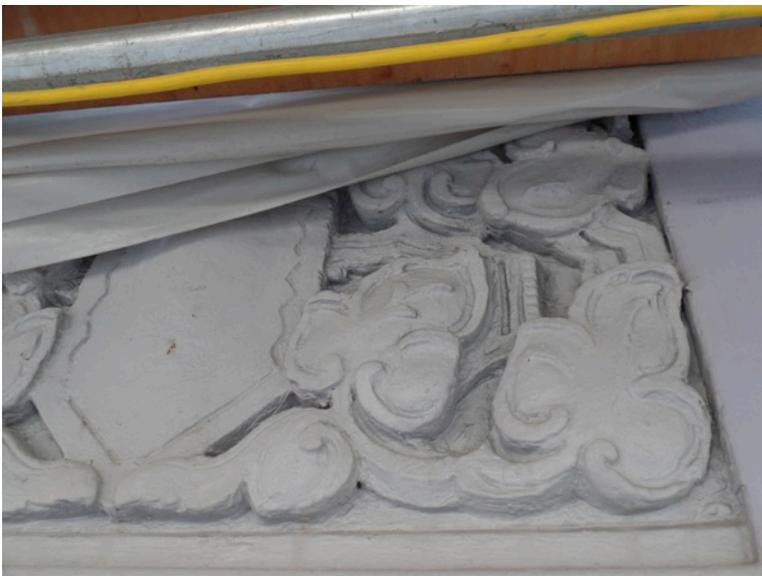
Figure 9. Detail of typical paneling over windows and doors. (Photograph by Garavaglia Architecture, Inc., April 2015.)

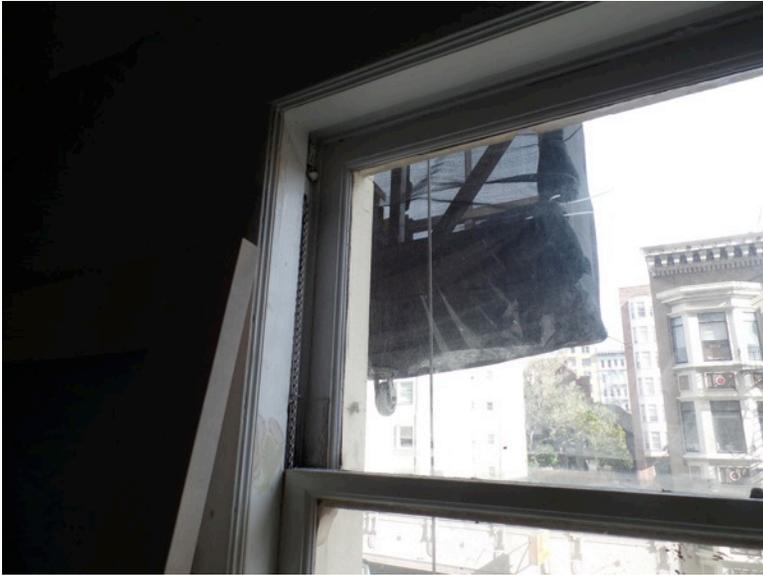
This elevation includes three arched bays at ground level: the center one includes the entry door, while the flanking ones include multi-lite steel casement windows. The upper floors feature wood double-hung windows (see Figures 10 through 11). Steel balconettes are accessed at the second floor windows; due to ongoing work, however, there was no access to them.

Figure 10. Overview of typical wood double-hung window unit along the north elevation. (Photograph by Garavaglia Architecture, Inc., April 2015.)

The windows along Post Street, which are the original wood windows, are in good to fair condition. A small amount of paint loss appears to be evident, but that is typical of windows that are regularly operated.

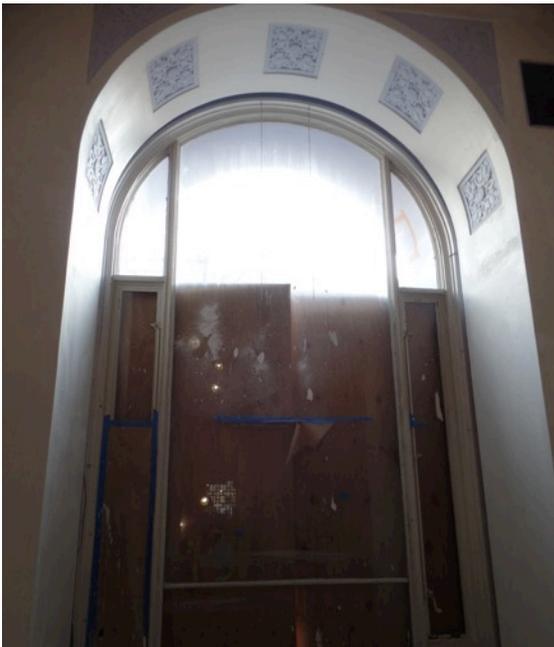
Figure 11. Overview of fixed and casement assembly at ground floor. The exterior is obscured. (Photograph by Garavaglia Architecture, Inc., April 2015.)

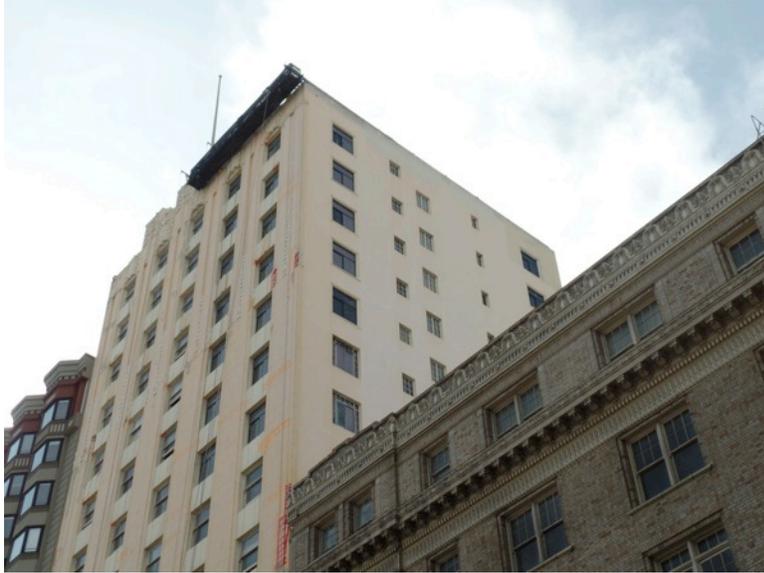
Limited access is available to the off-street elevations. They consist of reinforced concrete topped in a coating similar to that along Post Street. Fenestration consists of a combination of aluminum sliding and double-hung units, as well as steel casement windows at the fire stairs (see Figures 12 through 13).

Figure 12. Overview of north and east elevations. (Photograph by Garavaglia Architecture, Inc., April 2015.)

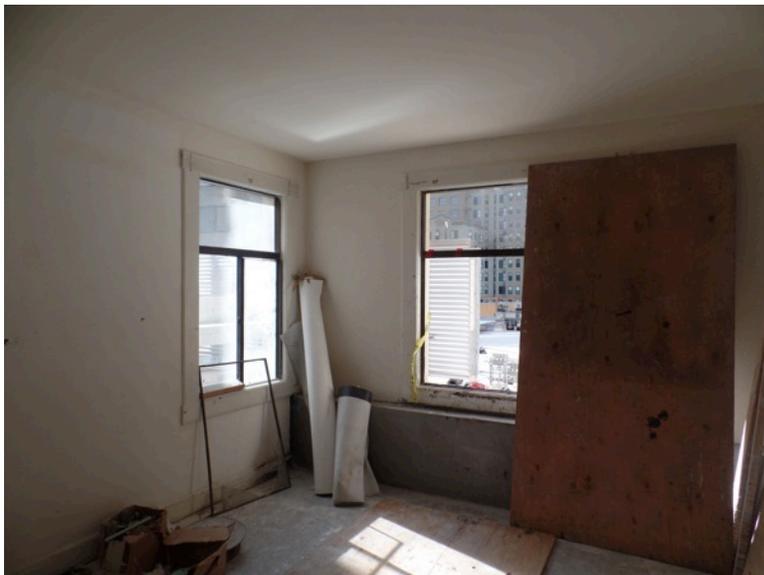
Figure 13. View of aluminum windows at off-street elevations. (Photograph by Garavaglia Architecture, Inc., April 2015.)

The aluminum sliding assemblies along the off-street elevations are in fair to poor condition, and have outlived their reasonable service life.

Item #6: Window Replacement at Aluminum Windows
Rehabilitation: Proposed
Contract Year Work Completion: 2016
Total Cost: \$225,000
Scope of Work:
Removal of all existing aluminum windows along off-street elevations, followed by cleaning of all recesses left by removal, as well as sealing of all holes. New aluminum windows shall be installed with new seals and weather stripping, and shall have a 4-inch maximum window opening. All window perimeters should be sealed with backer rod, and caulked.

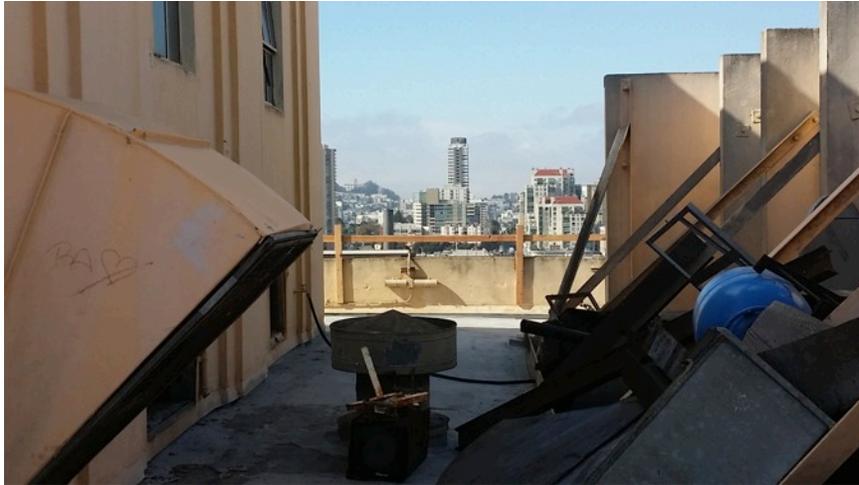
The roof is an asphalt composite roof topped with a UV-resistant aluminum coating, and houses much of the building's mechanical equipment. It also features an elevator bulkhead (see Figures 14 through 16).

Figure 14. Overview of main roof level, showing mechanical equipment. (Photograph provided by RLJC, April 2015.)

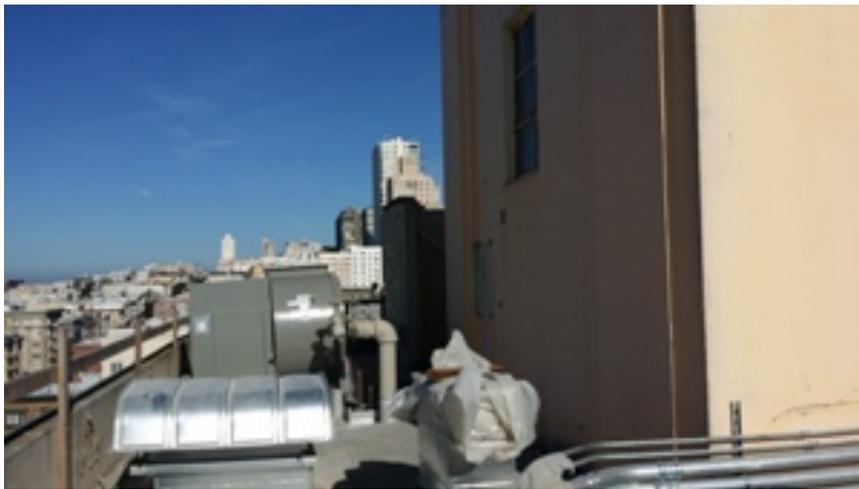
Figure 15. Overview of main roof, showing mechanical equipment and elevator bulkhead. (Photograph provided by RLJC, April 2015.)

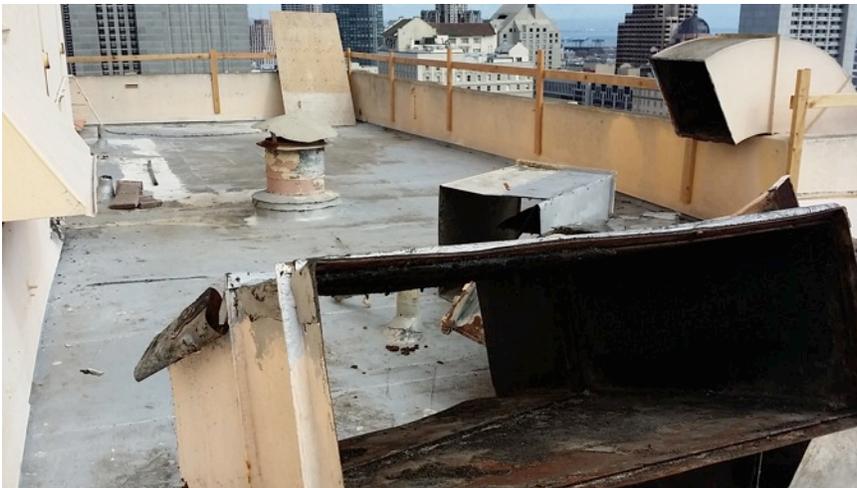
Figure 16. Detail of main roof. (Photograph provided by RLJC, April 2015.)

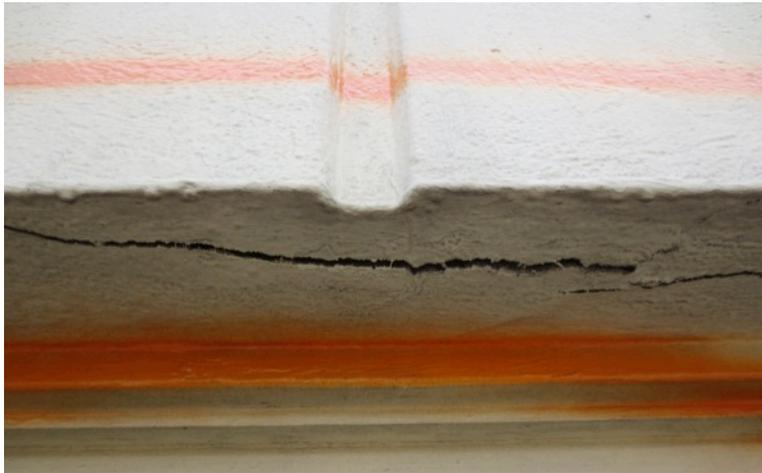
Cracked and spalled concrete was observed at the Post Street elevation (see Figures 17 through 19). This deterioration was observed most notably at the lintels and around windows. In some cases, corroded reinforcing bars were observed. This condition is likely due to inadequate coverage of the reinforcing bar by the concrete, followed by sustained water infiltration.

Figure 17. Cracked concrete above window at the fifth floor along the north elevation. (Photograph provided by RLJC, April 2015.)

Item #3: Concrete Repair/Restoration – Post Street Elevation
Rehabilitation: In Progress
Contract Year Work Completion: 2015
Total Cost: \$108,281
Scope of Work:
<p>At spalls: the examination/sounding out of all reinforced concrete along the north (Post Street) elevation, followed by the marking of all cracks, spalls, and other defects; cleaning of all exposed reinforcing bar (rebar) with a wire brush to remove corrosion and dust, followed by coating with a corrosion-resistant coating (“RustDestroyer,” manufactured by Advanced Protective Products, or approved equal). In locations where rebar is no longer sound, new rebar should be installed. New stainless steel pin sets to be anchored into sound concrete, followed by installation of wire matrix system where necessary. After necessary rebar repair/replacement and pin/wire system installation, application of appropriate concrete repair mortar.</p> <p>The newly repaired concrete should be repainted throughout with a breathable coating suitable for use on historic concrete.</p> <p>At cracks: the cutting of all cracks down to sound concrete, followed by cleaning with compressed air and wire brush. All prepared cracks should be sealed with epoxy, and allowed to cure.</p> <p>Ornamental concrete: where ornamental concrete segments are damaged past the point of repair, segments should be replaced, utilizing molds prepared from other sound sections. All replacement segments should match the existing in color, size, texture, and profile.</p> <p>All work within this scope shall be completed in accordance with <i>Preservation Brief 15: Preservation of Historic Concrete</i>, issued by the National Park Service.</p>

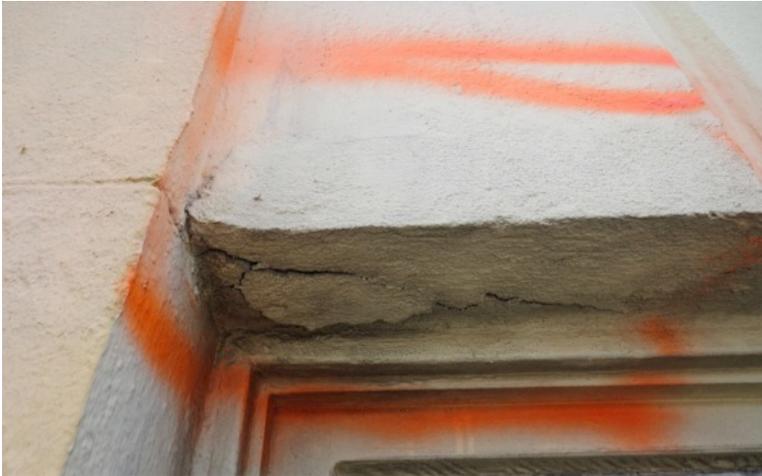
Figure 18. Cracked concrete above window at the seventh floor along the north elevation. (Photograph provided by RLJC, April 2015.)

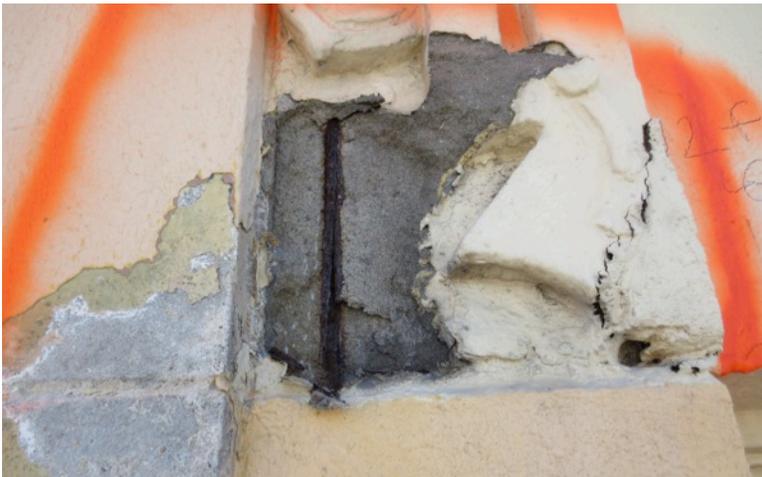
Figure 19. Exposed reinforcing bar at the twelfth floor along the north elevation. (Photograph provided by RLJC, April 2015.)

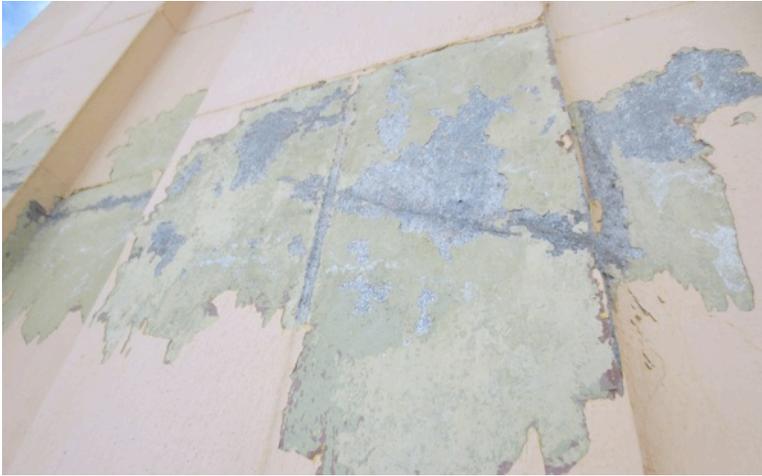
Peeling coating was observed throughout the exterior (see Figures 20 and 21). This is likely related to the fact that the coating, which appears to be regular latex paint, has exceeded its reasonable service life; alternately, insufficient surface preparation at application could result in peeling and chipped paint.

Figure 20. Peeling coating along the north elevation. (Photograph provided by RLJC, April 2015.)

Item #11: Repainting of Facade
Maintenance: Proposed
Contract Year Work Completion: 2025
Total Cost: \$75,000
Scope of Work:
<p>The entire facade should be repainted every ten years after the initial repainting. Work shall include removal of loose areas of paint, followed by application with a coating system appropriate for historic concrete.</p> <p>All work within this scope shall be completed in accordance with <i>Preservation Brief 15: Preservation of Historic Concrete</i>, issued by the National Park Service.</p>

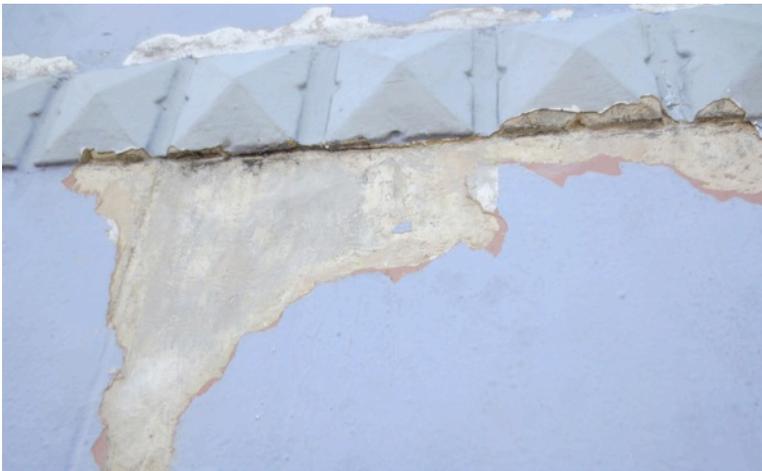
Figure 21. Peeling coating along the north elevation. (Photograph provided by RLJC, April 2015.)

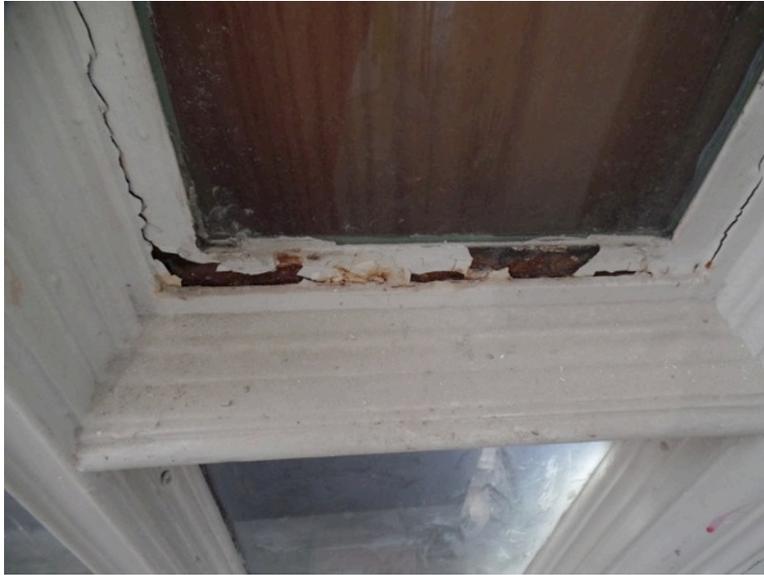
The fixed and casement windows at the ground floor appear to be in good condition. Some corrosion and peeling paint was observed (see Figure 22).

Figure 22. Peeling paint and corrosion at ground floor window. (Photograph by Garavaglia Architecture, Inc., April 2015.)

Item #7: Window Rehabilitation at Steel Casement Windows
Maintenance: Proposed
Contract Year Work Completion: 2016
Total Cost: \$50,000
Scope of Work:
Examination of all existing steel casement windows at ground floor and fire stairs, followed by repair/replacement of broken or corroded frames. All broken panes should be replaced in-kind. All hardware should be inspected for operability, and repaired; if replacement is necessary, hardware should be replaced in-kind. All windows should be scraped, primed, and painted, with new glazing compound applied throughout. All window perimeters should be sealed with a backer rod, and caulked.
All work within this scope shall be completed in accordance with <i>Preservation Brief 13: Repair and Thermal Upgrading of Historic Steel Windows</i> , issued by the National Park Service.
