1 [Planning Code - Landmark Designation - One Montgomery Street (aka 1-25 Montgomery  
2 Street) (Crocker National Bank Building)]

# ARTICLE 10 LANDMARK DESIGNATION FACT SHEET

# ONE MONTGOMERY STREET (CROCKER NATIONAL BANK BLDG) LANDMARK DESIGNATION (BOS FILE NO. 210898)

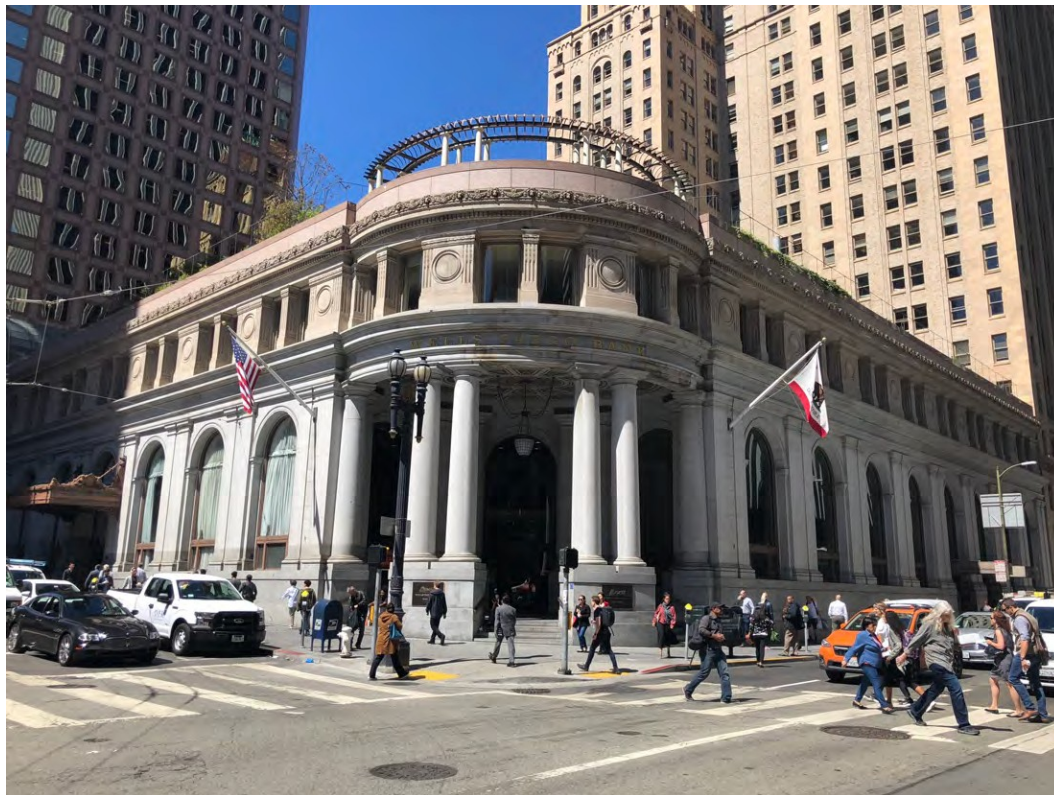
One Montgomery Street, October 2019. Source: architecture + history, llc (2020) report

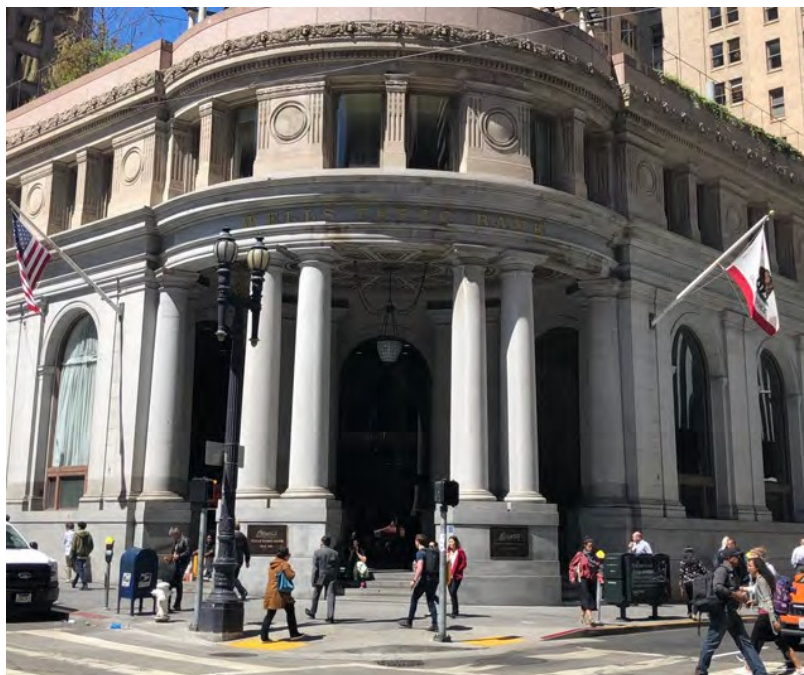
Detail of the rotunda entry, October 2019. Source: architecture + history, llc (2020) report

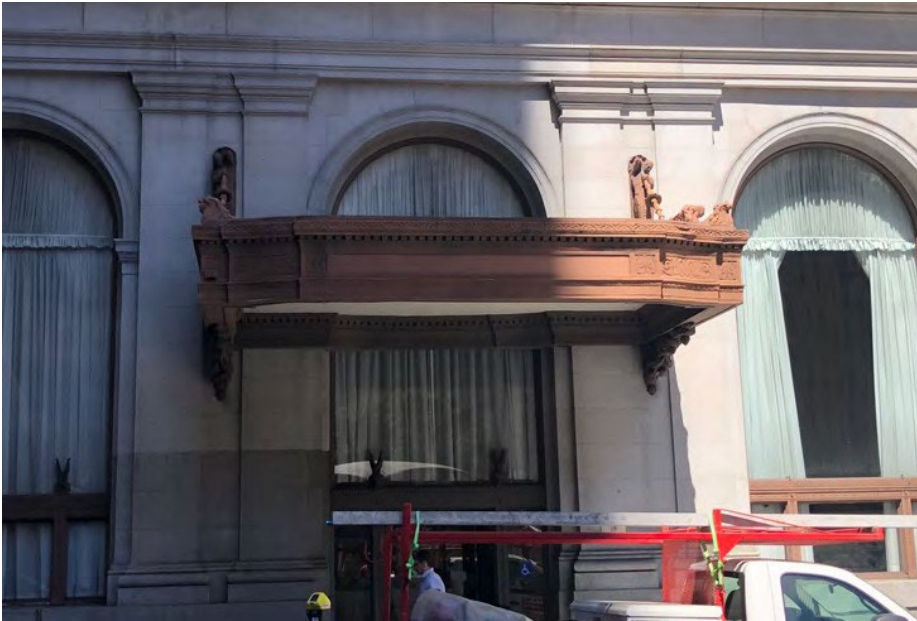
Canopy at Post Street entry, October 2019. Source: architecture + history, llc. (2020) report

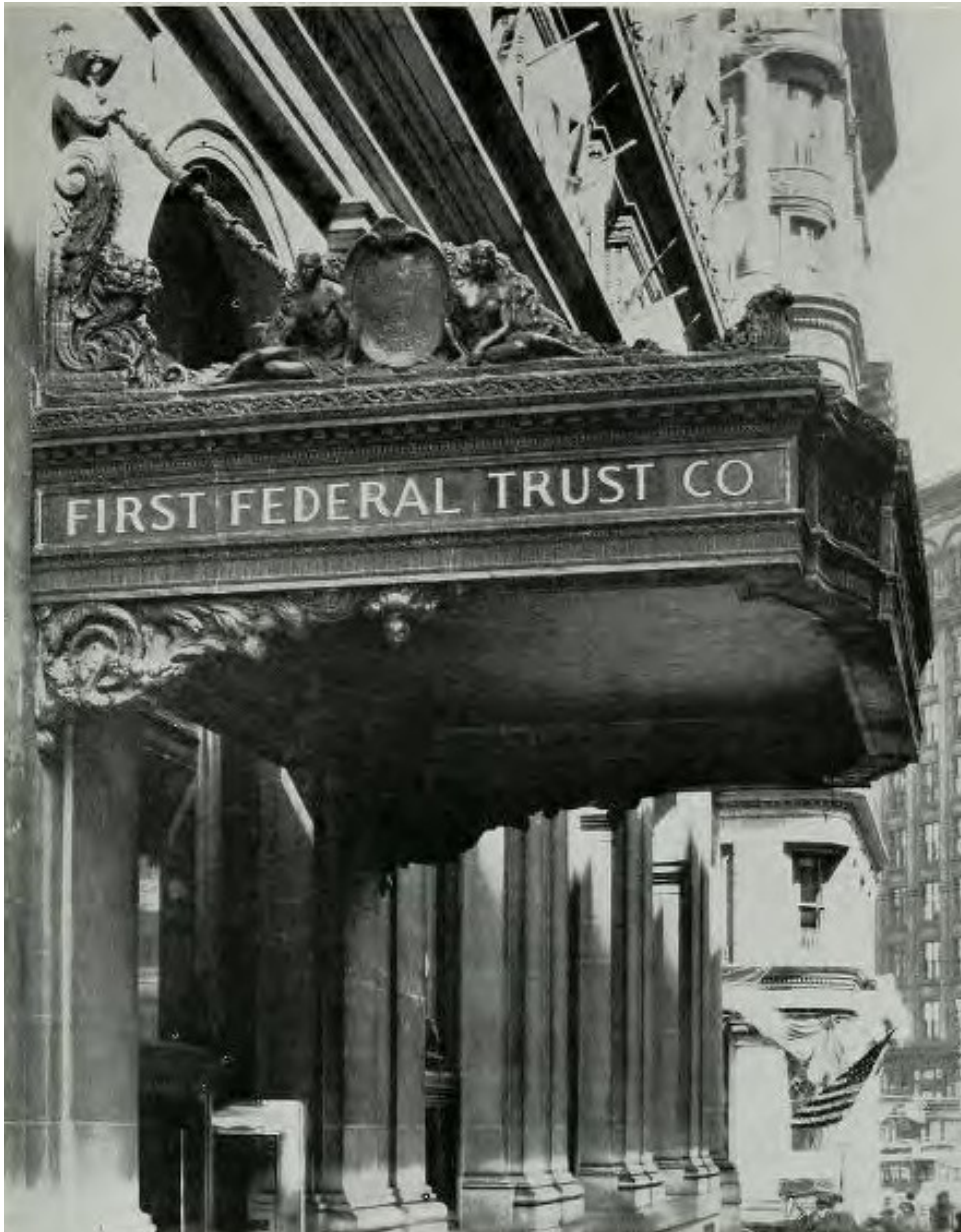
View of the canopy from the October 1925 *Architect & Engineer*.  
Source: architecture + history, llc. (2020) report

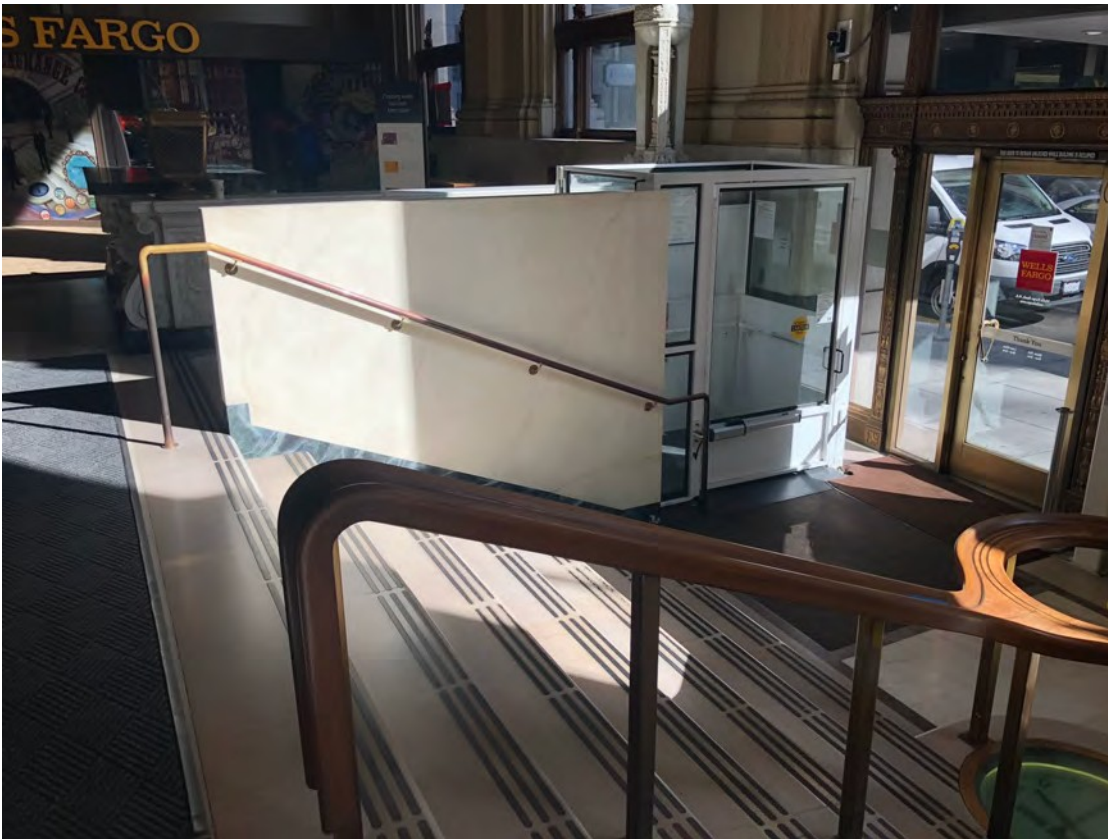
View of the Montgomery Street entry with the inserted lift and detail of railing, October 2019.  
Source: architecture + history, llc. (2020) report

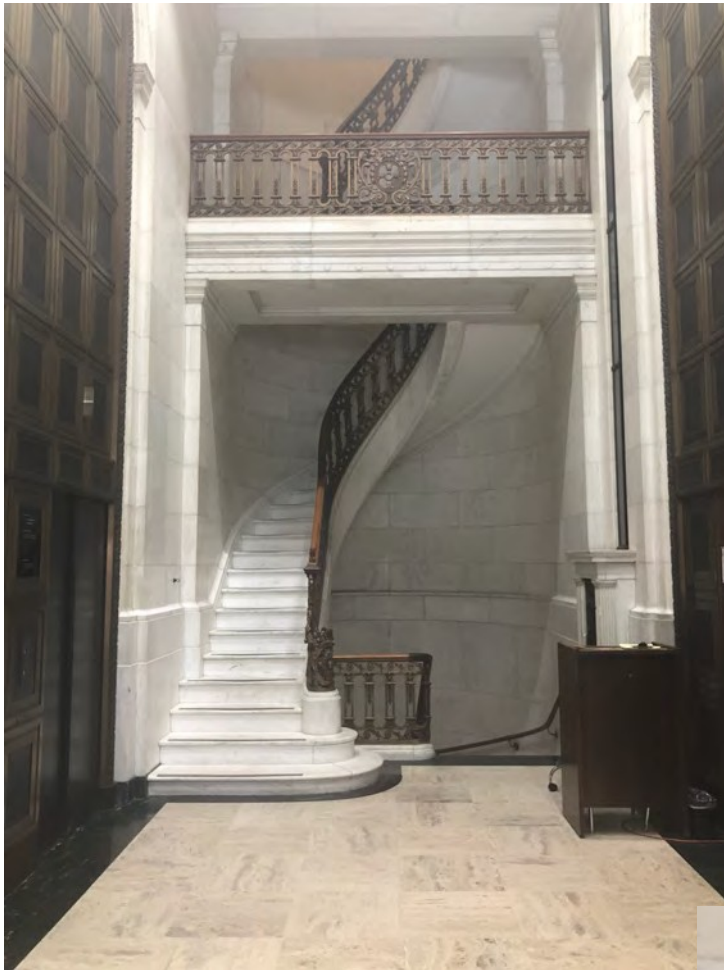
View of the curved stairway in the original 1908 lobby and detail view of the squirrel on the newel post, 2019. Source: architecture + history, llc. (2020) report

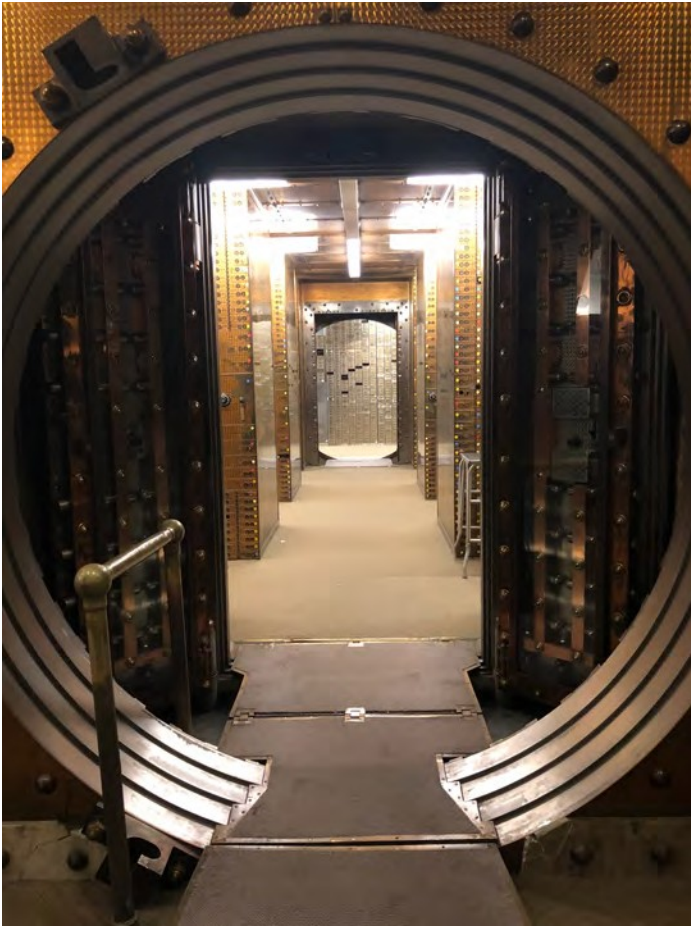
Detail view of the main vault and grille work on cage at vault in basement, 2019.  
Source: architecture + history, llc. (2020) report

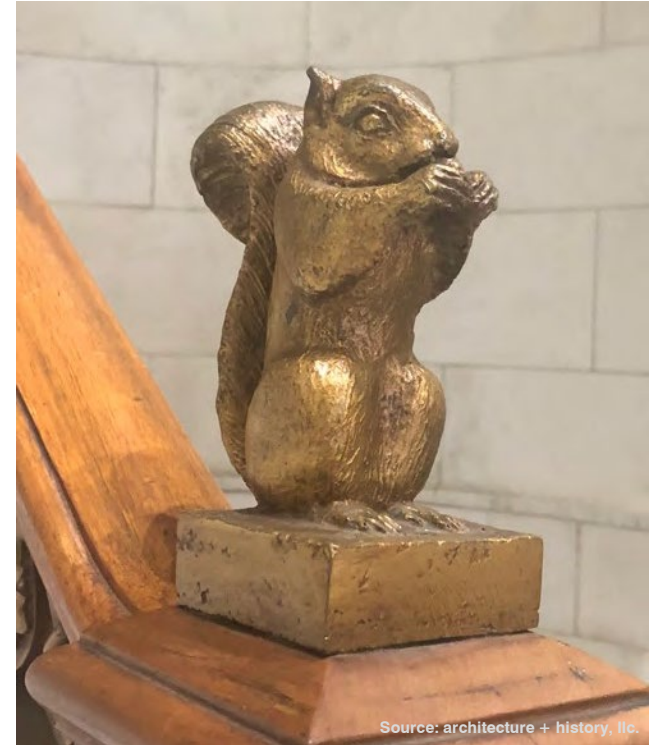
1908 lobby with elevators, marble stairs and squirrel newel post, 2019
