SAN FRANCISCO PLANNING DEPARTMENT

Landmark Designation Case Report

Hearing Date: July 1, 2015
Case No.: 2015-005887-DES
Project Address: 90-92 Second Street / 600 – 600½ Mission Street
Zoning: C-3-0(SD) – Downtown-Office (Special Development)
Block/Lot: 3707/012
Property Owner: Laura Yee Marital Trust (50%) and
Moon Park Yee Residuary Trust (50%)
804 Stanyan Street
San Francisco, CA 94117
Staff Contact: Jonathan Lammers – (415) 575-9093
jonathan.lammers@sfgov.org
Reviewed By: Tim Frye – (415) 575-6822
tim.frye@sfgov.org

Bourdette Building 90-92 Second Street / 600-600½ Mission Street

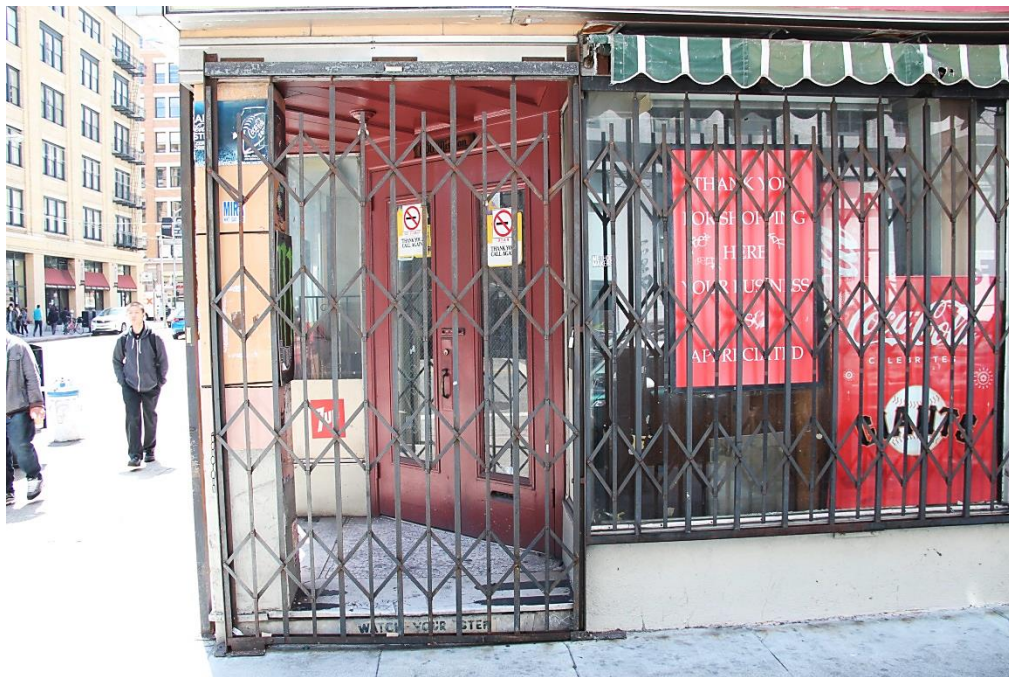
Corner storefront addressed as 600 Mission Street. Note mosaic tile threshold and paneled ceiling.

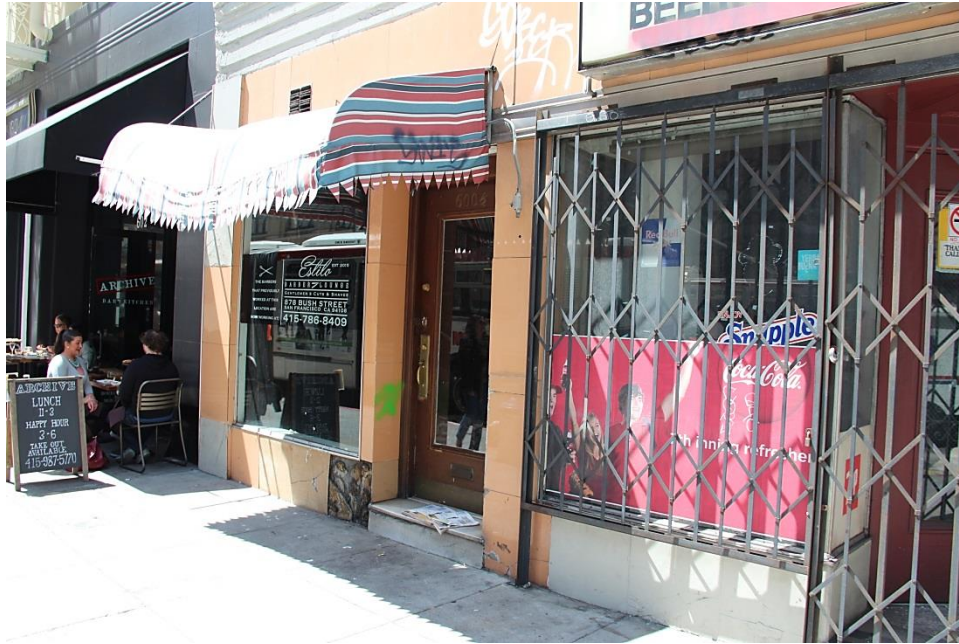
Storefront addressed as 600½ Mission Street. Note marble step.

Immediately to the west is a smaller storefront address as 600½ Mission Street. It features a slightly-recessed entry with a fully-glazed wood door and a marble step. The storefront is covered by an aluminum frame fabric awning. Some panels of the Vitrolite veneer are missing from the base and western portion of the storefront.

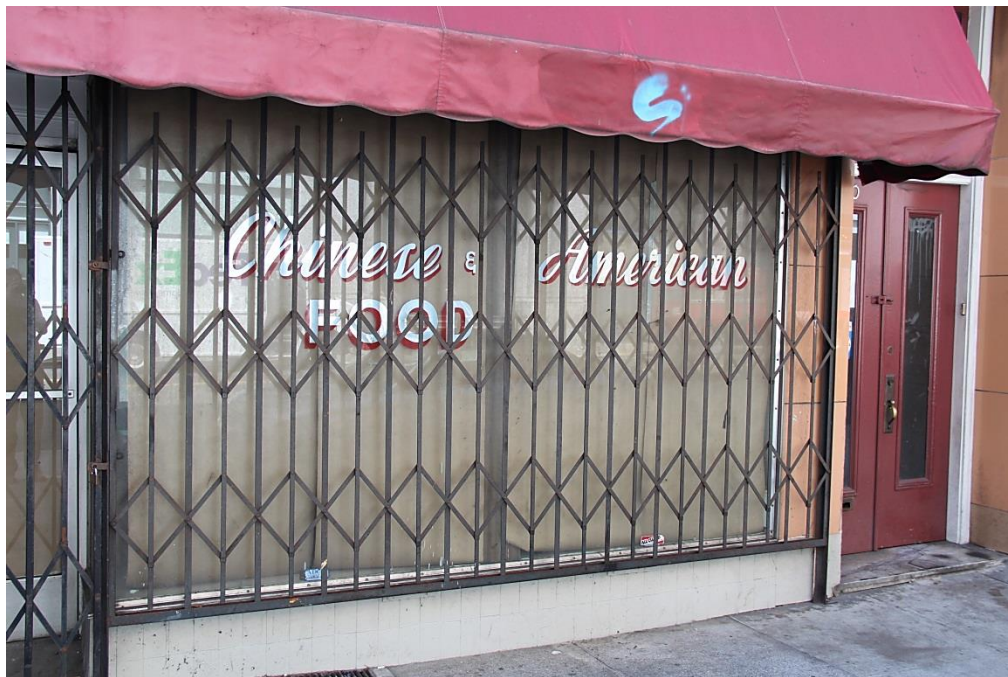
*Detail of painted sign on the northern portion of the storefront at 92 Second Street.
Note the stacked tile veneer on the bulkhead.*

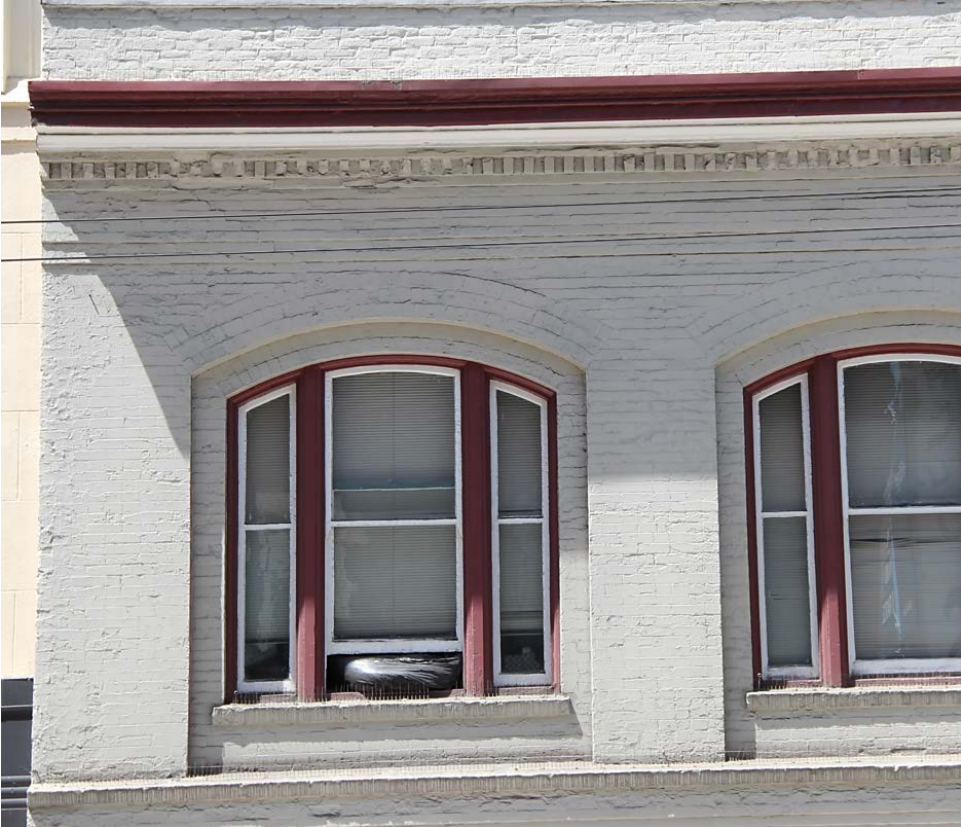
Detail of windows and roofline on the Mission Street facade.

smaller (one-over-one) fixed wood windows. The tops of window frames are arched in alignment with the window opening. The bases rest on a brick sill. Just above the arches is a slightly-projecting brick stringcourse.

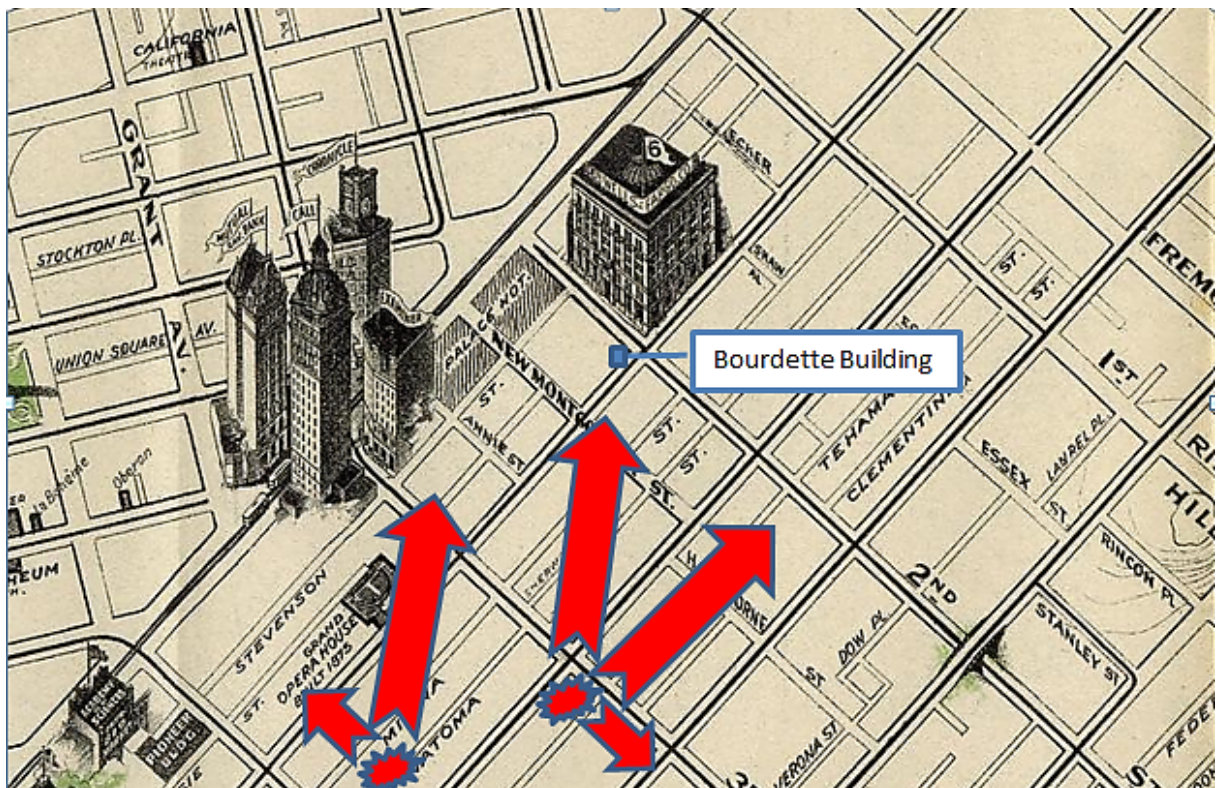
Progress of the 1906 fire in the vicinity of the Bourdette Building, approximately 6:00 am – 12:00 pm, April 18, 1906. (August Chevelier Commercial, Pictorial and Tourist Map of San Francisco, 1904; edited by author).

At No. 282 Natoma Street, near Fourth fire broke out in a small frame dwelling house. Spreading to the north, it crossed Minna Street, reached Mission Street at about 9 o'clock, and crossed to the Grand Opera House at 9:30. Burning through to Market, it destroyed the buildings along the south side of Market Street from Third to Fourth by noon. The Call building was on fire at 11 o'clock. This same Natoma Street fire burned east to Third Street, crossed Third at the Oaks Hotel, at Minna and Third, and was burning in that block at the end of the first period....

The fire north of Howard Street between Third and Second Streets finally got to the Palace Hotel, after the tremendous fight made to save it from a private water supply, at 3 o'clock, and at half past 3 it was all ablaze. From it the Grand Hotel took fire, and early Wednesday night practically the whole south side of Market Street from the Ferry west was burned down.²²
