Re: **Transmittal of Planning Department Case Number 2021-002831DES**  
**One Montgomery Street (aka 1-25 Montgomery Street, Crocker National Bank Building) Landmark**  
**Designation**  
BOS File No. 201404

# LANDMARK DESIGNATION RECOMMENDATION EXECUTIVE SUMMARY

# ARTICLE 10 LANDMARK DESIGNATION FACT SHEET

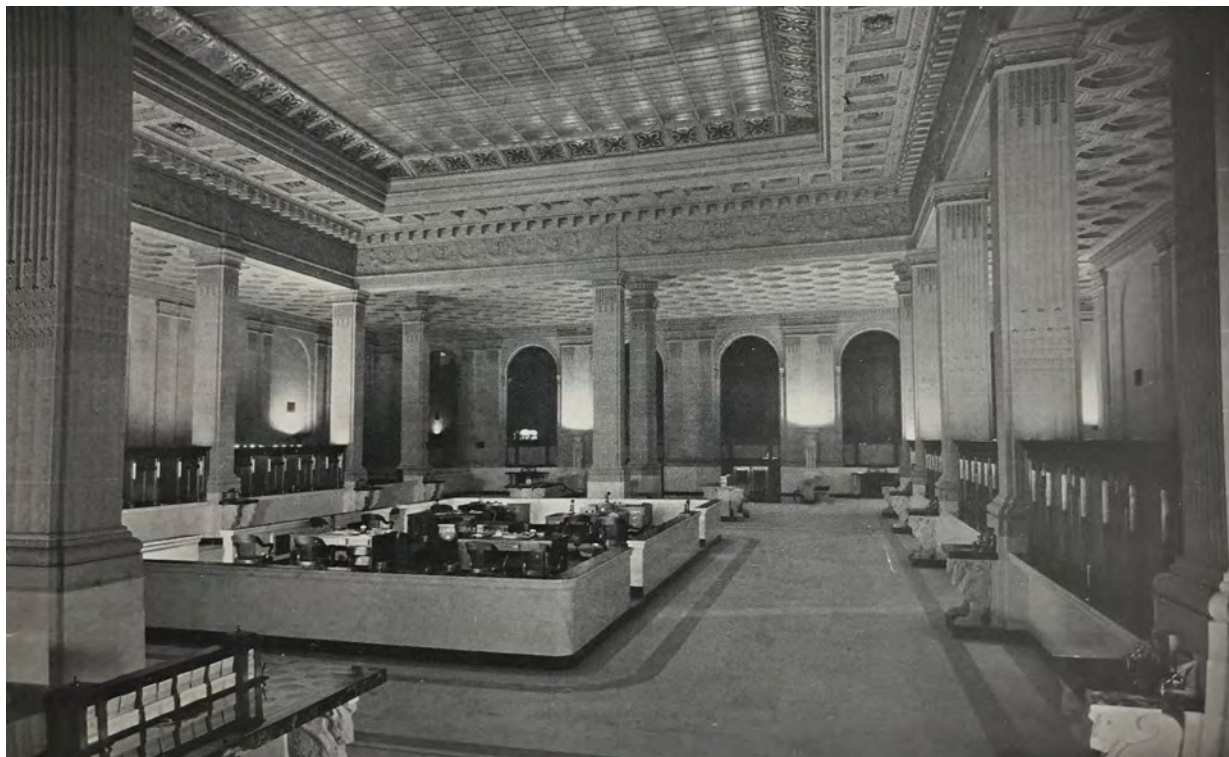
View of the 1920 banking hall, looking east, from *The Architect and Engineer*, October 1922. Source: architecture + history, llc. (2020) report

The 1908 banking hall is divided down the long axis by fluted, plaster square columns placed on marble pedestals. The plaster fluting is embellished with a floral pattern similar to that found on the exterior frieze panels. The capitals feature elaborate plaster foliated egg and dart motifs. The south wall along Post Street (the original location of the tellers' "wickets" or counters / windows) is articulated by large full-height window openings flanked by paired pilasters. Pilasters also divide the north wall into bays. A horizontal molding divides the north wall into two horizontal sections, marking the location of the original office mezzanine, which has been enclosed. At the eastern end of the banking hall, the north wall is angled where it meets the rear side of the elevator shaft.

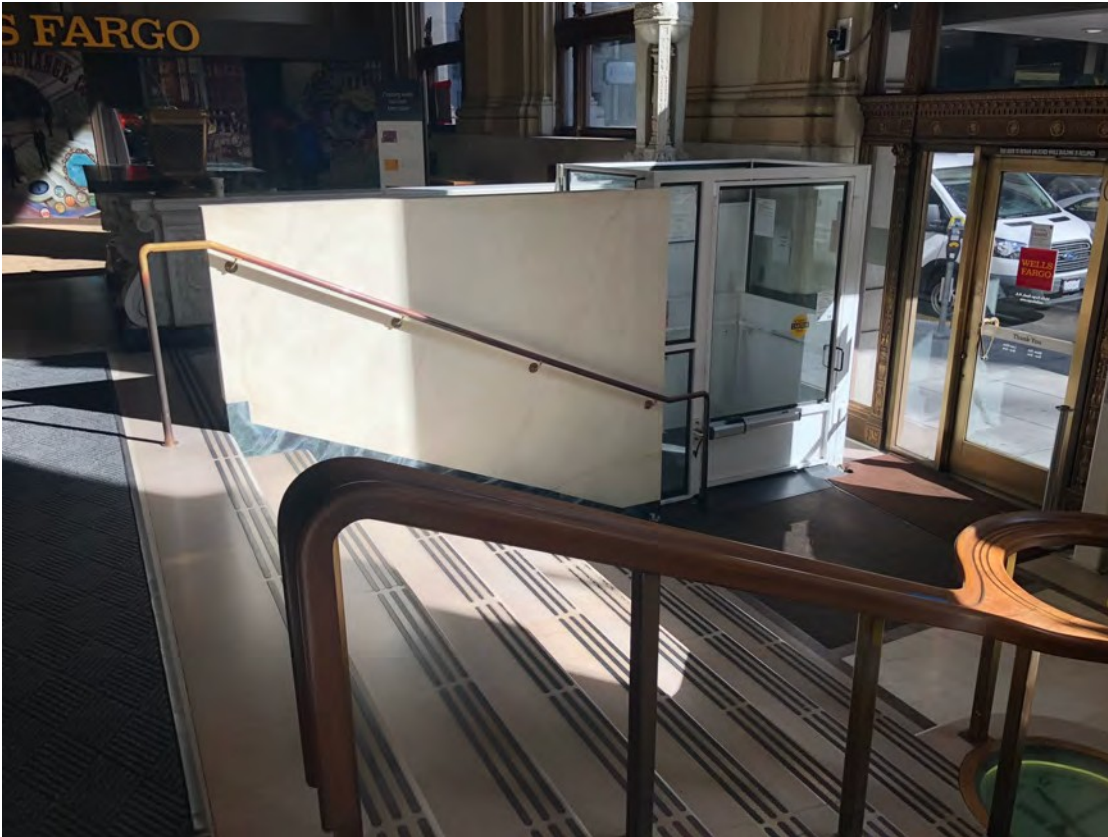
View of the Montgomery Street entry with the inserted lift and detail of railing, October 2019.  
Source: architecture + history, llc. (2020) report
