Re: 3637-3657 Sacramento St- Case 2007.1347E

We are the proposed contractors for the demolition, shoring and excavation of the above project. This is a typical infill project in San Francisco. We have completed hundreds of very similar projects.

Small Selection of 2017 and 2018 projects

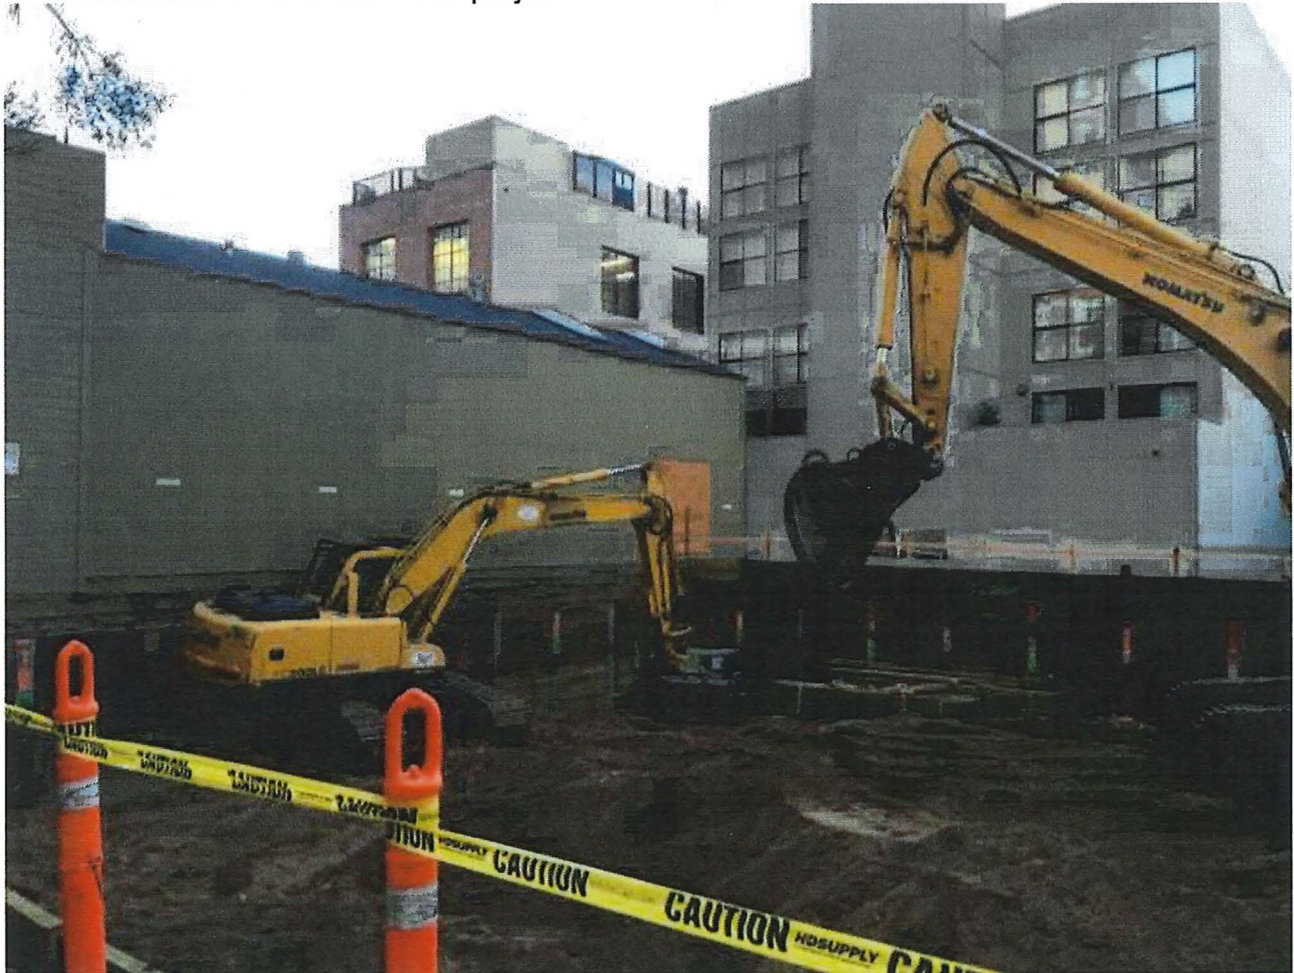
Figure 1 915 Minna excavation using conventional equipment (Demolition, Excavation and shoring 5,000CY)

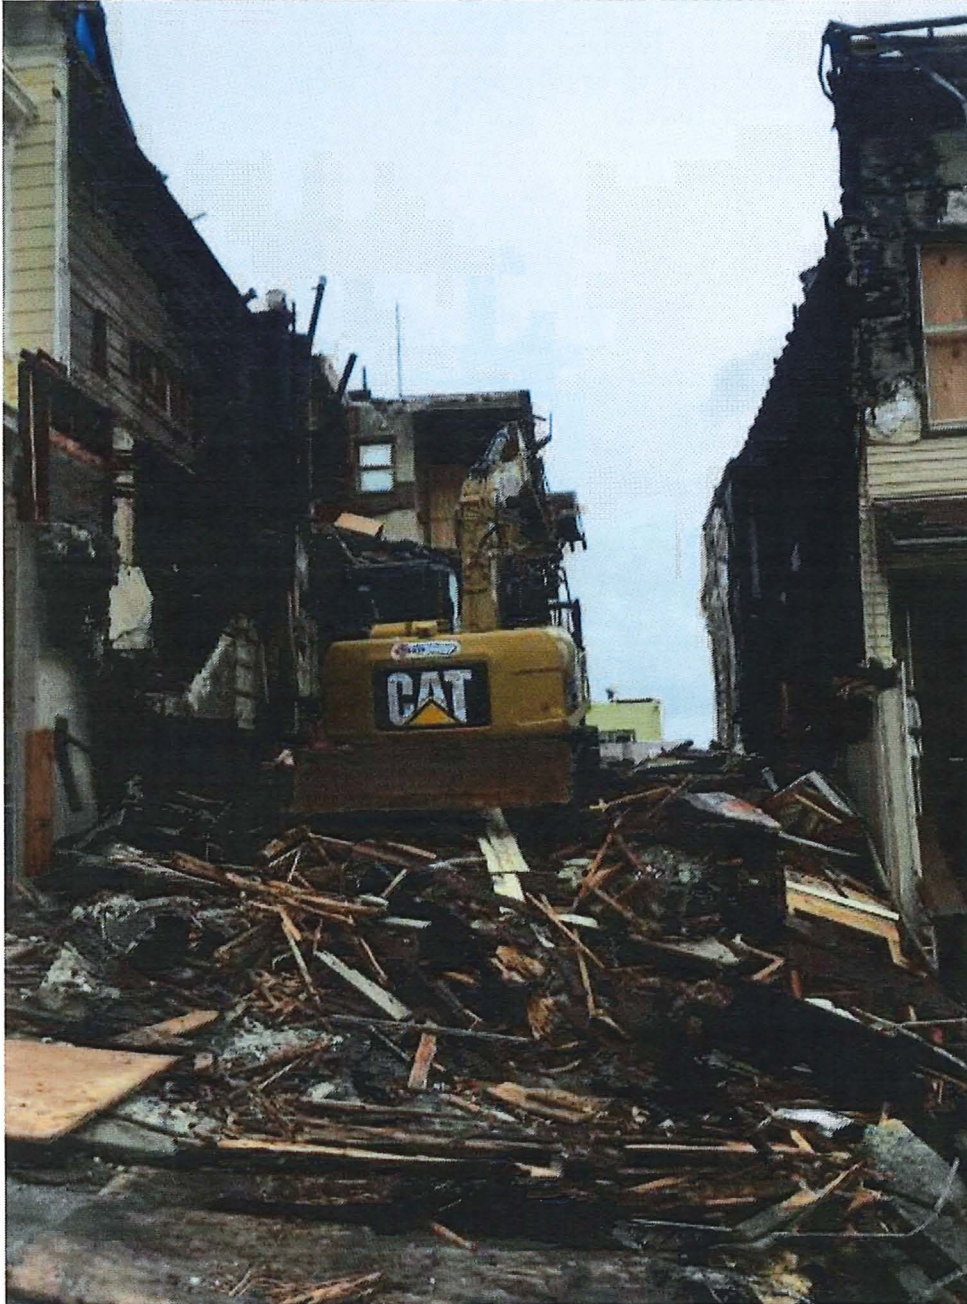
Figure 2 Hattie Street Demolition using excavator with no hoe-ram (Demolition, Excavation and shoring 2,000 CY)

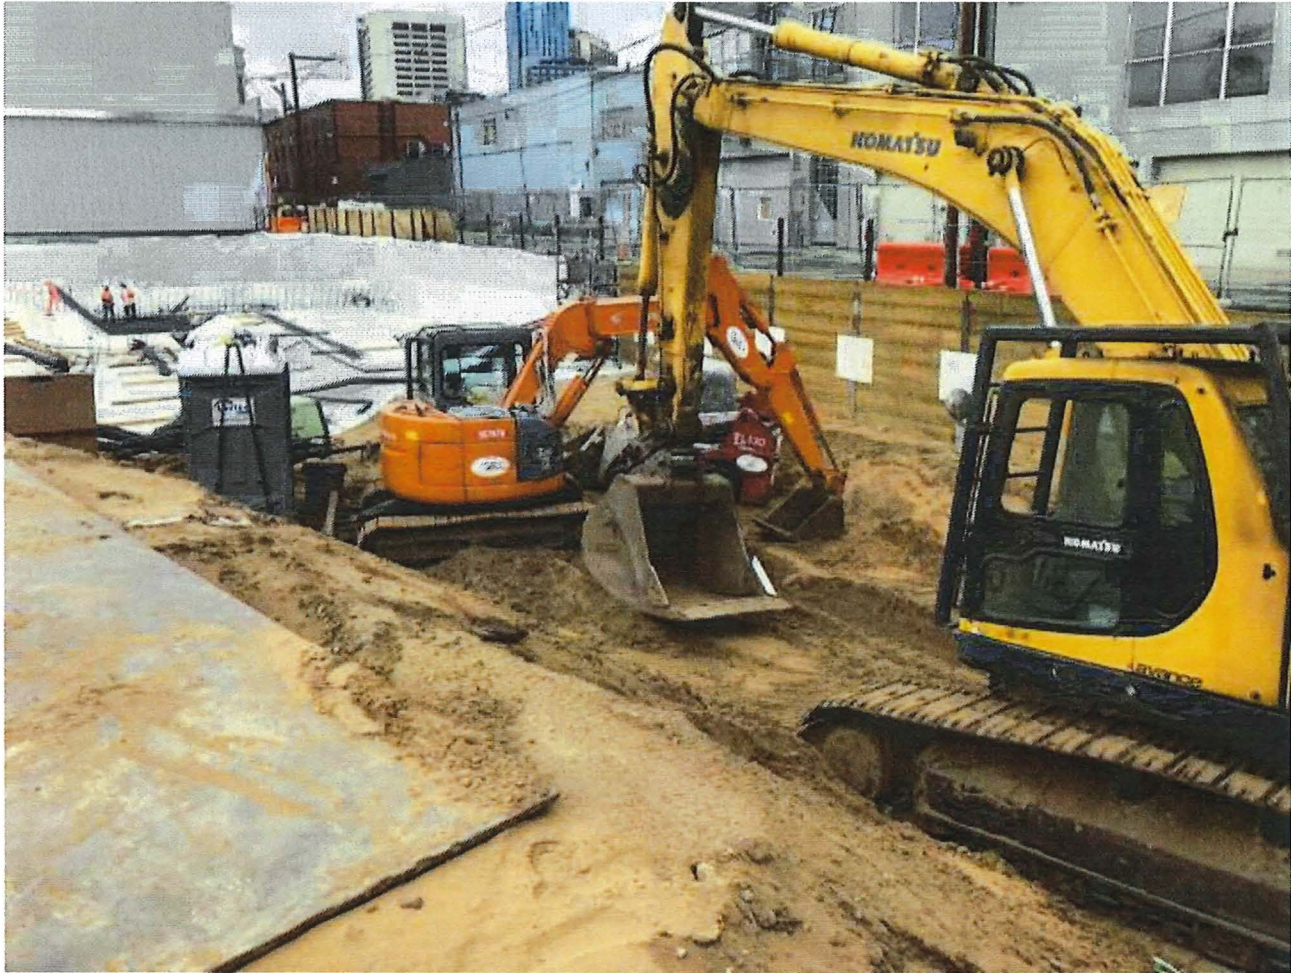
Figure 3 333 12th Street Conventional Equipment (Demolition, Excavation and shoring 20,000 CY)

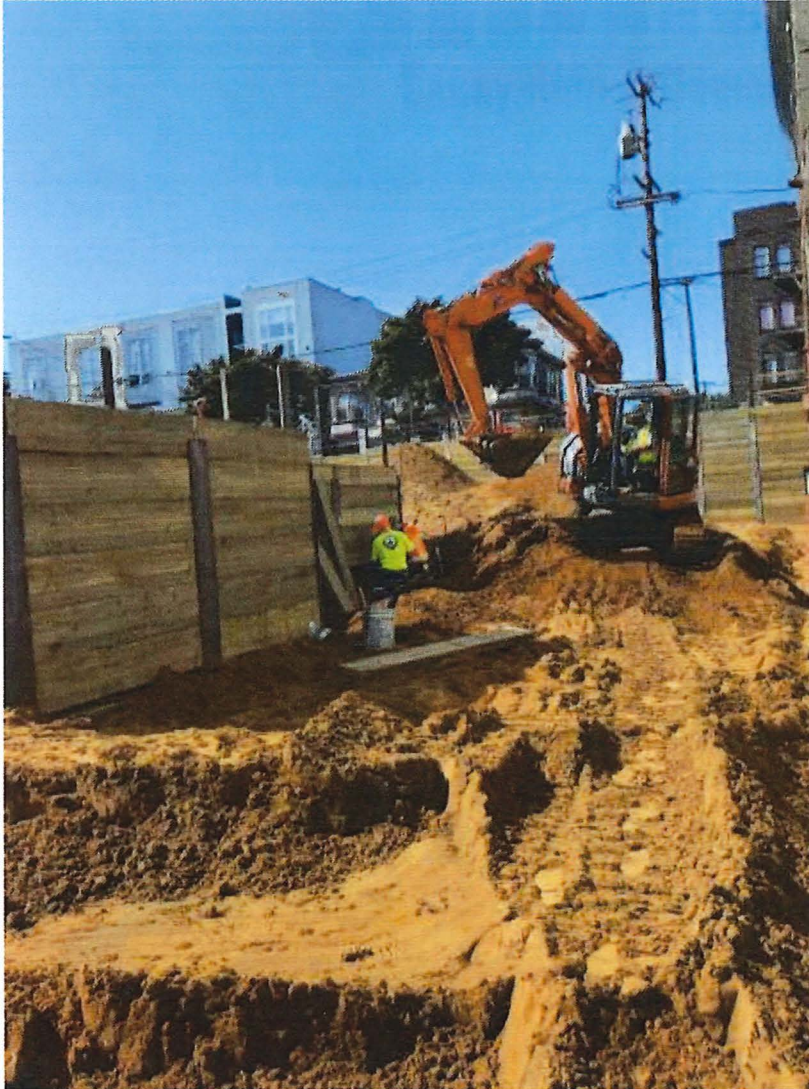
Figure 4 333 12th Street Conventional Equipment (Demolition, Excavation and shoring 20,000 CY)

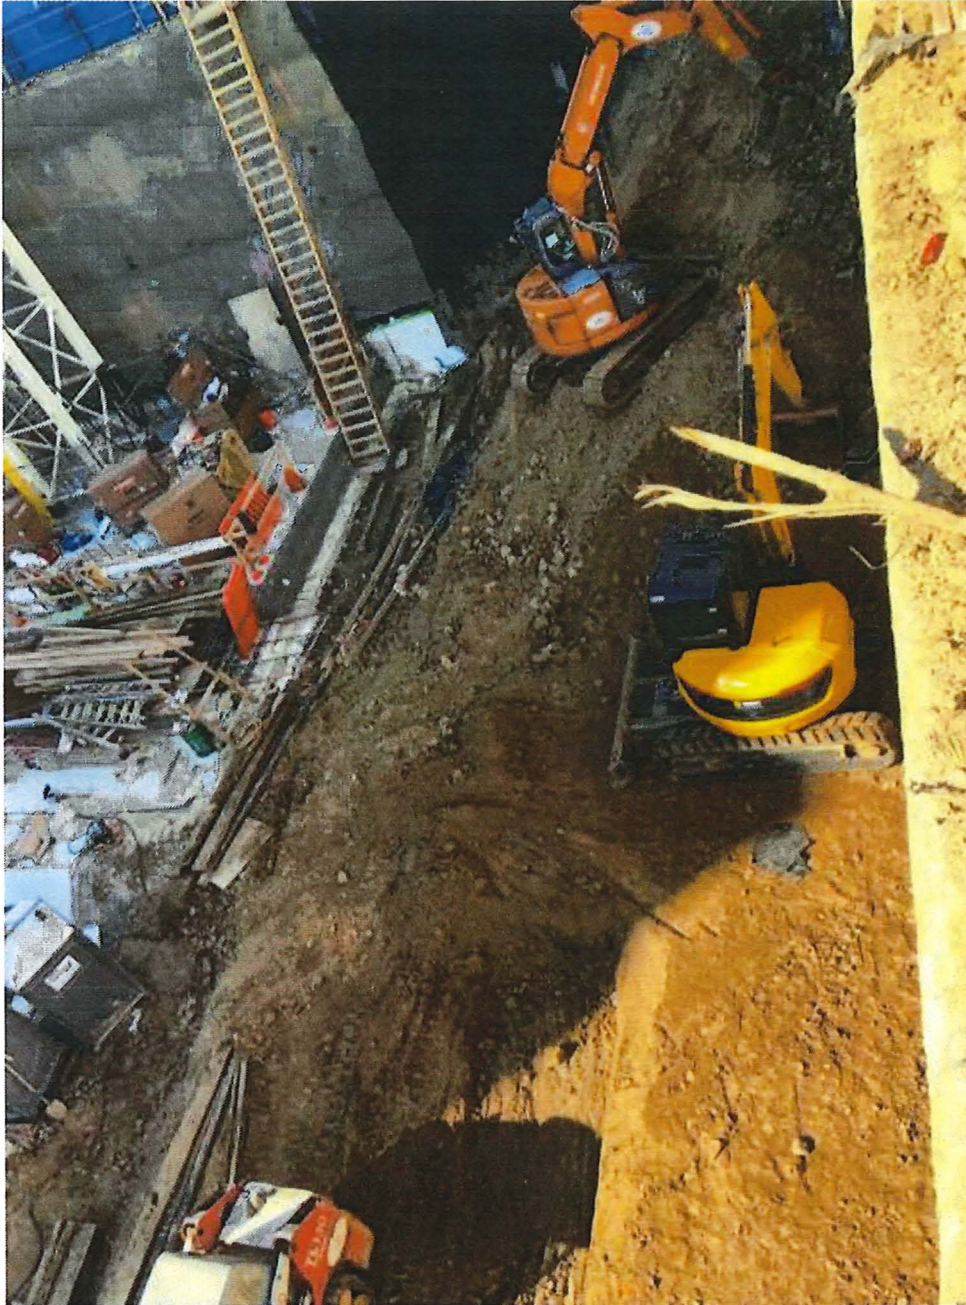
Figure 5. 390 1st Street Excavation of sandstone with no hoe-rams. All equipment shown is <63hp (Demolition, Excavation and shoring 28,000 CY)

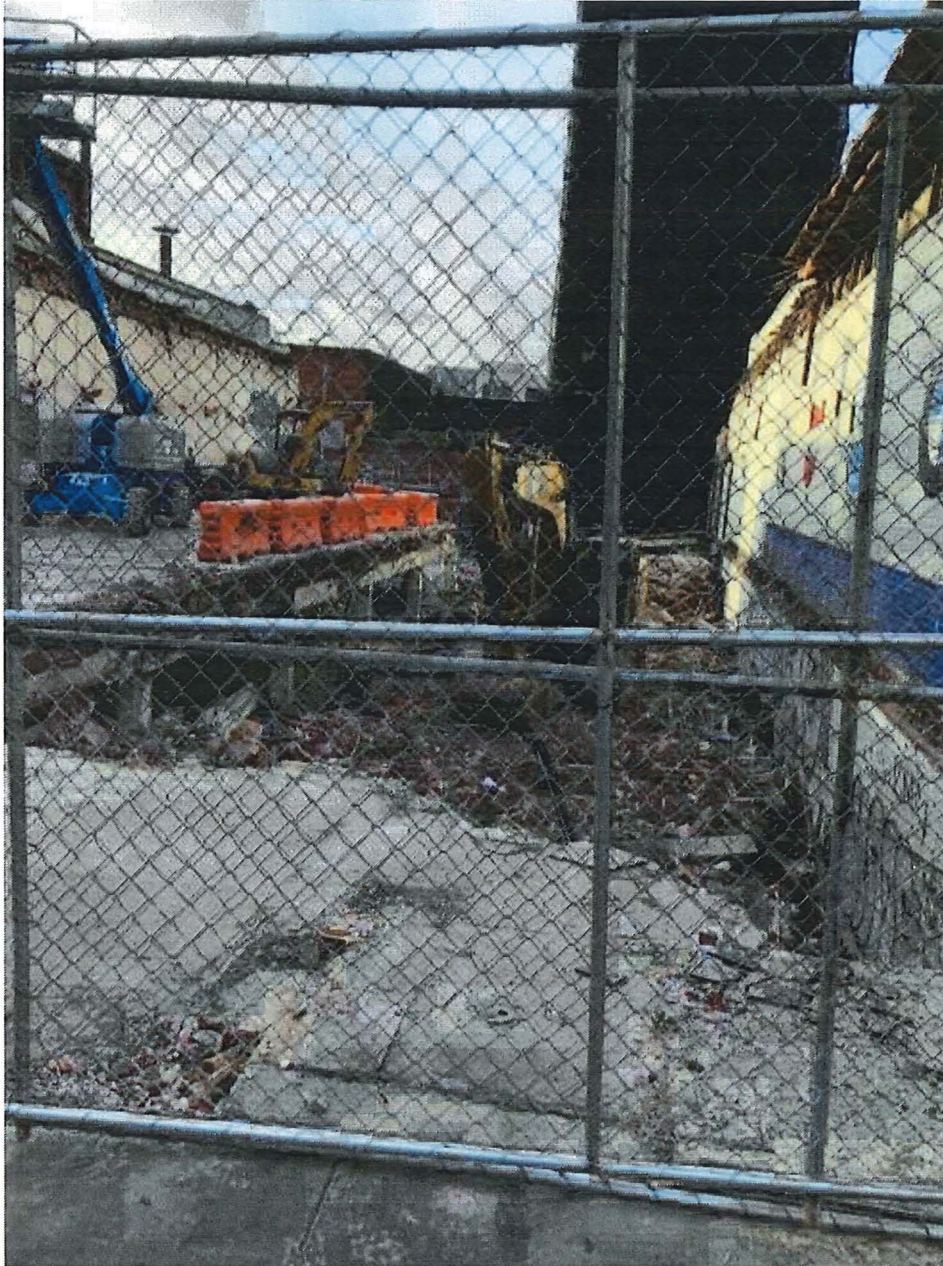
Figure 6 1433 Bush Street Demolition, Excavation and shoring 6,000 CY

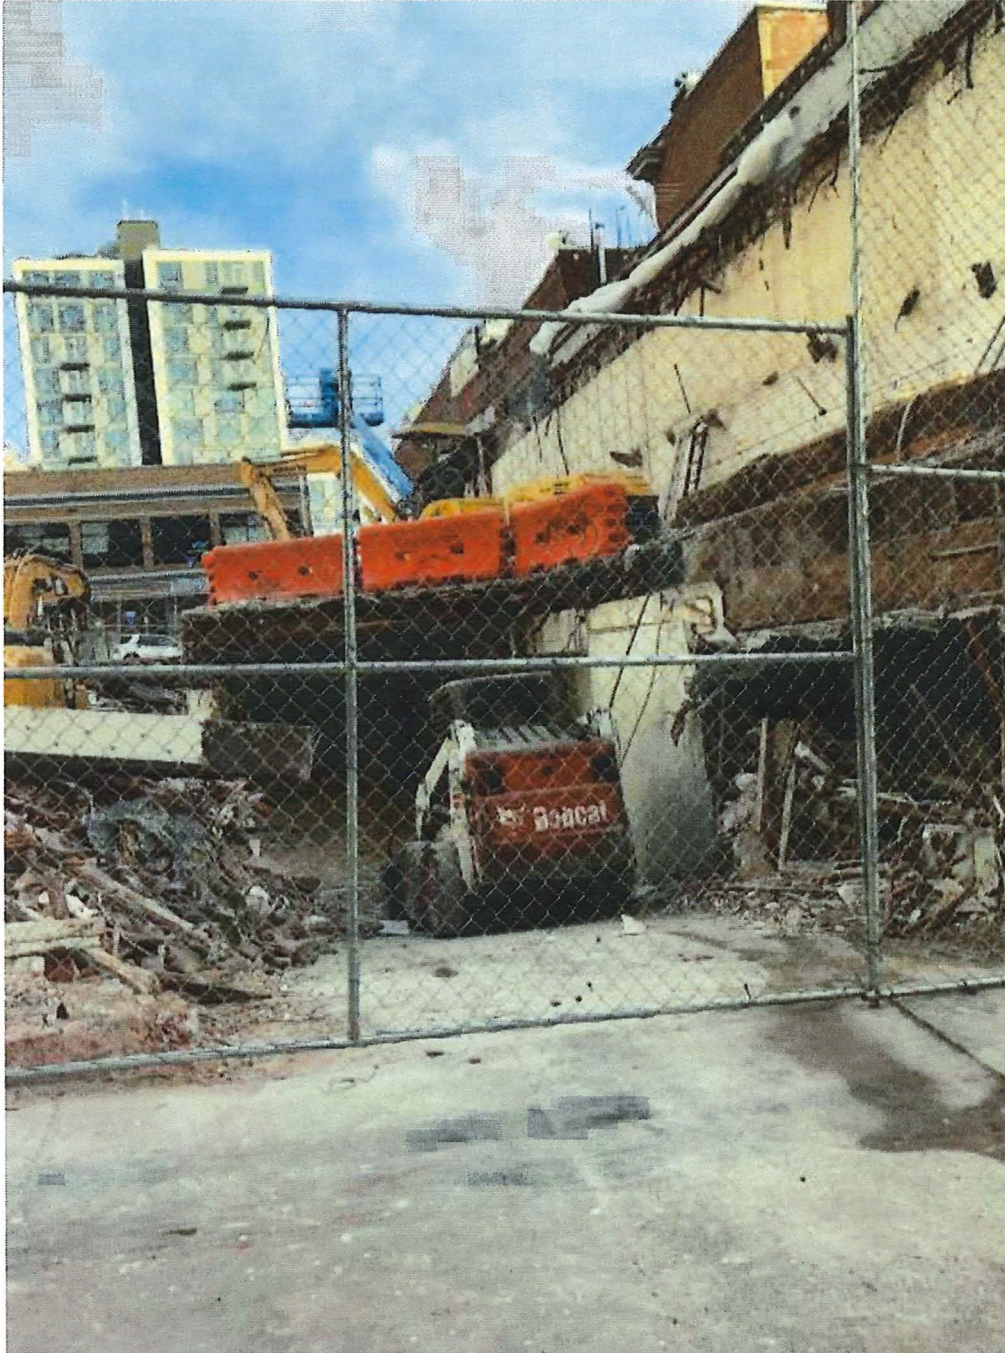
Figure 7 1433 Bush Street Demolition using small tools

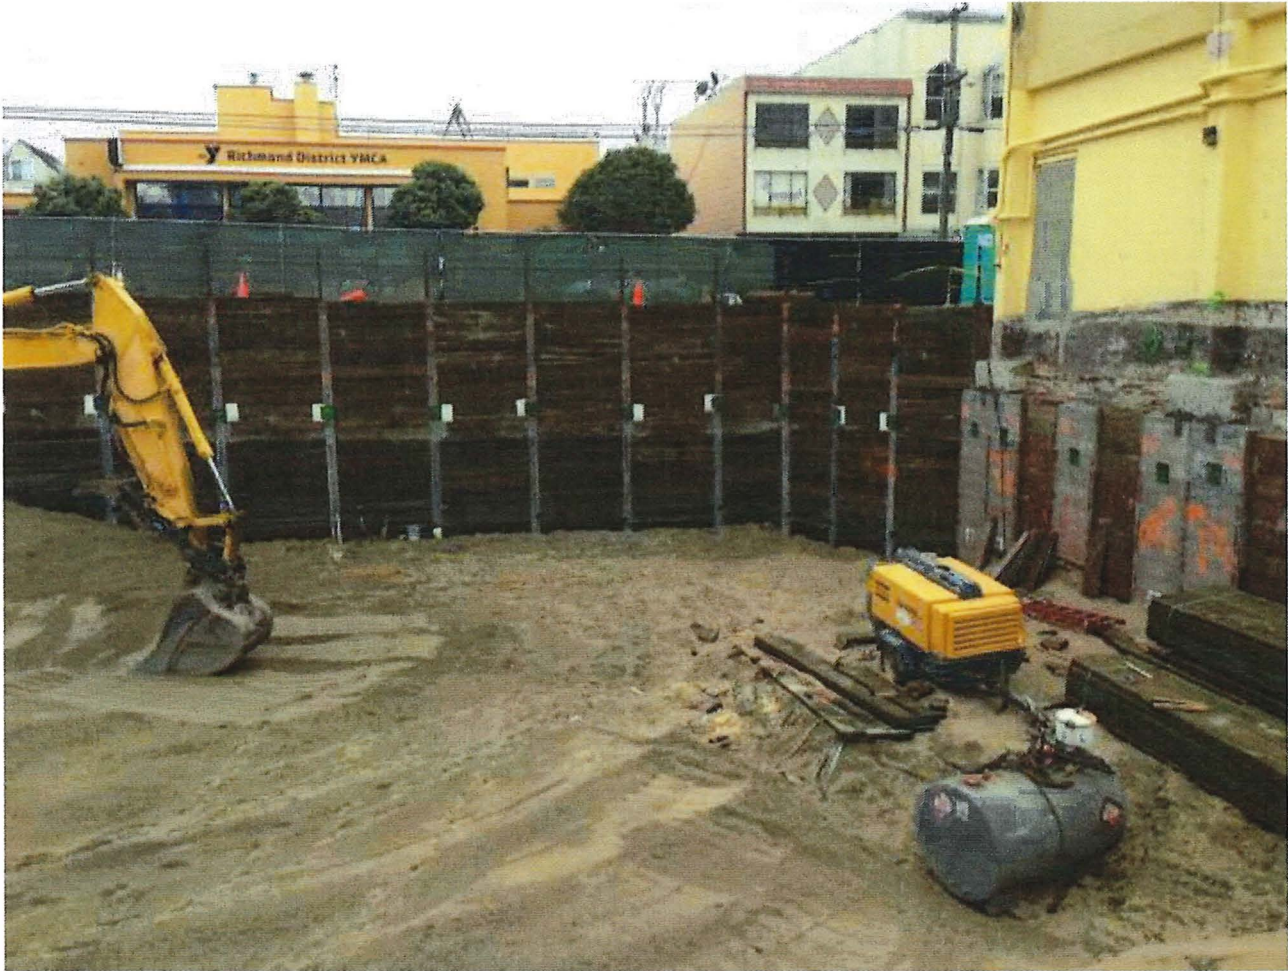
Figure 8 1810 8th Ave - 30,000 CY of sand. All compaction done with water and excavator. No vibratory rollers. Note hand dug pits.

Shoring and underpinning is done with a small drill rig and the underpinning pits are hand dug under adjacent foundations. Rebar and concrete are placed in the pits. All of this work is observed on a daily basis by the design engineers, inspected by the SF Department of Building Inspection, the original soil engineer, a testing laboratory for the concrete and the surveyor monitors property lines, settlement lines, etc.

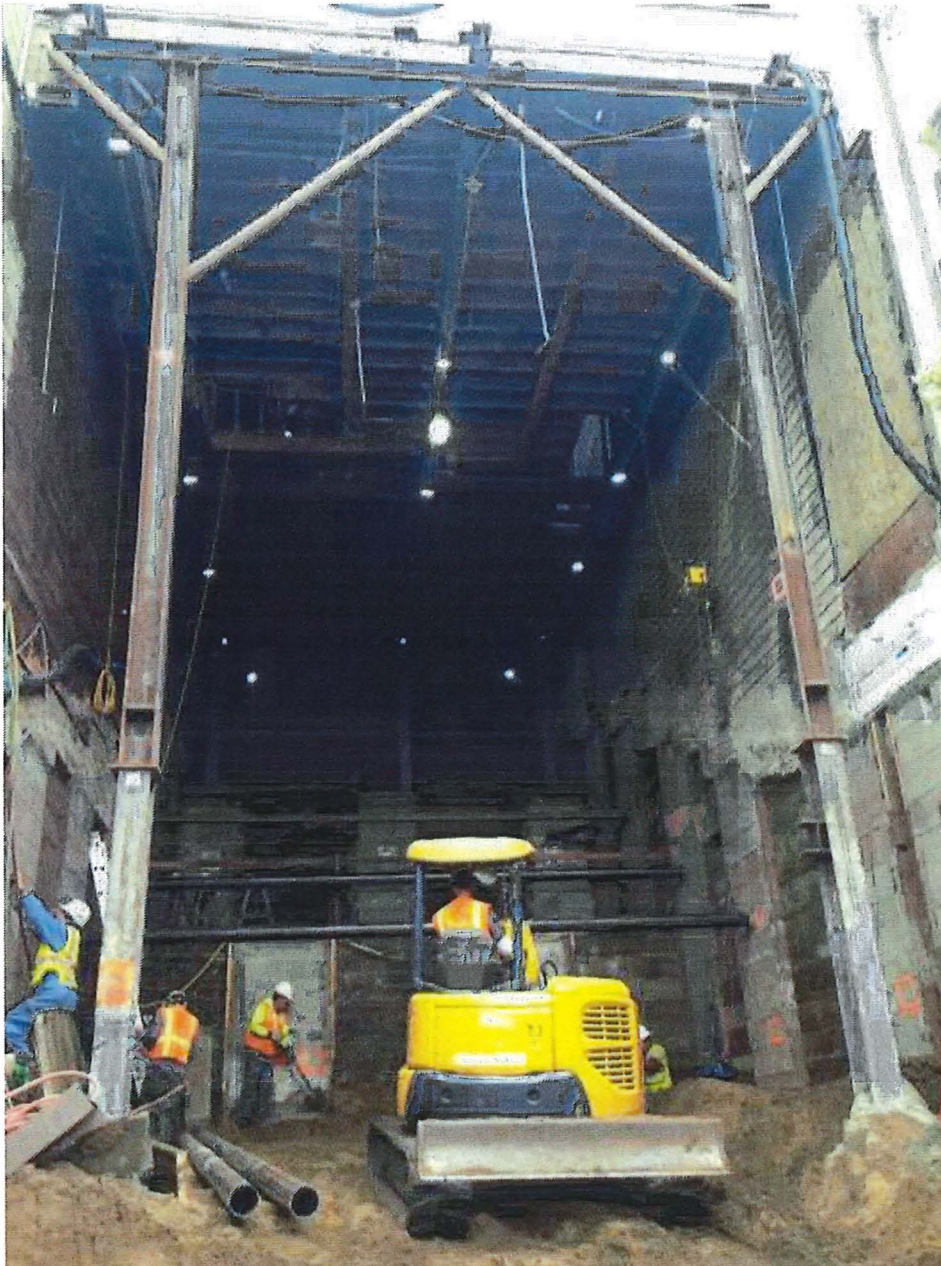
Figure 9 - 2833 Vallejo St - Hand dug pits and internal bracing
