MEMORANDUM

SUBJECT: Cost Estimate of Kearny Street Pedestrian Bridge Demolition and Public Right-of-Way Restoration

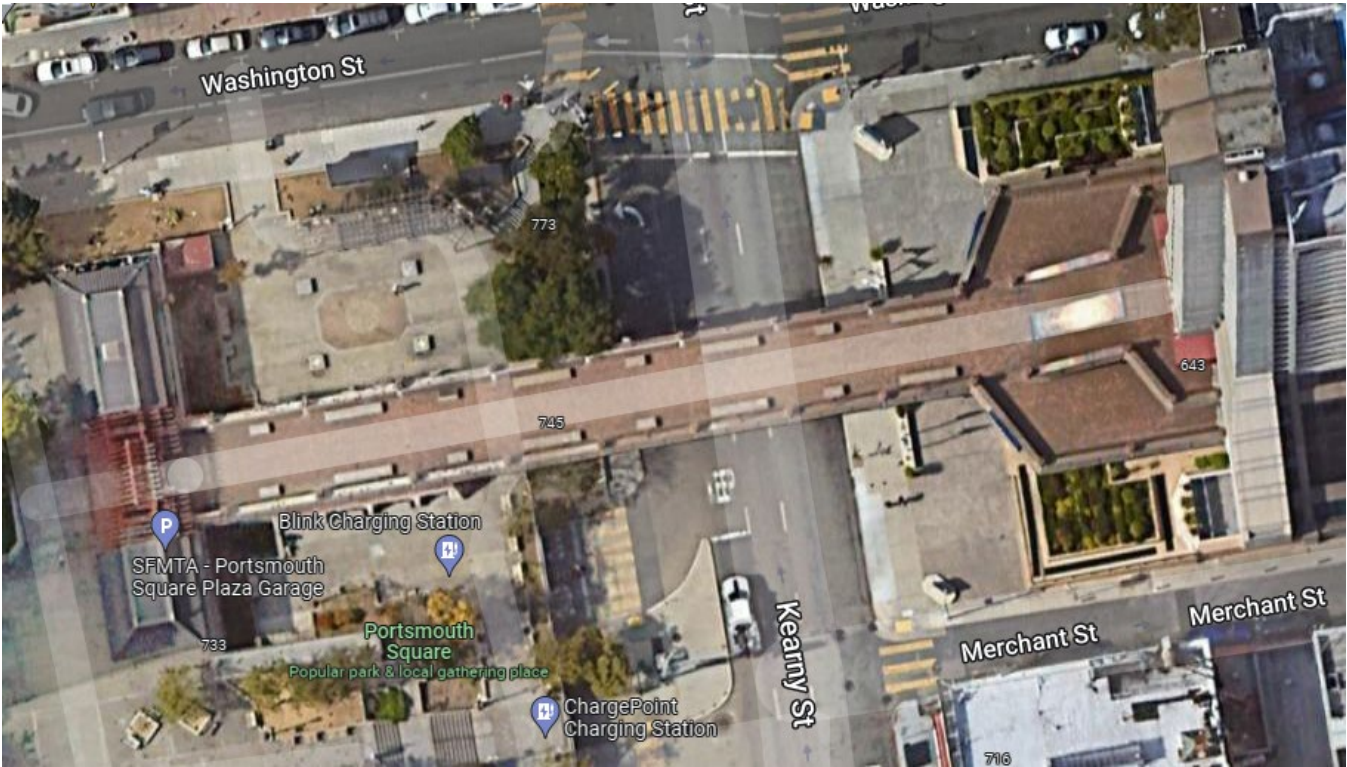
Figure 1: Bird's Eye View of Pedestrian Bridge

Spanning over four lanes of Kearny Street, the two-span pedestrian bridge measures approximately 28 feet wide and 210 feet long. The structural system of the bridge comprises 6¼-inch thick post-tensioned concrete slab supported by transverse concrete beams that span to two perimeter post-tensioned concrete girders.

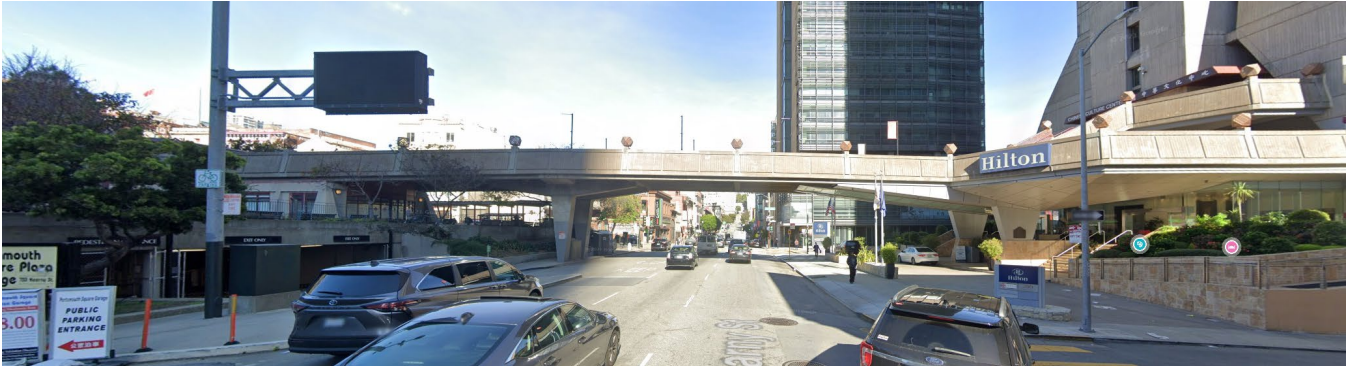
Figure 2: View of Pedestrian Bridge Looking North
