File No. 210898 Committee Item No. 1
Board Item No. _____

RESOLUTION TO RECOMMEND TO THE BOARD OF SUPERVISORS LANDMARK DESIGNATION OF ONE MONTGOMERY STREET (AKA 1-25 MONTGOMERY STREET, CROCKER NATIONAL BANK BUILDING), ASSESSOR'S PARCEL BLOCK NO. 0292, LOT NOS. 001A AND 002, AS LANDMARK NO. XXX CONSISTENT WITH THE PURPOSES AND STANDARDS OF ARTICLE 10

ARTICLE 10 LANDMARK DESIGNATION FACT SHEET

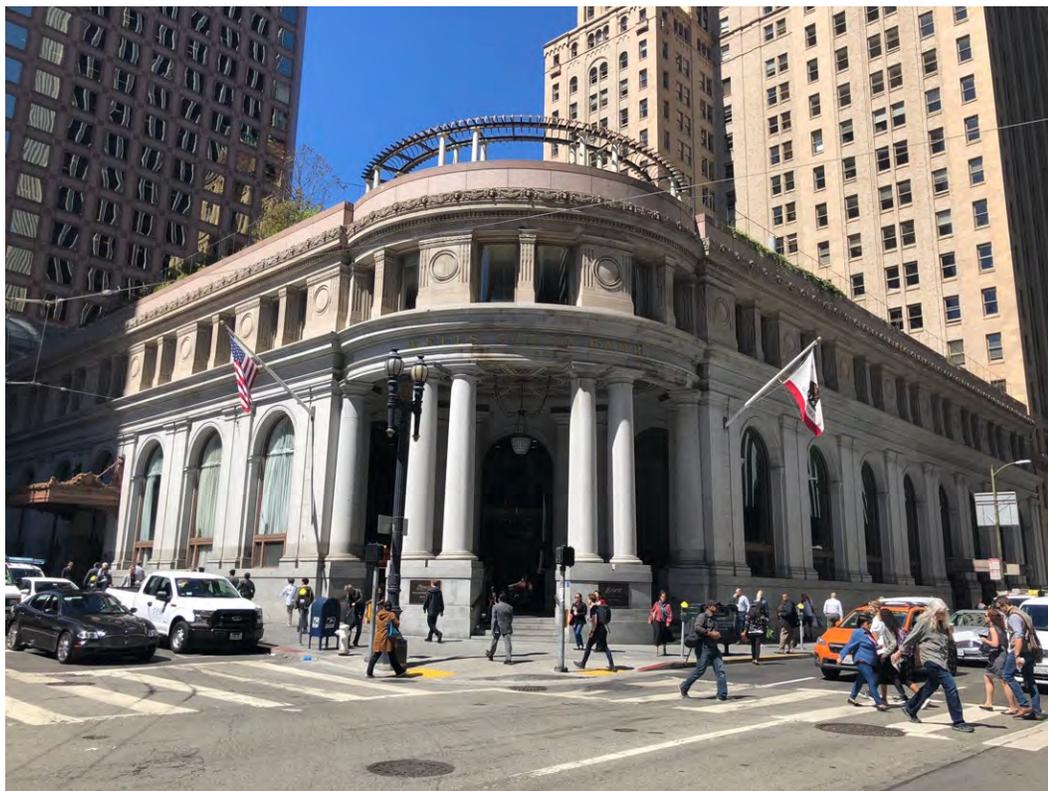
One Montgomery Street, October 2019. Source: architecture + history, llc (2020) report

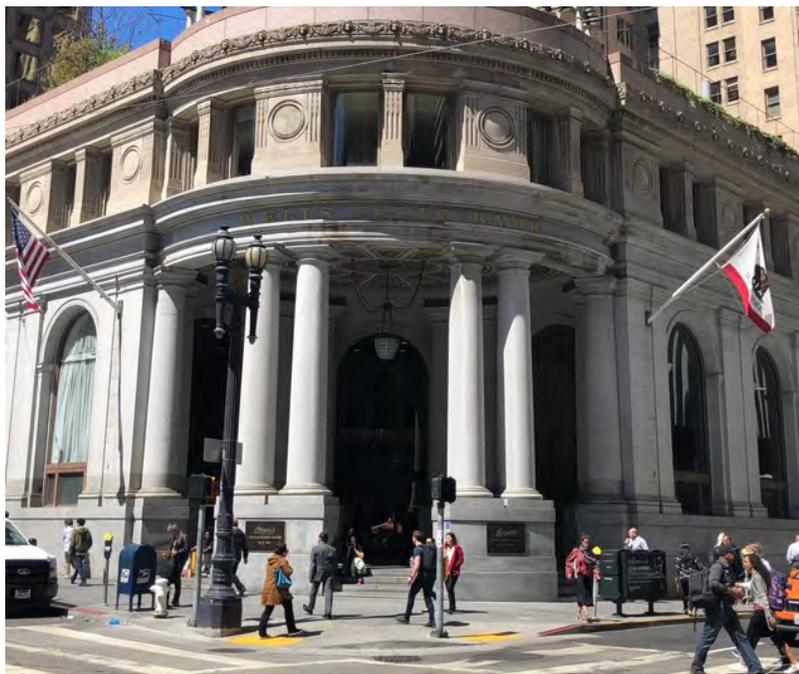
Detail of the rotunda entry, October 2019. Source: architecture + history, llc (2020) report

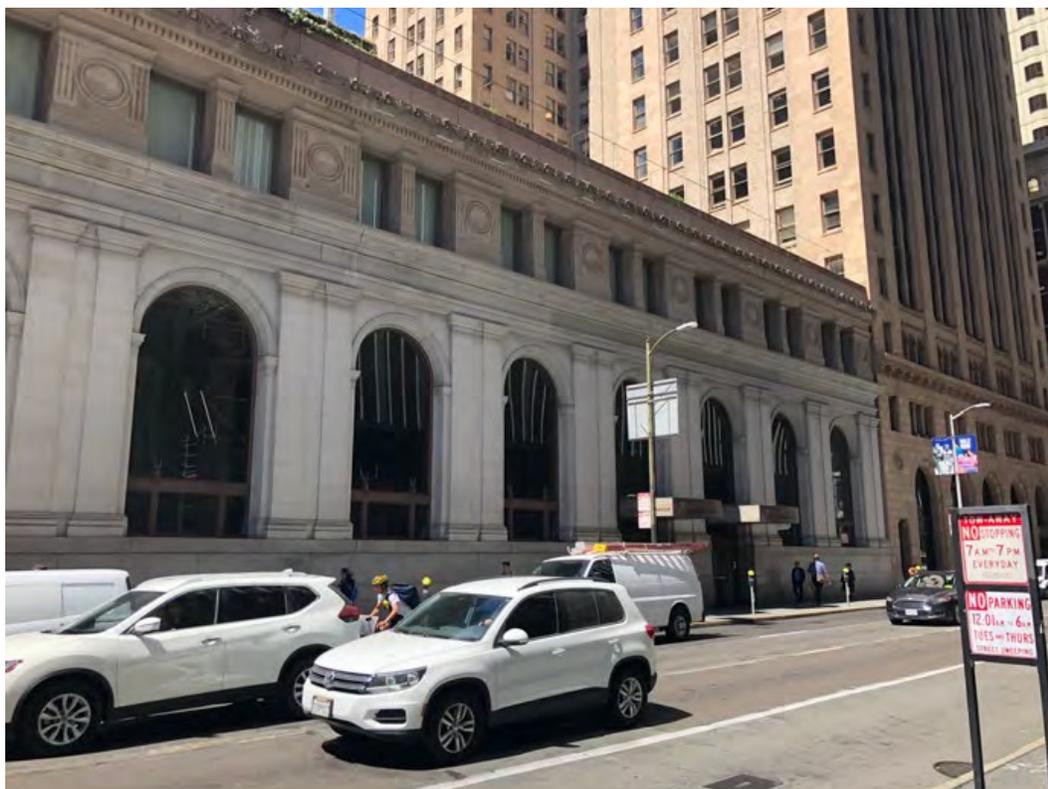
Montgomery Street elevation, view northwest, October 2019. Source: architecture + history, llc (2020) report

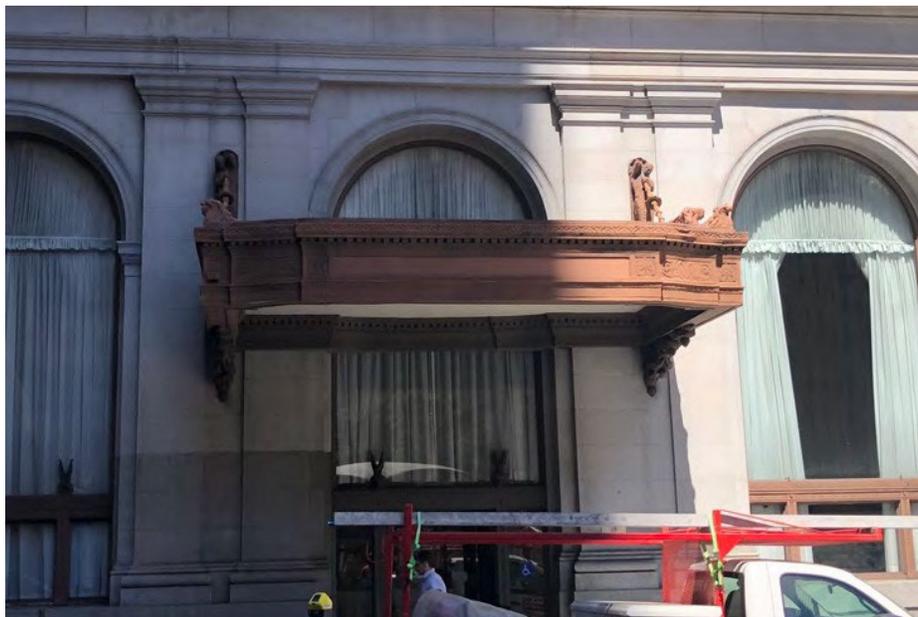
Canopy at Post Street entry, October 2019. Source: architecture + history, llc. (2020) report

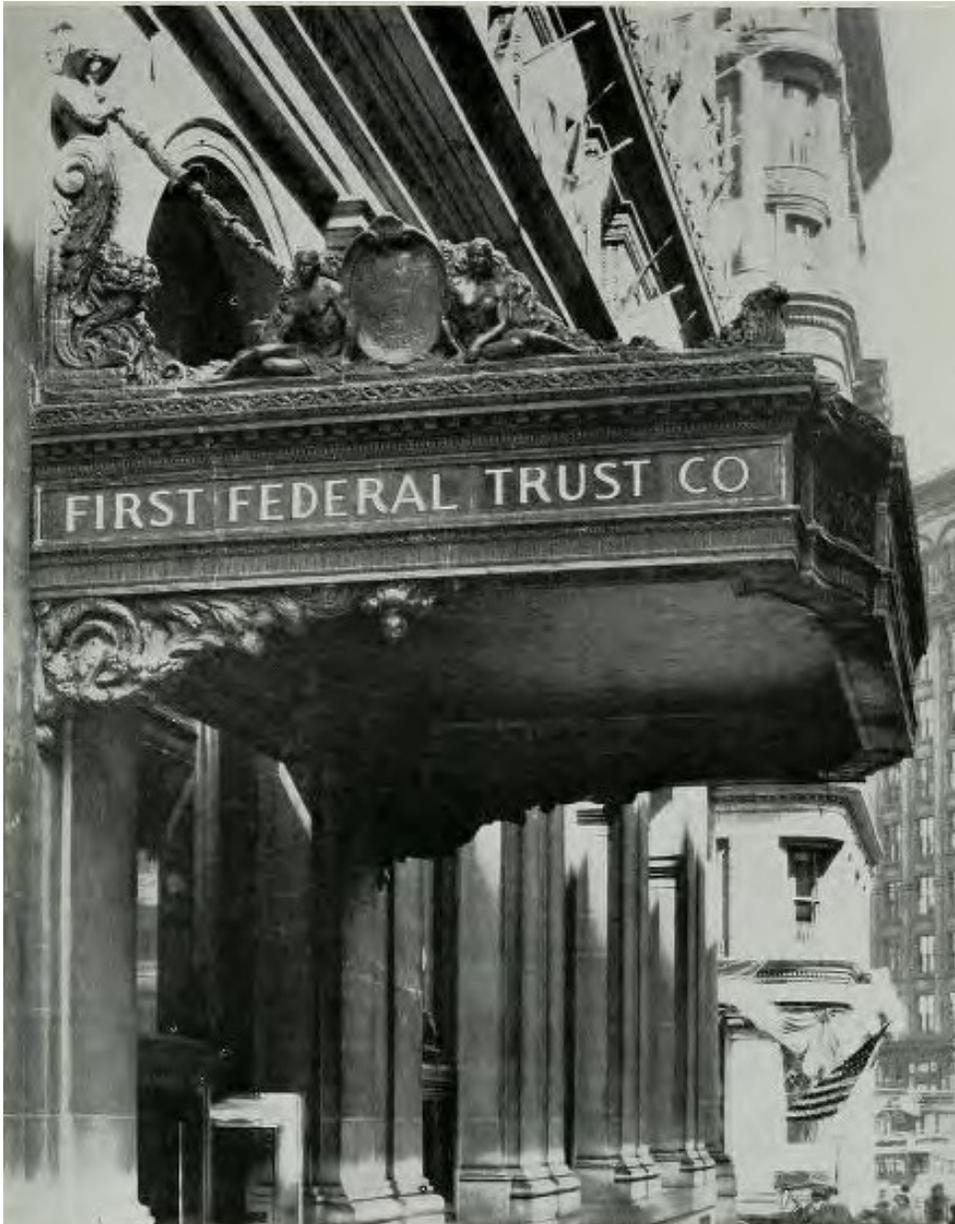
View of the canopy from the October 1925 *Architect & Engineer*.
Source: architecture + history, llc. (2020) report

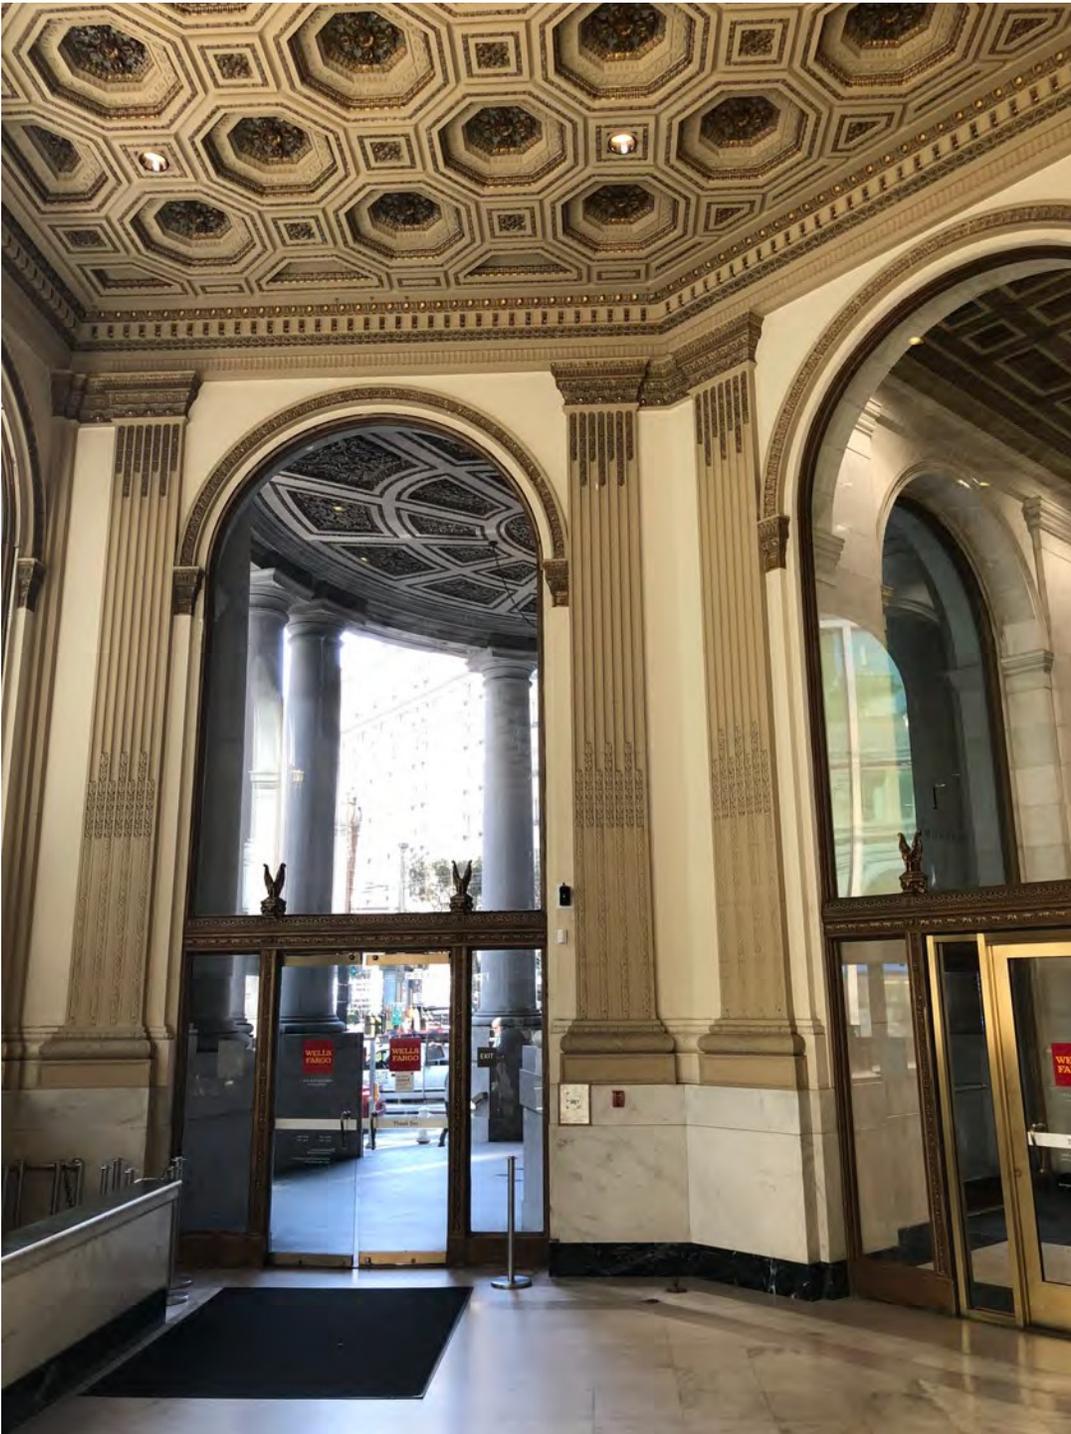
Interior of lobby in 1920 banking hall with exterior rotunda in background, view south, 2019.
Source: architecture + historic, llc. (2020) report

The 1908 banking hall is divided down the long axis by fluted, plaster square columns placed on marble pedestals. The plaster fluting is embellished with a floral pattern similar to that found on the exterior frieze panels. The capitals feature elaborate plaster foliated egg and dart motifs. The south wall along Post Street (the original location of the tellers' "wickets" or counters / windows) is articulated by large full-height window openings flanked by paired pilasters. Pilasters also divide the north wall into bays. A horizontal molding divides the north wall into two horizontal sections, marking the location of the original office mezzanine, which has been enclosed. At the eastern end of the banking hall, the north wall is angled where it meets the rear side of the elevator shaft.

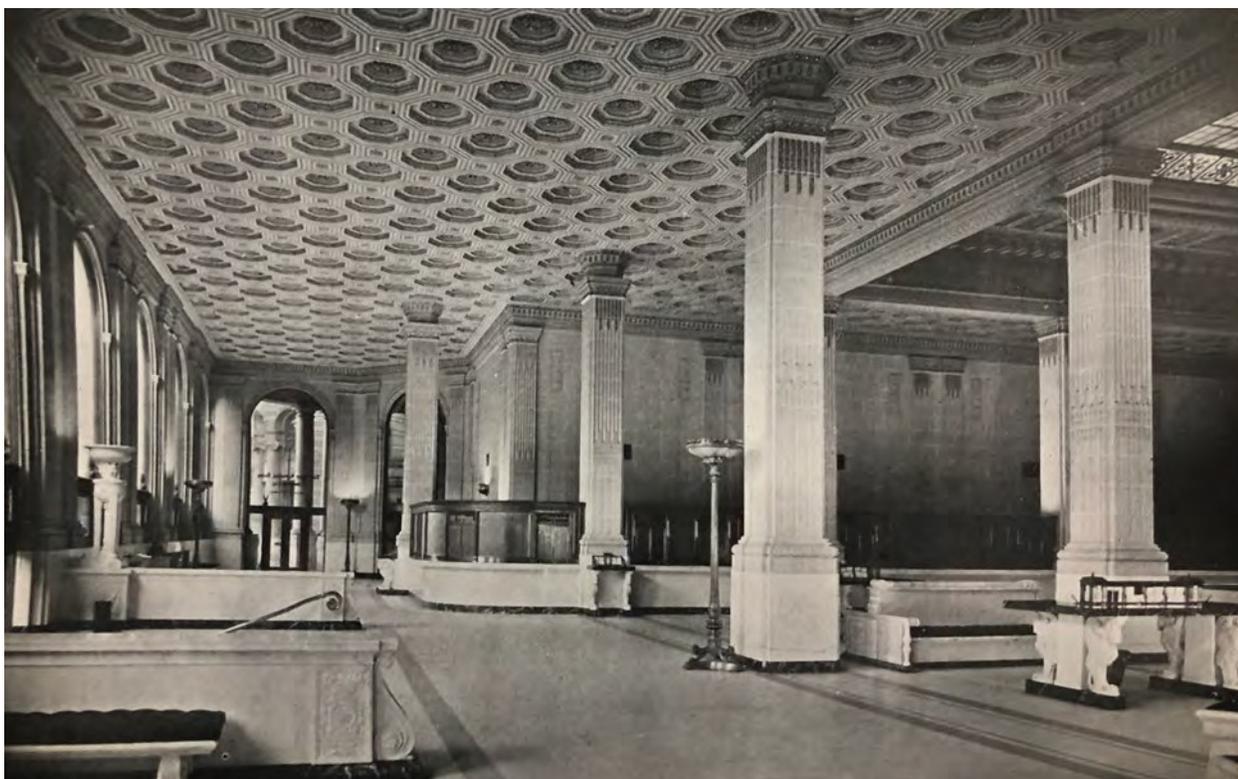
View of interior of 1920 banking hall with stair to Montgomery Street and “teller” windows/counters, looking south, from *The Architect and Engineer*, October 1922. Source: architecture + history, llc. (2020) report

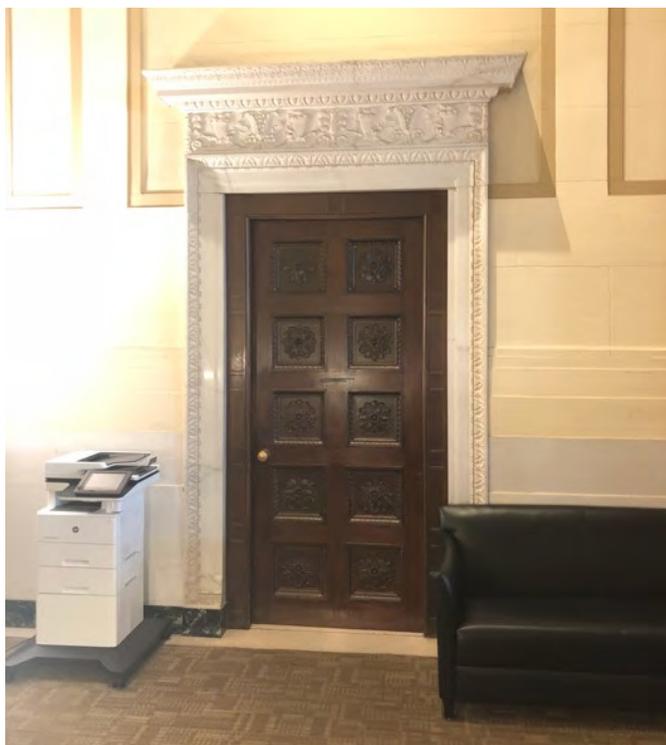
Above: Door and surround in 1920 banking hall, 2019.
Source: architecture + history, llc. (2020) report

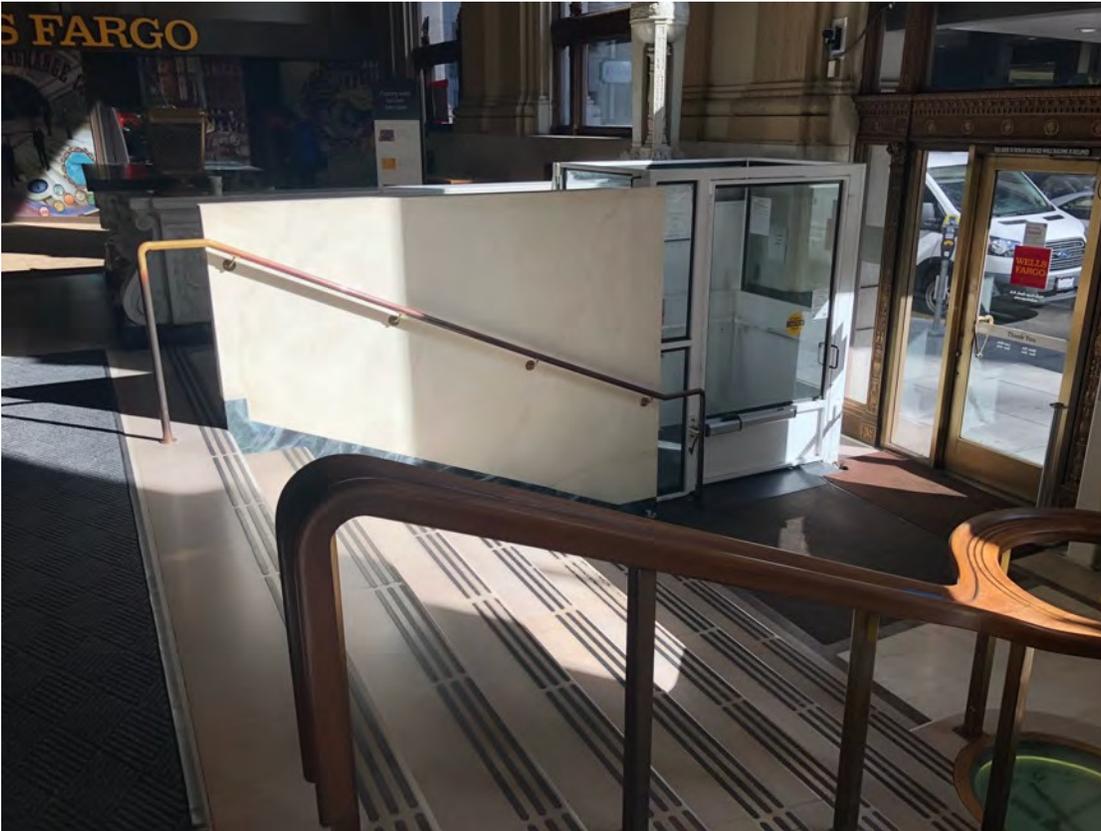
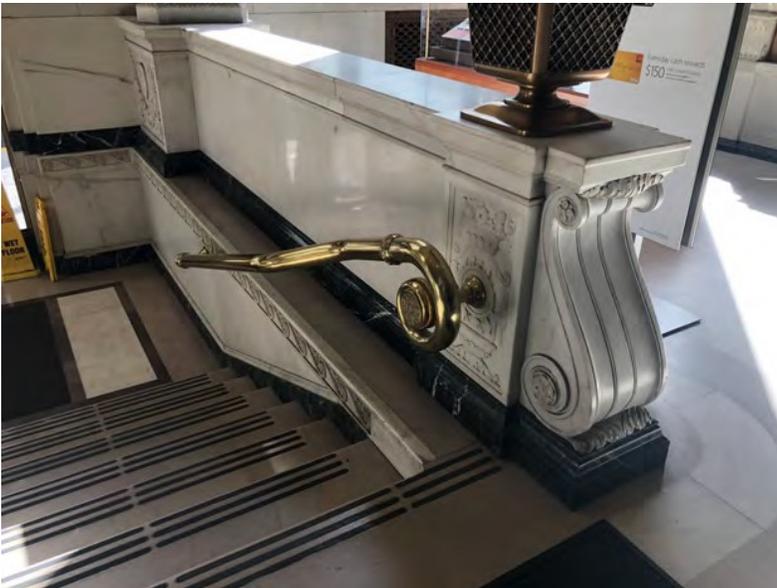
View of the Montgomery Street entry with the inserted lift and detail of railing, October 2019.
Source: architecture + history, llc. (2020) report

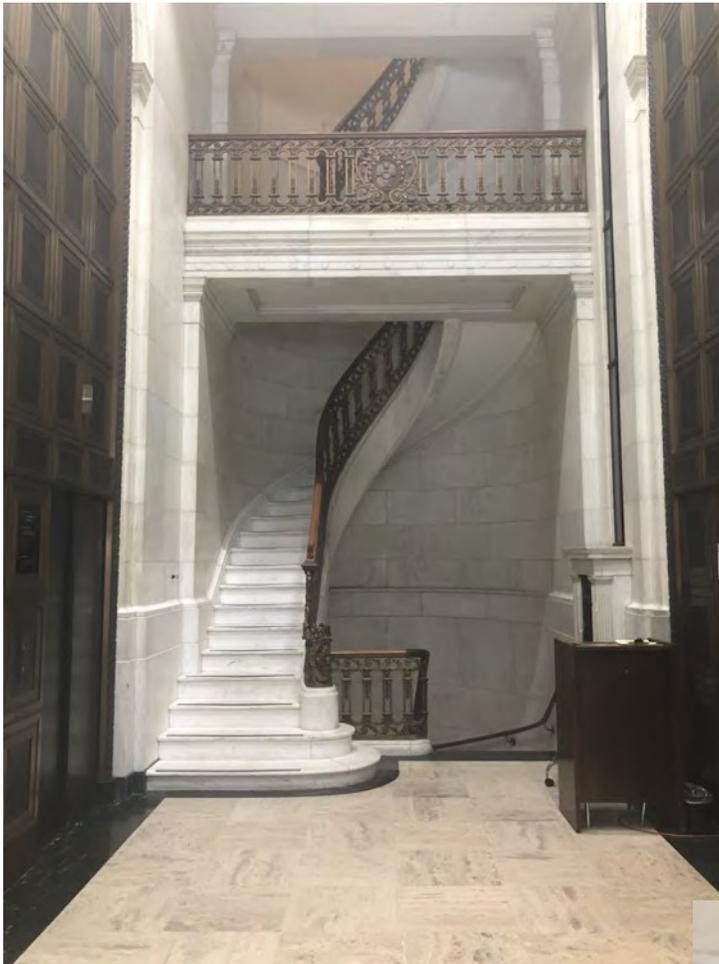
View of the curved stairway in the original 1908 lobby and detail view of the squirrel on the newel post, 2019. Source: architecture + history, llc. (2020) report

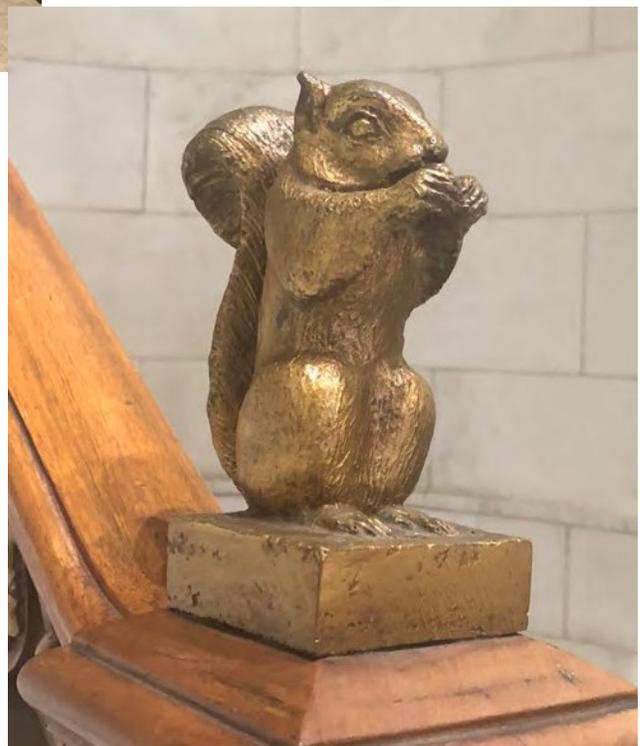
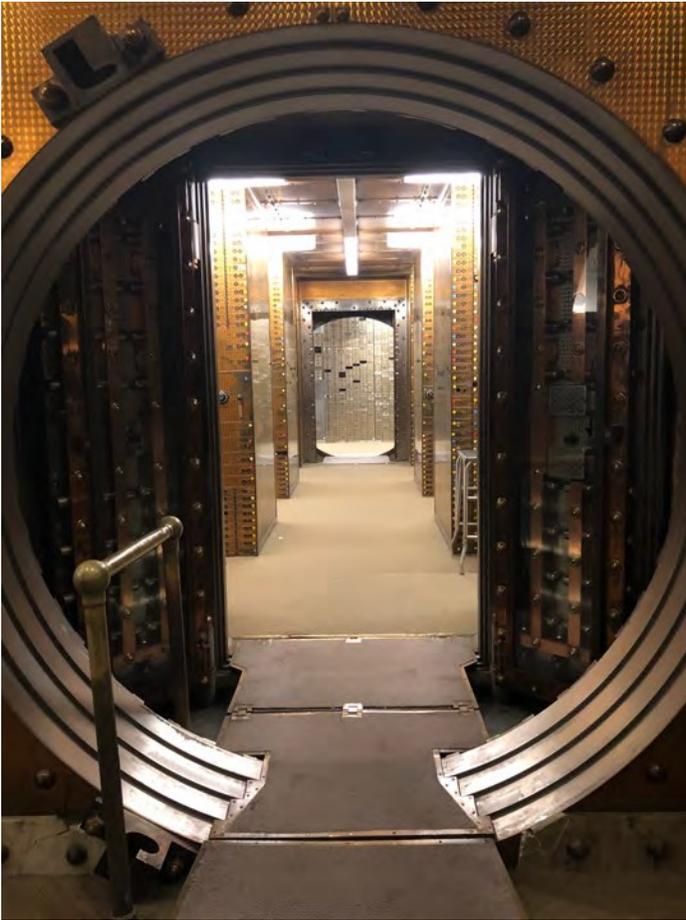
Detail view of the main vault and grille work on cage at vault in basement, 2019.
Source: architecture + history, llc. (2020) report
