# LANDMARK DESIGNATION REPORT

## Benedict-Gieling House

22 Beaver Street

July 16, 2018

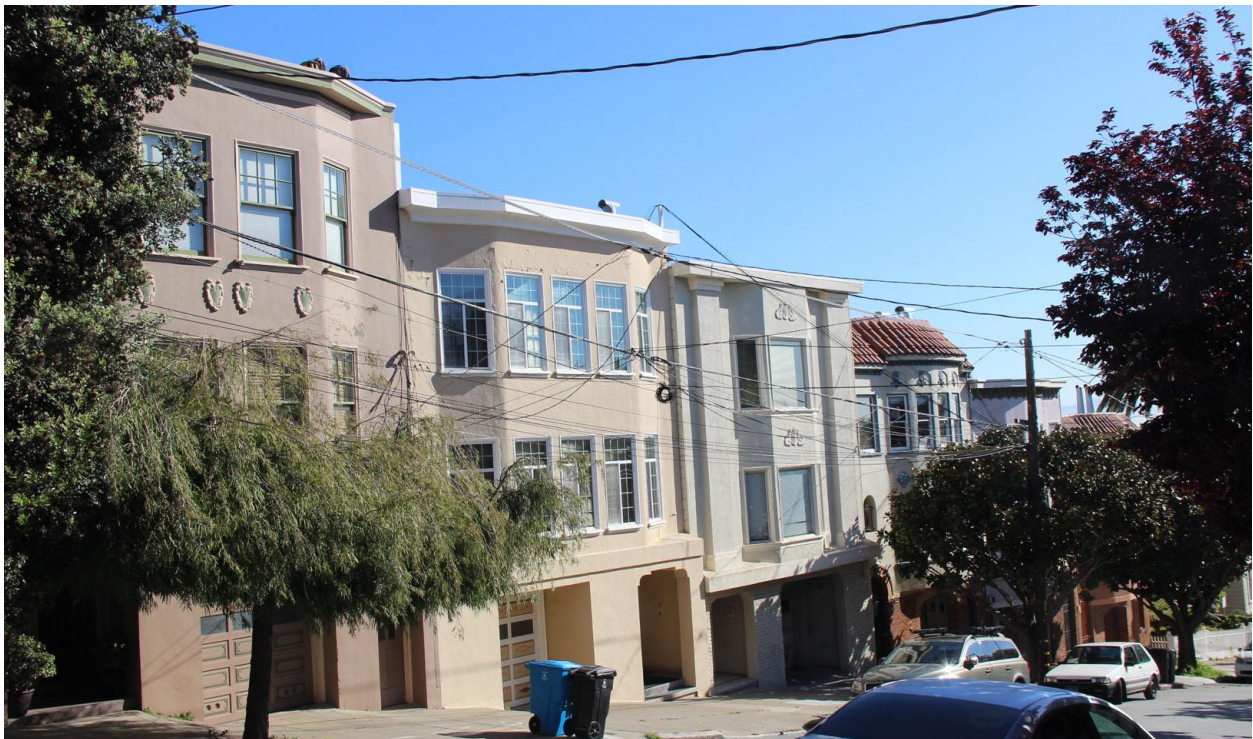
Figure 13. Row of Mediterranean-style flats at 46-48 to 68-70 Beaver Street; view toward northeast.

The north side of Beaver Street is more diverse than the south side, in part because it has several newer infill buildings constructed on the sites of former estates that were subdivided and redeveloped after the 1906 Earthquake. One of the oldest houses on the block is the Bragg-Martenstein House at 245 Castro Street, which occupies a lot at the northeast corner of Castro and Beaver Streets. Built ca. 1878, the property contains a two-story, flat-fronted Italianate dwelling (**Figure 11**). Continuing downhill from Castro Street is a pair of Stick-Eastlake-style houses at 76 and 80-82 Beaver Street, which were both built in the mid-1880s (**Figure 12**). Beyond them are two contiguous groups of six Mediterranean-style flats built in the 1910s and 1920s at 46-48 to 68-70 Beaver Street. These flats, which adjoin the Benedict-Gieling House to the west, disrupt the predominantly Victorian character of the block with their flat roofs, stucco façades, and zero lot line setbacks (**Figure 13**).

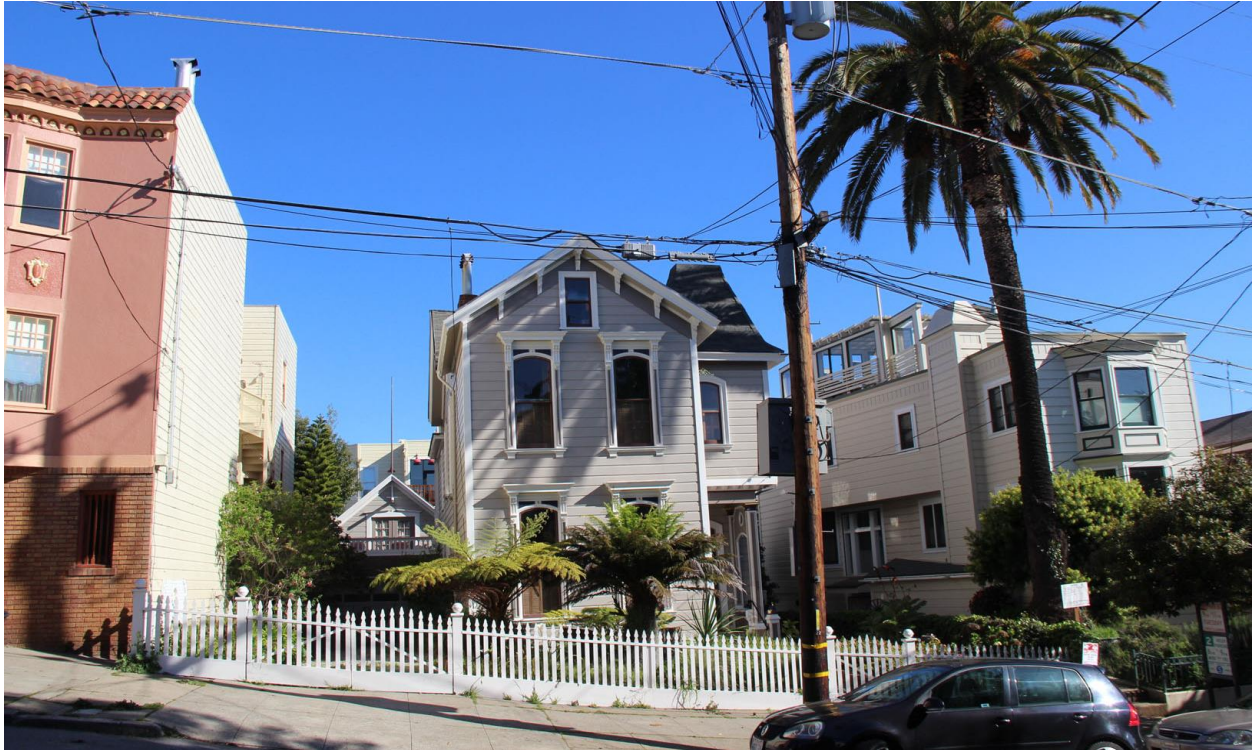
Figure 20. Overall view of 22 Beaver Street; view toward north.

A wood picket fence forms the southern boundary of the Benedict-Gieling property (**Figure 20**). The fence is divided into sections by wood bollards capped by globe-like finials. Toward the west side of the fence is a gate that provides access to the driveway. A pedestrian gate toward the east side of the property provides access to the main house. The main house, which is set back about 20 feet from the fence, occupies the center of the lot, leaving ample room at the front for a garden. This garden, which is defined by a low brick wall, until recently contained a large magnolia tree that all but concealed the primary façade from view. The garden now contains several tree ferns and maidenhair ferns. At the left side of the property, the driveway leads to the garage/carriage house (**Figure 21**). The driveway is paved with gravel and the brick-lined planting beds along each side contain a variety of plantings, including a flowering plum tree, a flowering quince, fuchsias, hydrangeas, and a rhododendron. The cement pedestrian path along the east side of the property is defined by low planting beds as well that contain several small fruit trees, flowering shrubs, herbs, flowers, and vines (**Figure 22**). At the rear of the property, where the main house and the garage/carriage house meet, is a quarry tile-covered patio. The patio serves as a landing spot for a wood exterior stair that provides a secondary means of egress from the attic and the second floor level (**Figure 23**). Along the north side of the patio is a small planting bed containing impatiens and jasmine vines (**Figure 24**).

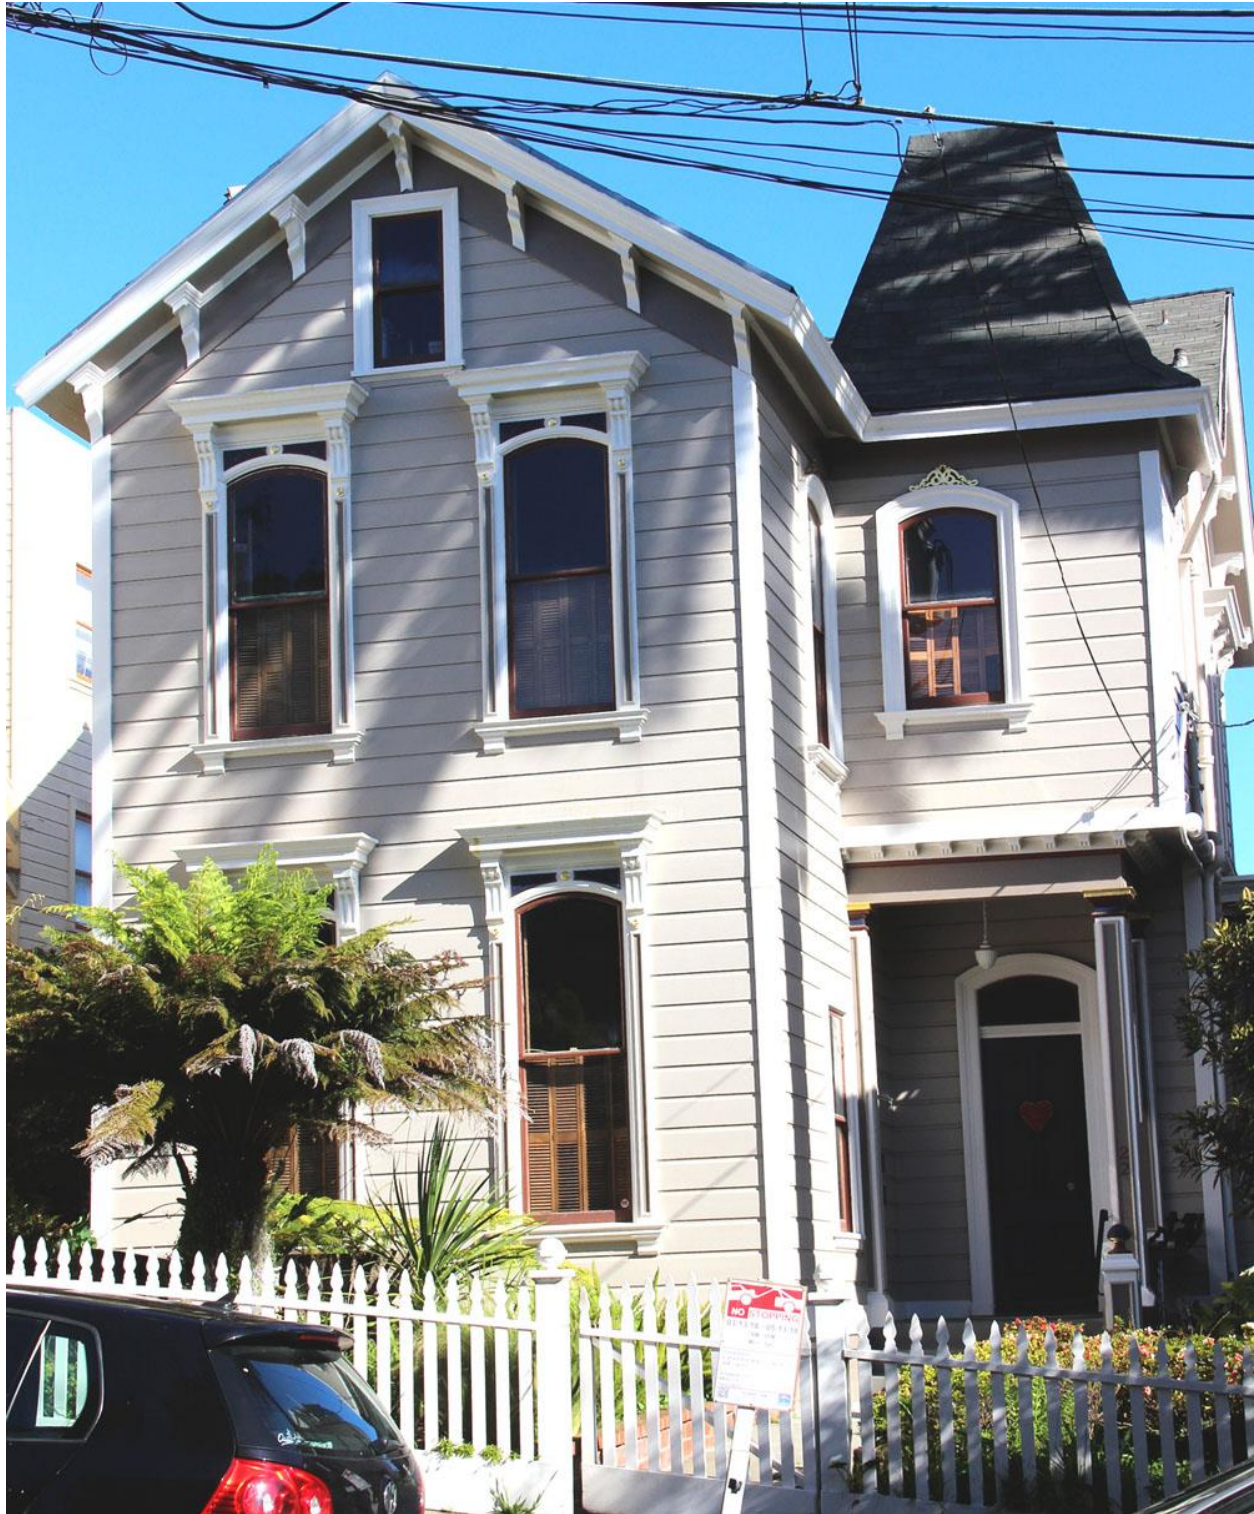
Figure 25. South (primary) façade of the Benedict-Gieling House; view toward north.

The south (primary) façade of the Benedict-Gieling House faces Beaver Street (**Figure 25**). It is three bays wide, with the right bay recessed 15 feet back from the rest of the façade. The main part of the south façade is massed as a rectangle capped by a triangular gable. The fenestration pattern is symmetrical, consisting of four double-hung windows, as well as a smaller attic window in the gable. The windows are embellished with Italianate ornament, including fluted casings, impost blocks, segmental arch headers, and bracketed hoods. The attic window, which may have been added later, has unornamented casings. The main part of the south façade is capped by a plain wood frieze and a raking cornice supported by angled, scroll-sawn brackets. The recessed bay contains the main entrance, which is located inside a portico capped by a denticulated entablature supported by fluted columns (**Figure 26**). The entrance itself contains a multi-panel wood door flanked by fluted casings. It is capped by a segmental-arch transom. Above the portico is the ca. 1906 tower. Built to contain a bathroom, the south wall of the tower contains a double-hung window capped by a segmental-arch header. This window, as well as many of the others on the east and west façades, is detailed slightly differently from those on the primary façade, with simple fluted moldings, impost blocks, and a gilded foliate cresting; it has no bracketed hood (**Figure 27**). The tower is capped by a steeply pitched hipped roof. Purely cosmetic, the roof was intended to update the appearance of the house, which was already 36 years old at the time.

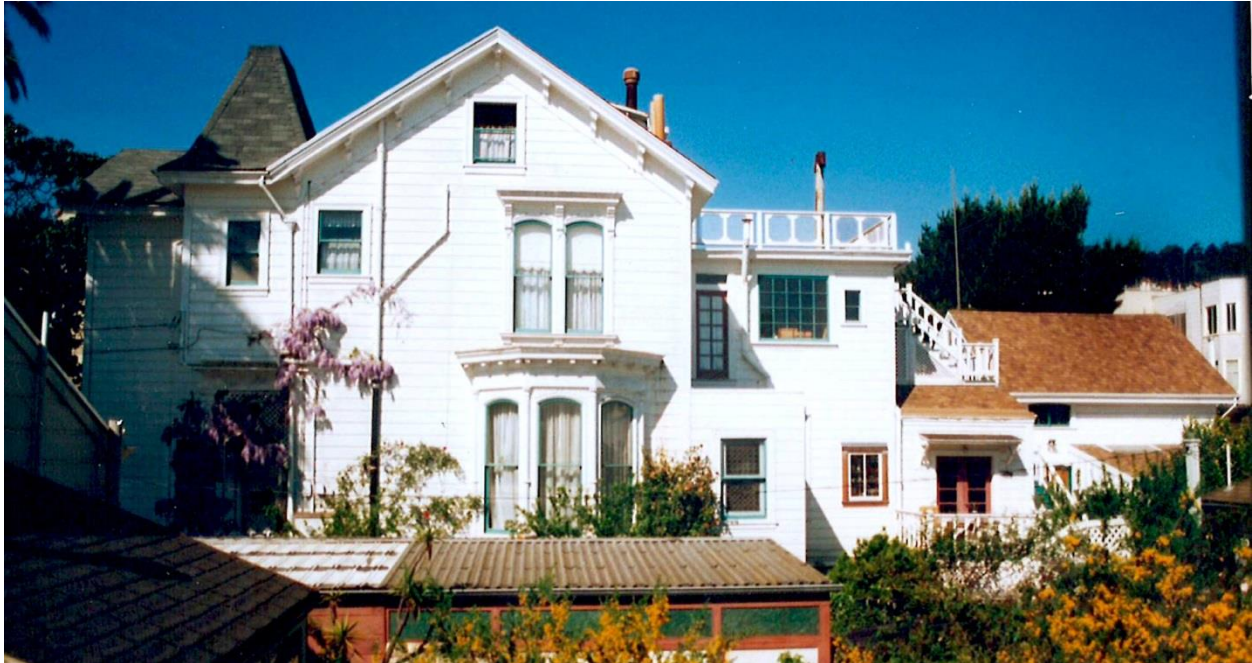
Figure 28. East façade, 1990; view toward west.  
Source: Imogene Gieling

The east façade of the Benedict-Gieling House is detailed almost the same as the primary façade. This was due to its visual prominence, as it originally faced the garden that once occupied the eastern third of the property (now 20 Beaver Street). The east façade is nearly impossible to photograph due to the tight space between the house and the neighboring property at 20 Beaver Street. To aid the reader's understanding, we have included a photograph taken in 1990 that shows the east façade prior to the construction of the house at 20 Beaver (**Figure 28**). As this photograph illustrates, the east façade is composed of three parts: the front section adjoining the main entrance, a central gable-roofed portion, and the rear service wing. The front portion contains a pair of windows: one at both the first and second floor levels (**Figure 29**). The window at the first floor level is simpler than its counterparts, whereas the window at the second floor level matches the windows on the nearby tower.

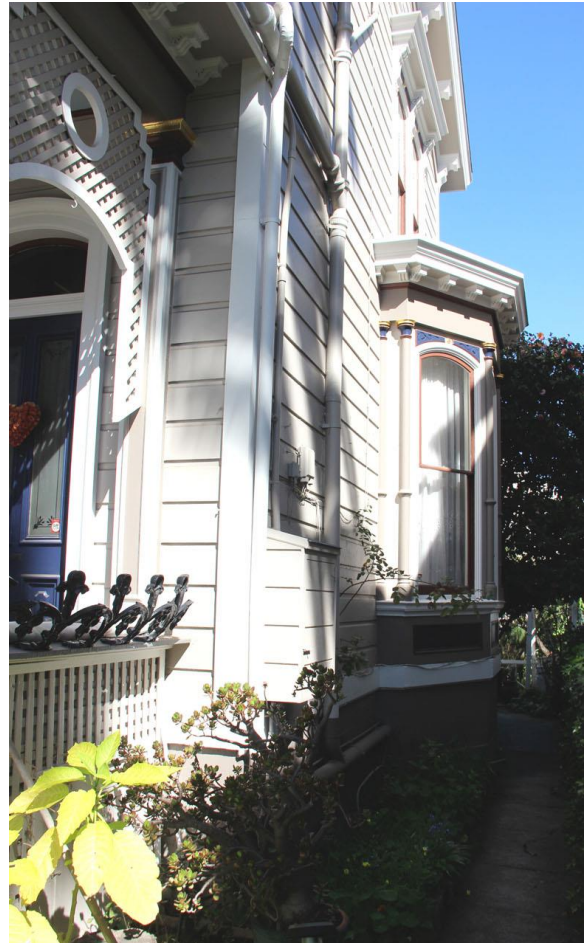
Figure 30. Bay window; view toward north.

The central part of the east façade is encompassed within the gable-roofed part of the house. This section features a three-sided bay window at the first floor level (**Figure 30**). The bay window contains three double-hung windows and it is embellished with pipe colonnettes and a bracketed entablature. Above the bay window, at the second floor level, is a pair of windows detailed the same as those on the front façade, including a bracketed hood. To the left of this group is one double-hung window next to the tower. It does not have any ornamentation. At the apex of the gable is a double-hung window that provides light and air to the attic. The gable is defined by a plain frieze and a broad raking cornice supported by angled brackets similar to the primary façade.

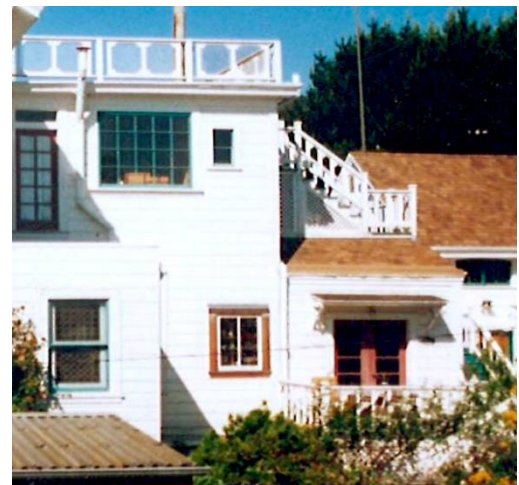
Figure 31. Detail of east façade of service wing; view toward west.

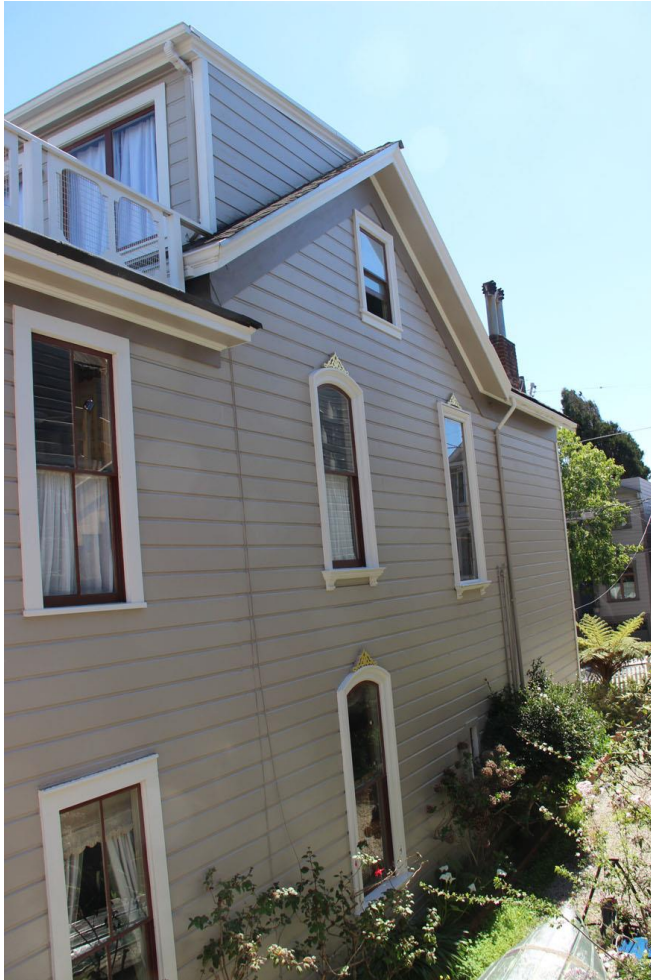
Figure 32. West façade; view toward south.

balustrade added ca. 1976. The central section of the west façade is located within the gable-roofed section. Unlike its counterparts on the south and the east façades, the cornice on the gable of the west façade has no brackets. This part of the west façade is articulated by four windows. At the first floor, there is a double-hung wood window with a segmental-arched header, impost blocks, and gilded cresting that matches several of the windows on the east façade. To the right, is a louvered vent. The second floor level has a matching window in the left bay and a large art glass window in the right bay. The latter illuminates the stair inside the house. The front part of the west façade is not fenestrated because the brick chimney is located inside the house.

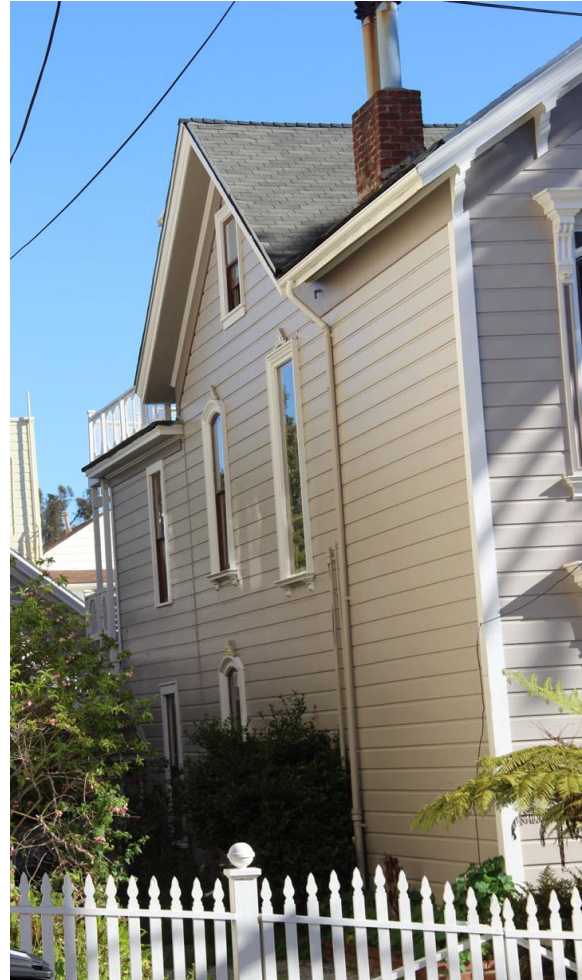
Figure 33. West façade; view toward north.

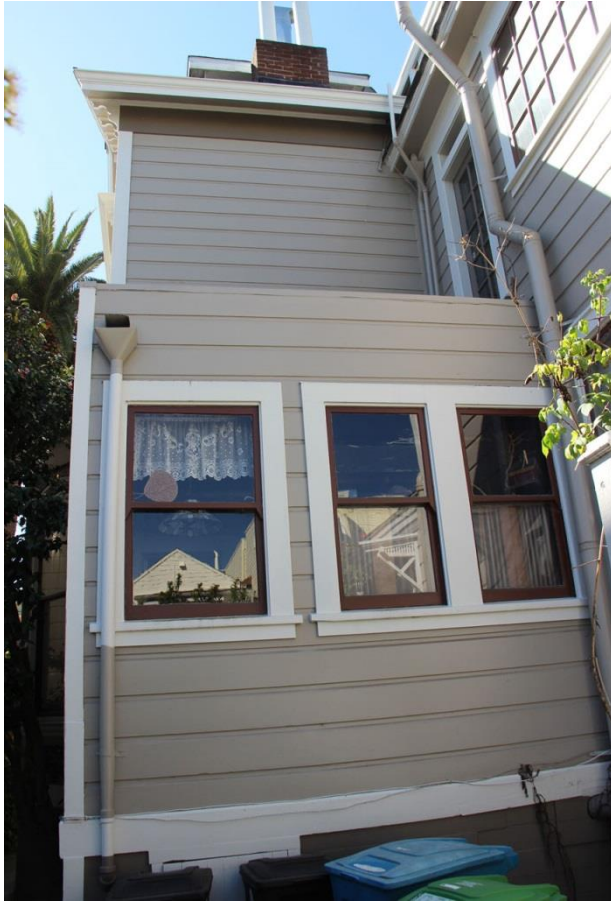
Figure 34. Ca. 1906 bathroom addition; view toward south.

The north façade of the Benedict-Gieling House faces the rear yard. It is part of the rear service wing, and it has no ornament. It is massed as a series of one and two-story volumes, including the ca. 1906, one-story bathroom addition on the east side (**Figure 34**); the 1933, one-story kitchen addition at the center (**Figure 35**); the original 1870, two-story service wing; and the ca. 1976 attic dormer (**Figure 36**). Due to the cramped conditions at the rear of the property, the north façade can only be photographed in sections.

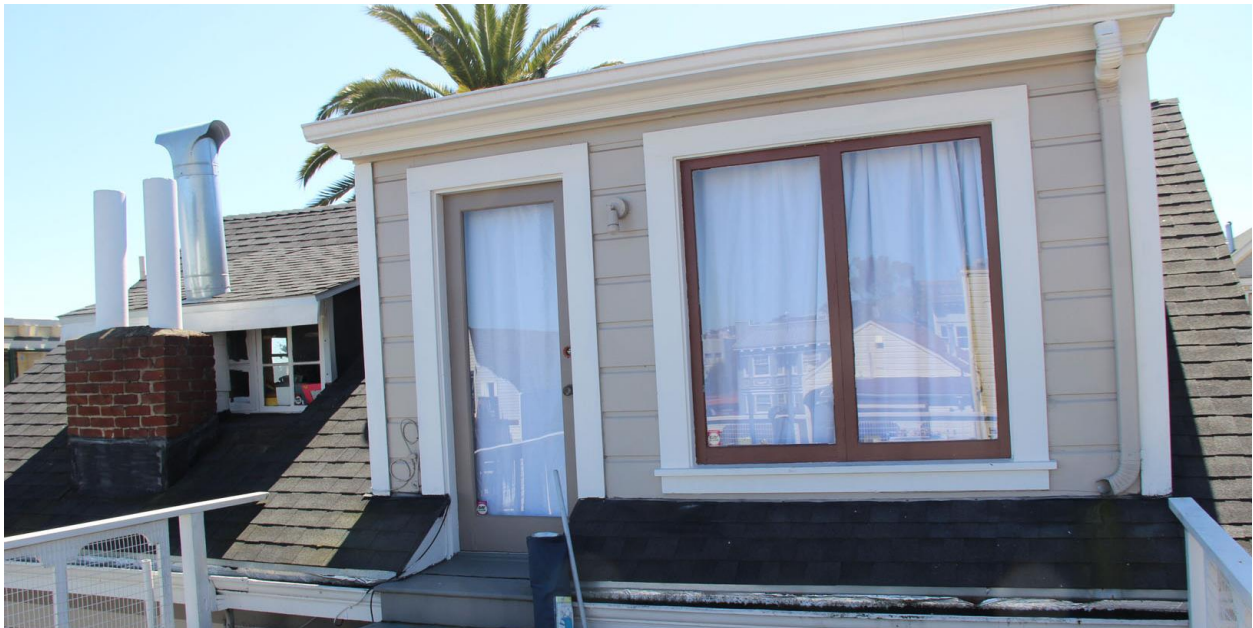
Figure 36. 1976 attic dormer on north side; view toward south.

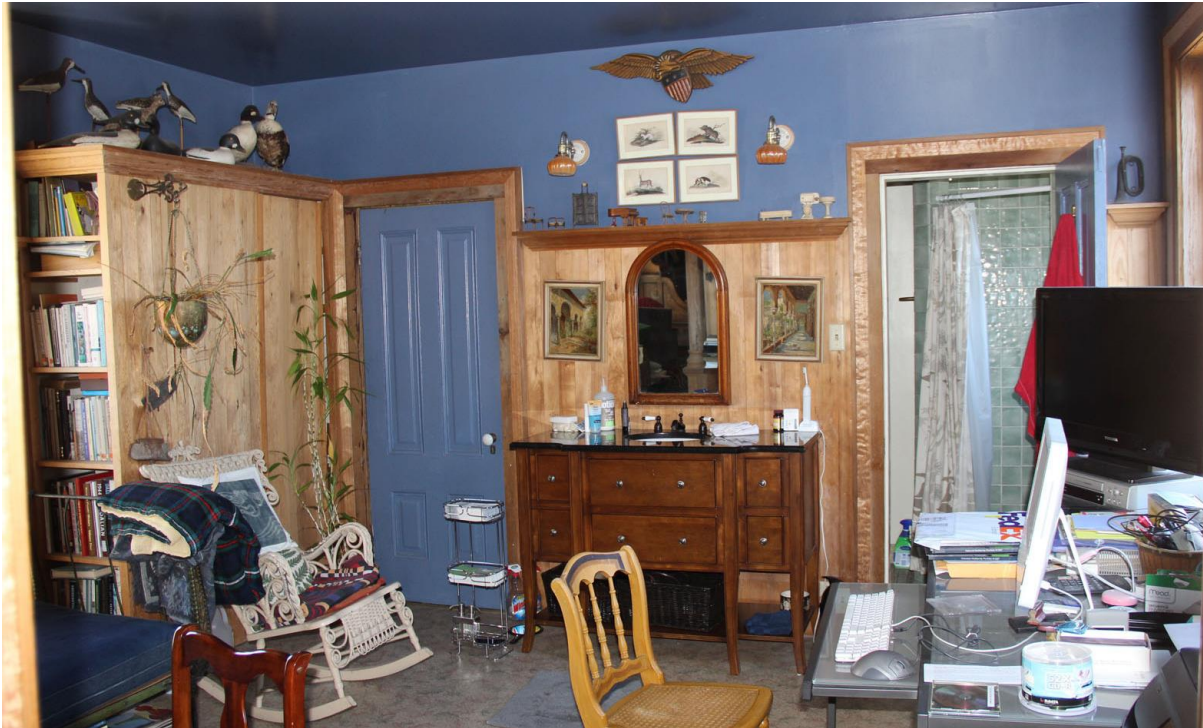
**Figure 47. Study at rear of second floor level; view toward northwest.**

The study at the rear of the second floor level is directly above the dining room. It is finished in contemporary materials, suggesting that it may have originally been a storage room that was later converted into a bedroom. It has resilient tile flooring, gypsum board walls and ceiling, and unpainted (possibly salvaged) wood wainscoting and trim (**Figure 47**). Along the rear (north) wall of the study is a pair of Victorian-era doors providing access to a closet on the west and a bathroom on the east. The bathroom is finished in 1970s (and later)-era materials.

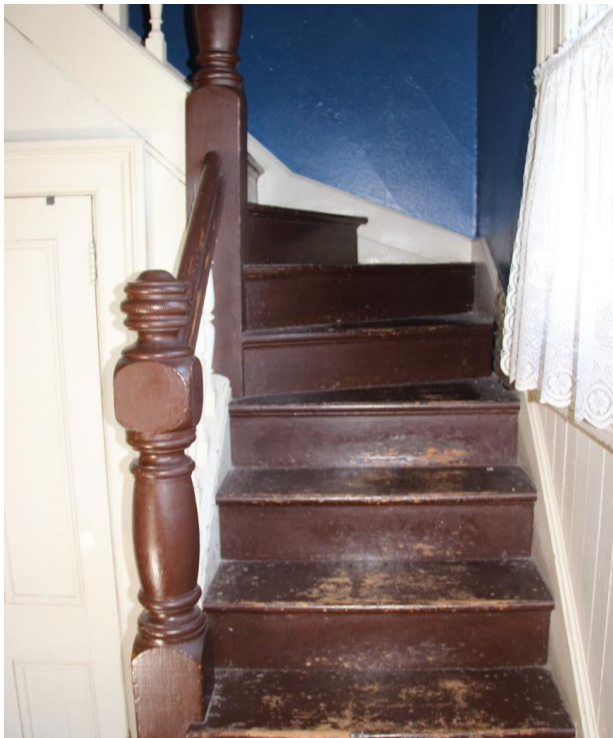
Figure 50. Attic stair; view toward north.

A narrow quarter-turn stair leads up to the attic level, which contains a small suite of rooms historically used as the servants' quarters. Like the main stair, the attic stair has unpainted wood balusters (**Figure 50**). The attic level is confined within the cross-gabled section of the roof where there is enough headroom for occupancy. It was enlarged in 1976 when a shed-roofed dormer was added to the roof (**Figure 51**). The attic is finished in lath and plaster walls and ceilings. It has some decorative trim, including high wood baseboards and door and window casings that match the bedrooms below, suggesting that the attic has always been finished. The attic has its own bathroom and a bar with a sink.

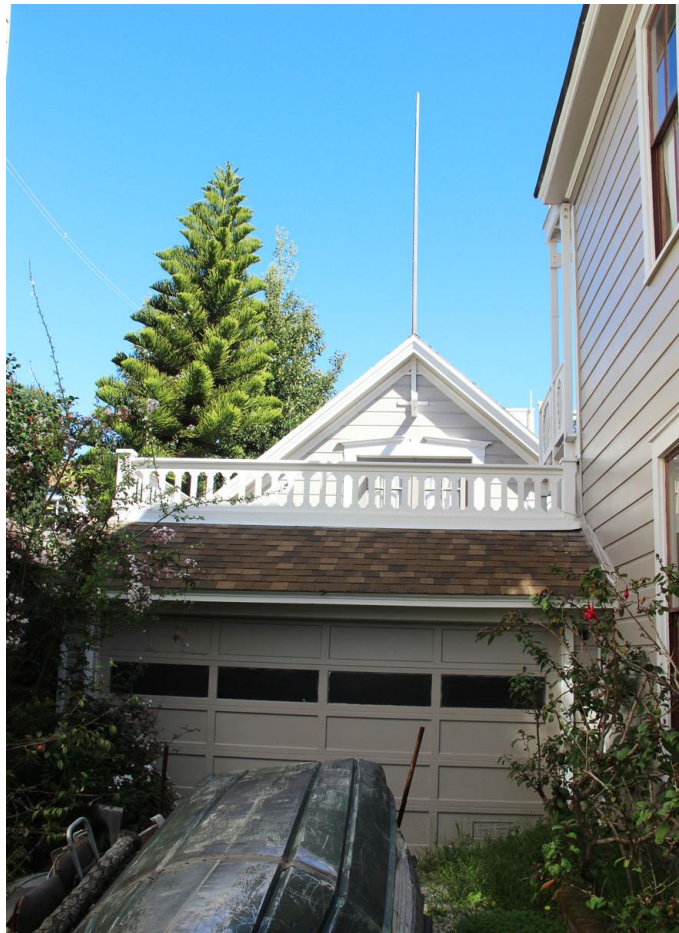
**Figure 52. Garage/carriage house; view toward north from driveway.**

The carriage house was built approximately the same time as the Benedict-Gieling House, in ca. 1870. As originally designed, the first floor would have held carriages and other horse-drawn conveyances, and possibly a horse. Meanwhile, the second floor would have been the hay loft where feed was stored. At some point in the 1890s, the hay loft was converted into a dwelling unit.<sup>1</sup> In 1915, the owner of the property constructed a one-story, 250-square-foot garage in front of the carriage house. The garage cut off access to the carriage house from Beaver Street, suggesting that it was no longer being used for its original purposes. The building remained in use as a dwelling until the 1950s, when it appears to have been abandoned. In 1976, the current owner hired architect Albert Lanier to remodel it as a secondary residential unit. Lanier left the exterior largely the same, but the interior of the heavily deteriorated building was entirely rebuilt.

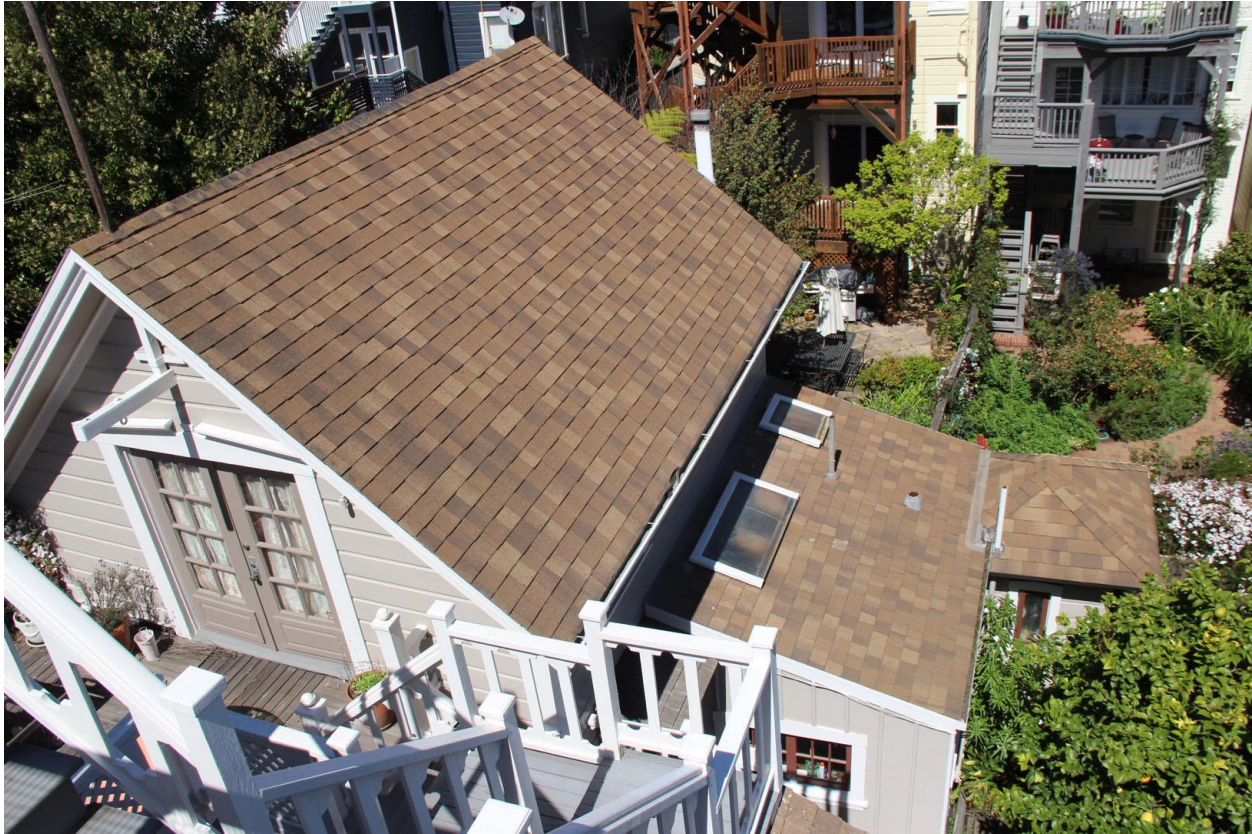
Figure 53. Garage/carriage house; view from attic of main house; view toward northwest.

The garage/carriage house is a wood-frame building consisting of a one-story, flat-roofed garage at the front and a one-and-a-half-story, gable-roofed dwelling at the rear (**Figures 52-53**). It is clad in rustic channel and board and batten siding. The building has a contemporary concrete perimeter and slab foundation. The exterior is articulated by a variety of window and door types. The interior contains a single-car garage in the front and a dwelling unit behind consisting of a kitchen, living room, bathroom, and a bedroom. The bedroom is located in the former hay loft on the second floor level, and a pair of French doors provides access to a roof deck on top of the garage. The front of the carriage house is capped by a lightning rod and a beam originally used to hoist hay (**Figure 54**). The east side of the carriage house has a pair of additions that date to the late nineteenth century, including a shed-roofed lean-to containing a kitchen and a pyramidal-roofed structure, originally an outhouse, that now contains a bathroom (**Figure 55**).

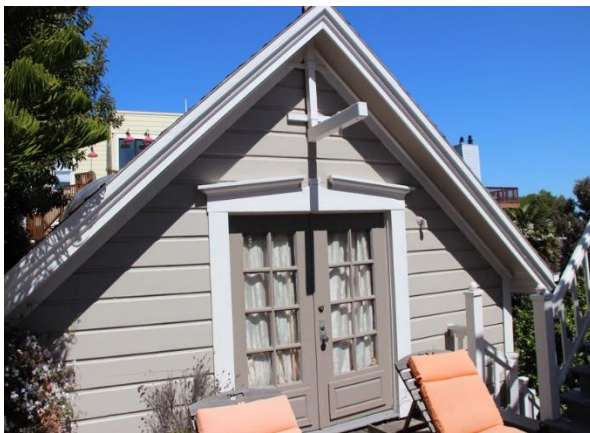
Figure 54. Primary façade of carriage house; view toward northeast.

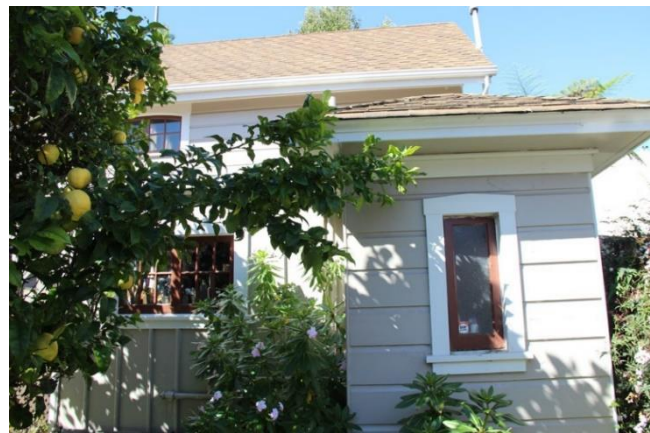
Figure 55. Additions on east side of carriage house; view toward west.

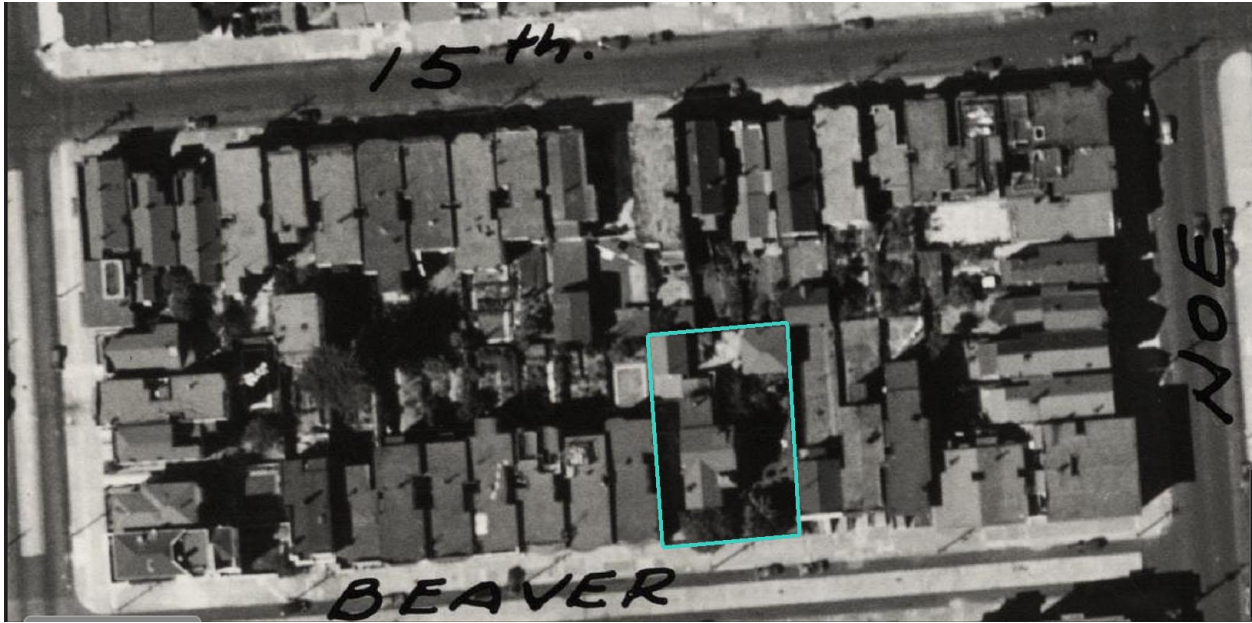
Figure 60. 1938 aerial photograph of the subject block showing 22 Beaver Street in blue.

Lucile Russell made no apparent changes to 22 Beaver Street in the eight years that she owned the property. According to aerial photographs taken of San Francisco by aerial photographer Harrison Ryker in 1938, the subject property looked a lot like it does now. The 1938 aerial photographs show the ca. 1870 house centered on the lot **(Figure 60)**. At the back of the house one can see the 1933 kitchen wing addition. The addition adjoins the 1915 garage addition on the front of the carriage house. Meanwhile, the ca. 1906 cottage is visible at the northeast corner of the lot. The rest of the property was dedicated to driveways and gardens, including a generous lawn to the south and east of the main house. Visible in the garden are a large magnolia tree in front of the main house and a Canary Island palm at the southeast corner of the property. The 1938 aerial photographs indicate that 22 Beaver Street was the last of the large suburban villas on the subject block. Since 1913, developers had built two rows of identical Mediterranean-style flats on the sites of the other estates at 32 Beaver Street and 2273 15<sup>th</sup> Street.

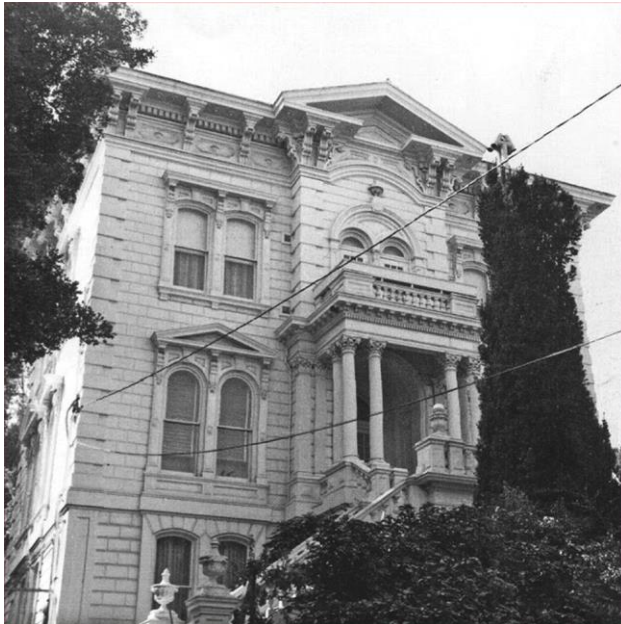
**Figure 54. Casebolt House, 2727 Pierce Street, 1964.**  
Source: San Francisco Historical Photograph Collection,  
San Francisco Public Library, Image No. AAC-5960

The Italianate villa is similar to the Italianate rowhouse described above, except that it is a freestanding dwelling with no adjoining structures to obscure its side façades. Indeed, San Francisco’s narrow urban lots have resulted in a residential pattern focused on rowhouse development with no side yard setbacks. Because the side elevations of rowhouses are not visible from the street, they are usually given a utilitarian treatment. The Italianate villa is different. Because they were often built by wealthy individuals on large landscaped lots, most were provided with ornament on three sides, including the front (primary) façade and the two side elevations. Typically built with a bigger budget than the average Italianate rowhouse, the Italianate villa is typically much larger and often incorporates features not seen on rowhouses, such as a tower, portico, porte-cochère, more than one bay window, and a higher level of trim, including quoins, imitation ashlar, oversized brackets, turned balusters, and pediments. Only about a dozen good examples remain in San Francisco. Those that retain their original lots often have gardens and/or freestanding outbuildings, such as a carriage house, stable, or secondary residence. Two good examples include the Casebolt House at 2727 Pierce Street (**Figure 54**) and the Coleman-Wormser House at 1834 California Street (**Figure 55**), which are both in the Western Addition. Others can be found in the Mission District, Potrero Hill, Noe Valley, and Pacific Heights.
