SAN FRANCISCO PLANNING DEPARTMENT

PRE-APPROVAL INSPECTION REPORT

Report Date: May 24, 2019
Inspection Date: May 22, 2019; 11:00am
Filing Date: May 1, 2018
Case No.: 2019-006384MLS
Project Address: 1401 Howard Street
Block/Lot: 3517/035
Eligibility Article 10 Landmark No. 120: Saint Joseph's Church
National Register listed property
Zoning: RCD – Regional Commercial District
Height & Bulk: 40-X
Supervisor District: District 6 (Matt Haney)
Project Sponsor: Christopher Foley of 1401 Howard LLC
Address: 1401 Howard Street
San Francisco, CA 94103
415-305-4600
cfoley@groundmatrix.com
Staff Contact: Michelle Taylor – (415) 575-9197
michelle.taylor@sfgov.org
Reviewed By: Tim Frye – (415) 575-6822
tim.frye@sfgov.org

**MILLS ACT APPLICATION
1401 HOWARD STREET
SAN FRANCISCO, CALIFORNIA**

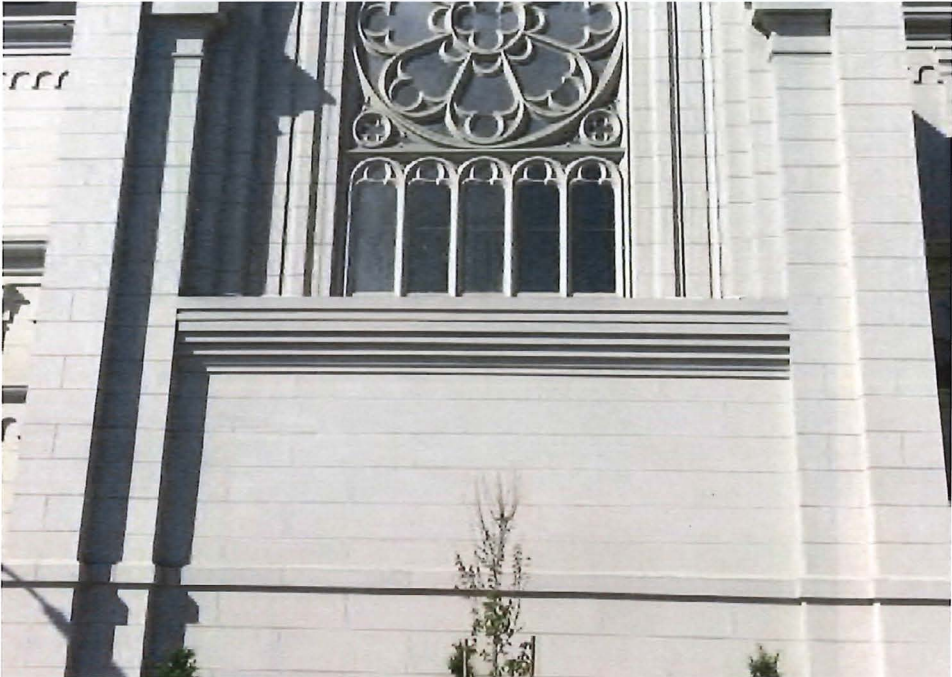
Figure 52. West façade, showing stucco condition after restoration (Page & Turnbull, 05/25/2018).
