STATUTORY EXEMPTION APPEAL

Embarcadero Fountain (a.k.a. “Vaillancourt Fountain”) Removal

RE: **Board File No. 251202**
Planning Record No. 2025-010275APL
Appeal of Statutory Exemption for Embarcadero Fountain Removal

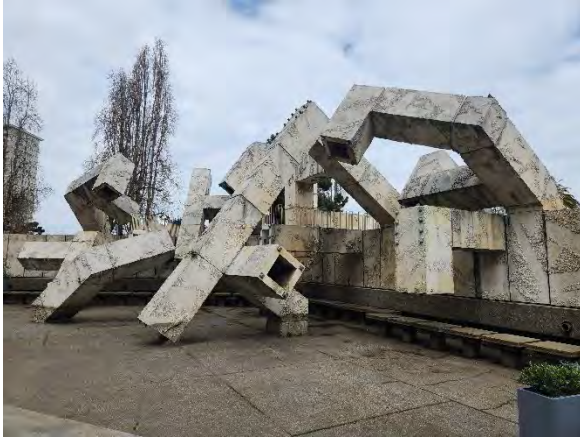
Overall view of fountain, particularly the hollow, pre-cast concrete "arms," looking north.

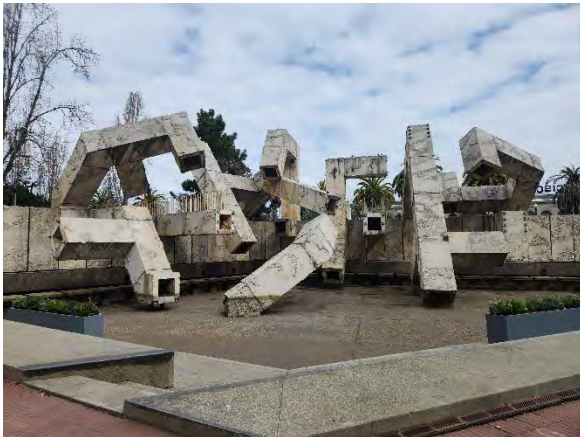
Overall view of fountain, particularly the hollow, pre-cast concrete "arms," looking northeast.

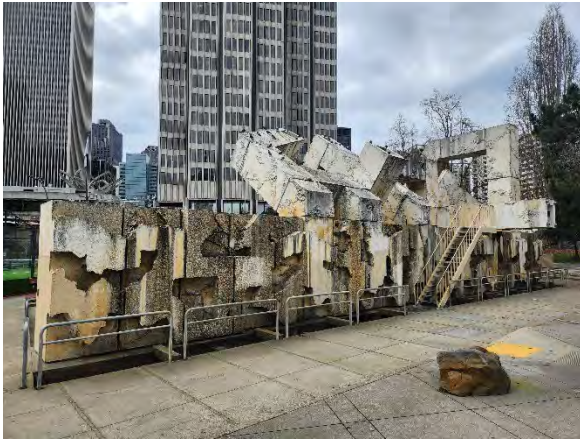
Overall view of the hollow, pre-cast concrete panel wall, east side of fountain looking northwest.

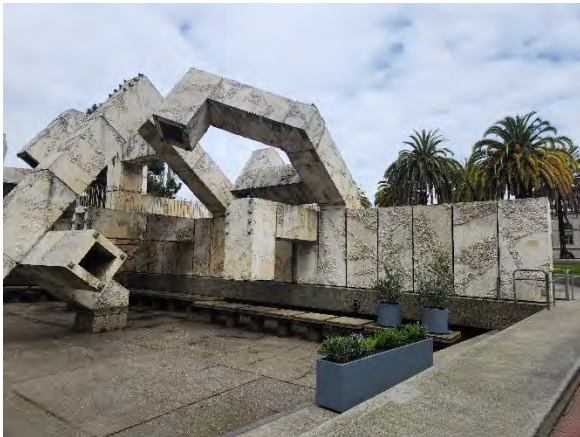
Overall view of the hollow, pre-cast concrete panel wall, east side of fountain looking northeast.

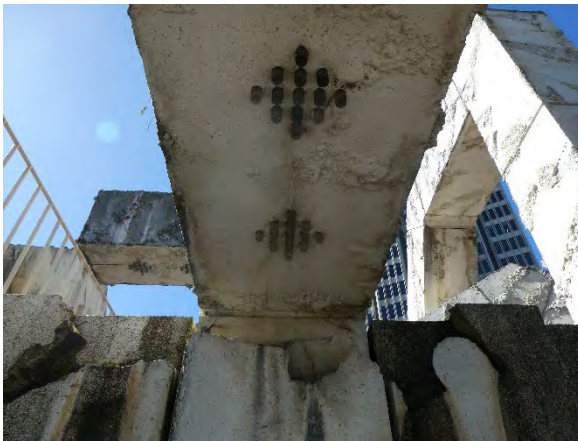
Typical glass cylinders on the underside of the hollow, pre-cast concrete arms.

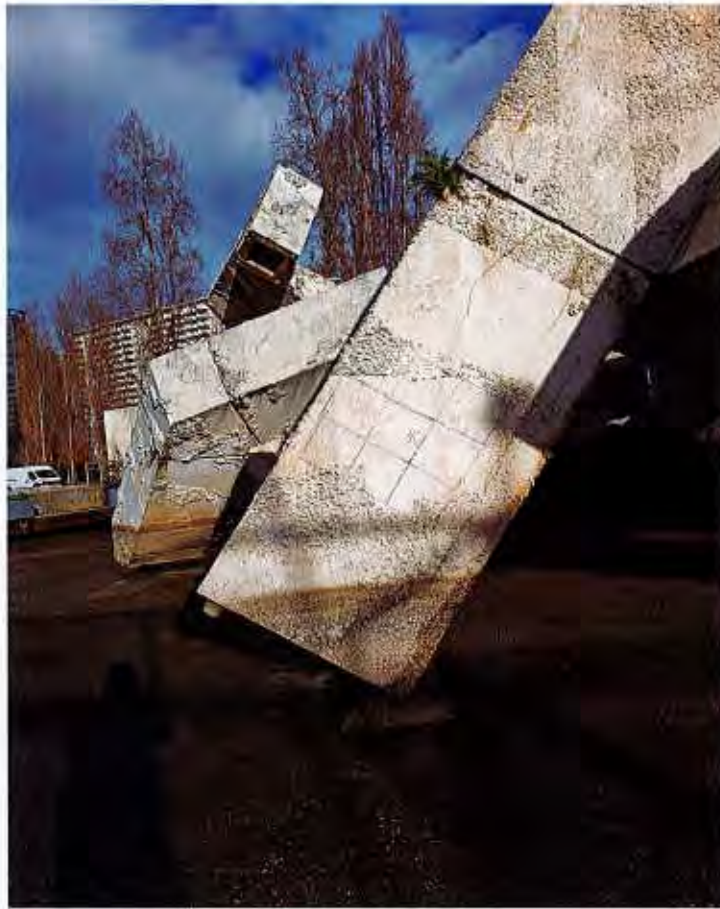
Photo 1. Side view of one of the tubes with GPR scan markings on the face of the tube.

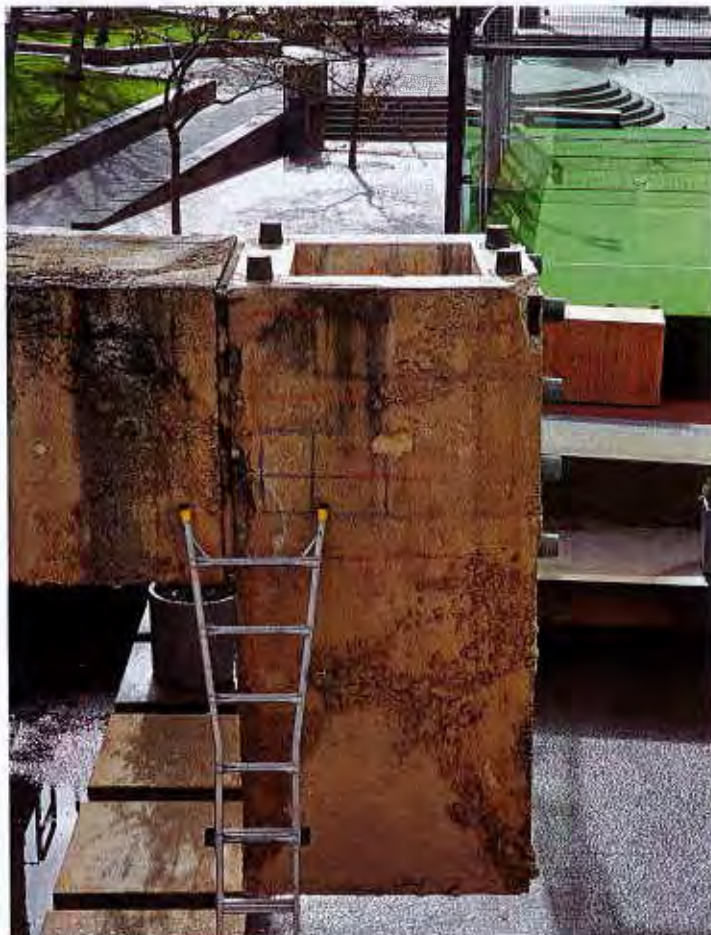
Photo 2. Red GPR scan markings indicate a rod of an unknown material connecting the tubes.

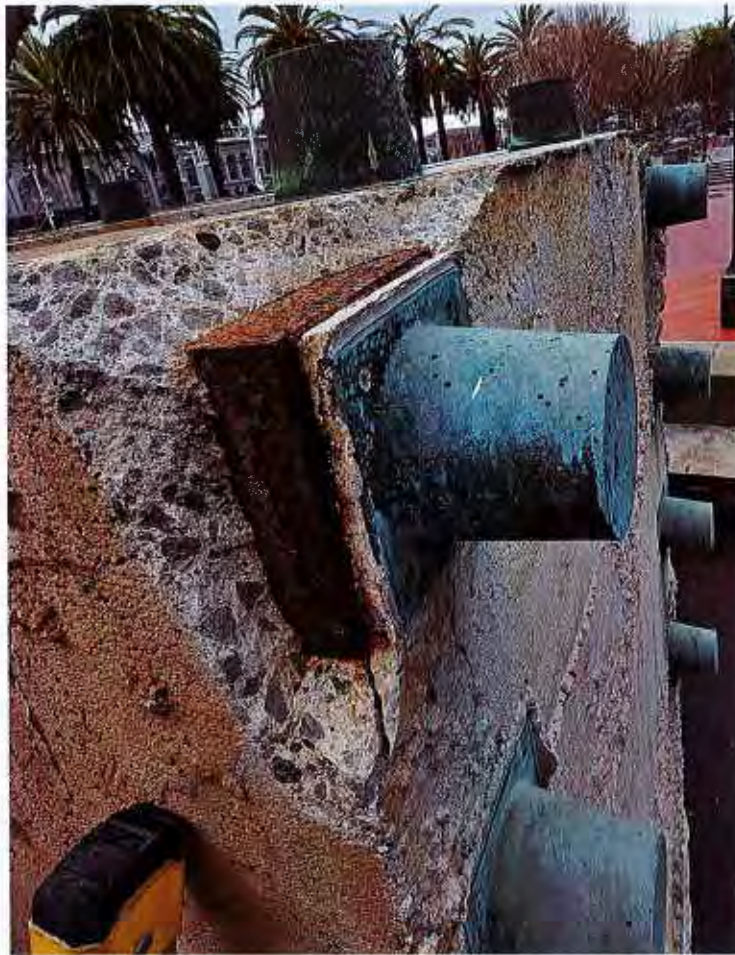
Photo 3. Steel plate at end cap.

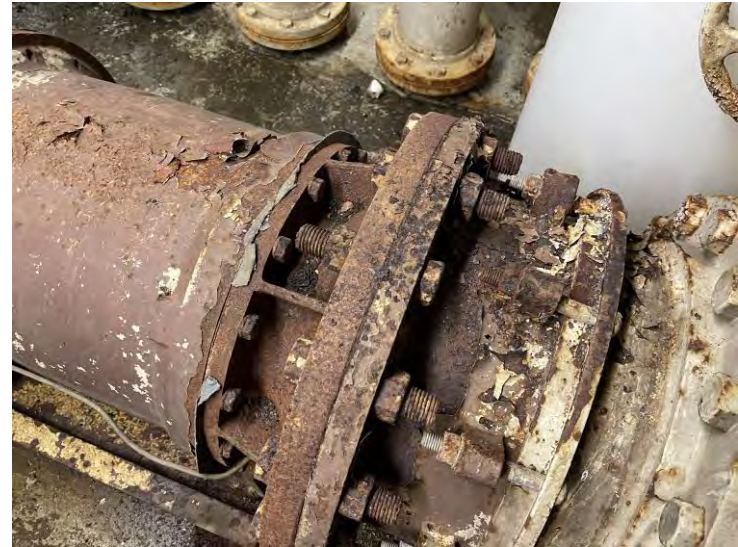
Photo # 2

Description: ACM¹ Pipe Gasket and Multiple LBP² Surfaces at Main Pump Room

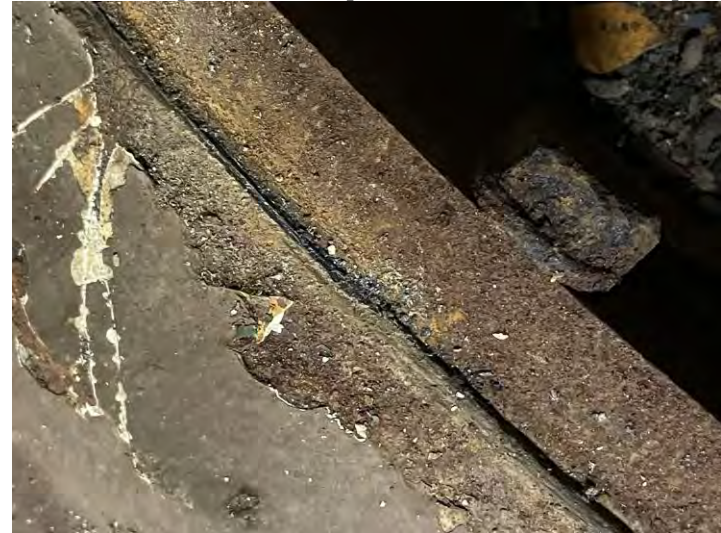
Photo # 4

Description: Close Up of ACM¹ Pipe Gaskets at Main Pump Room

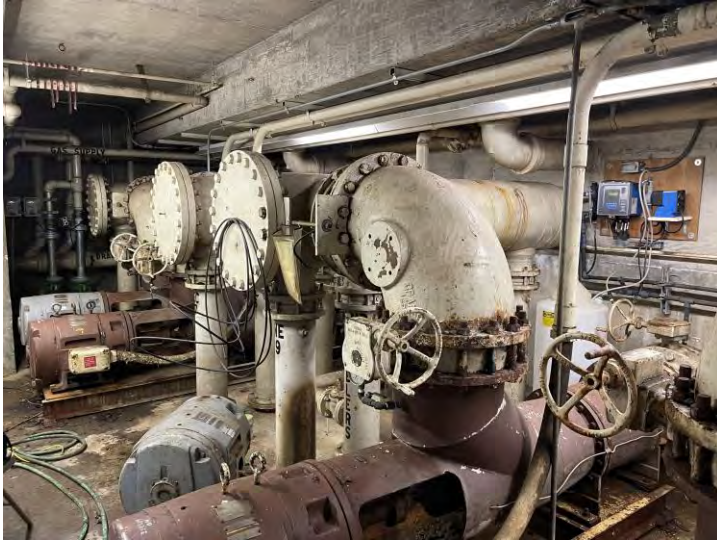
Photo # 5

Description: ACM¹ Gaskets at Pipe Flanges and Caps, LBP² and LCP³ Surfaces Throughout Main Pump Room

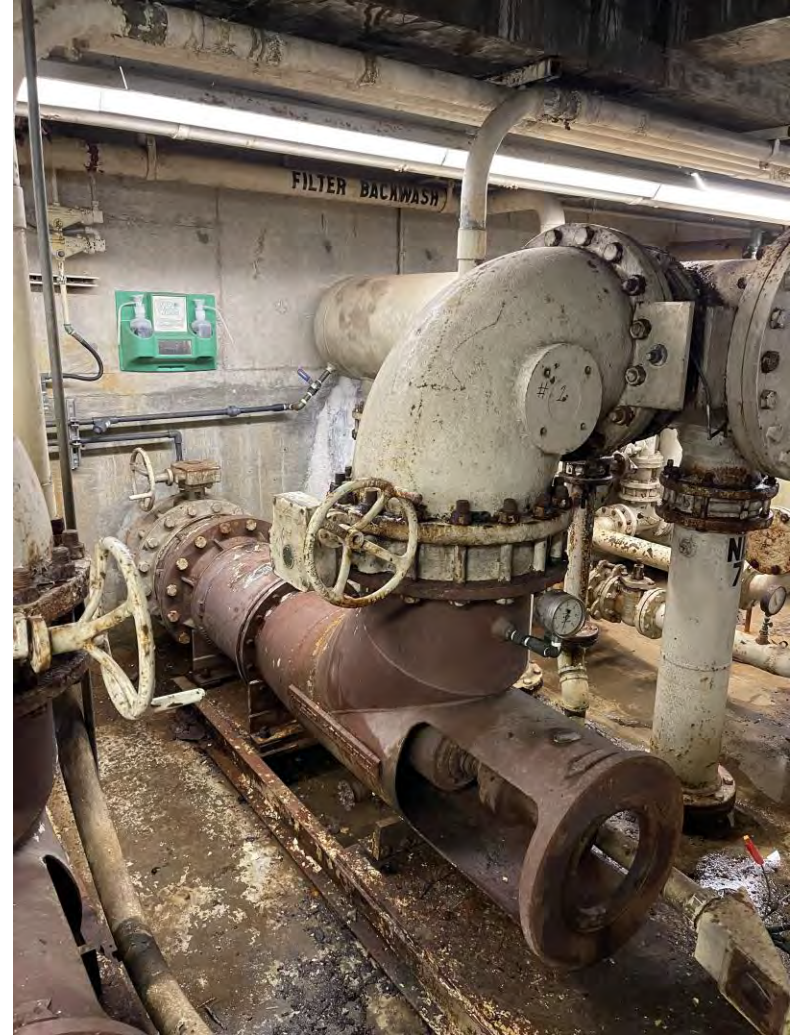
**Photo # 6**

Description: ACM¹ Gaskets at Pipe Flanges and Caps, LBP² and LCP³ Surfaces Throughout Main Pump Room

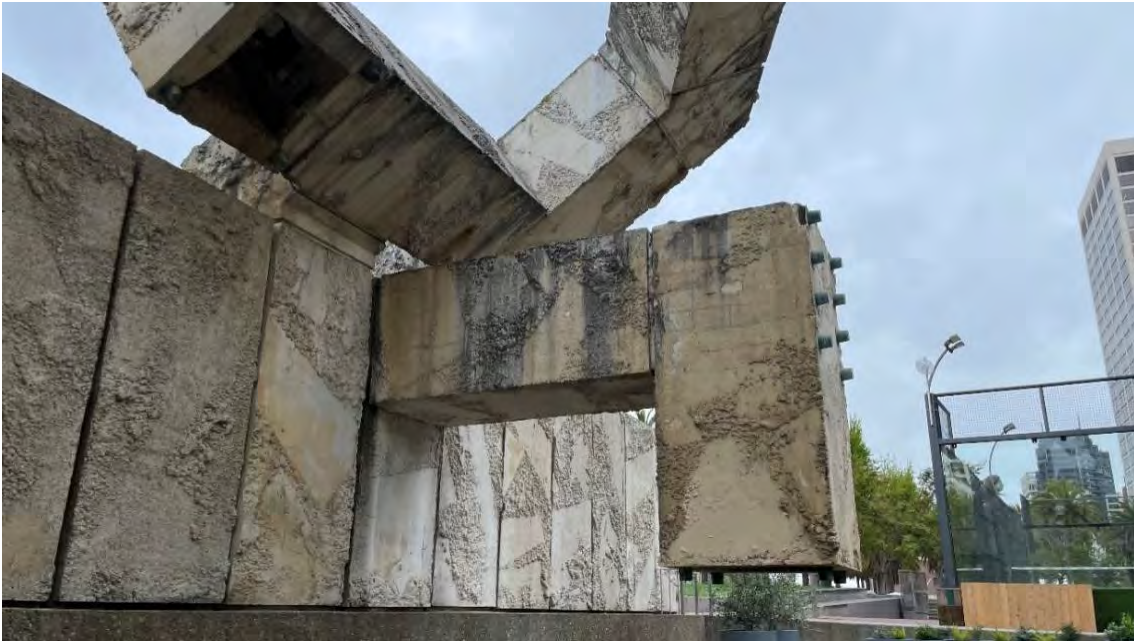
Protruding, cylindrical caps are observable at the ends of most precast concrete tubes and designate anchor locations of the steel tension rods. In locations where these anchor caps are damaged or missing, embedded steel pipes can be seen running longitudinally through the precast concrete tubes (reference *Figure 5* through *Figure 7*).

Figure 5: Vaillancourt Fountain - Cantilevered Elements Showing Tension Rods and Caps

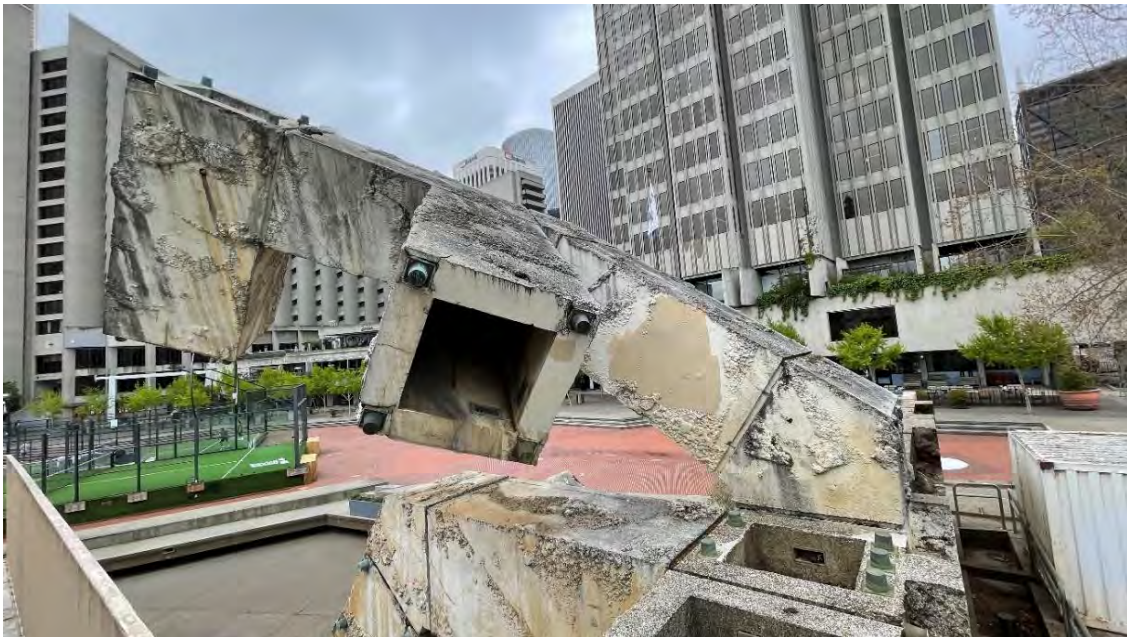
Figure 6: Vaillancourt Fountain - Cantilevered Elements Showing Tension Rods and Caps

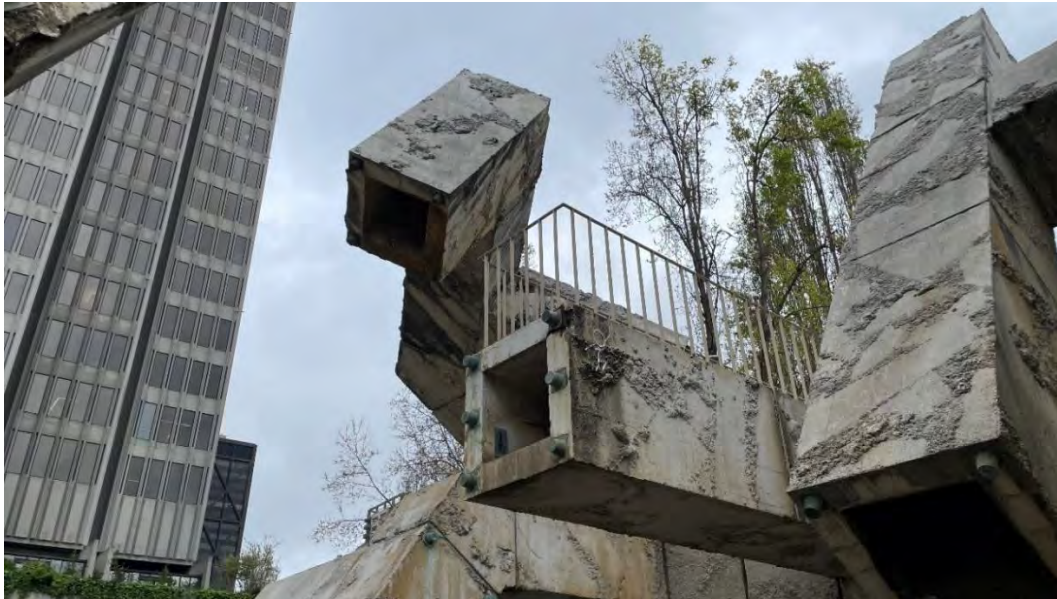
Figure 7: Vaillancourt Fountain - Cantilevered Observation Deck and Fountain Elements.
