# STATUTORY EXEMPTION APPEAL

## Embarcadero Fountain (a.k.a. “Vaillancourt Fountain”) Removal

**RE:** **Board File No. 251202**  
**Planning Record No. 2025-010275APL**  
**Appeal of Statutory Exemption for Embarcadero Fountain Removal**

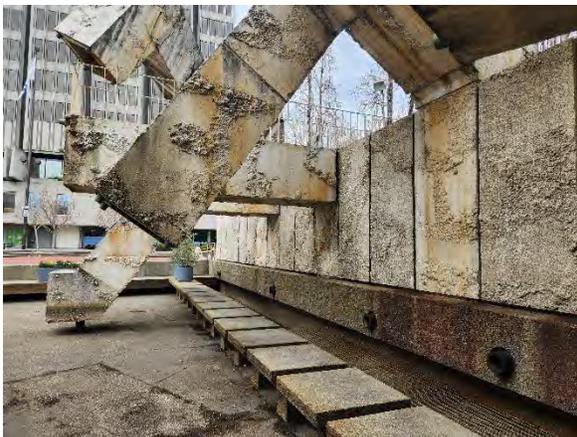
The concrete pedestals are generally in good condition, exhibiting some chipping at the edges and soiling, but otherwise appear sound without significant cracking, incipient spalls, or other spalling.

Typical overall condition of concrete “lily pad” pedestals, north side of fountain, looking west.

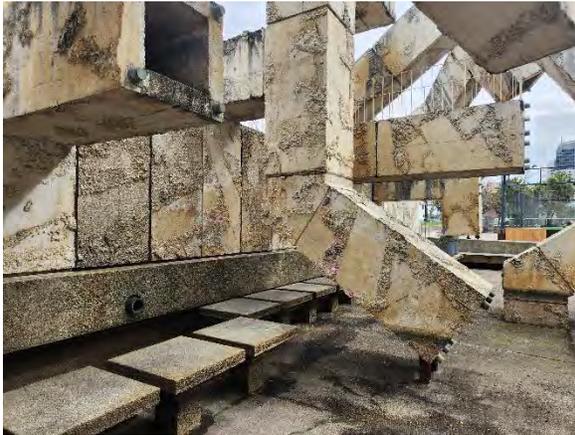
Typical overall condition of concrete "lily pad" pedestals, east side of fountain, looking southeast.

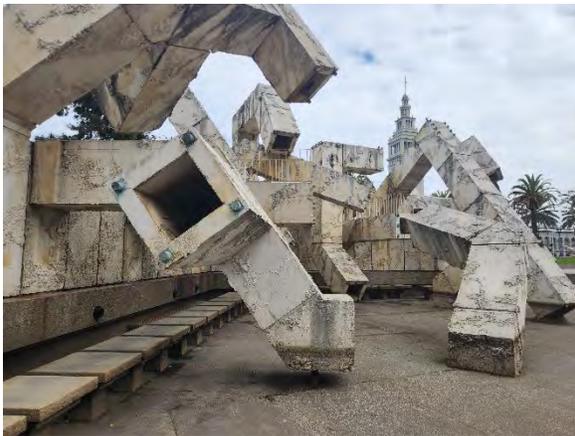
Typical overall condition of concrete "lily pad" pedestals, north side of fountain, looking east.

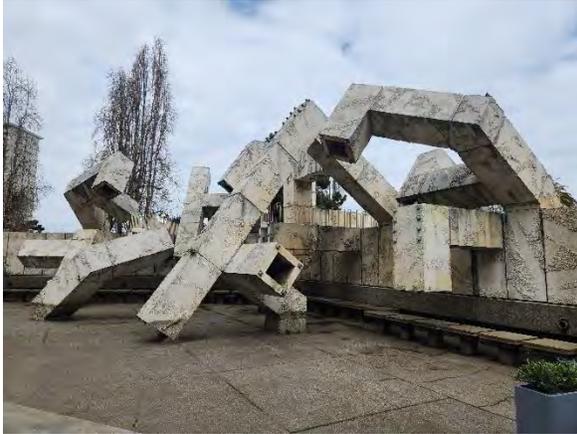
The concrete of the pre-cast concrete arms of the fountain is generally in fair to poor condition. Most exhibit some combination medium to large cracks, as well as spalls and incipient spalls. The majority of this deterioration appears to be a result of moderate to severe corrosion of the steel reinforcing within the pre-cast sections. A pattern of more significant cracking was also observed at high stress locations such as at structural transitions and connections. Exposed edges and both interior and exterior corners appear the most vulnerable to this type of deterioration. In particular, there is advanced corrosion in most of the locations where the bronze caps sit at the ends of the steel reinforcing, suggesting that galvanic corrosion may be an exacerbating factor, especially in the marine environment. In one location the cap is missing, and the steel rod within could not be verified. There is ferrous staining in numerous locations where iron oxides have been carried down the face of the elements with the flow of water. There is biological colonization in the form of algae or lichen colonies on the surface of the concrete, as well as limited observed plant colonization in the form of ferns at the joints between the pre-cast sections, which is indicative of retained or infiltrating moisture. There is dark soiling running down from many of the horizontal or nearly horizontal

Overall view of fountain, particularly the hollow, pre-cast concrete "arms," looking north.

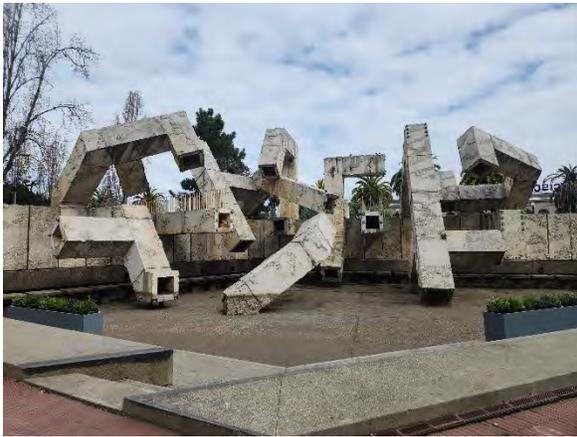
Overall view of fountain, particularly the hollow, pre-cast concrete "arms," looking northeast.

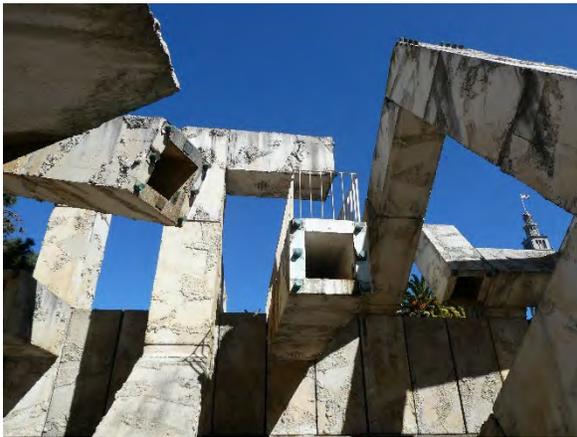
Overall view and condition of hollow, pre-cast concrete arms of fountain, looking east.

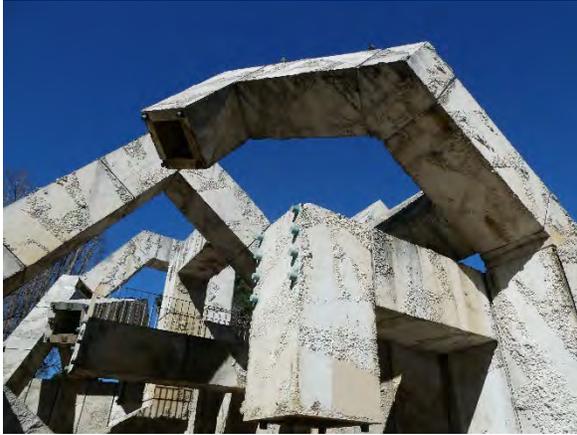
Overall view and condition of hollow, pre-cast concrete arms of fountain, looking north.

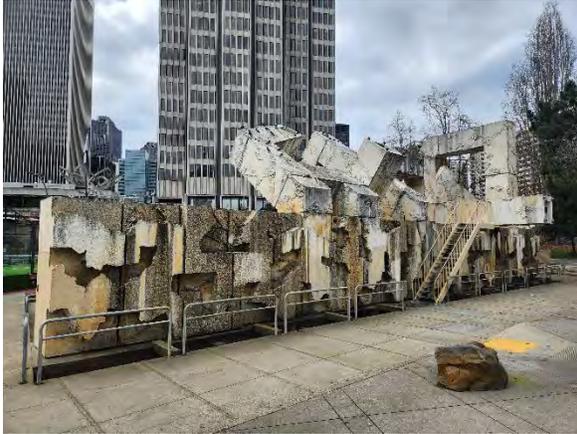
Observation of the pre-cast panel wall of the fountain was limited to the visible faces of each section, but from these surfaces it appears to be in generally fair condition, exhibiting early signs of deterioration. There are areas of crazing with hairline to small cracks, particularly in the irregular projections on the rear face of the panels; these cracks are most likely the result of surface shrinkage during the drying and curing process. Some small cracks run from edge to edge along a non-linear, irregular path, which could be from a variety of causes, including thermal stress or settlement. There are some instances of spalls and incipient spalls, most often at the upper corners where reinforcing, anchors, or other ferrous embedments have corroded. There is widespread discoloration from a variety of sources: efflorescence, soiling, ferrous staining, localized graffiti (and overpaint), and suspected mineral encrustation. There is also biological colonization of the surface primarily from algae and/or lichen, indicative of retained moisture which can contribute to the corrosion of reinforcing in the concrete.

Overall view of the hollow, pre-cast concrete panel wall, east side of fountain looking northwest.

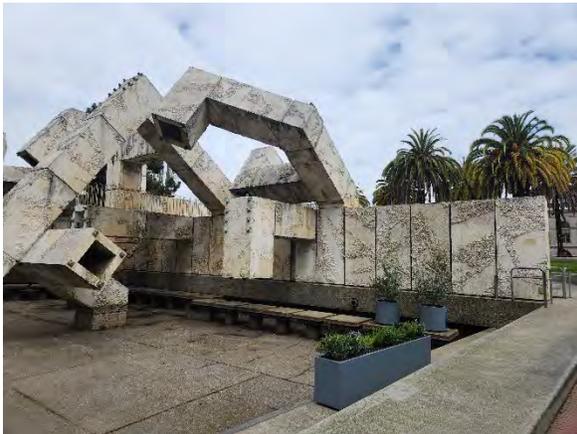
Overall view of the hollow, pre-cast concrete panel wall, east side of fountain looking northeast.

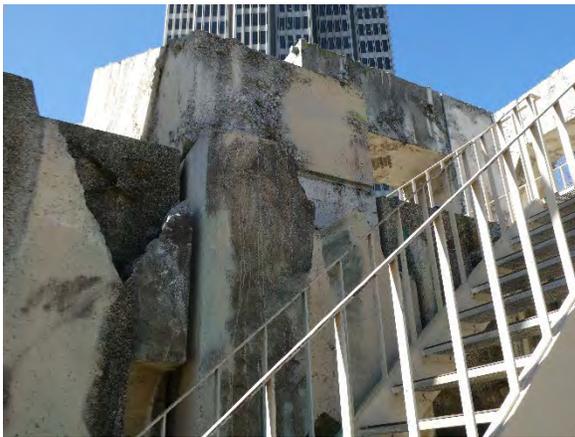
The original steel stairs, viewing platforms, and railings are painted a light buff color similar to the color of the finished concrete, and are in generally good condition. There is some soiling on the underside of the stairs and landings, as well as some localized surface corrosion and minor paint loss. Where the steel viewing platforms connect to the concrete structure, there are incipient spalls and evidence of corrosion, however it is not clear from only visual assessment whether the corroding member is the connection between the platform and the concrete or just other reinforcing within the concrete. This condition may compromise the long-term stability and safety of the platforms and should be evaluated further, particularly if the platforms are to remain accessible.

Typical overall condition of painted steel stairs on the east side of the fountain.

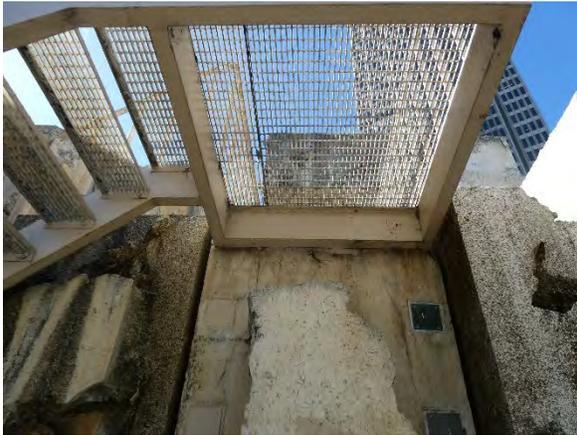
Typical condition of underside of east viewing platform landing and stairs.

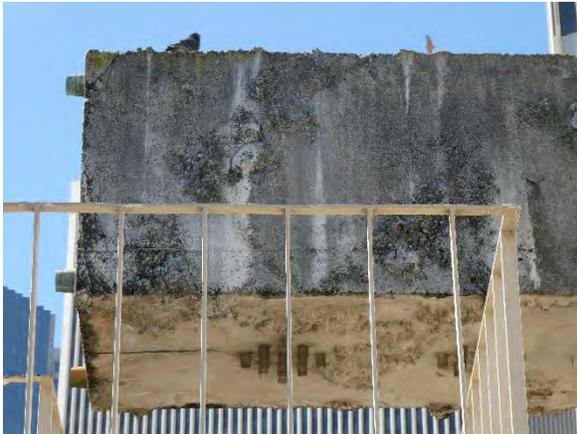
Typical condition of platform and landing railings.

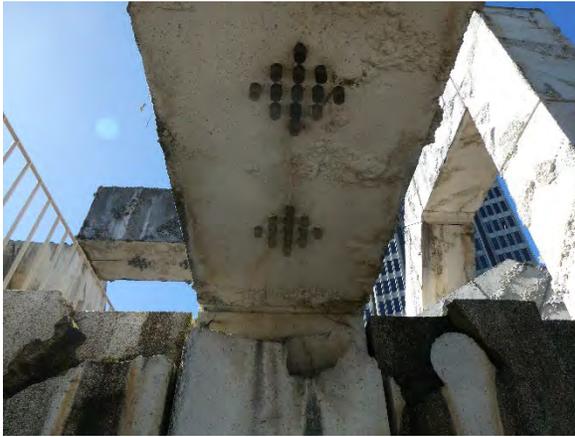
The light fixtures do not appear to still be functional, and a few of the glass cylinders have chipped or broken off (approximately 6 of the latter), however most of the glass cylinders are intact and appear to be in otherwise good to fair condition. Some have been partially painted where graffiti has been covered. The electrical lamping components of the light fixtures were not evaluated as part of this assessment, however the maintenance report from RPD indicates that the lighting system has deteriorated beyond repair and requires replacement to restore functionality.

Typical glass cylinders on the underside of the hollow, pre-cast concrete arms.

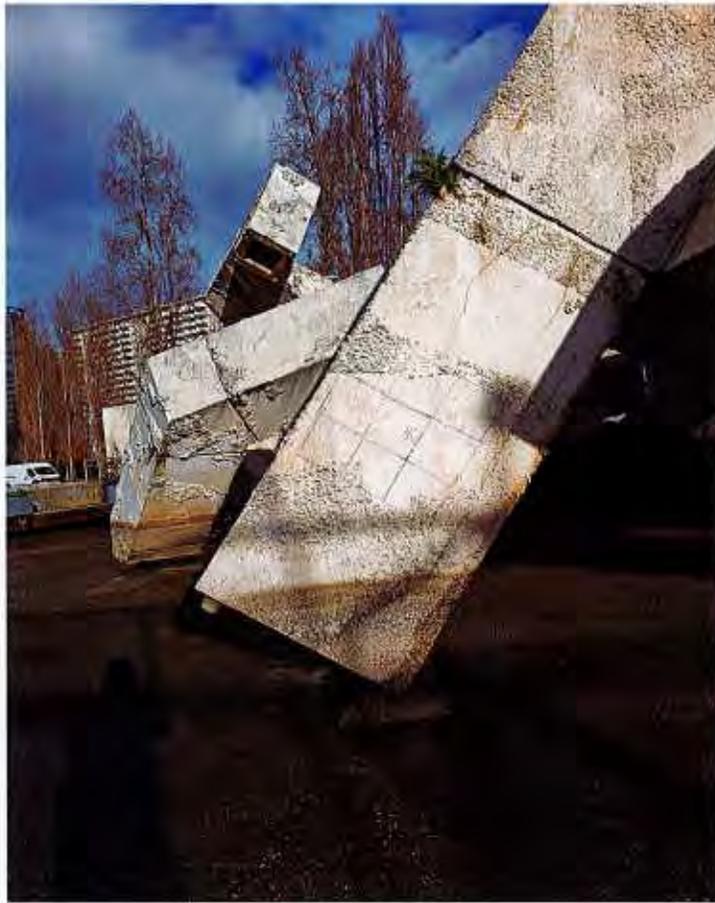
<b>Photo I.D. *</b>	<b>Surveyed Area Description Summary</b>
1	Precast tube reinforcing spacing is 12" on center each way with 4" and 3½" cover from outside face.
2	The precast tubes appear to have some sort of connection/through bolt or pipe holding cantilevered sections together. See red markings in Photo 2. Red markings indicate potential through bolt connections which line up with end caps at exterior of precast tube. Blue marking indicates reinforcing steel.
3	Steel plate at end cap.
4	Rear wall near staircase. No reinforcing at protruding precast formed shapes.

**Photo 1. Side view of one of the tubes with GPR scan markings on the face of the tube.**

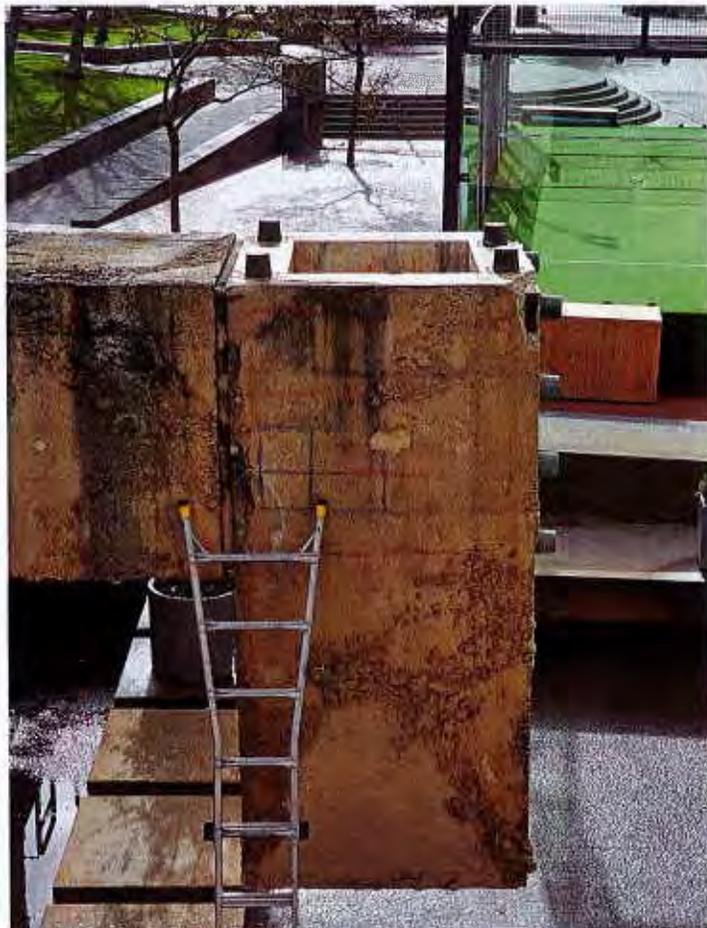
**Photo 2. Red GPR scan markings indicate a rod of an unknown material connecting the tubes.**

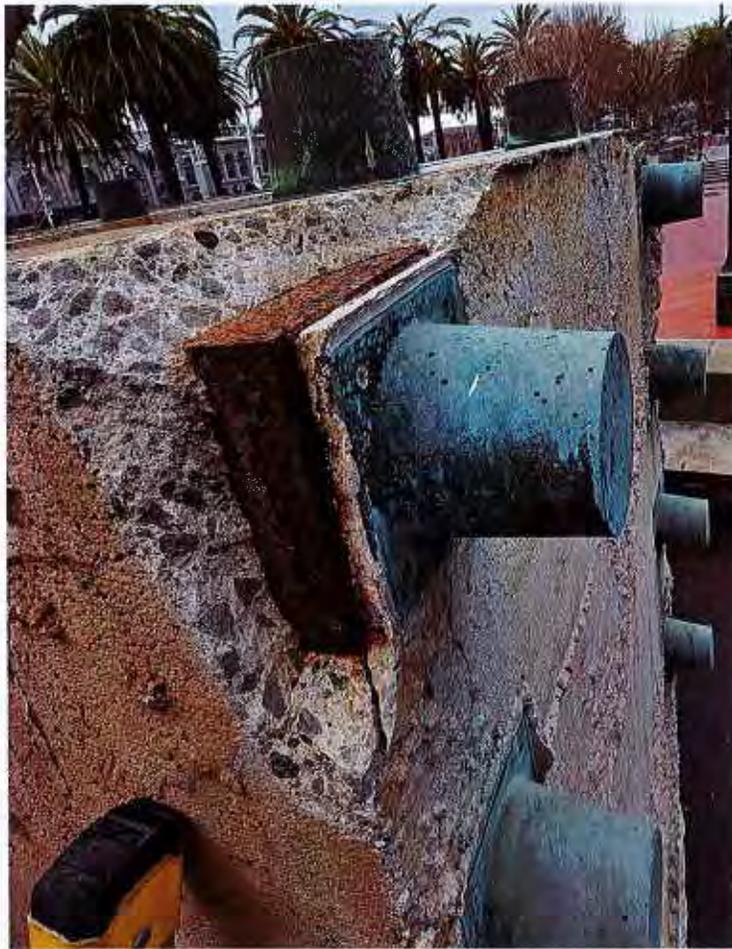
**Photo 3. Steel plate at end cap.**

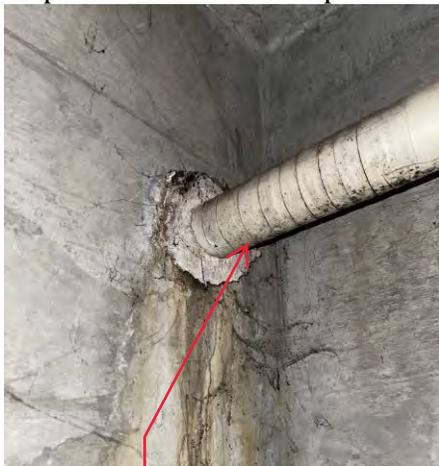
**Photo # 1**

Description: ACM<sup>1</sup> Pipe Insulation at Pump Room Closet

This is the only area where ACM pipe insulation was identified. This insulated pipe run exits the room through a wall opening, presumably to the exterior underground area)

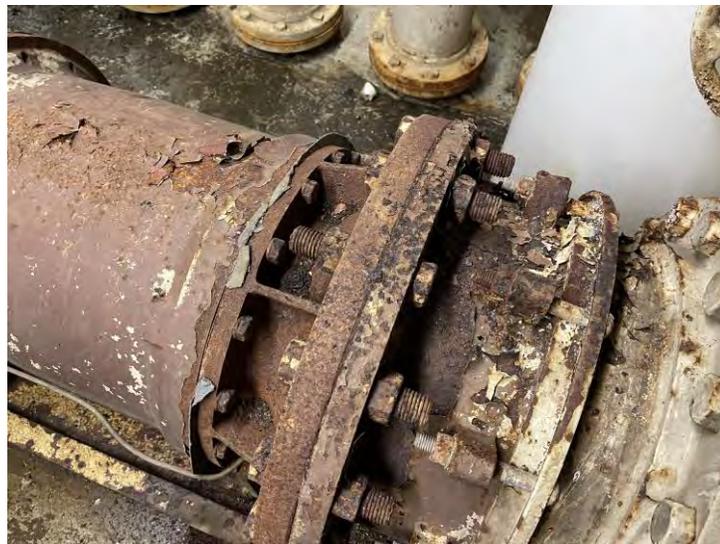
**Photo # 2**

Description: ACM<sup>1</sup> Pipe Gasket and Multiple LBP<sup>2</sup> Surfaces at Main Pump Room

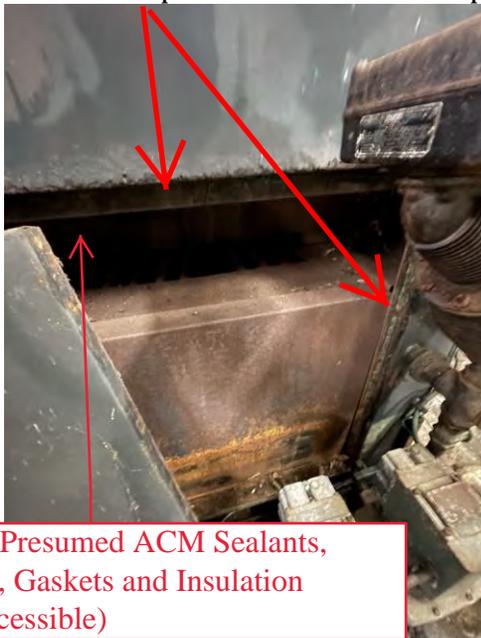
**Photo # 3**

Description: ACM<sup>1</sup> Boiler Rope Gasket at Main Pump Room

Boiler Interior is Presumed ACM Sealants, Ribbing Material, Gaskets and Insulation (Concealed/ Inaccessible)

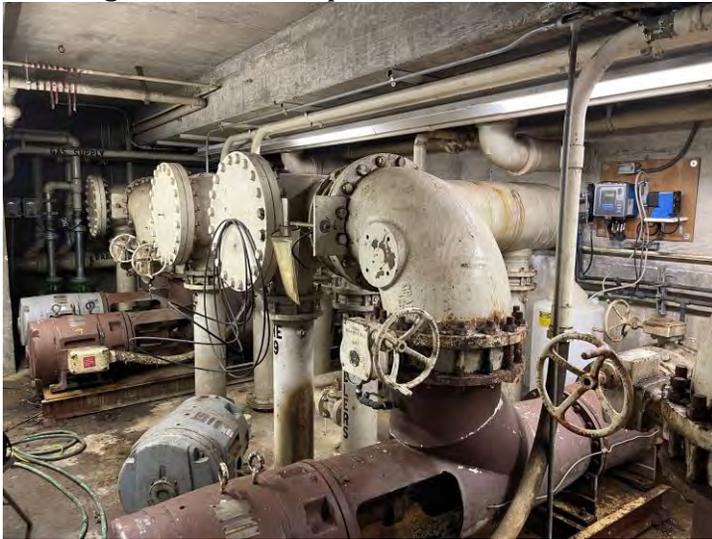
**Photo # 5**

Description: ACM<sup>1</sup> Gaskets at Pipe Flanges and Caps, LBP<sup>2</sup> and LCP<sup>3</sup> Surfaces Throughout Main Pump Room

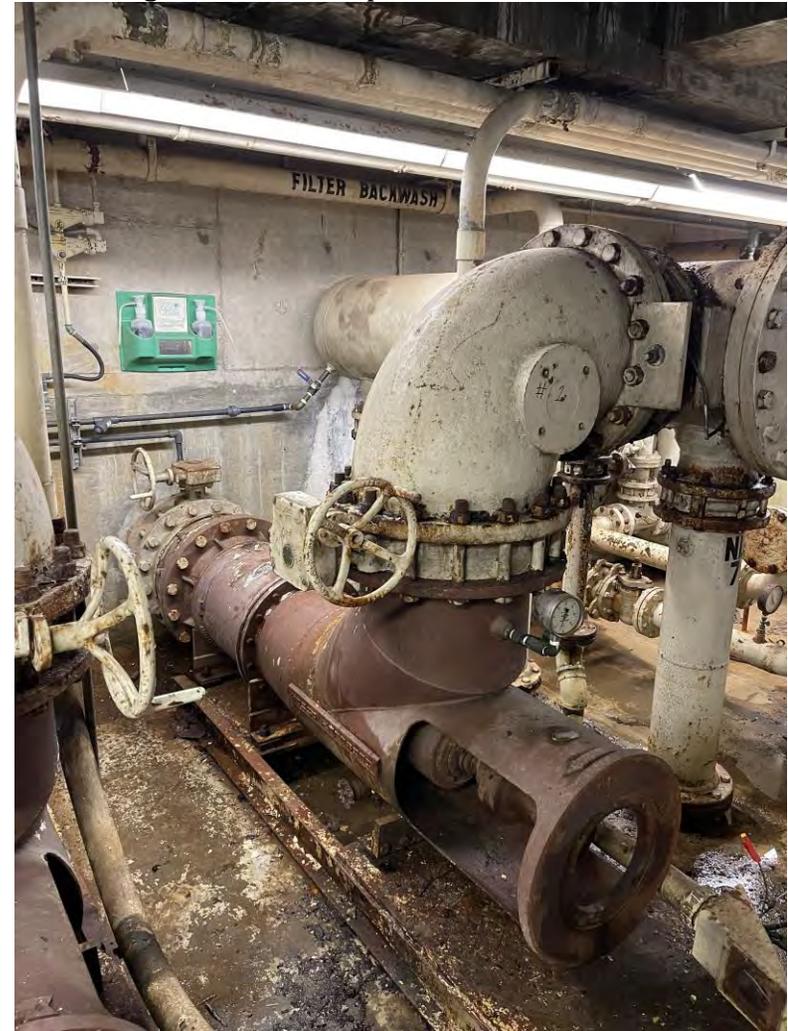
**Photo # 6**

Description: ACM<sup>1</sup> Gaskets at Pipe Flanges and Caps, LBP<sup>2</sup> and LCP<sup>3</sup> Surfaces Throughout Main Pump Room

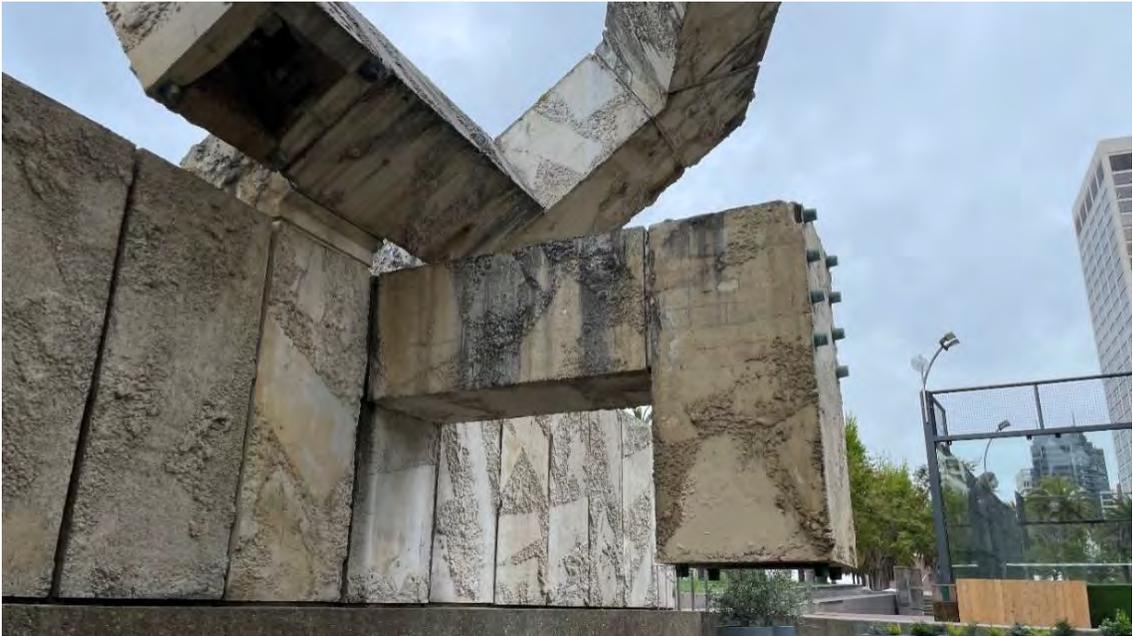
Protruding, cylindrical caps are observable at the ends of most precast concrete tubes and designate anchor locations of the steel tension rods. In locations where these anchor caps are damaged or missing, embedded steel pipes can be seen running longitudinally through the precast concrete tubes (reference *Figure 5* through *Figure 7*).

*Figure 5: Vaillancourt Fountain - Cantilevered Elements Showing Tension Rods and Caps*

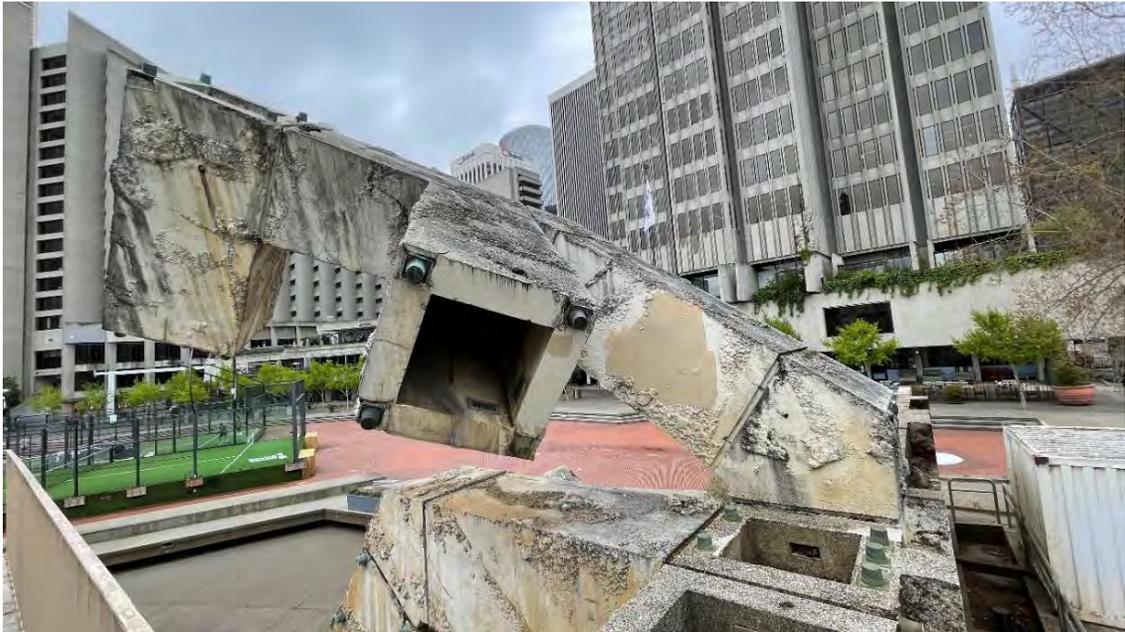
*Figure 6: Vaillancourt Fountain - Cantilevered Elements Showing Tension Rods and Caps*

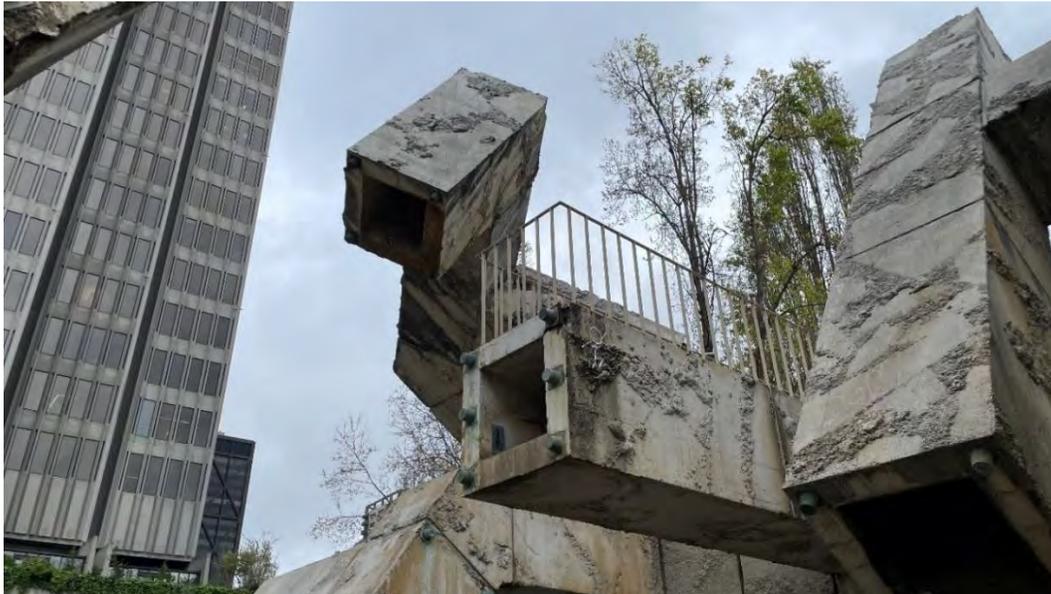
Figure 7: Vaillancourt Fountain - Cantilevered Observation Deck and Fountain Elements.
