Re: Transmittal of Planning Department Case Number 2013.0910L:
149-155 9th Street, Article 11 Change of Designation
BOS File No: _____ (pending)
Historic Preservation Commission Recommendation: Approval

RESOLUTION TO RECOMMEND TO THE BOARD OF SUPERVISORS AN ARTICLE 11 CHANGE OF DESIGNATION FOR 149-155 9TH STREET, LOT 048 IN ASSESSOR'S BLOCK 3728, AS A CATEGORY III (CONTRIBUTORY) BUILDING PURSUANT TO SECTION 1106 OF THE PLANNING CODE

ARTICLE II HISTORIC BUILDING REPORT

MAINTENANCE PLAN

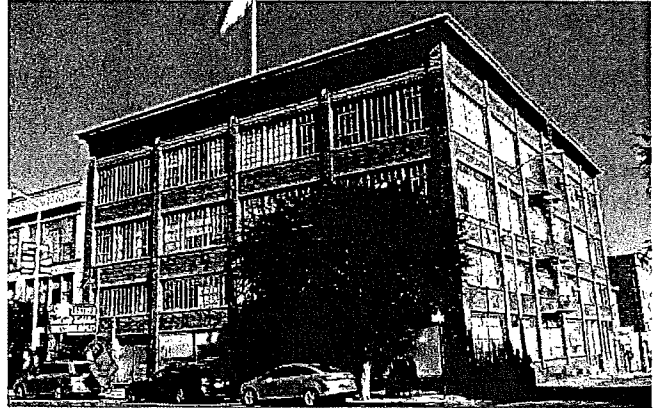
General building features appear in good to fair condition. Any specific concerns or points of note are detailed within each individual section. There is some noticeable soiling of the building base and trash/debris at sidewalks along both the south and west (Natoma Street and 9th Street respectively). The north and east elevations have some locations of noted paint/graffiti.

Figure 1. 149 9th Street; view from 9th Street looking east.

Power wash exterior of building prior to maintenance work. Utilize low-pressure spray only (100-800 psi), keeping fan tip nozzle minimum of 6 inches away from surface being cleaned. Higher pressure washing can damage masonry.

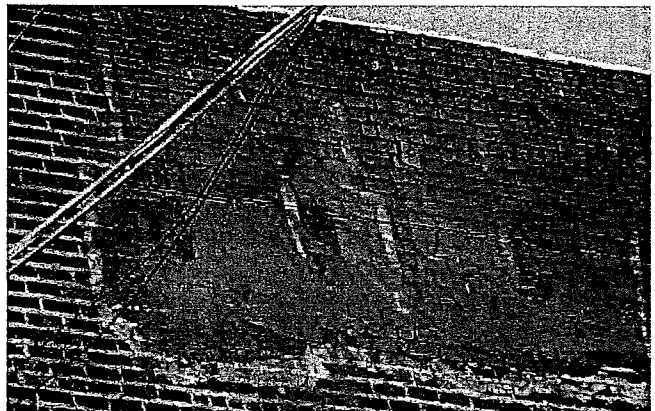
Figure 2. East Elevation; note graffiti & paint to be removed.

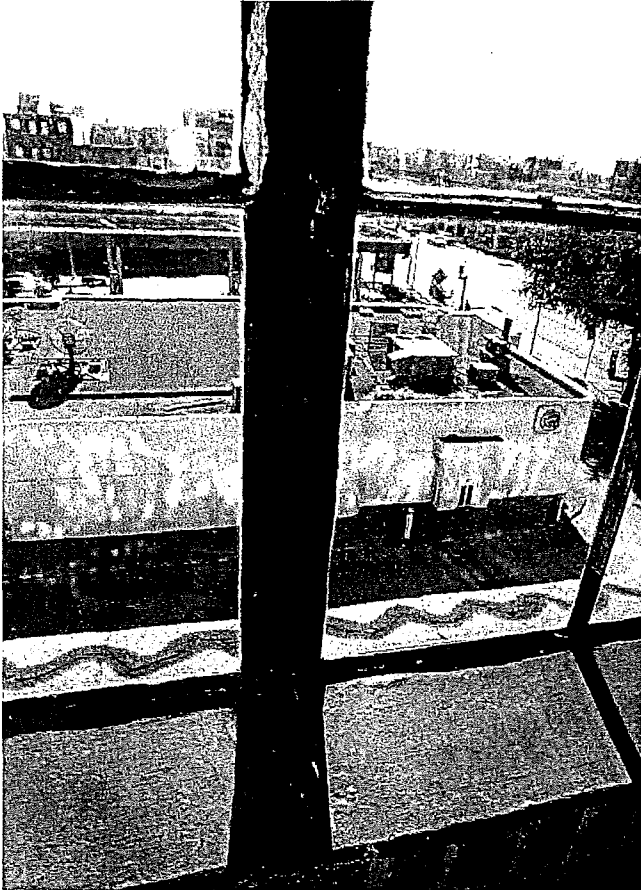
Figure 3. Steel window frame detail.

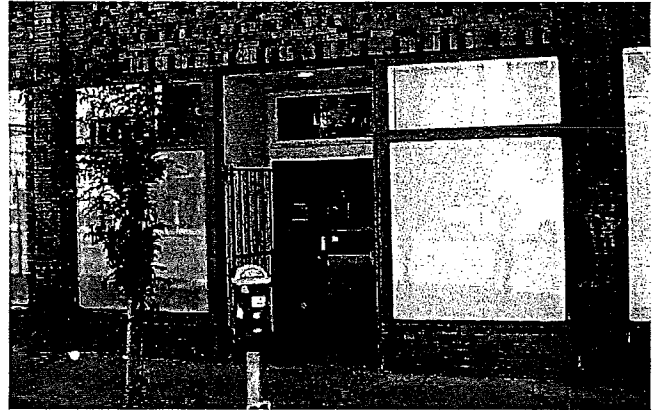
The wood frame storefront system occupies the center bay at the first floor west (9th Street) elevation, with a recessed entrance central at this location. The lower, larger panes of glass are set in a steel frame similar to those found within the other bays. The transoms are fixed with wood stops. The entire assembly is painted. The recessed entry has a concrete floor leading to a metal door with metal sidelight and transom (see *Feature III-E: Exterior Door Type B – Metal*). The entire assembly appears to be in good condition.

Figure 1. Storefront at west elevation.

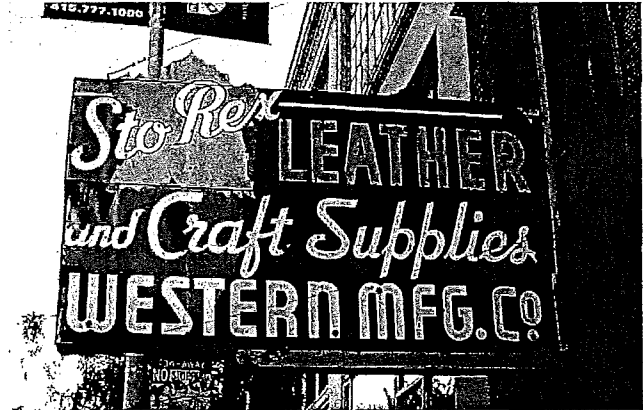
Figure 1. Projecting Sign along 9th Street (west elevation).

Any replaced metal for attaching frame to be compatible with, or isolated from, adjacent materials to avoid galvanic action and corrosion.
