# HISTORICAL STRUCTURE REPORT

1338 Filbert LLC

LANDMARK DESIGNATION REPORT  
DATE: JULY 12, 2001  
CASE NO.: 2001.0232L

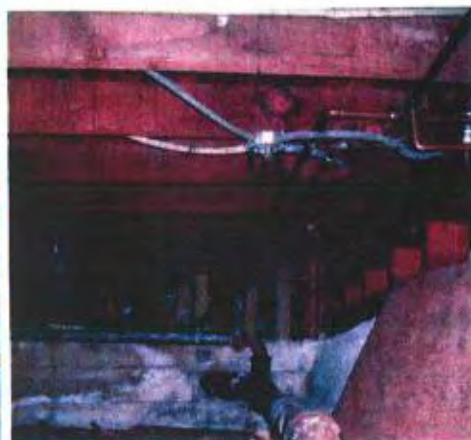
**Figure 17 (right):**  
 Wood framing members,  
 view from crawlspace  
 below upper unit.

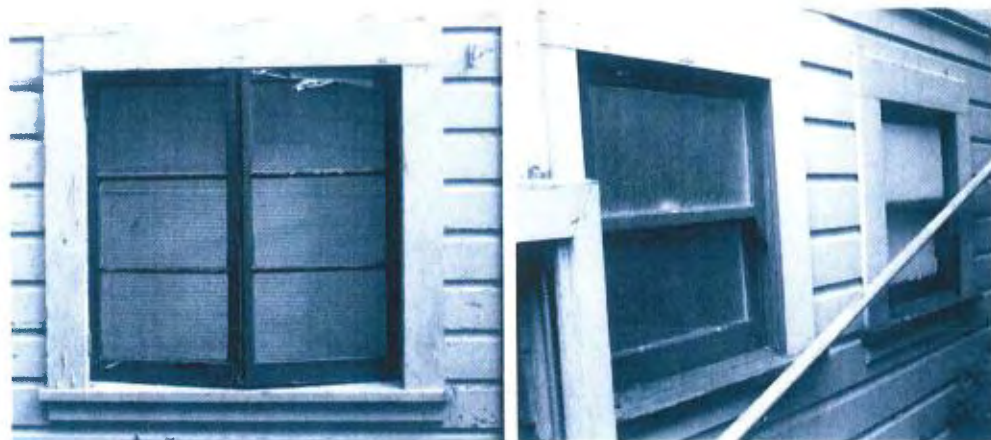
**Location:** Cottages  
**Value:** Significant  
**Condition:** Fair - Poor

**Figure 20 (left):**  
Divided wood casement.

**Figure 21 (right):**  
One-over-one wood double-hung.

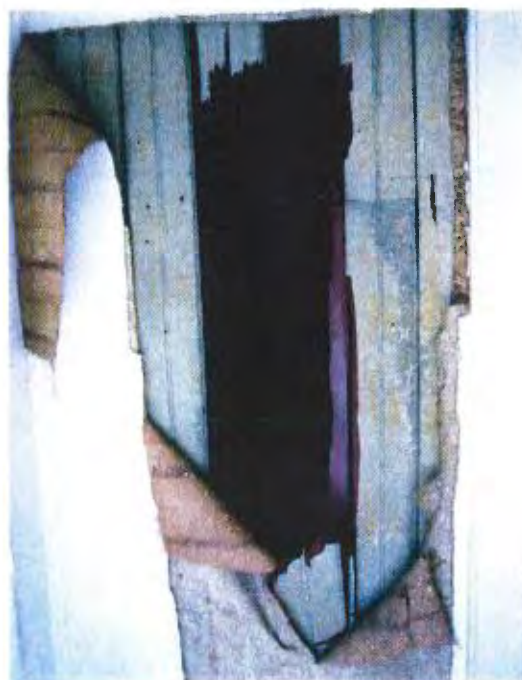
**Figure 30 (right):**  
Bead board mounted to substrate, exposed in Cottage A.

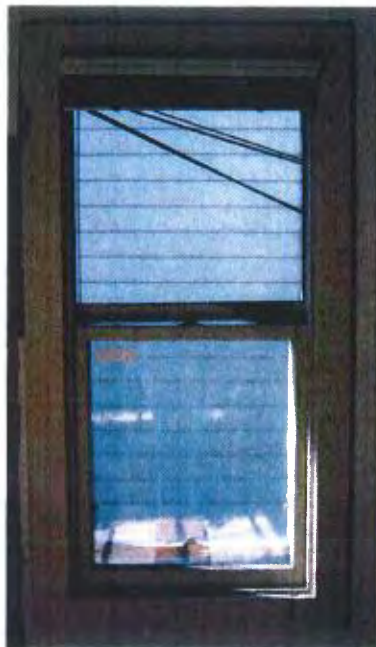
**Figure 31 (left):**  
Interior window trim around double-hung window, west wall of Cottage A.

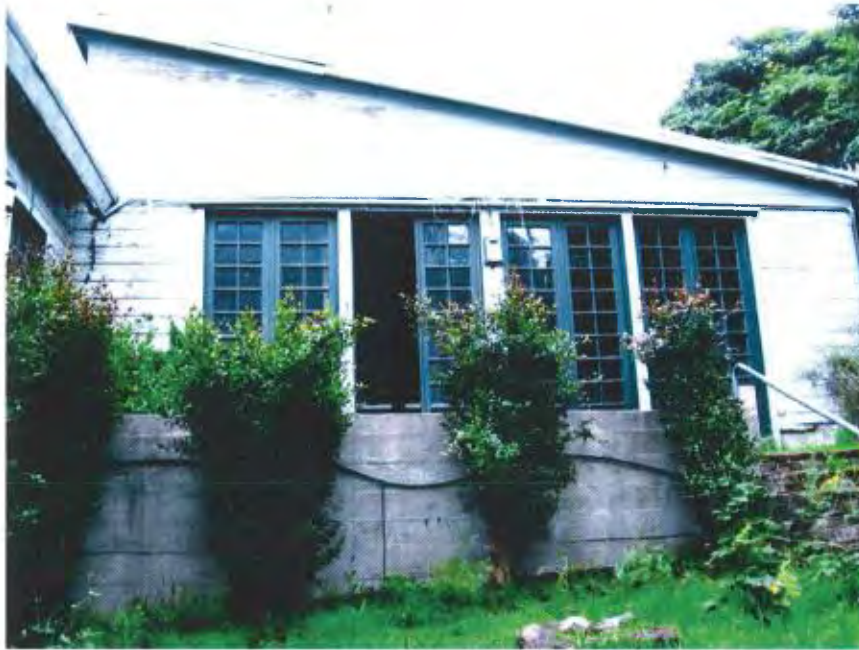
Figure 4. View of the primary (west) façade of the studio.

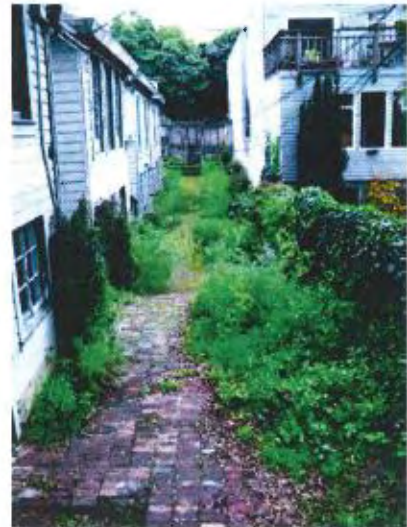
Figure 1: View looking south of the brick path and 1907 cottages, at left.

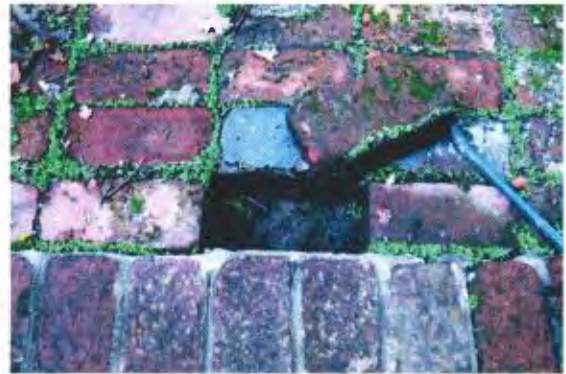
- All bricks sit upon a compacted sandy soil bed (no evidence of concrete setting bed or slab was found except at the stairs and patio adjacent to the studio) (Figure 3).

Figure 3: Bedding is a soil/sand mixture
