149-155 9TH STREET  
SAN FRANCISCO, CA

ARTICLE 11 CHANGE OF DESIGNATION DOCUMENTS

- ARTICLE 11 HISTORIC BUILDING REPORT
- MAINTENANCE PLAN

JULY 25, 2014

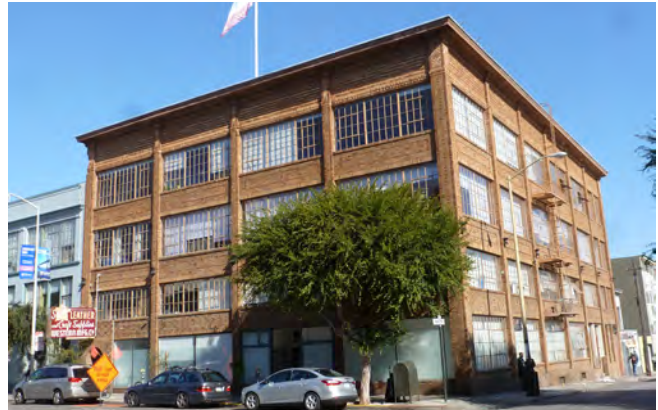
General building features appear in good to fair condition. Any specific concerns or points of note are detailed within each individual section. There is some noticeable soiling of the building base and trash/debris at sidewalks along both the south and west (Natoma Street and 9<sup>th</sup> Street respectively). The north and east elevations have some locations of noted paint/graffiti.

Figure 1. 149 9th Street; view from 9th Street looking east.

Power wash exterior of building prior to maintenance work. Utilize low-pressure spray only (100-800 psi), keeping fan tip nozzle minimum of 6 inches away from surface being cleaned. Higher pressure washing can damage masonry.

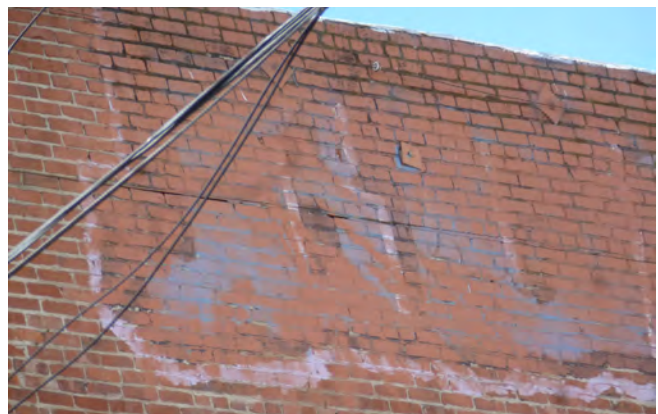
Figure 2. East Elevation; note graffiti & paint to be removed.

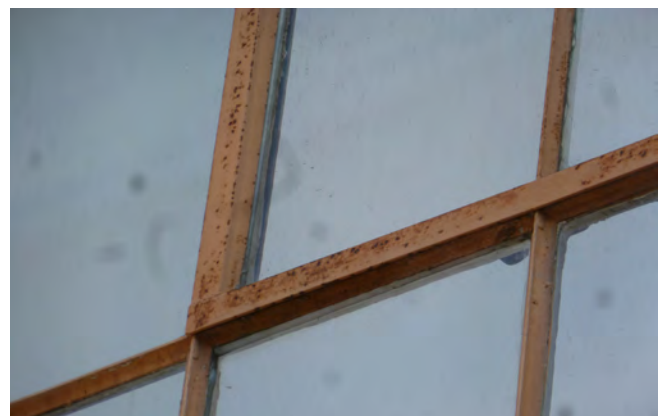
Figure 2. Steel window frame details

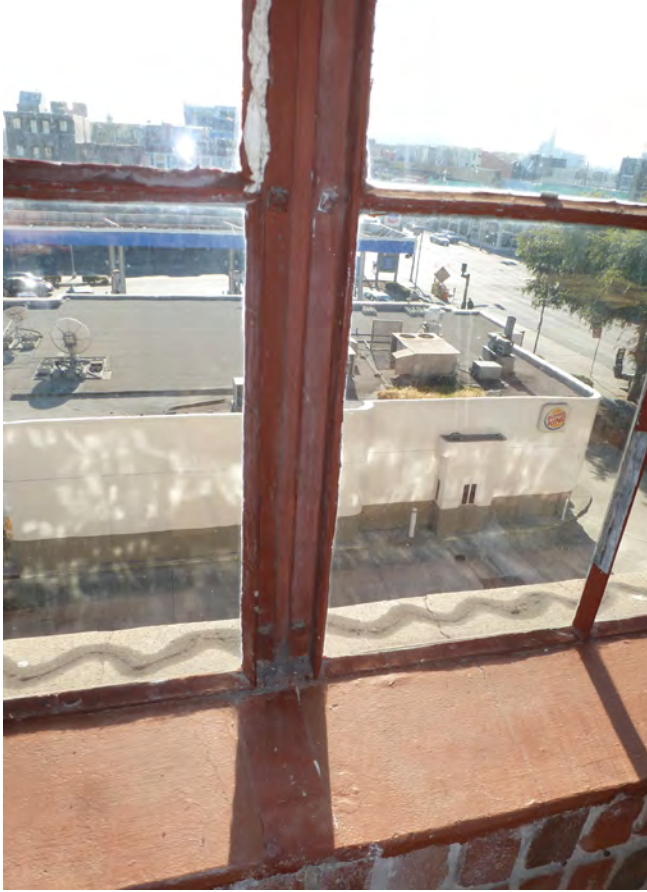
**Figure 3. Steel window frame detail.**

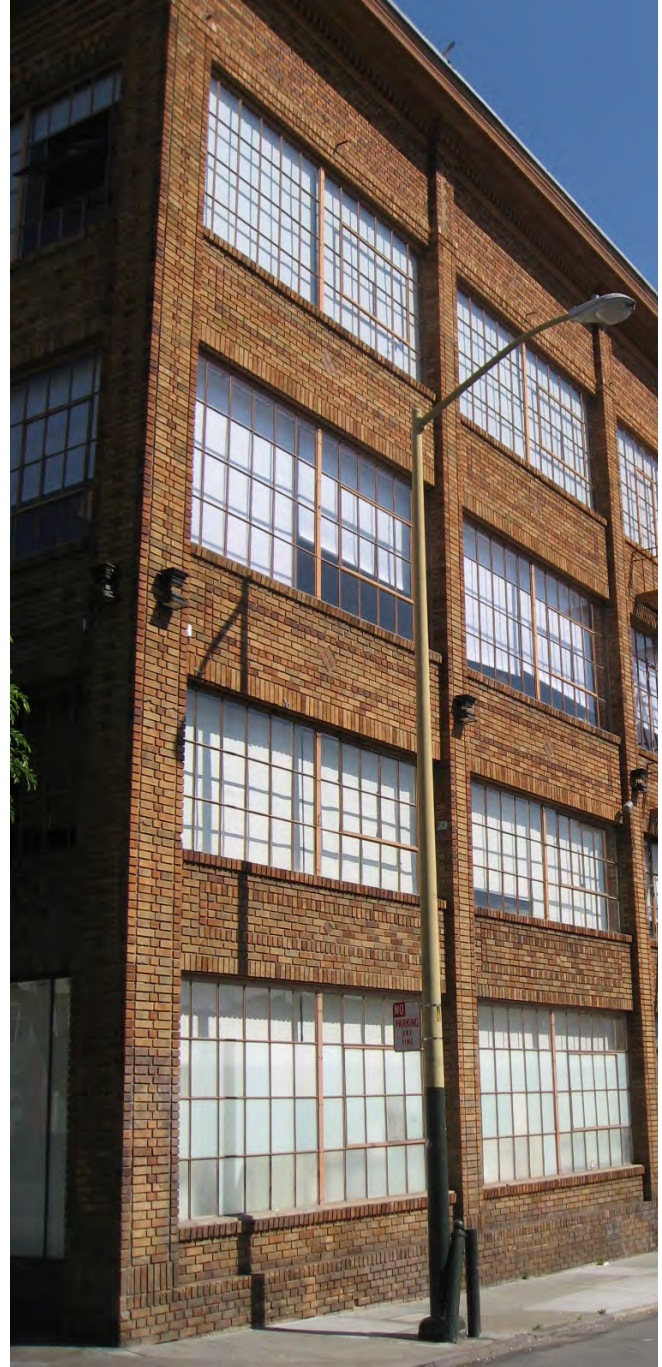
**Figure 5. Typical window bay (south elevation)**

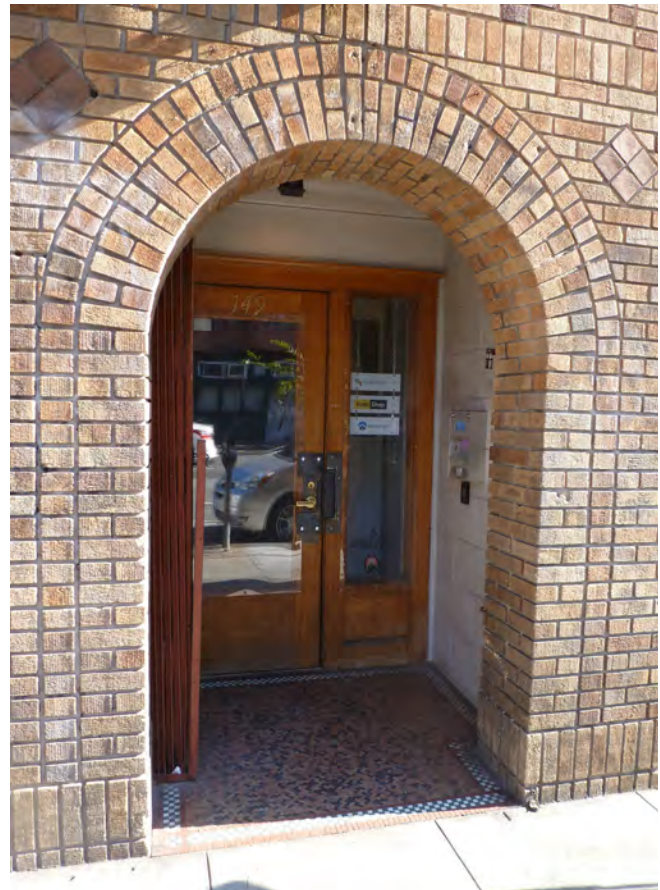
Figure 1. Entrance at northwest corner.

Due to noted security issues at northwest entrance door, consider replacement of security gates at entrances. Replacement gates should be comparable with existing gates along Natoma Street.

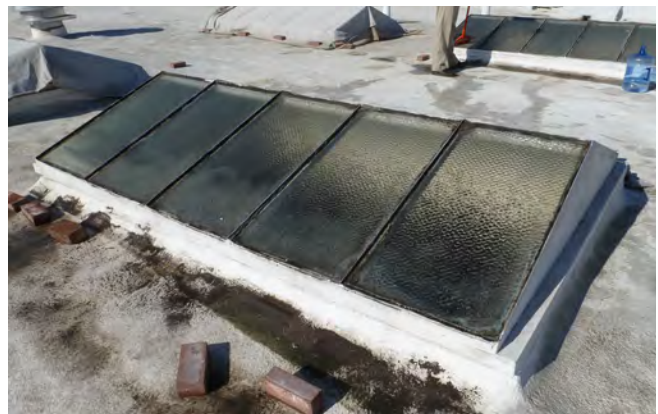
Figure 2. Typical skylight.

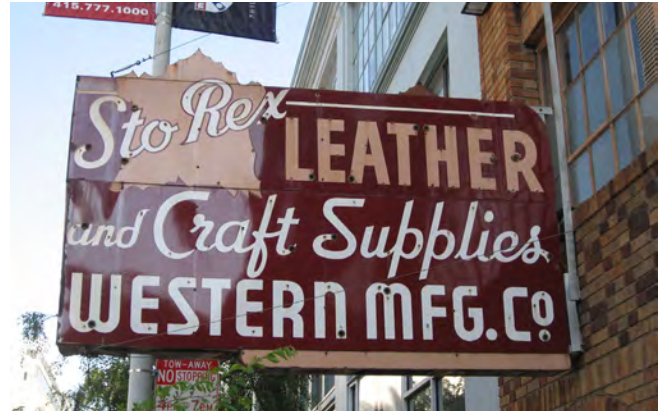
Figure 1. Projecting Sign along 9th Street (west elevation).

Any replaced metal for attaching frame to be compatible with, or isolated from, adjacent materials to avoid galvanic action and corrosion.

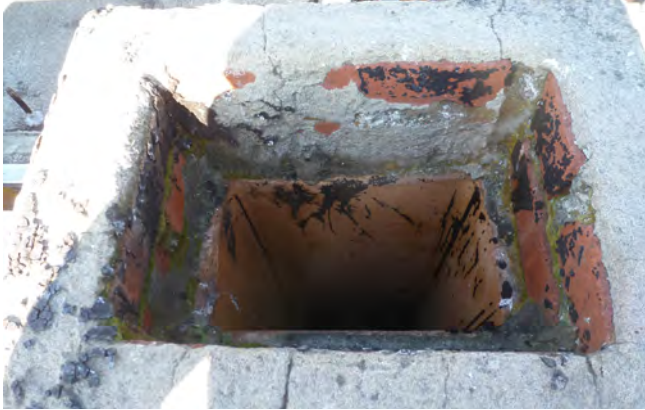
**Figure 2.** Open ventilation stack on north wall; cover with sheet metal as needed.

Inspect flashing and caps annually. Consider caps or flashing/protection for the vent stacks (if not in use). Prepare, prime, paint and seal. Inspect annually for cracks or other signs of movement at the stacks. Repair as needed.
